MBK Mill Leach pad – Contaminated Water

GN reference #: 2024-207 & 2024-232

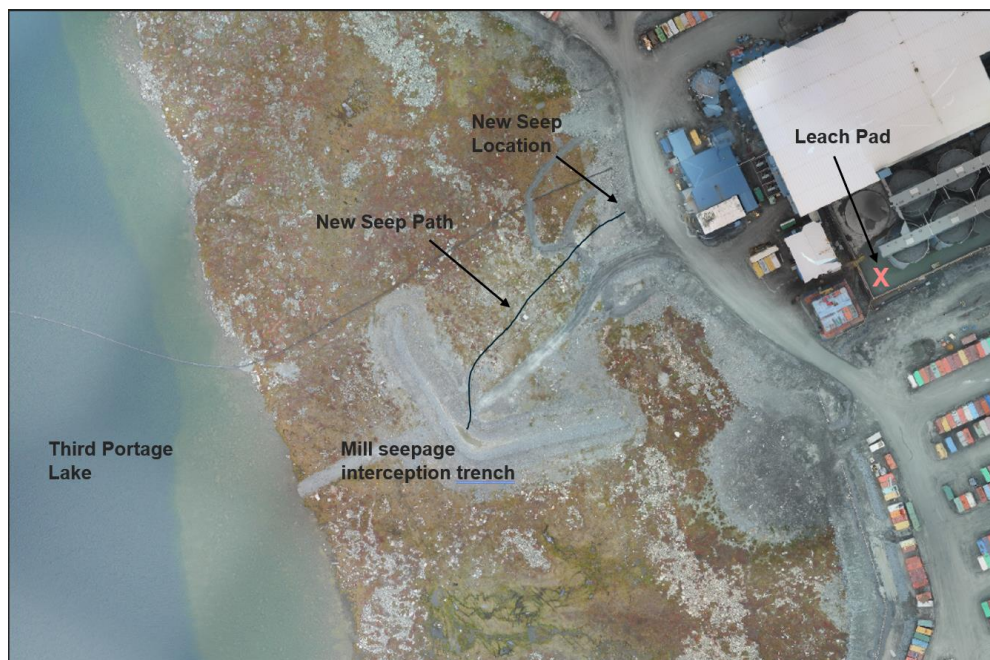
During routine monitoring of an identified area on May 20th, evidence of seepage was observed on the west side of the assay lab road. Since the previously reported December 2023 event (#2023-524) in the same area, no evidence of seepage had been noted. Monitoring had been carried out throughout the winter and was subsequently increased for the freshet season. During freshet pumping and recovery operations on May 22nd, 2024, it was observed that the level of the leach pad containment area was decreasing faster than anticipated. Upon further inspection, it was discovered that certain areas of the containment were not watertight, allowing water to escape into a depression outside the containment. Further investigation determined that the source of the spill reported on May 21st (#2024-232) was the same as that of the spill reported on May 23rd (#2024-207). There were no off-site impacts or discharges as the seep was contained within existing water management infrastructure previously constructed.

Figure 1. Site aerial image with water management infrastructure identified

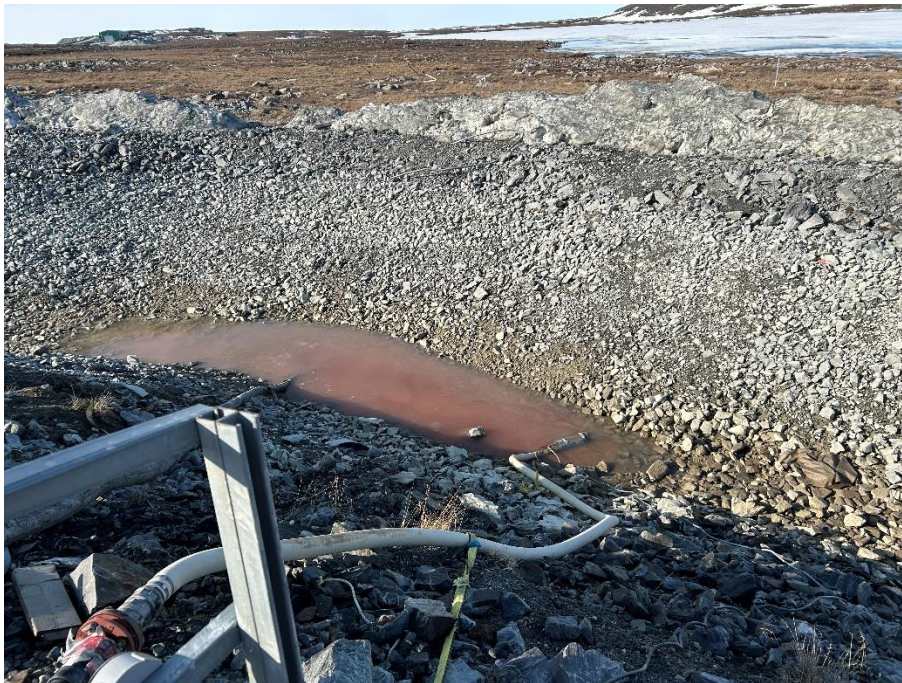
Secondary containment integrity

Upon discovering the water inflow, an investigation was launched to identify potential sources. Samples were collected to pinpoint the source of the seepage, and a red dye test was conducted at the mill leach pad containment. The dye test conclusively determined that the source of the spill was the leach pad secondary containment. The contaminated water was contained and managed within the existing water management infrastructure. The pumping system in place directed the contaminated water back to the mill system. Additional samples were collected from the downstream environment (Third Portage Lake) and sent to external labs for analysis.

Figure 2. Dyed water from the leaching pad reporting to the mill trench

Agnico will be bringing in an expert to inspect the mill leach pad and provide guidance on the scope of repairs. Until the expert's visit and the implementation of an action plan based on his findings, the secondary containment will be kept as dry as possible.
