2024-06-12 MBK Baker Lake TSS

GN reference #: 2024-222

Description

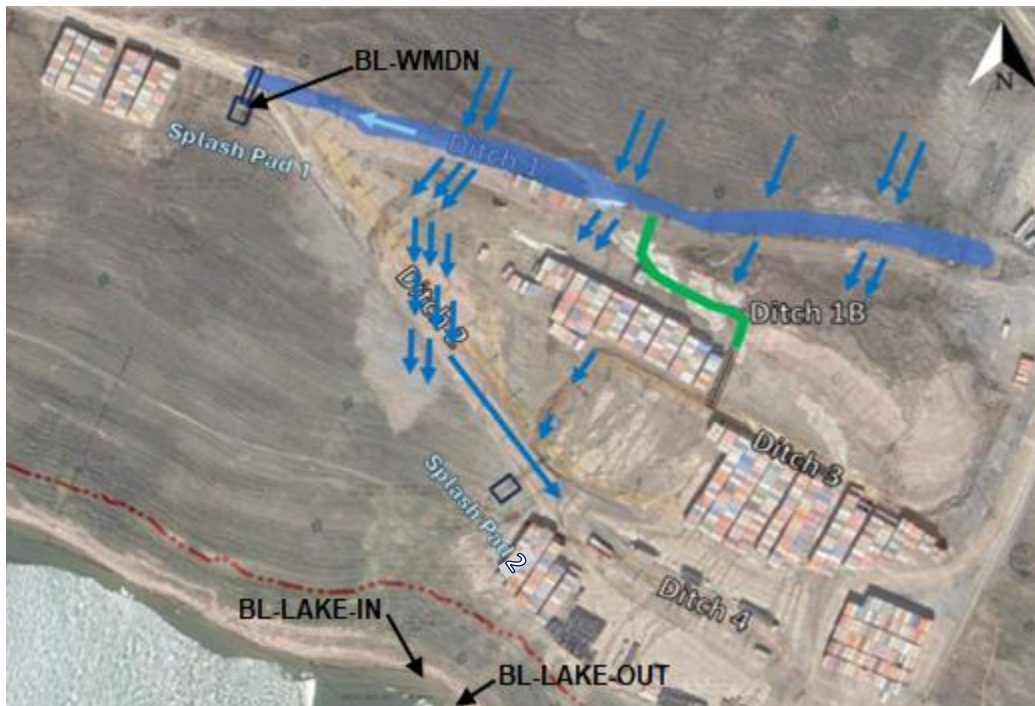
Figure 1. Overall Layout - Aerial Picture with the original flow path observed on June 12th.

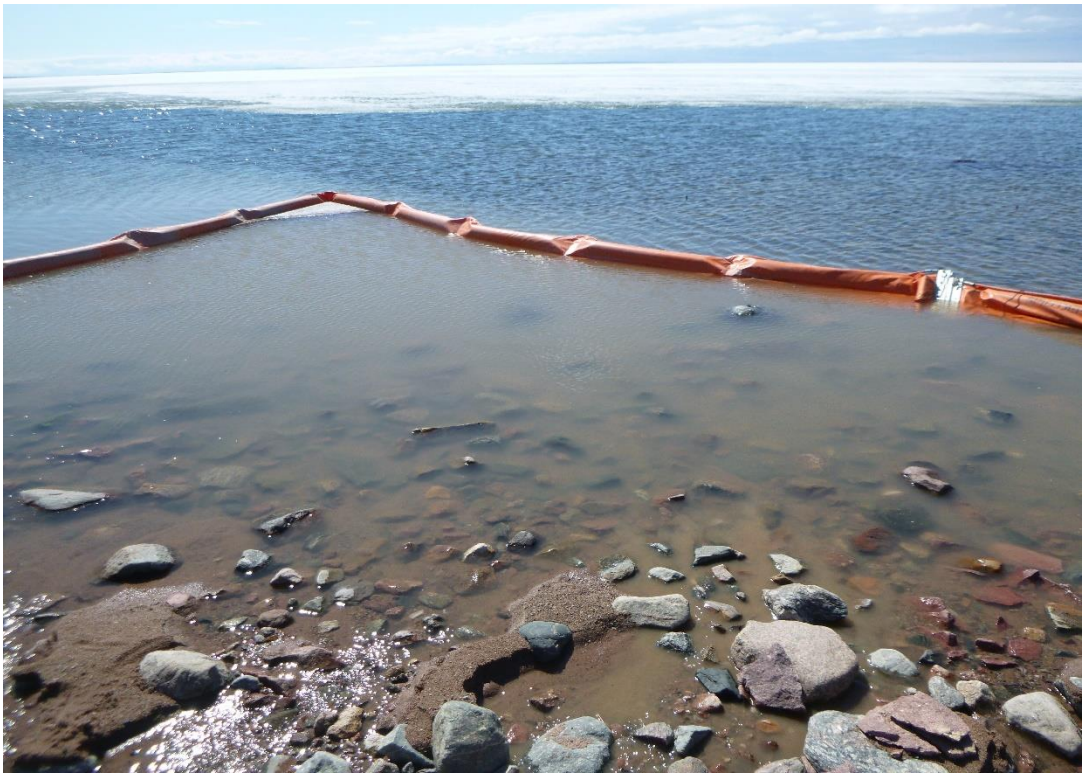
Figure 2 Area where turbid flow was observed entering Baker Lake and contained within turbidity barriers

Location: 64° 18'20" 95° 57'23". The impacted waterbody is Baker Lake.

Upon observation of the runoff into the lake maritime curtains were re-deployed and additional woodchip-log booms and silt fence were deployed to control the transportation of sediments. Over the next weeks, inspections and monitoring of the sector were performed by Agnico Eagle. During the monitoring, the TSS control measures were monitored, repaired, and added, if needed. Samples of the water quality (total suspended solids) of the lake at the inflow location were taken, as described in Table 1. As part of the Core Receiving Environmental Monitoring Program, water chemistry monitoring will occur in Baker Lake during the summer to evaluate potential lake water quality impact.

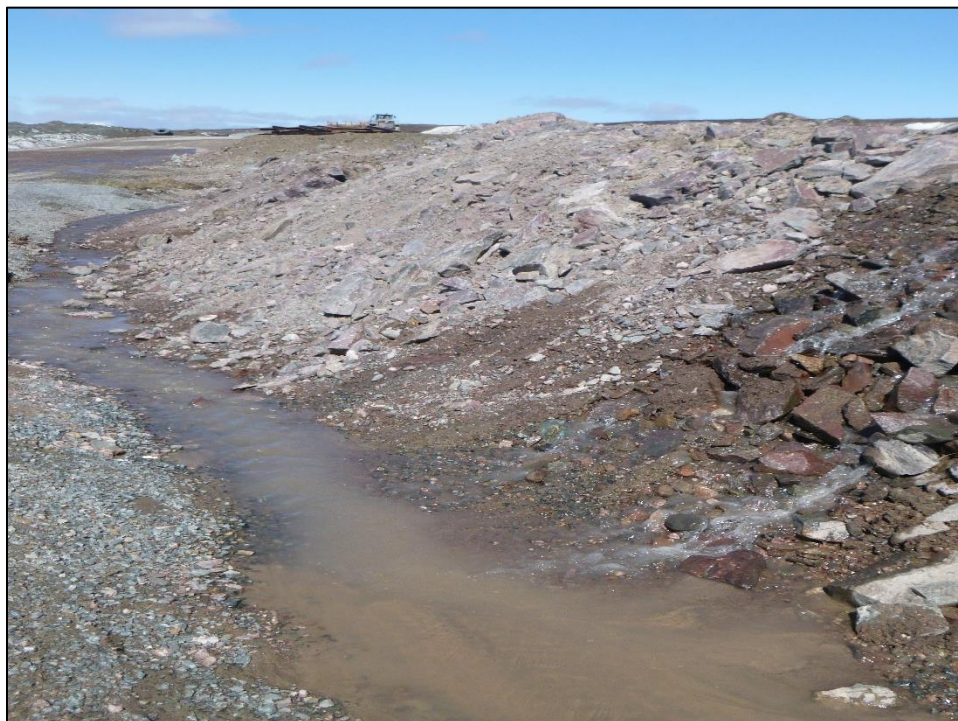
The observed turbid runoff is due to a portion of upstream meltwater resulting from snow accumulation passing through the Marshalling Facilities and seeping through the downstream slope of Ditch 1. The water that flowed over the pad was mostly collected by the downstream water management ditch (Ditch 2) and reported to Splash Pad 2 prior to flowing toward the lake, however some was observed bypassing both Ditch 2 and Splash Pad 2. TSS control measures such as Woodchip-log booms and silt fencing have remained downstream in previous areas of concern (exits of culverts, known runoff paths). These control measures are repaired/replaced on an as needed basis by Agnico Eagle and are used to slow the flow of water towards the lake. The water flows through exposed till material, from which sediments are transported towards the lake.

Figure 3. Water flow prior being collected in Ditch 2 (2024-06-12)

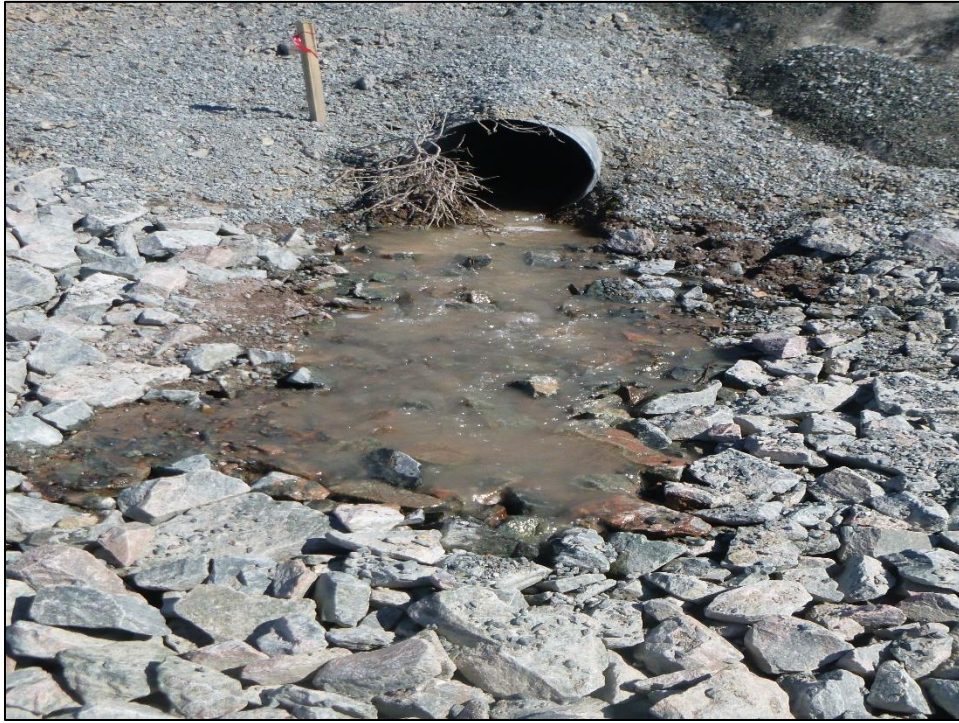
Figure 4. Outflow from Ditch 2 into Splash Pad 2 (2024-06-12)

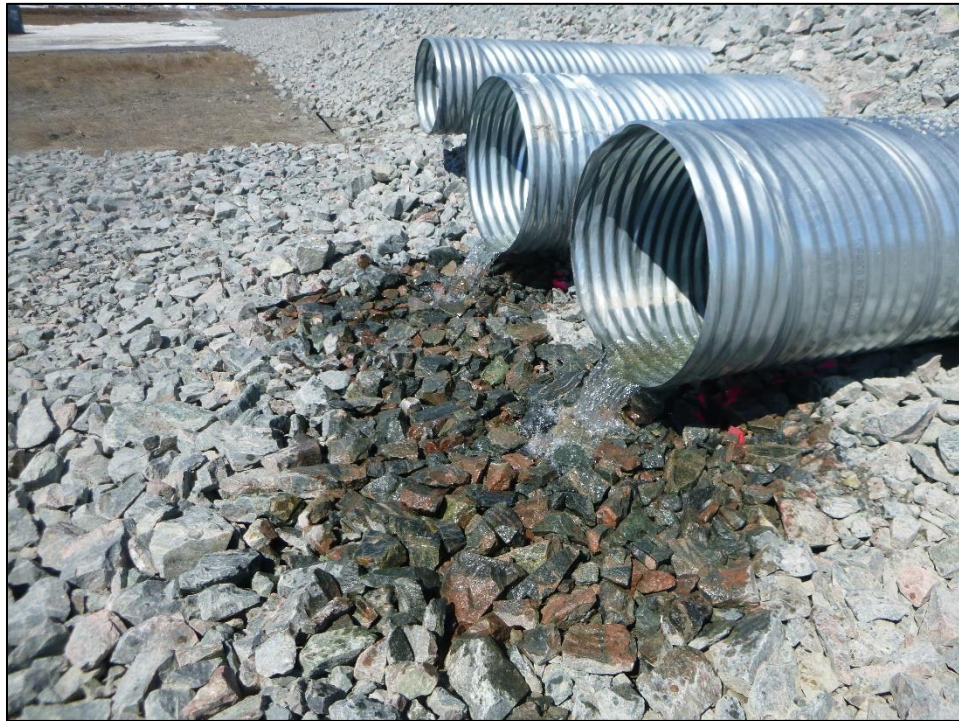
Figure 5. Outflow from Ditch 1 (2024-06-12)

Following the observation of localized seepage paths through ditch 1 downstream berm, a review and evaluation of the performance of the entire infrastructure is being conducted. If maintenance and remediation work is required as per recommendations of the water management infrastructure performance review, it will be planned accordingly.

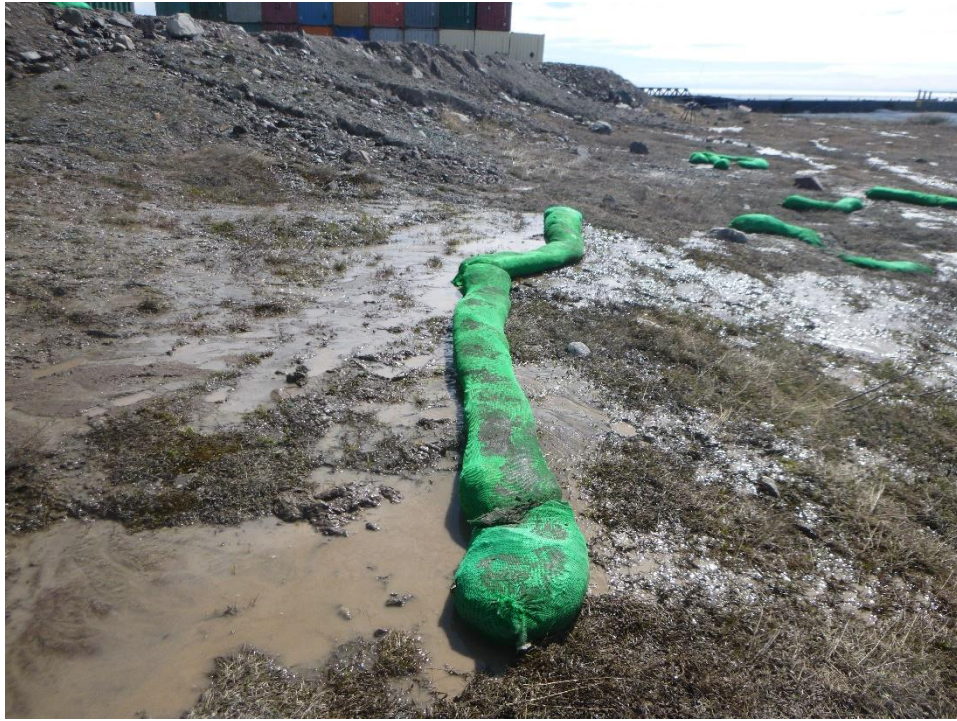
Figure 6. Additional turbidity controls installed to control water bypassing Ditch 2 and Splash Pad 2 (2024-06-15)

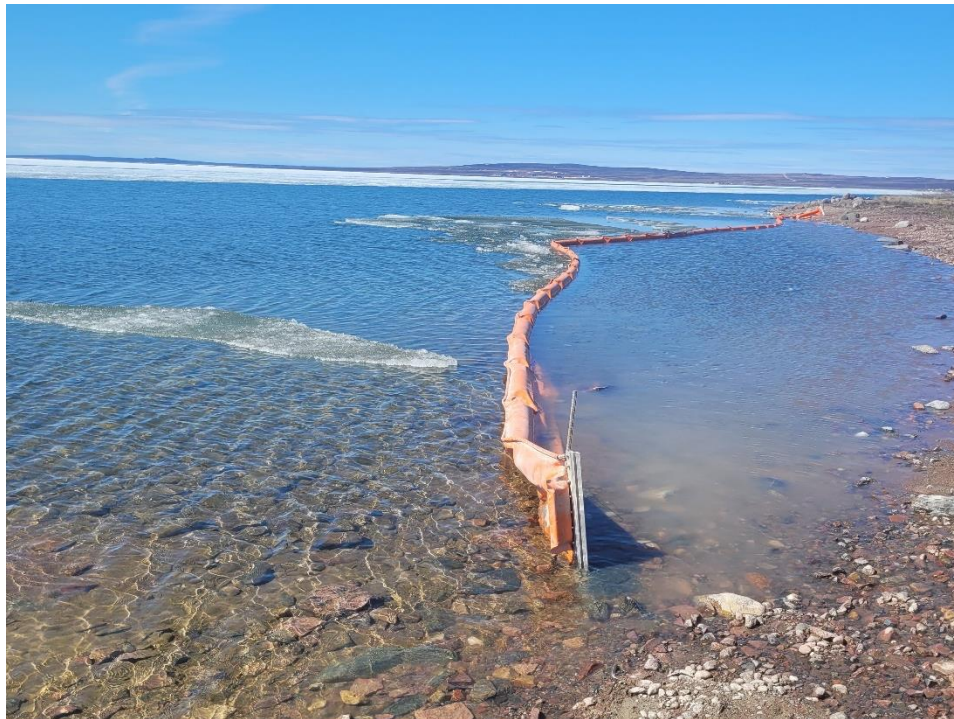
Figure 7. Contained turbidity & sediments at Baker Lake (2024-06-20)
