MBK 500L Diesel Fuel-Water Mixture

GN reference #: 2024-294

Please find the following information as a follow up to the spill report, #2024-294 submitted August 2nd by Agnico Eagle Meadowbank division. This detailed report is submitted to the Inspector in compliance with the conditions under the Nunavut Water Board License 2AM-MEA1530, Part H, Item 8c.

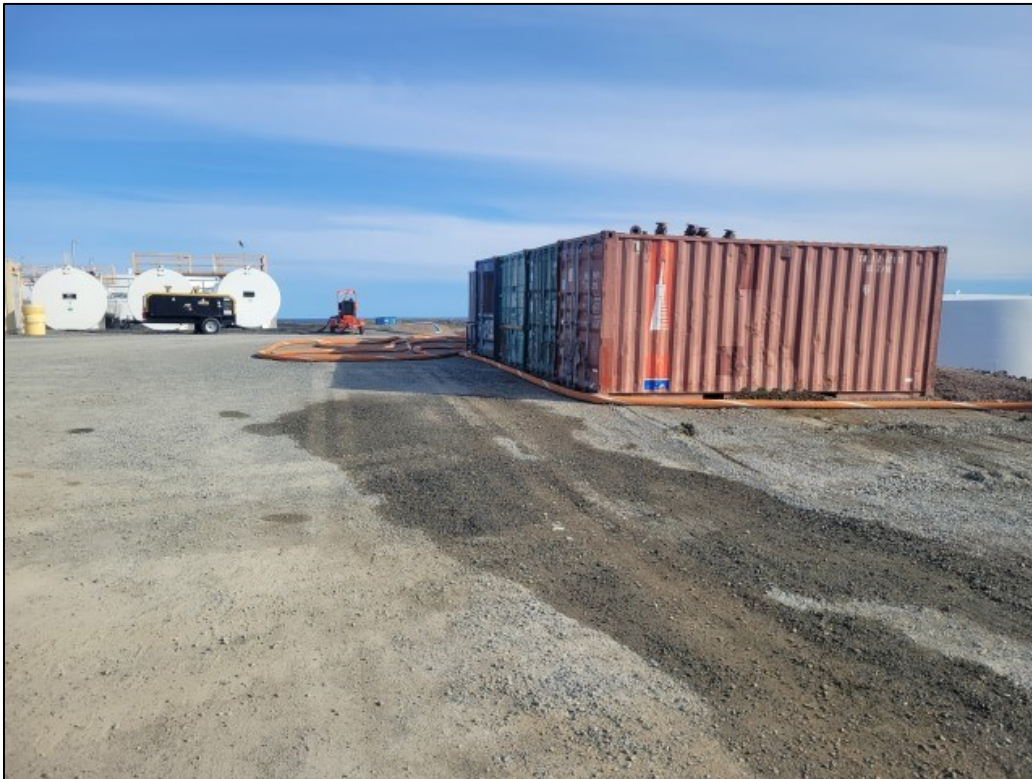
While performing water draw from the fuel tank #5 on the JET-A tanks pad at the Baker Lake Marshalling facilities, a worker failed to secure the disconnected hose used during the transfer between the fuel tank and the fuel tanker. The hose slipped from its upright position to the ground, releasing ~500L of Diesel Fuel and water mixture onto the pad due to gravity.

There were no off-site impacts or discharges to any receiving watercourse. Distance to the closest lake is 450m to Baker Lake.

Human Error

Following an onsite investigation, a formal procedure will be created and distributed to all workers required to perform this task. Additional equipment is being purchased to prevent the hose from leaking when disconnected.

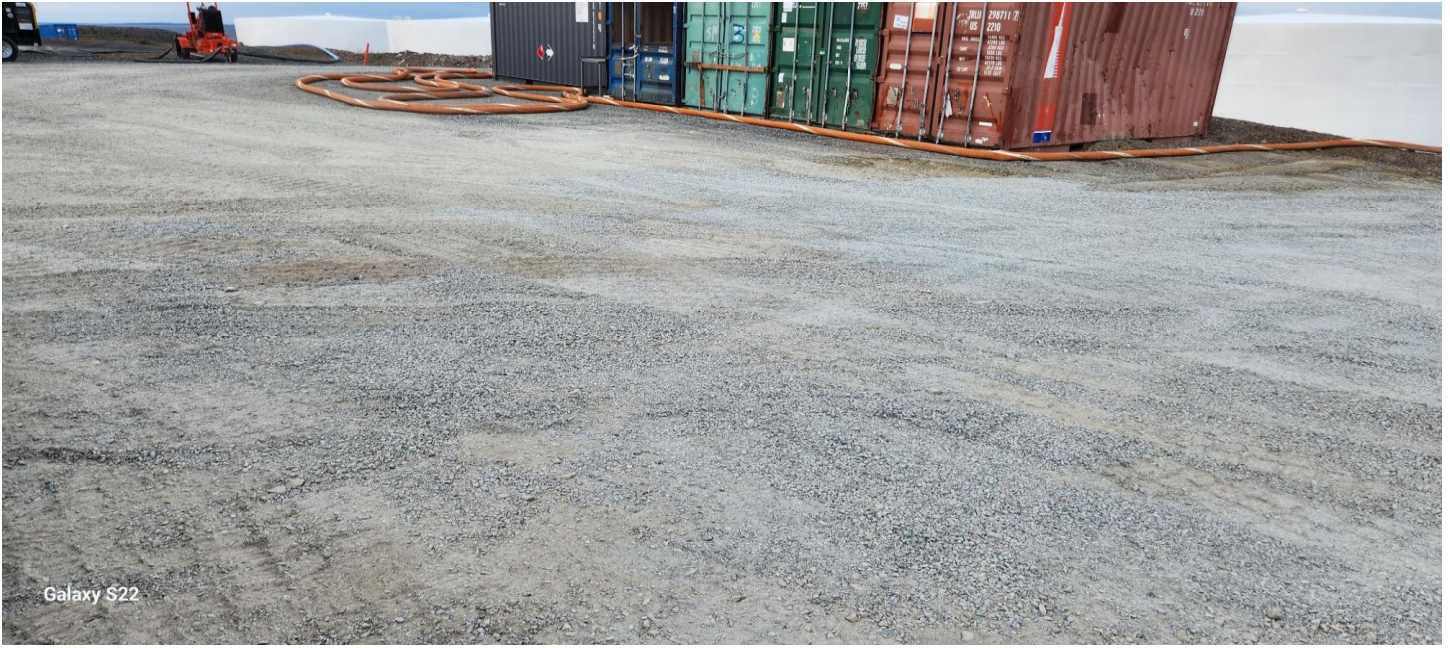
The spill was immediately contained, and a loader was called to remove the contaminated material. ~ 3 m³ of material was collected and brought to the Meadowbank Landfarm.
