## 2024-09-13 MBK 1000L Diesel

GN reference #: 2024-356

Please find the following information as a follow up to the Spill report submitted September 13, 2024 by Agnico Eagle Meadowbank division. This detailed report is submitted to the Inspector in compliance with the conditions under the Nunavut Water Board License 2AM-MEA1530, Part H, Item 8c.

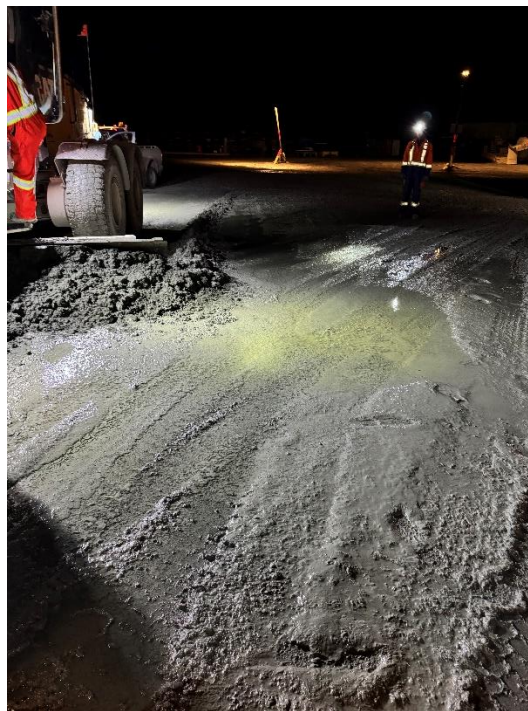
A fuel tanker was overfilled during the refueling process at the Meadowbank fuel farm, resulting in approximately 1000 liters of diesel fuel spilling onto the ground.

There were no off-site impacts or discharge to any receiving watercourses. Distance to the closest water body is 290 meters to Third Portage Lake.

Human error
