## 2024-09-08 MBK Baker Lake TSS

GN reference #: 2024-340

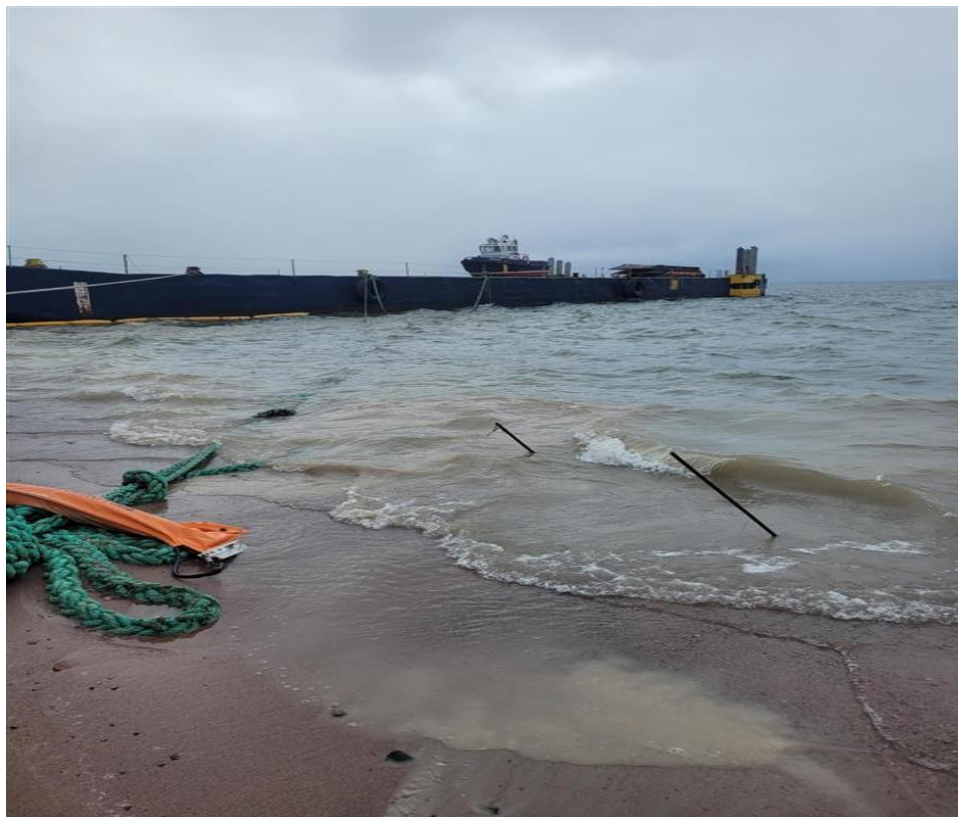
During an inspection of the Baker Lake Marshalling Facilities by Environment, a turbid flow of water from heavy rains was observed heading to the shore of Baker Lake, creating apparent plumes of TSS along the shore adjacent to the barge dock. The visible plumes in Baker Lake were mostly contained within a few feet from the shoreline, and water appeared clear a few meters into the lake. The plume is hereafter referred to as “BL-BARGE-Out” for the flow of water that entered on the West side of the dock (64°18'17.68" N, 95°57'11.11" W), See figure 1 below for general site layout information and flow path estimate.

*Figure 1. Baker Lake Dock Facilities – September 11*

The identified cause for the turbid runoff is the heavy rains received during the week of September 1<sup>st</sup> where above average volumes of water reported through the Marshalling Facilities without sufficient control measures in place. The volume of water flows through exposed till material, from which sediments are transported towards the lake.

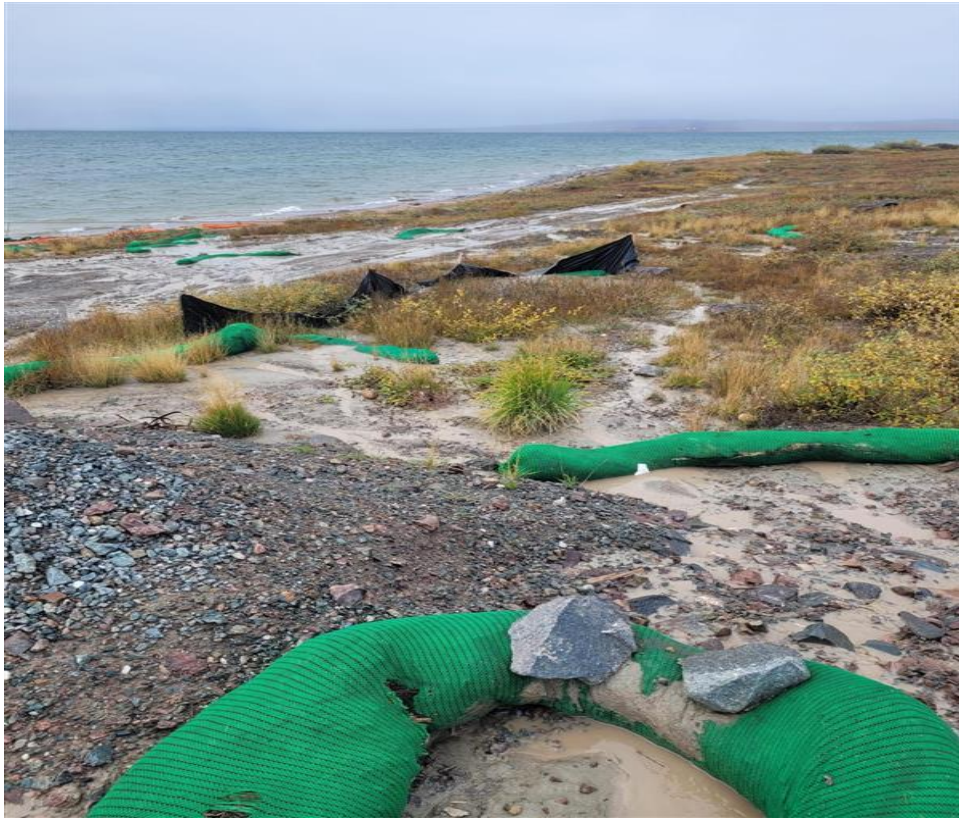
*Figure2. Mitigation Measures at BL-LAKE (2024/09/11)*

Upon observation of the runoff into the lake, the environmental personnel deployed, woodchip-log or straw-log booms and rock fill berm in the flow path of the runoff, to control the transportation of sediments. Over the next week, inspections and monitoring of the area was performed by environmental staff. During the monitoring, the TSS control measures were monitored, repaired and added, if needed. Samples of the water quality (total suspended solids) of the lake adjacent to the dock facilities were taken, as described in Table 1. Acute Lethality sample results are attached.

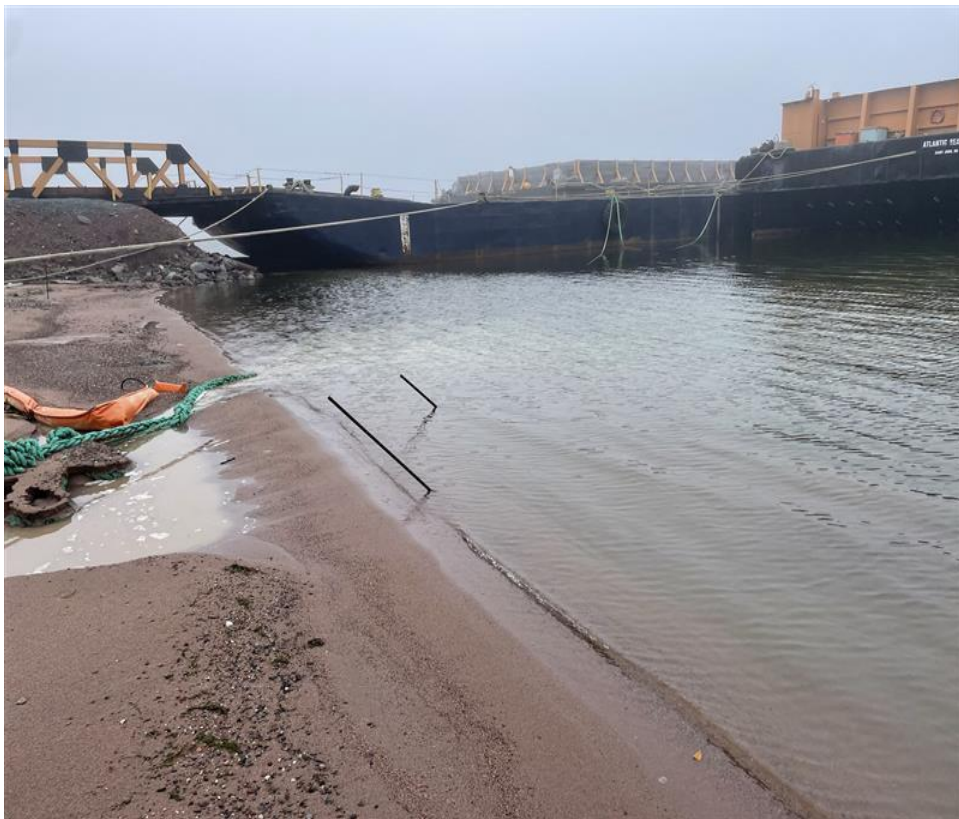
*Figure 3. Dock facilities (2024/09/18)*

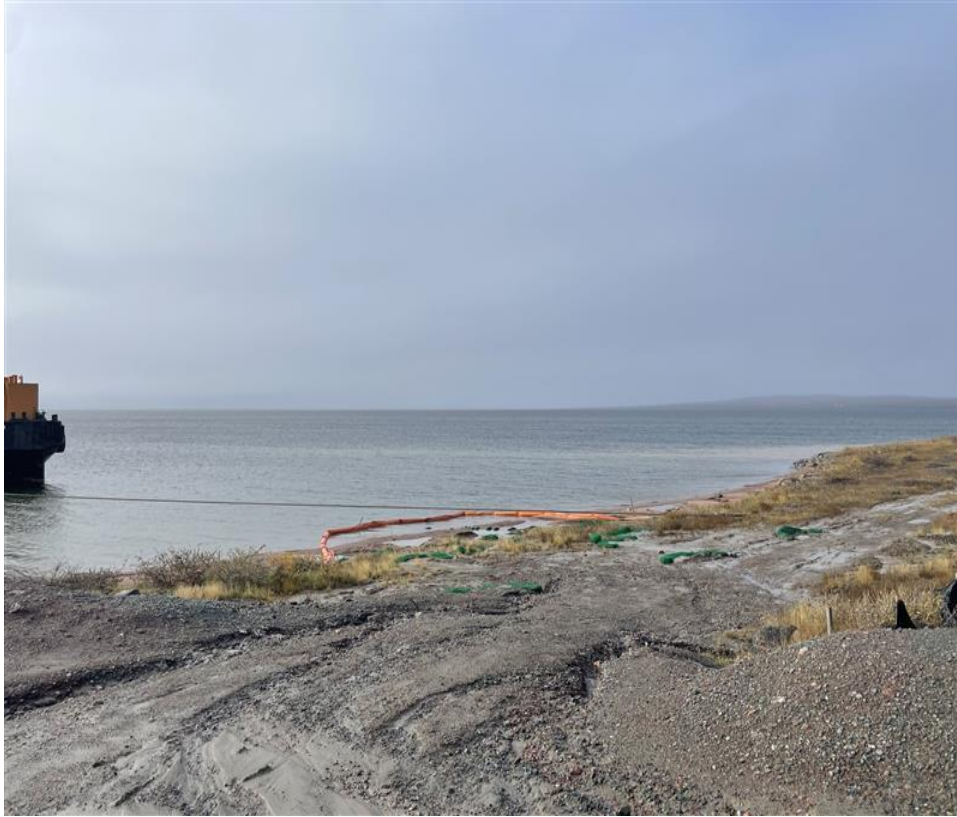
*Figure 2. Mitigation Measures at BL-BARGE (2024/09/22)*

From September 21<sup>st</sup> to 29<sup>th</sup> general earthwork improvements and water management maintenance occurred at the Baker Lake Marshalling facilities occurred. Some of the remediation work included ditch extensions, addition of diversion culverts, and pad resurfacing.
