2024-09-20 MBK NP2 Lake TSS

GN reference #: 2024-364

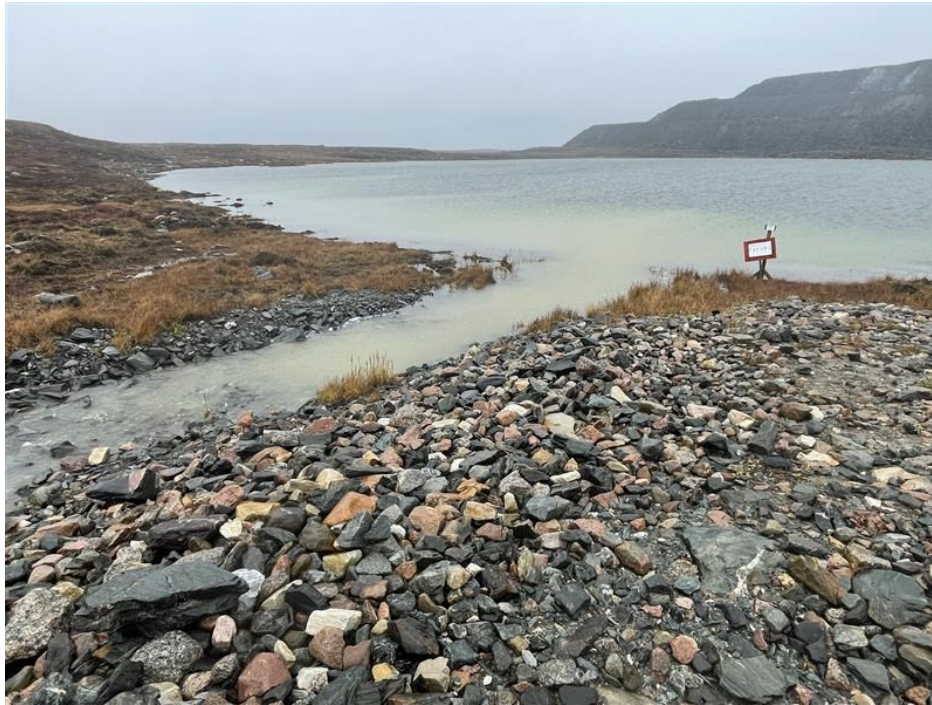
During a regular freshet inspection of the East Diversion Ditch, a turbid plume of water was observed at the exit of the diversion ditch where it connects to shore of NP2 Lake at the registered sampling point ST-5. The plume extended ~1m into the lake and ~5 m along the immediate shoreline, with no observable impact further into the lake.

Figure 1. NP2 Lake Shoreline at ST-5 Sample Location – September 20

The identified cause for the turbid runoff is the heavy rains received from September 20th to September 27th where above average volumes of water reported through the diversion ditch without sufficient control measures in place. The volume of water flows over the land and from the road which transported sediments into the ditch and towards the lake. On site precipitation results and general weather conditions are presented in Table 2 below.

Upon observation of the runoff into the lake, the environmental personnel deployed, additional woodchip-turbidity logs in areas of concerns and turbid inflows from the land to control the transportation of sediments. A silt curtain was installed along the shore of the lake to contain the plume and minimize further transportation of sediments. Over the next week, inspections and monitoring of the area was performed by environmental staff. During the monitoring, the TSS control measures were monitored, repaired and added, as needed. Samples of the water quality (total suspended solids) of the lake outside of the barrier were collected to ensure the control measure were functioning as intended. Acute Lethality sample results are attached. Sample results show no exceedance of water license parameters.

Monitoring of the area continued and was followed closely after each rain event to ensure the mitigation measures in place were effective. Agnico eagle intends to investigate and trial alternative means for sediment and erosion control during the 2025 Freshet. A geotechnical field investigation will be conducted by Agnico Eagle to identify further areas of improvement to the structure to prevent similar events from occurring.

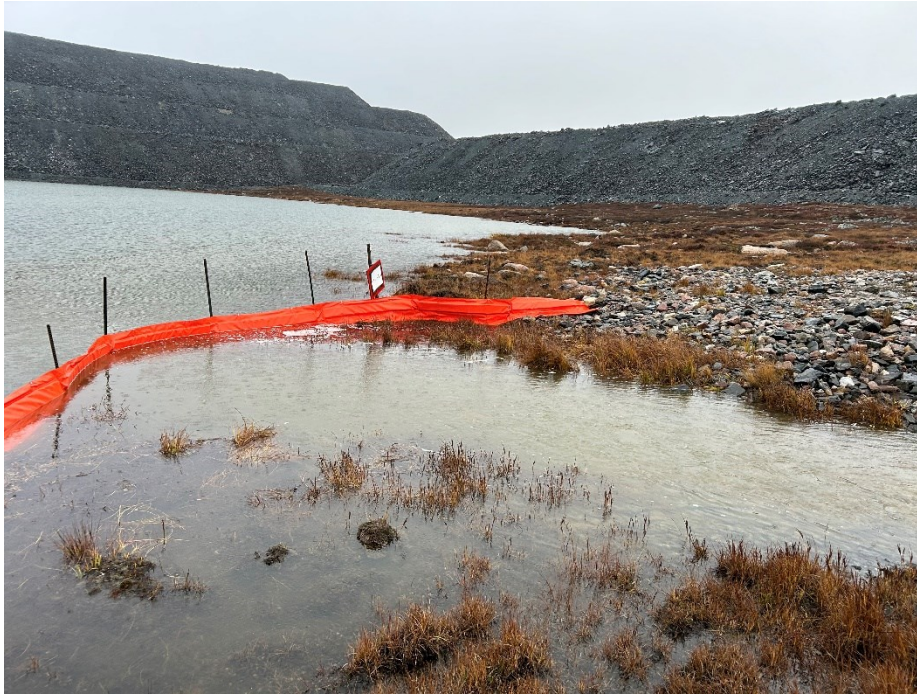
Figure 2. Mitigation Measures Upstream at ST-5 (2024/09/22)
