2024-12-26 MBK 15m3 Tailings

GN reference #: 2024-480

Please find the following information as a follow up to the Spill report submitted December 27th, 2024, by Agnico Eagle Meadowbank division. This detailed report is submitted to the Inspector in compliance with the conditions under the Nunavut Water Board License 2AM-MEA1530, Part H, Item 8c.

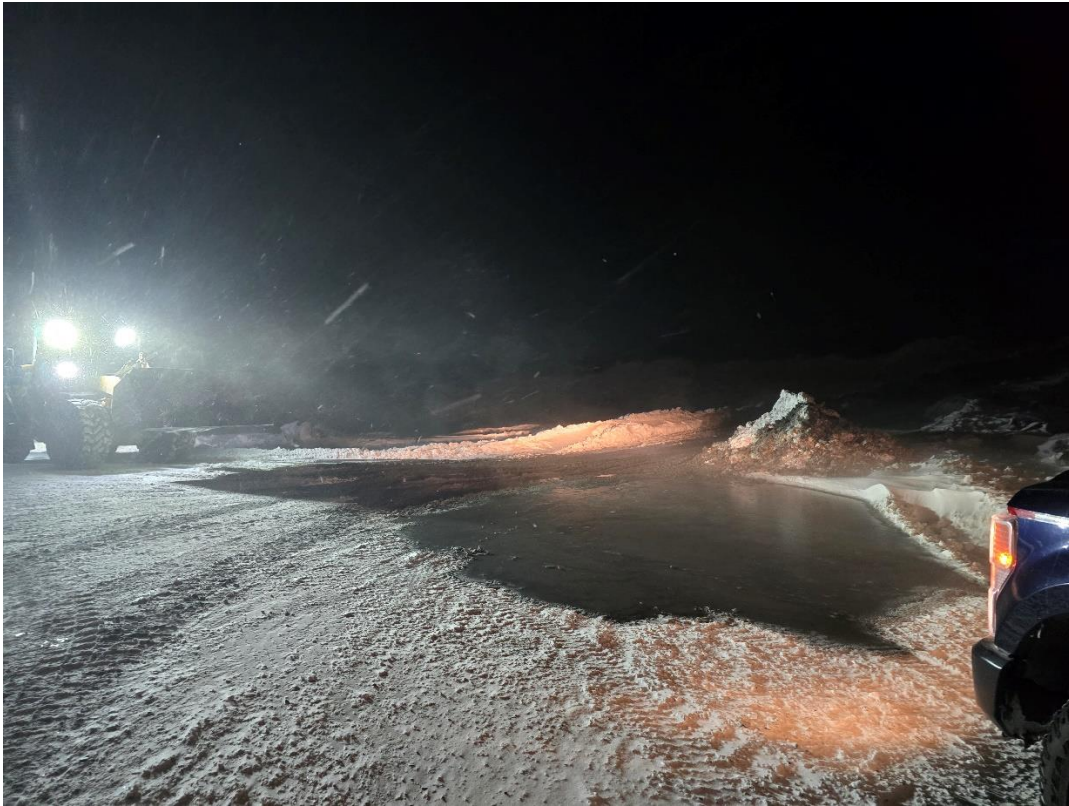
During regular operations, an operator noticed tailings leaking around the tailings line in the southern part of South Cell. Further investigation revealed that a section of the tailings line at the by-pass had failed, releasing approximately 15 cubic meters of material onto the ground.

Equipment failure

An investigation was initiated to determine the root causes of the spill and implement appropriate corrective actions. To prevent any potential operational deficiencies, the tailings line was reconfigured by bypassing the descaling device station until a thorough inspection and necessary adjustments to the system can be completed. Additionally, a comprehensive gap analysis of the installation process was initiated to identify any weaknesses in the protocols. The work standards in field operations were also updated, including revising the protocol to ensure all pipes are properly blanked when not in use and revising the daily walk down procedure of the live tailing pipeline. These corrective and preventive actions are designed to enhance operational safety, improve communication, and ensure adherence to best practices. Continuous monitoring and periodic reviews will be conducted to ensure the effectiveness of these implementations.
