2024-12-29 MBK 900m3 Tailings

GN reference #: 2024-482

Spill Description

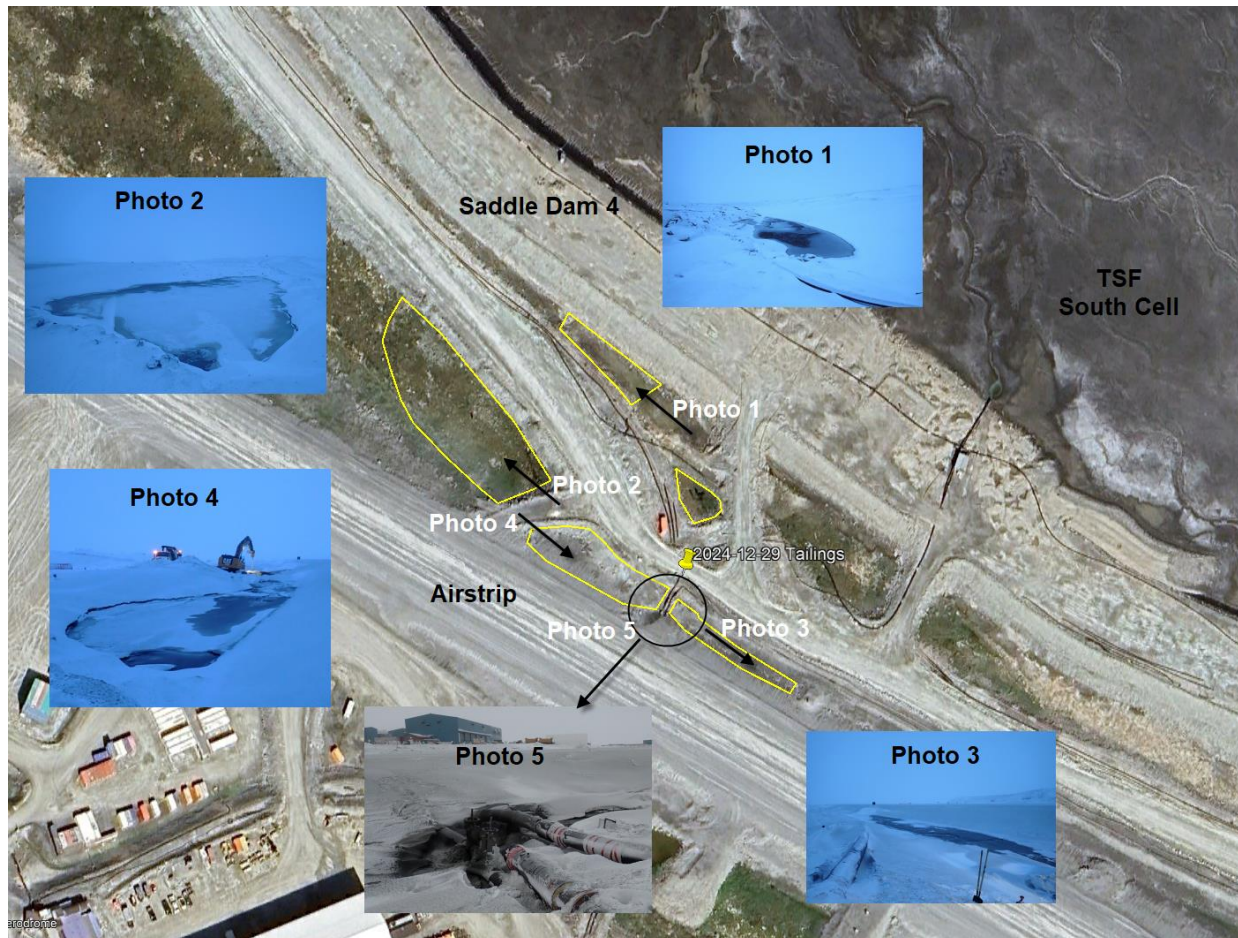
During regular operations, an operator noticed tailings pooling around the tailings line between the air strip and the Saddle Dam 4 infrastructure. Further investigation revealed that the pipe had failed at the gate valve flanges, releasing approximately 900 cubic meters of material onto the ground.

Equipment failure

An investigation is on-going to determine the root causes of the spill and implement appropriate corrective actions. As part of the on-going investigation, the gate valve will be assessed to determine the cause of failure. An on-site inspection was completed of the tailings line system to ensure no similar valves were not in use, prior to restarting tailings deposition. Further corrective actions can be shared ,upon request, once the investigation has been concluded.
