## 2025-03-06 MBK 300L Hydraulic Oil– Hyster

GN reference #: 2025-119

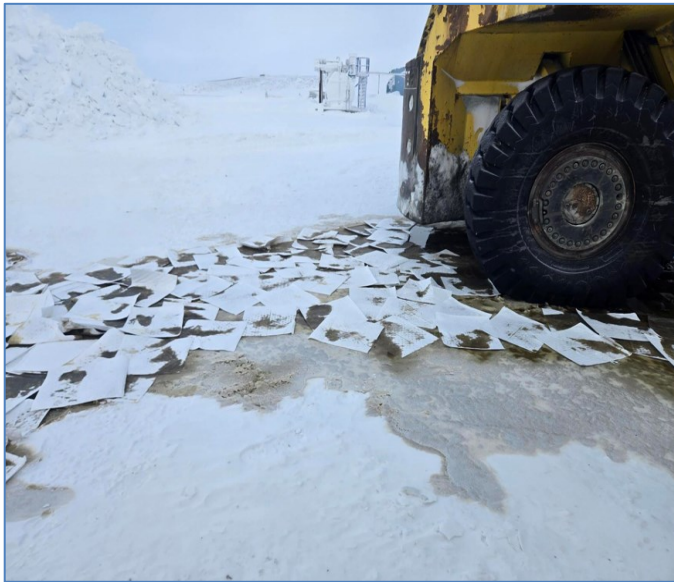
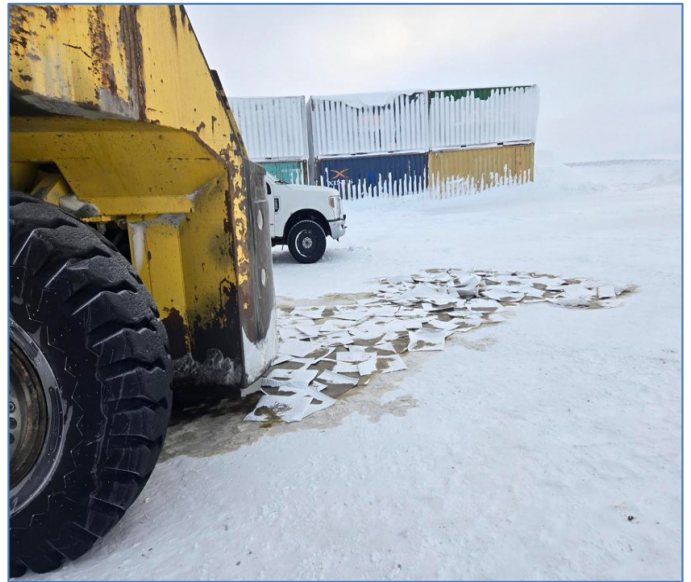
During operations at Meadowbank, Hyster TPA03 was parked and idling at the EMR Yard in between shifts. When arriving to the location the employee noticed a hydraulic oil spill under the equipment.

Mechanical Failure

TPA03 was towed to the maintenance shop for repair, damaged hydraulic lines were replaced, and the unit was assessed. A review of pre-operational checks and idling procedure was completed with warehouse crews.
