2025-05-22 MBK 750L Waste Oil

GN reference #: 2025-221

Please find the following information as a follow up to the Spill report submitted May 22nd, 2025, by Agnico Eagle Meadowbank division. This detailed report is submitted to the Inspector in compliance with the conditions under the Nunavut Water Board License 2AM-MEA1530, Part H, Item 8c.

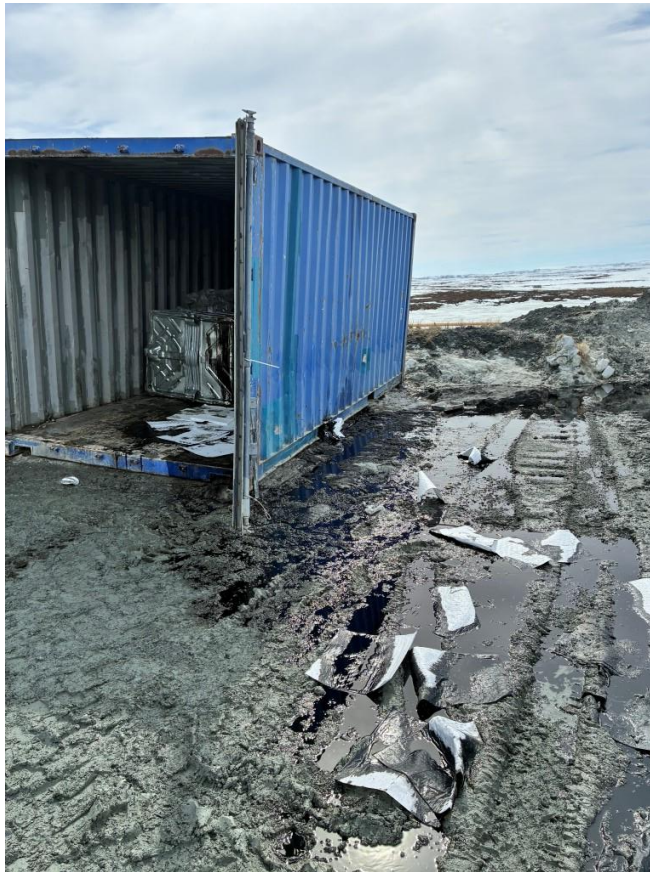
During the transfer of a tote inside a seacan in the Hazmat area, the operator misjudged the position of the loader forks, resulting in the puncture of the tote being handled as well as an adjacent one. This caused 750L of waste oil to leak onto the floor of the seacan and eventually escape the container.

Human Error

A comprehensive review of the incident and investigation, encompassing all crews, was completed. As a corrective measure, an action plan is being implemented to assess the feasibility of eliminating the need to filter contaminated waste oil totes, thereby significantly reducing the handling of totes.
