2025-10-02 MBK TBD Diesel Fuel

GN reference #: 2025-397

Spill Description

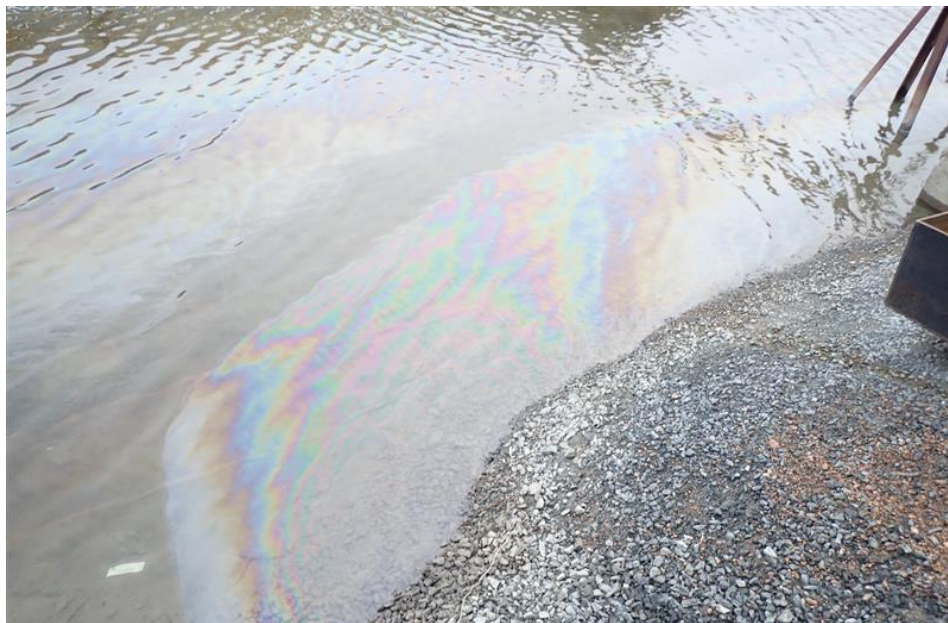
During a routine inspection of the fuel tank secondary containment, as sheen was observed on water within the secondary containment. Upon further investigation the sheen appeared to originate from the aggregate around the base of the fuel tank. A plumber was immediately called to investigate. The exact location of the spill is unknown, however it is believed that the spill originates from the tank.
