2025-11-08 MBK 20KG COPPER SULFATE

GN reference #: 2025-432

Please find the following information as a follow up to the spill report submitted on November 8th, 2025, by Agnico Eagle Meadowbank division. This detailed report is submitted to the Inspector in compliance with the conditions under the Nunavut Water Board License 2AM-MEA1530, Part H, Item 8c.

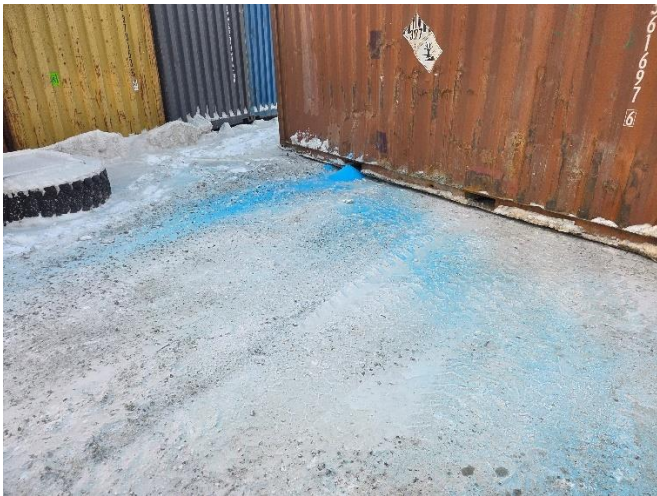
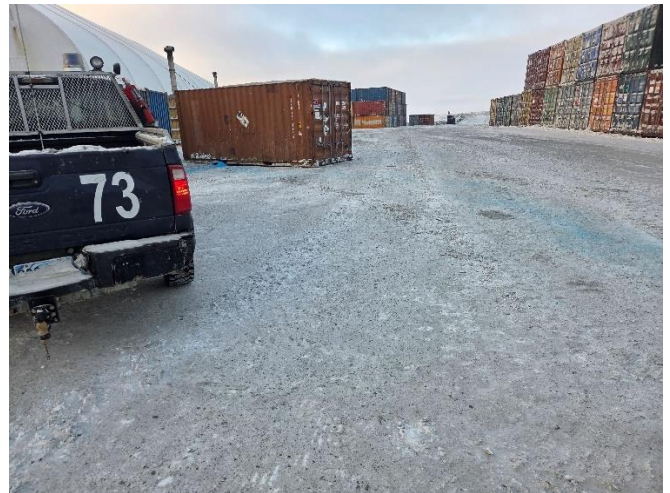
During operations at the Meadowbank site, a sea can was being transferred to the warehouse when the operator noticed a loss of material. Upon inspection, two small holes were found in the sea can and in the bag containing copper sulfate. This resulted in approximately 20 kg of copper sulfate spilling onto the warehouse pad.

Equipment damaged

The holes in the sea can were sealed, and equipment was dispatched to scrape and clean the affected area. The contaminated material was then transported to the tailing storage facility for disposal.

An investigation was conducted to determine the root cause of the damage to the sea container and the bag. The exact cause could not be identified because of the incident occurrence timeline, and no clear evidence was available. As a corrective measure, the operators were reminded to thoroughly inspect the condition of any sea can holding hazardous materials before moving it for delivery.
