2025-12-01 MBK 700L Waste Oil

GN reference #: 2025-453

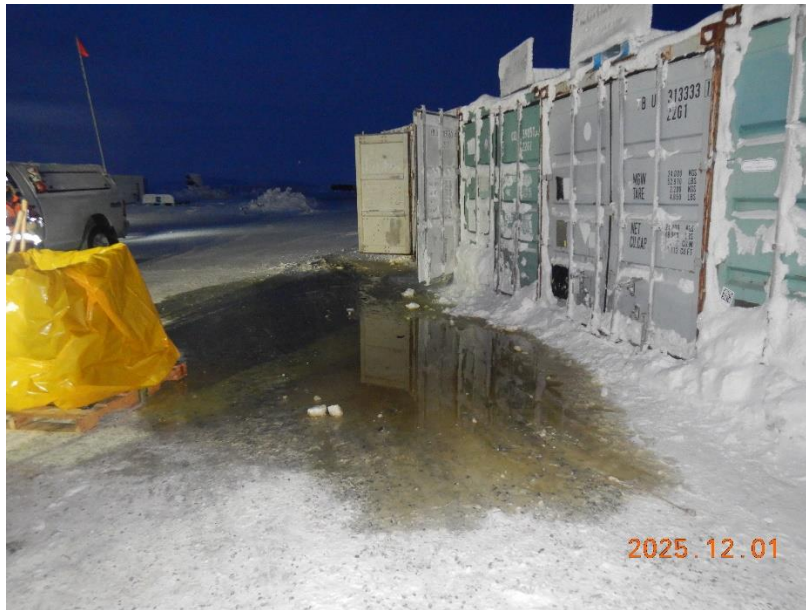
65° 0'57.79"N 96° 4'04.30"W (on IOL)

During the transfer of a tote inside a seacan in the Hazmat area, the operator misjudged the position of the loader forks, resulting in the puncture of the tote. This caused 700L of waste oil to leak onto the floor of the seacan and eventually escape the container.

There were no off-site impacts or discharges. Distance to the closest water body is 210m to Third Portage Lake
