2023-01-05 MBK 400L Diesel

GN reference #: 2023-004

Please find the following information as a follow up to the Spill report submitted January 6, 2023, by Agnico Eagle Meadowbank division. This detailed report is submitted to the Inspector in compliance with the conditions under the Nunavut Water Board License 2AM-MEA1530, Part H, Item 8c.

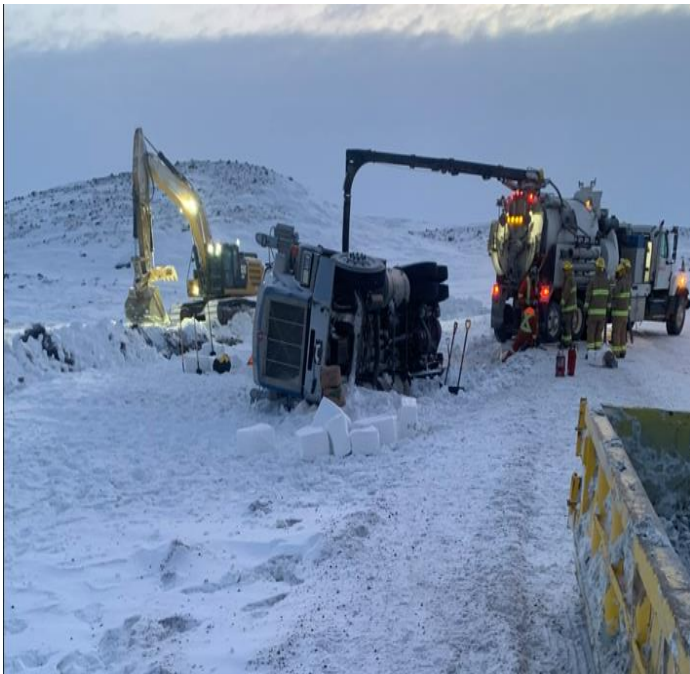
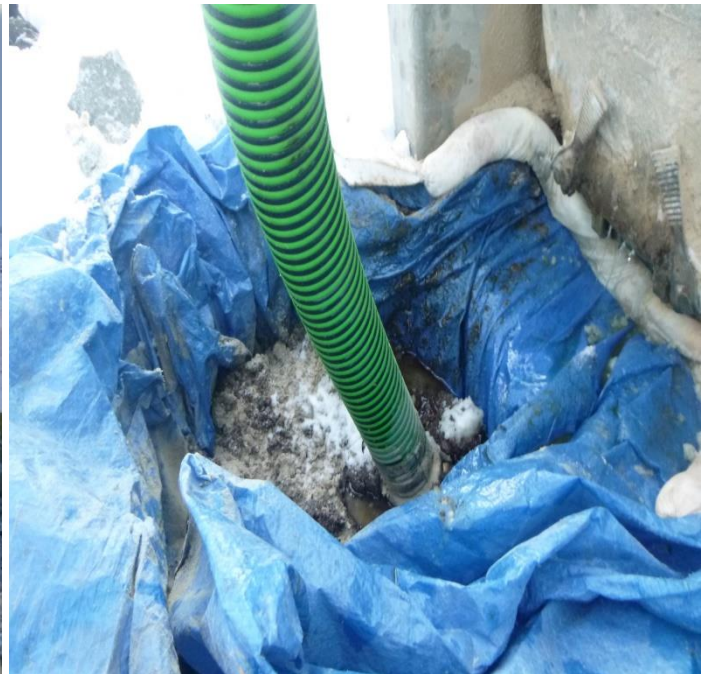
During operations at Meadowbank, a loaded diesel fuel tanker operated by Arctic Fuel was travelling northbound on the AWAR to Meadowbank. The tanker went off the road at KM97 and tipped over, spilling 400L of Diesel fuel from the top vent and fuel cap.

The operator of the diesel fuel tanker was reaching to adjust his Sepura radio and took his eyes off the road. While reaching for his radio, the tanker drifted to the East side of the road, got pulled into the snow at the shoulder of the road and tipped over.

The All-Weather Access road and Whale Tail haul road transportation standard operating procedure will be modified to include “all vehicles/equipment must come to a complete stop when using the dial function on a Sepura base radio”. Site wide communication package will be sent to ensure all workers/operators of vehicles understand the changes to the transportation procedure. AEM will also investigate the possibility of having a hands-free communication device for all mobile equipment.
