November 30, 2009

# 2009 Annual Geotechnical Inspection - Meadowbank Gold Project, Nunavut

Agnico-Eagle Mines Limited  
Meadowbank Division  
P.O. Box 540  
Baker Lake, Nunavut  
X0C 0A0

**Project Number:** 09-1428-0018  
Doc. No. 969 Ver. 0

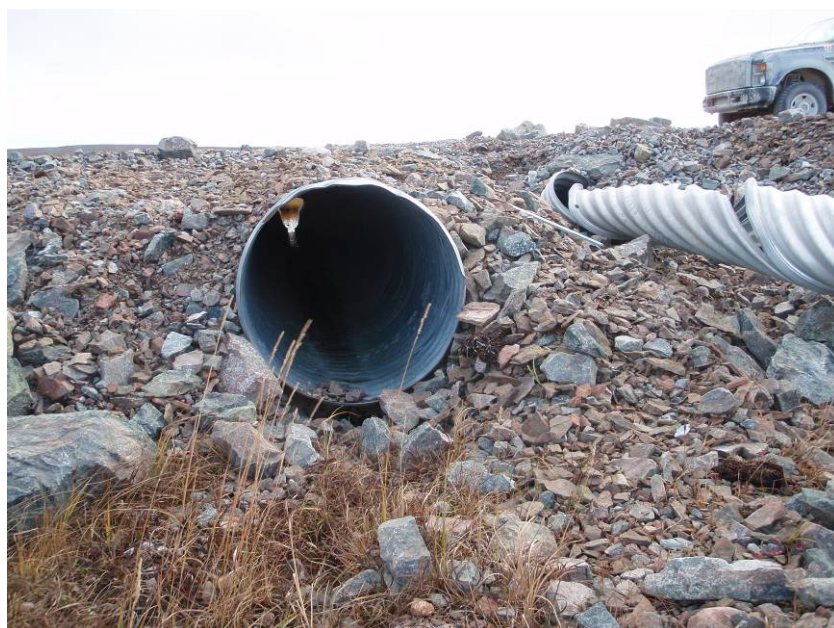
*PHOTOGRAPH 12 – PC-14, km 4+260*

At km 4+260, PC-14, there are two 600 mm diameter CSP culverts. The upstream end of the culvert closest to Baker Lake is damaged and would severely impede flow. The adjacent culvert is in good condition, with only minor crushing along the haunch evident. At this location, there is no apparent channel and at the time of the inspection no flow was evident through the culverts. The capacity for the single functional culvert to handle flows should continue to be monitored, especially during the spring freshet to ensure adequate drainage.

**Description:** Upstream view of culverts. Culvert closer to Baker Lake is damaged on upstream side. Other culvert has minimal crushing on haunch of culvert near the center of the road. Uniform grade, no obstructions.

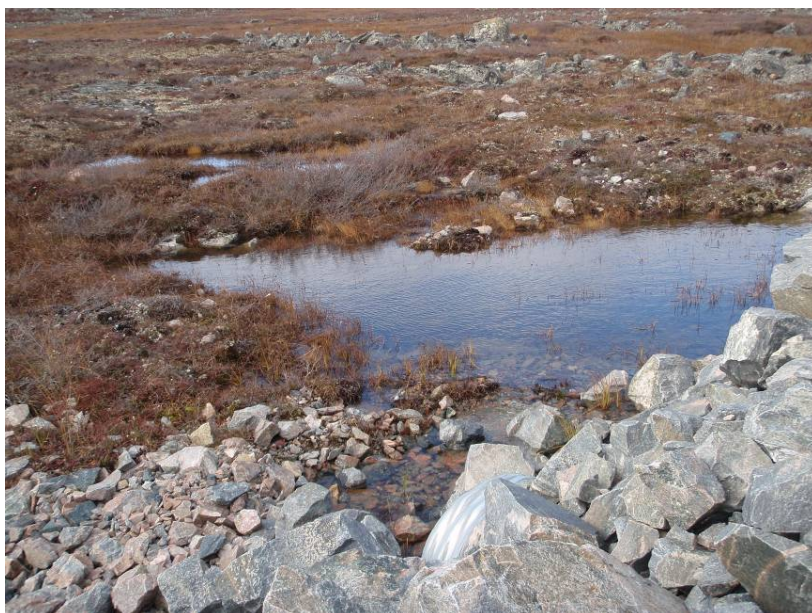
*PHOTOGRAPH 26 – PC-2, km 13+405*

**Description:** View through culvert from upstream to downstream. Crushing and dent on side and haunch near upstream end of culvert. Likely damaged during installation, continue to monitor as road bed consists of gravel and some larger cobbles (angular), potential for condition to worsen. Uniform grade, no blockage evident.

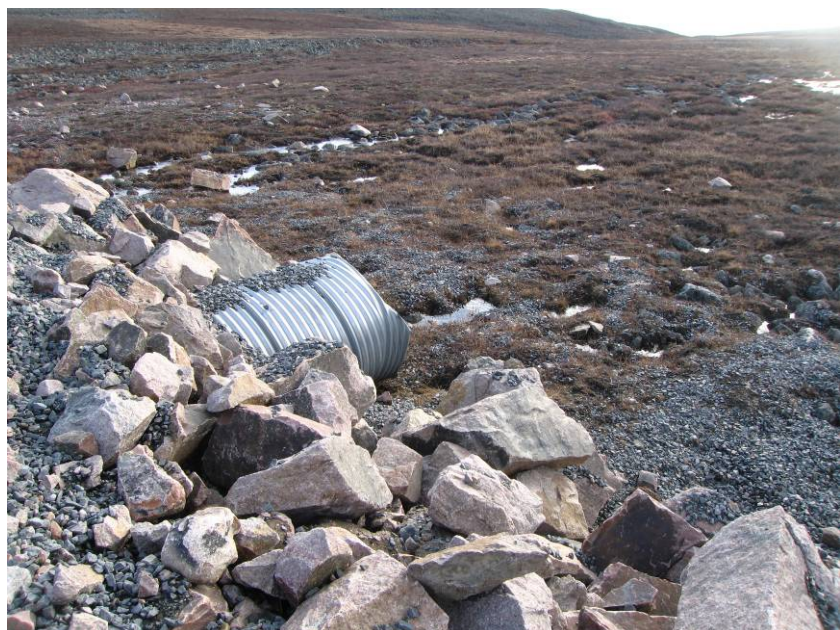
*PHOTOGRAPH 80 – R-23, km 93+600*

**Description:** Upstream to downstream view through culvert. Moderate crushing along haunch of culvert centerline, uniform grade, no blockages, and no sign of erosion observed.

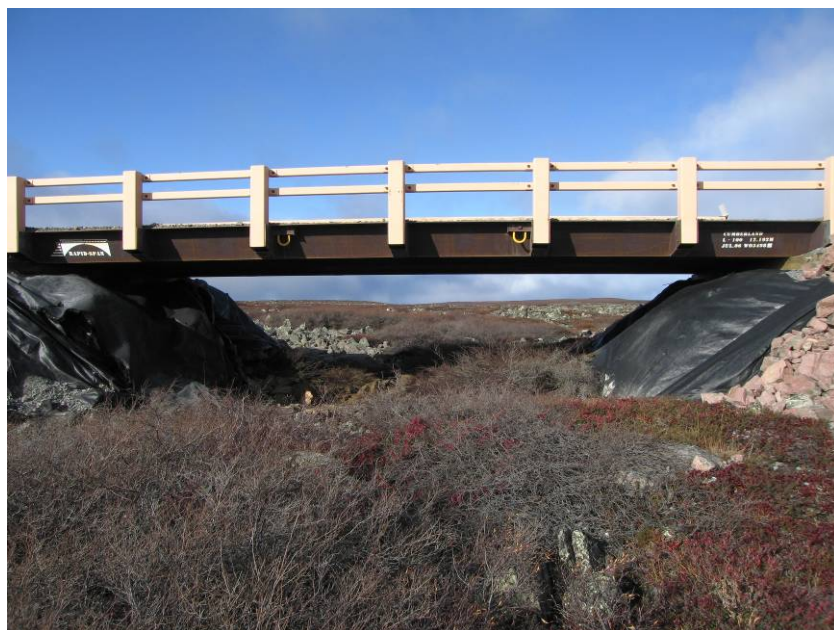
*PHOTOGRAPH 50 – Bridge 8 - R18, km 79+500*

**Description:** View of right abutment from upstream to downstream. Damaged geotextile beneath abutment, blowing in the wind.

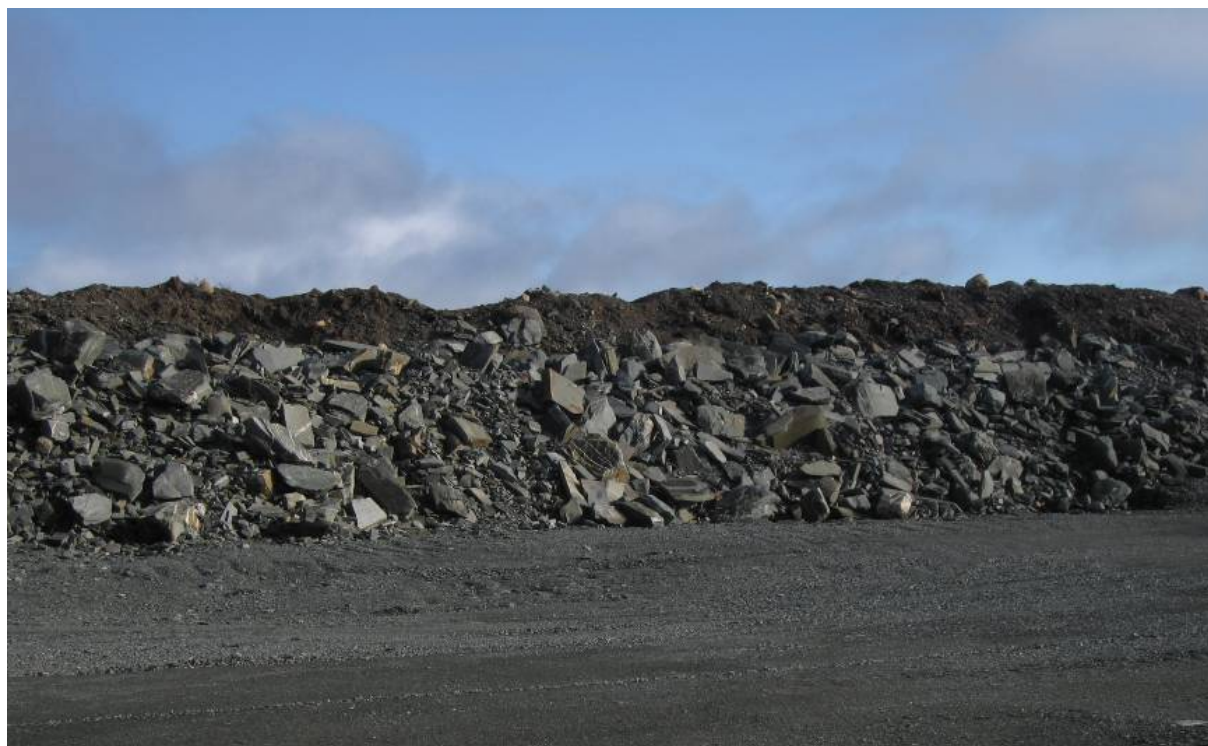
*PHOTOGRAPH 36 – Quarry 11*

**Description:** View of southern portion of the eastern wall. Stockpile of rock and crush in front of quarry wall. Vertical wall highly fractured, thin planar surfaces, ravelling.

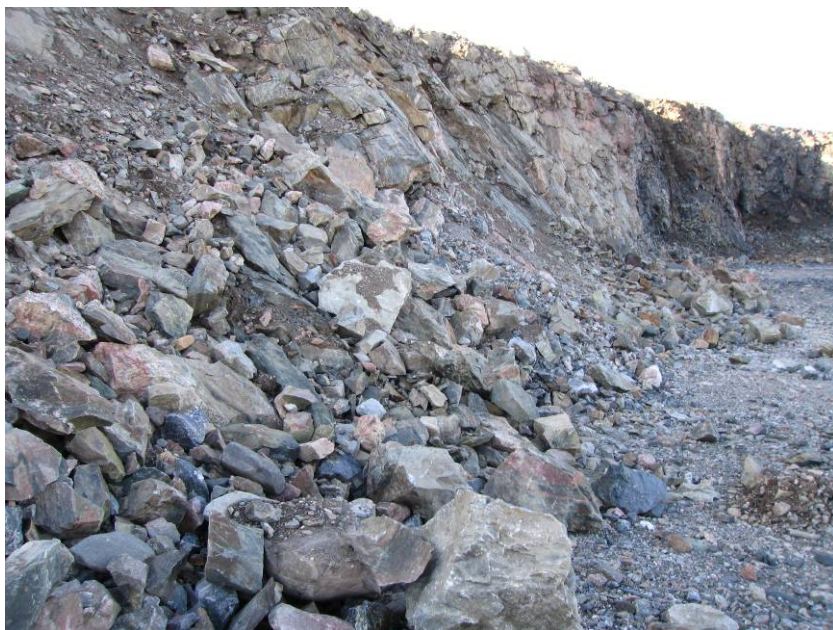
*PHOTOGRAPH 63 – Quarry 18*

**Description:** View of frost heave and thaw settlement at entrance of quarry, looking northeast.
