2010 Annual Geotechnical Inspection Meadowbank Gold Project, Nunavut

Submitted to:
Agnico-Eagle Mines Limited
Meadowbank Division
PO Box 540
Baker Lake, Nunavut
X0C 0A0

Project Number: 10-1428-0033/2000
Document Number: 1216 Ver. 0

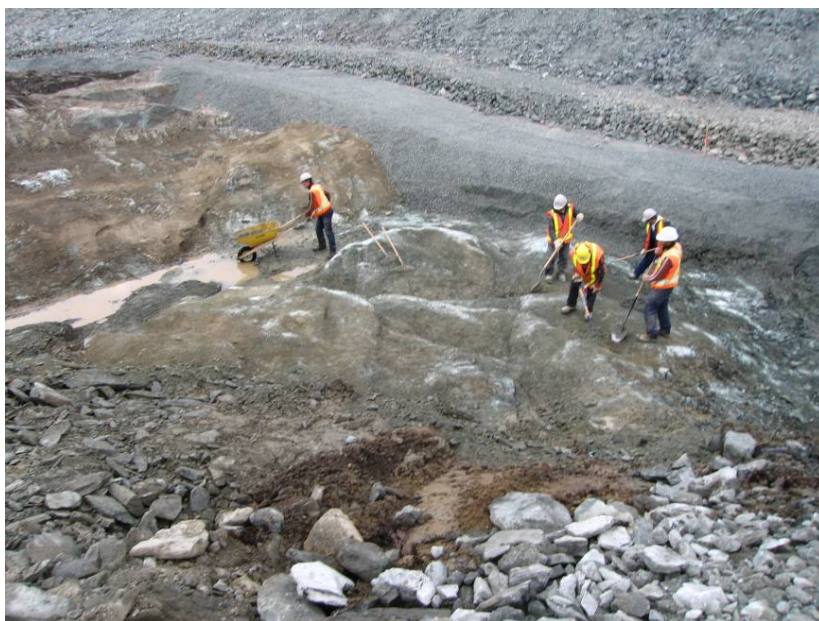
PHOTOGRAPH B3-4 – Saddle Dam 2

Description: Foundation preparation work of bedrock at toe of dike for liner connection. Note till placement above bedrock evident in far ground of photograph.

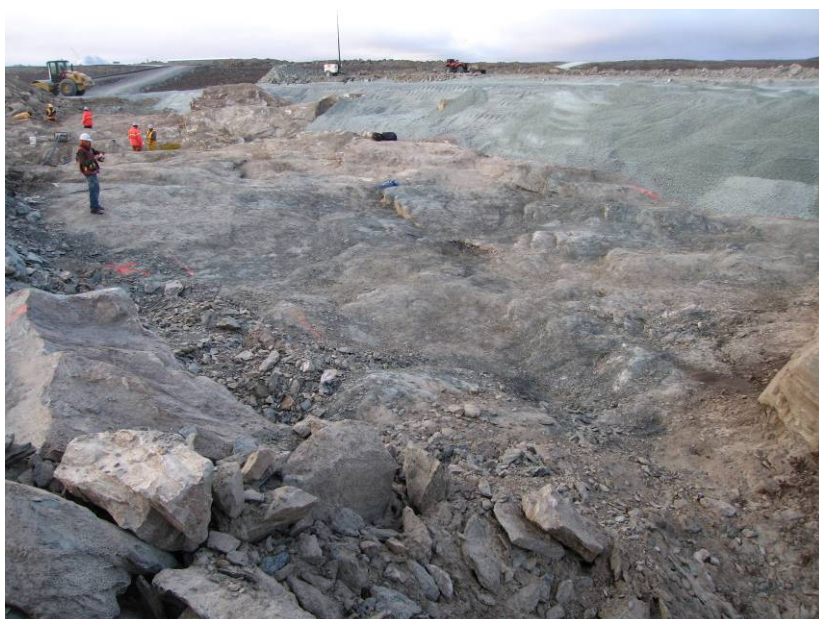
PHOTOGRAPH B3-10 – Saddle Dam 2

Description: Foundation preparation work for upstream liner toe connection on south abutment, view looking northwest.

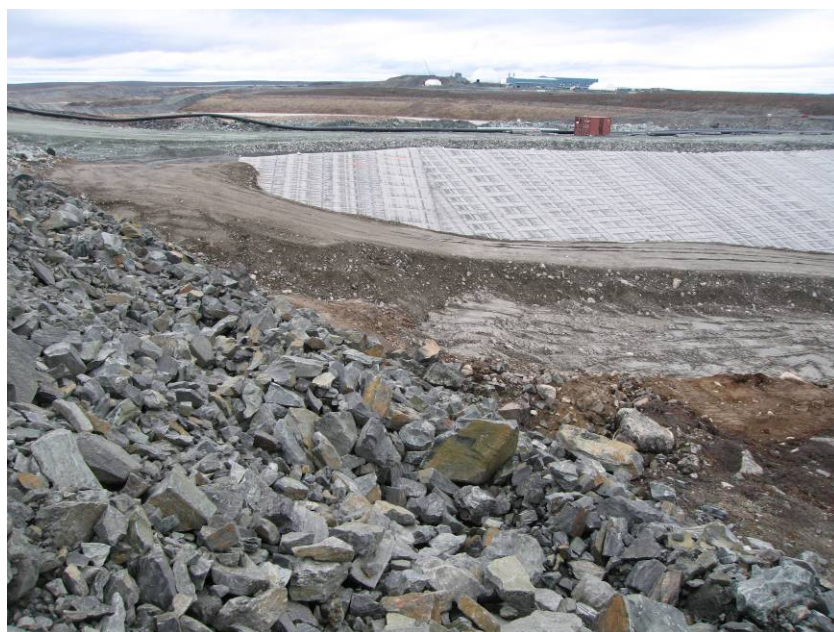
PHOTOGRAPH B4-14 – Stormwater Dike

Description: Damaged liner, still to be repaired, example near 10+650.

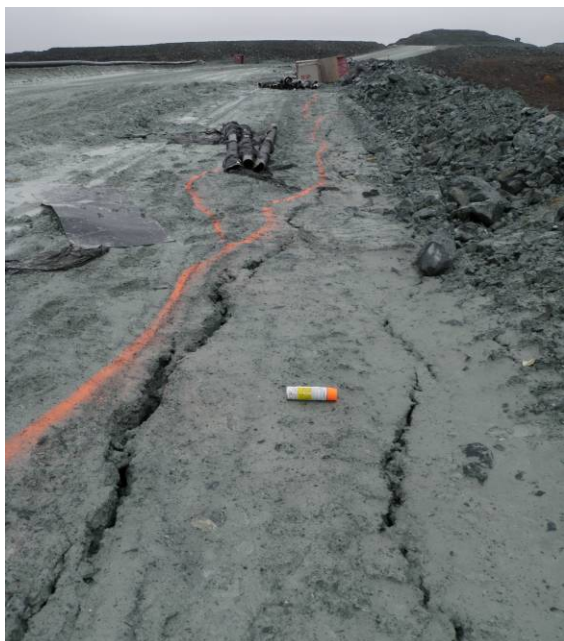
PHOTOGRAPH B4-18 – Stormwater Dike

Description: View near downstream crest between Sta. 10+849 and 10+940 showing tension cracks on the far right side of the photo and downstream rockfill slope, looking west.

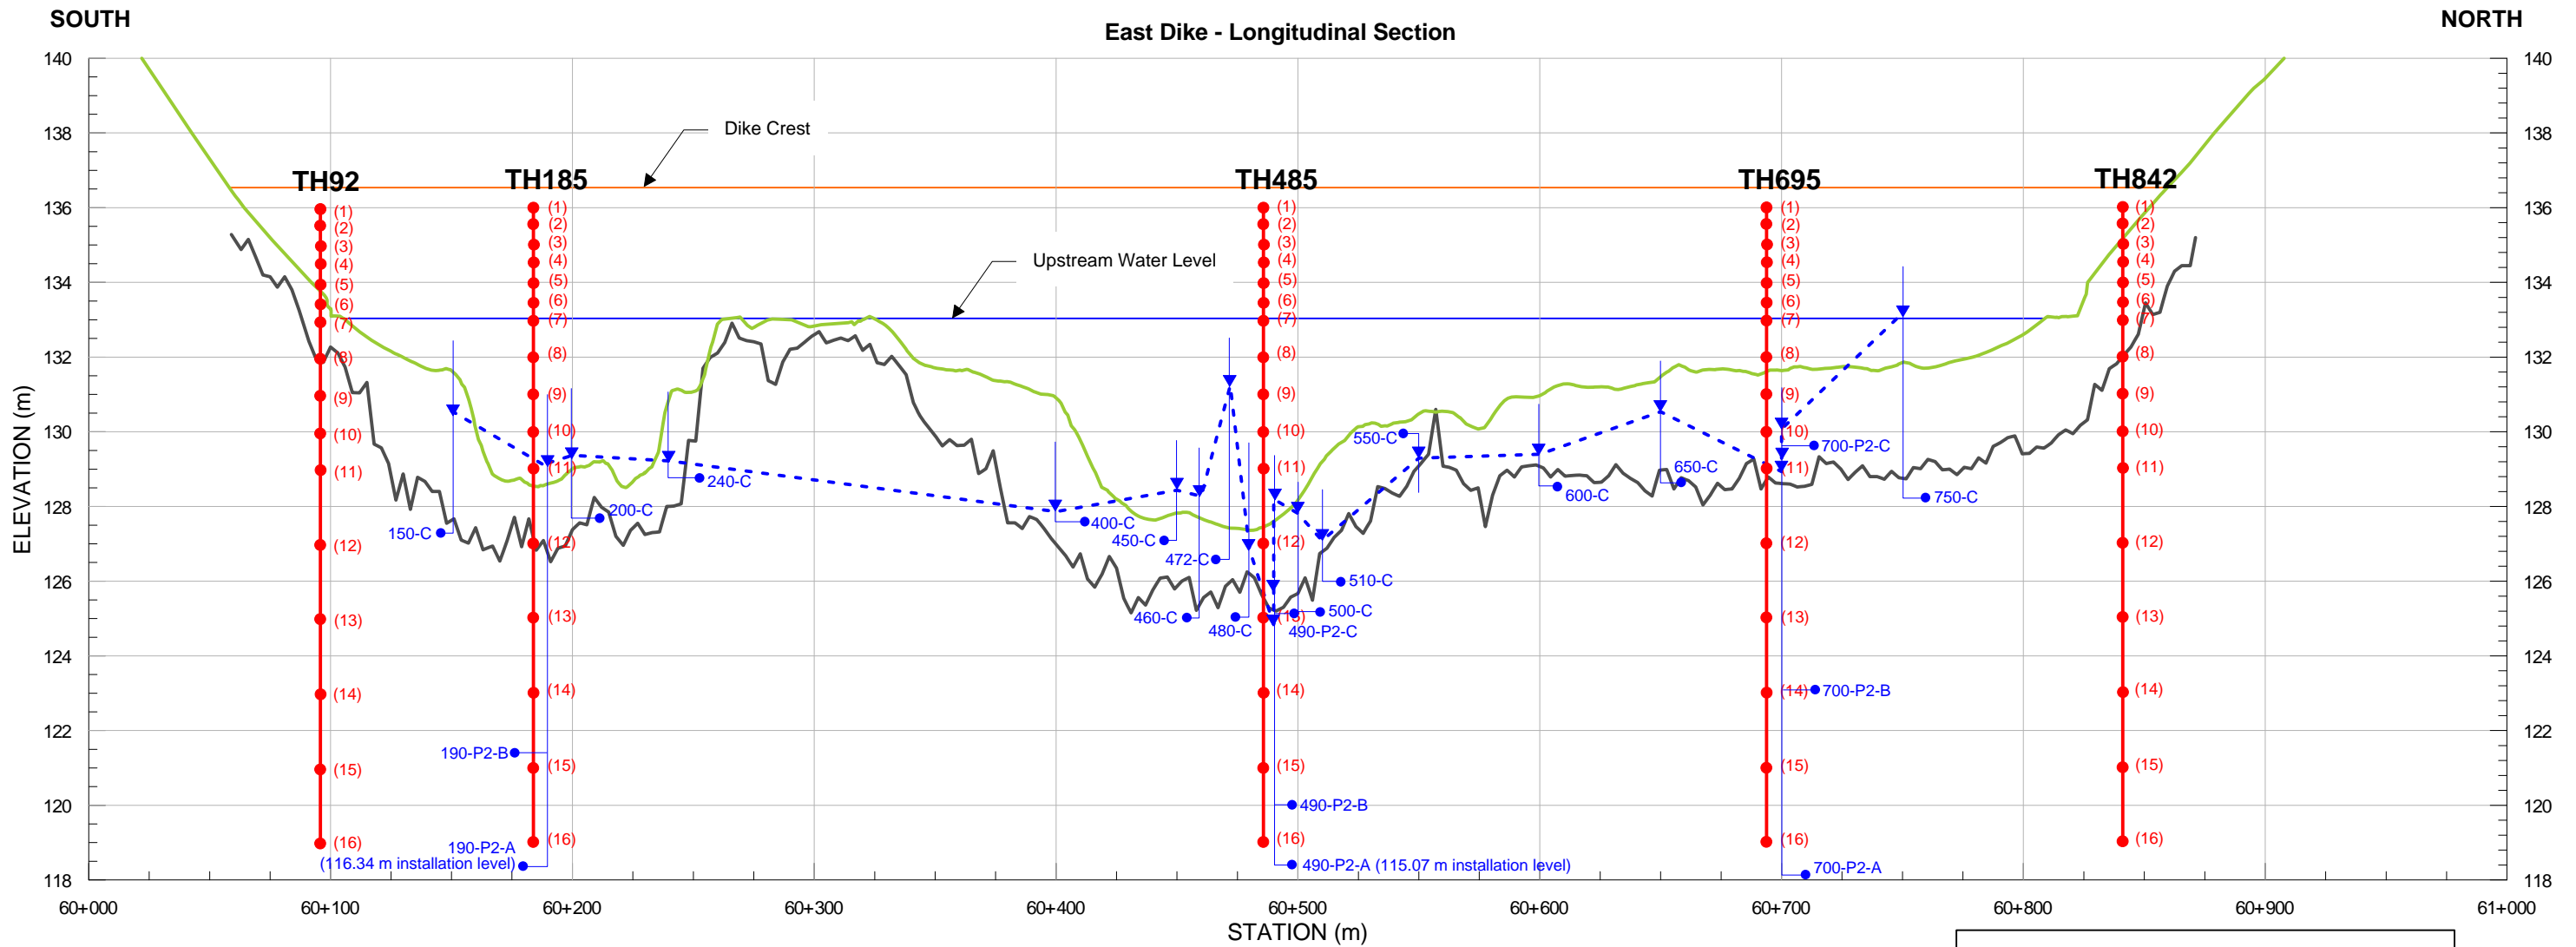
NOTE: TH92 node(9) at elevation 131, data not reported since May 1, 2010 as it appears not to be functioning.

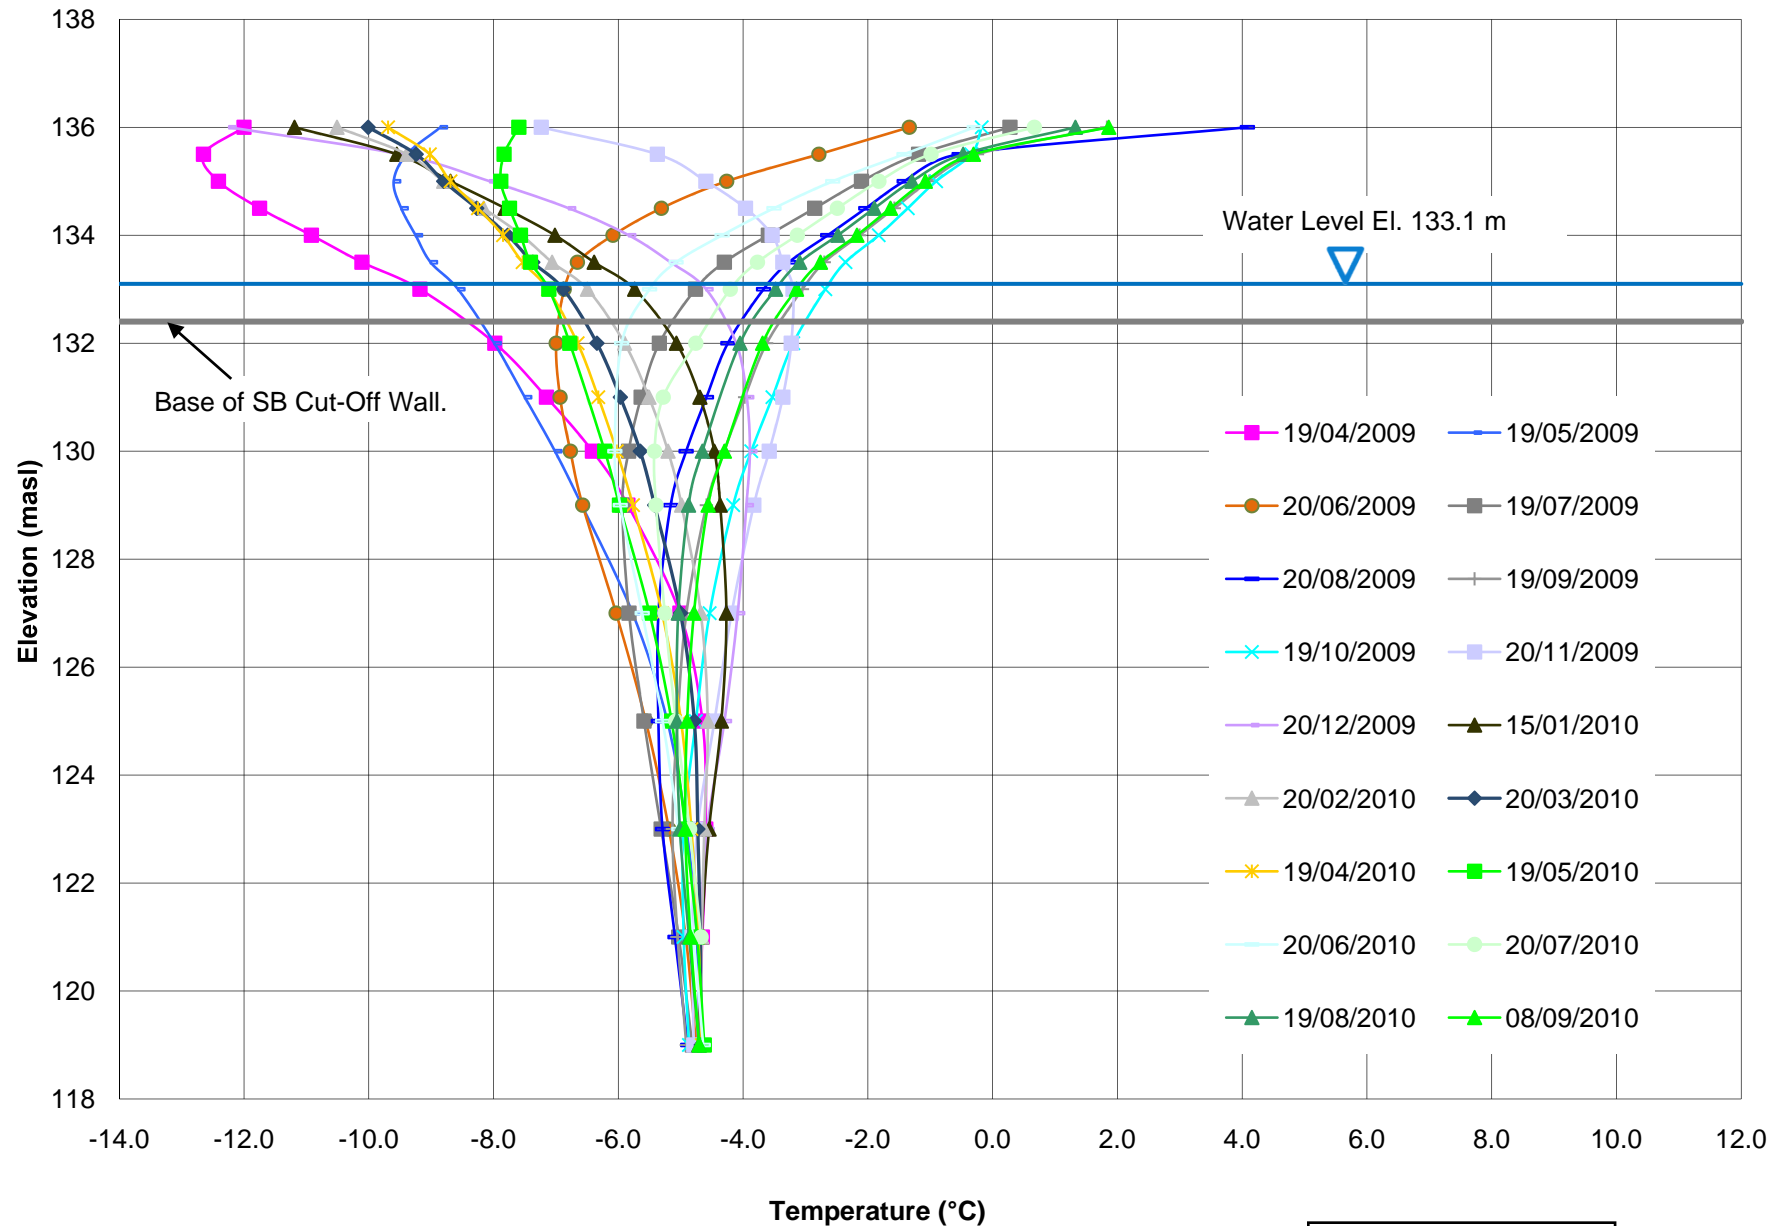
East Dike - TH92 Thermistor Data

Note: Node 9 (El. 131 m) values since May 2010 are unstable and therefore not shown.

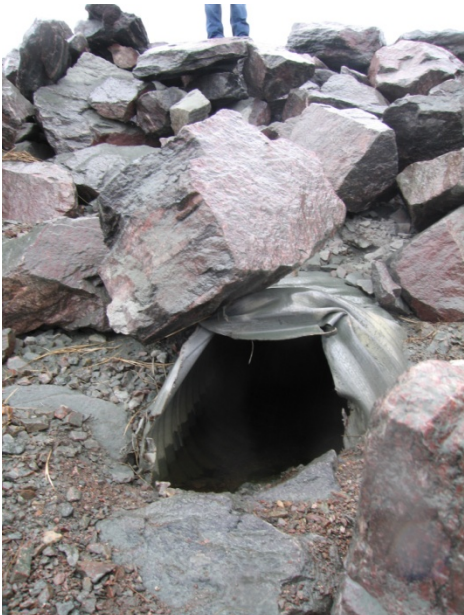
PHOTOGRAPH D2-2 – PRC-1, km 0+430

Description: Upstream view of culvert. Large rock from road work has fallen in front of culvert. Rock is not blocking culvert. Uniform grade through culvert observed. Inlet should be cleaned.

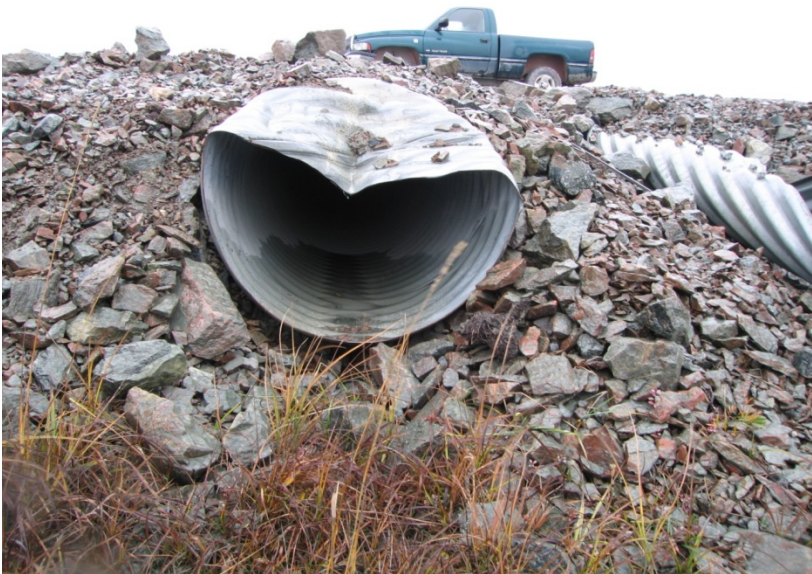
PHOTOGRAPH D2-10: PC-14, km 4+260

Description: Collapsed outlet. Road bed cover over culvert is too thin to provide protection. Uniform grade through culvert observed.

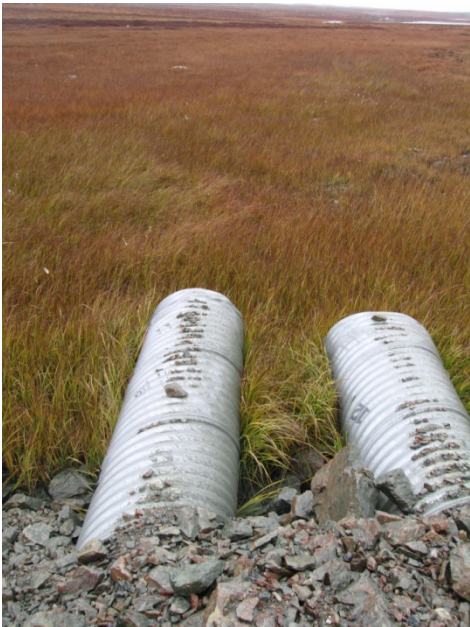
PHOTOGRAPHS D2-12: PC-14, km 4+260

Description: Upstream view of culverts and valley. Culvert on left in photo is filled with gravel, crushed / damaged. Culvert on right outlet partially crushed at inlet haunch, but still functions, uniform grade.

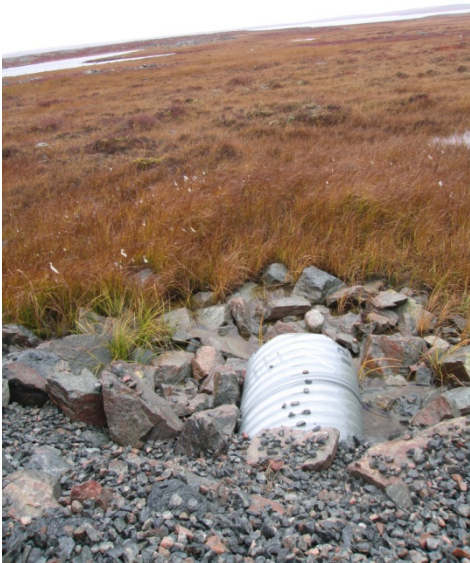
PHOTOGRAPH D2-22: PC-1, km 9+952

Description: Upstream view of culvert and valley. Good condition, uniform grade, no obstruction, no sign of erosion.

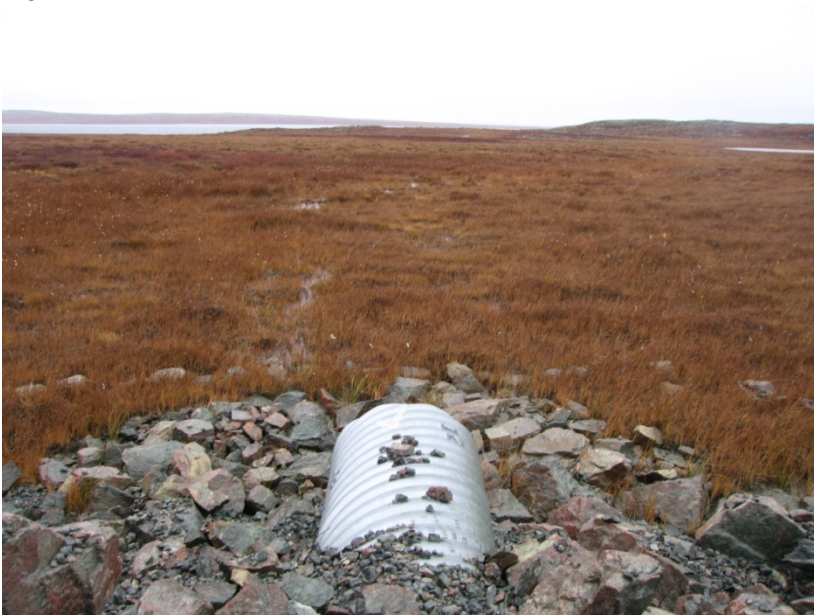
PHOTOGRAPH D2-24: R-03, km 10+580

Description: Upstream view of culvert and valley. Good condition, no obstruction, uniform grade, no sign of erosion.

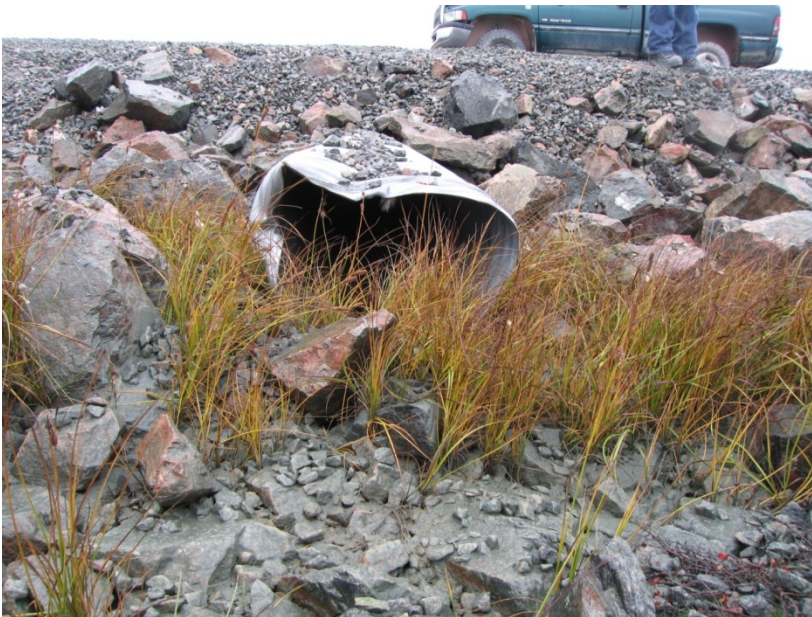
PHOTOGRAPH D2-28: PC-13, km 12+745

Description: Downstream view of culvert and valley. Good condition, uniform grade, no sign of erosion.

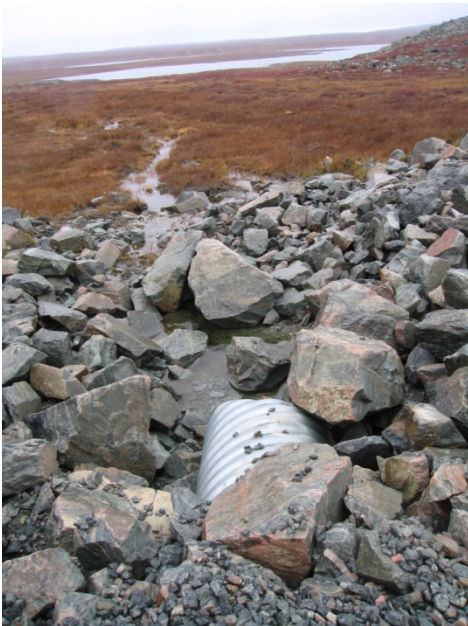
PHOTOGRAPH D2-36: PC-4, km 14+910

Description: From upstream looking at culvert inlet. Culvert set slightly above stream bed, water pools around base before flowing through. Good condition, uniform grade, no sign of erosion.

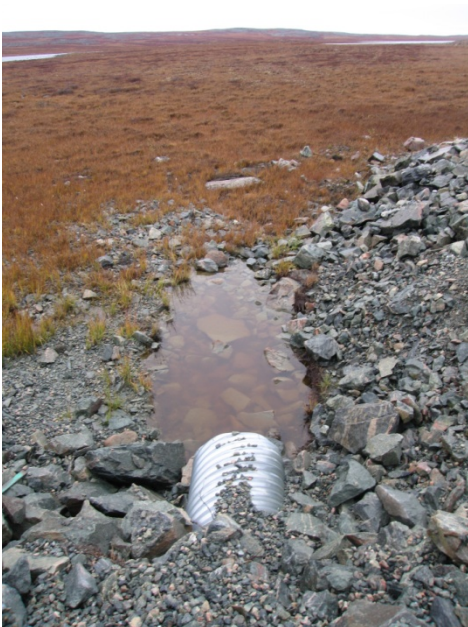
PHOTOGRAPH D2-40: PC-5, km 18+280

Description: Upstream view of culvert and valley. Good condition, uniform grade, no obstruction, no sign of erosion.

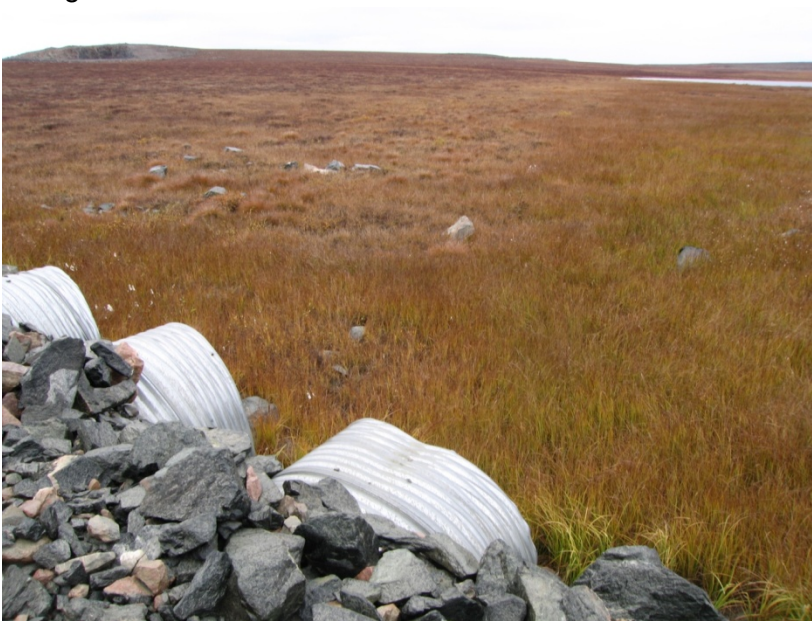
PHOTOGRAPH D2-66: R-18A, km 81+045

Description: Downstream view of culvert and valley. Good condition, uniform grade, no obstruction, no sign of erosion.

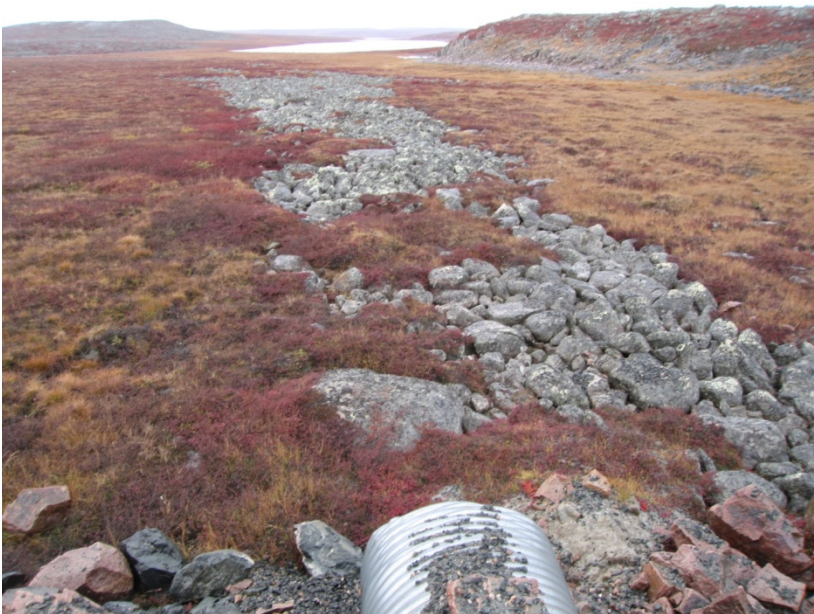
PHOTOGRAPH D2-70: R-20, km 85+490

Description: Upstream view of culvert and valley. Good condition, uniform grade, no obstruction.

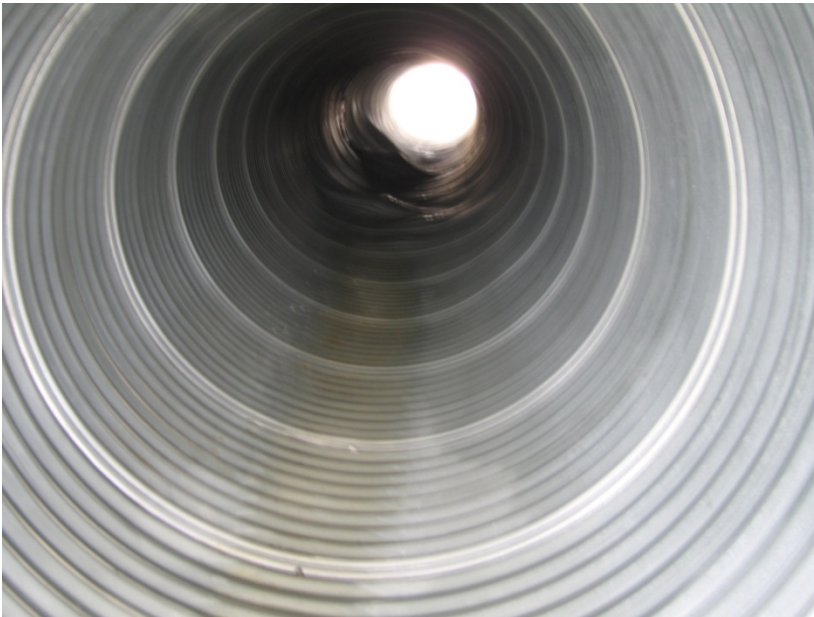
PHOTOGRAPH D2-72: R-21, km 87+500

Description: Upstream view of culverts and valley. Good conditions, uniform grade, no obstructions.

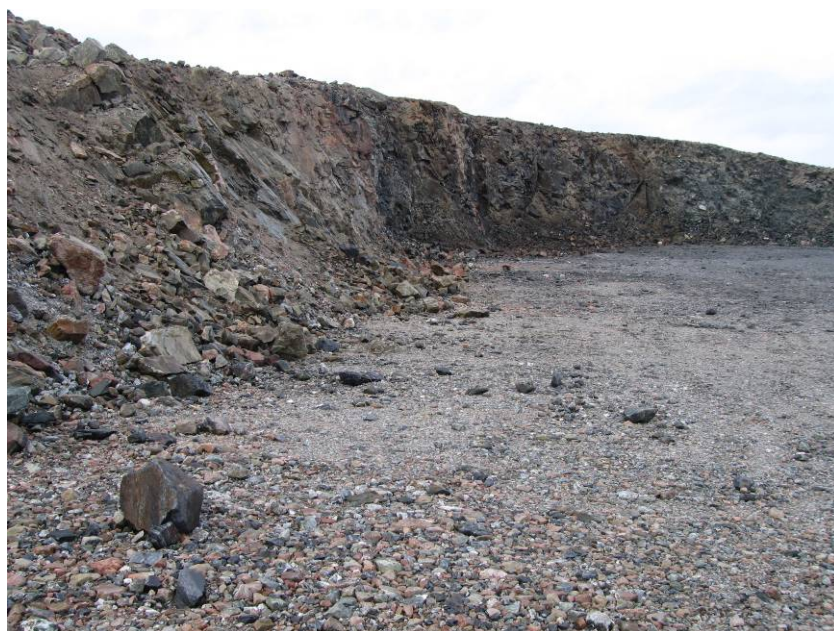
PHOTOGRAPH E-68 – Quarry 18

Description: Thermal degradation on access road at entrance to quarry.

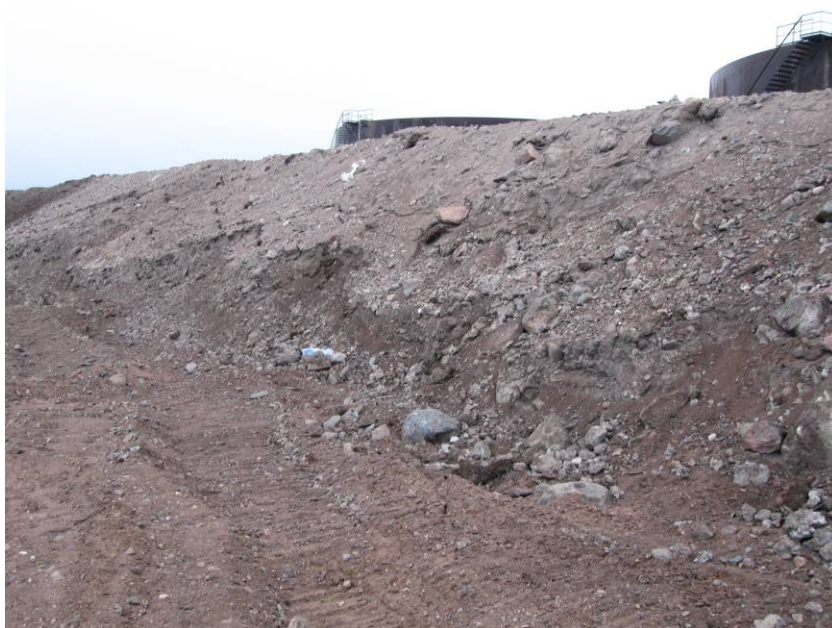
PHOTOGRAPH F1-22 – Baker Lake Tank Farm

Description: Looking east at tension cracks in upper soil slope between Tanks 3/4 and Tanks 5/6. Lower portion of slope appears to have been undercut.

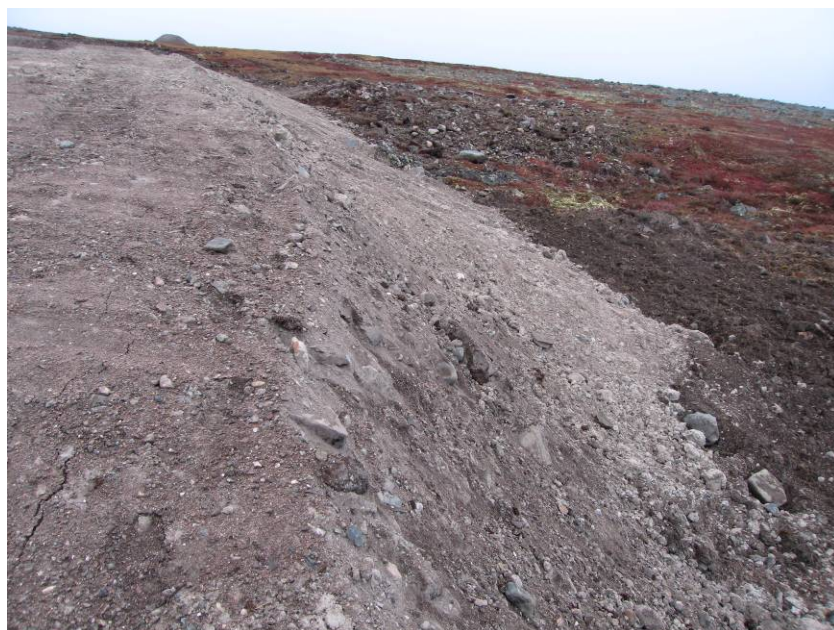
PHOTOGRAPH F1-28 – Baker Lake Tank Farm

Description: Southeast side of Tank 6, looking along slope of secondary containment. Installation of geotextile and geomembrane liner was observed.
