Project No. 09-1428-5007
Doc. No. 968 Ver. 0

RESPONSE TO REPORT NO.4 MEADOWBANK DIKE REVIEW BOARD, DATED AUGUST 19, 2009
SUBJECT: REVIEW COMMENTS

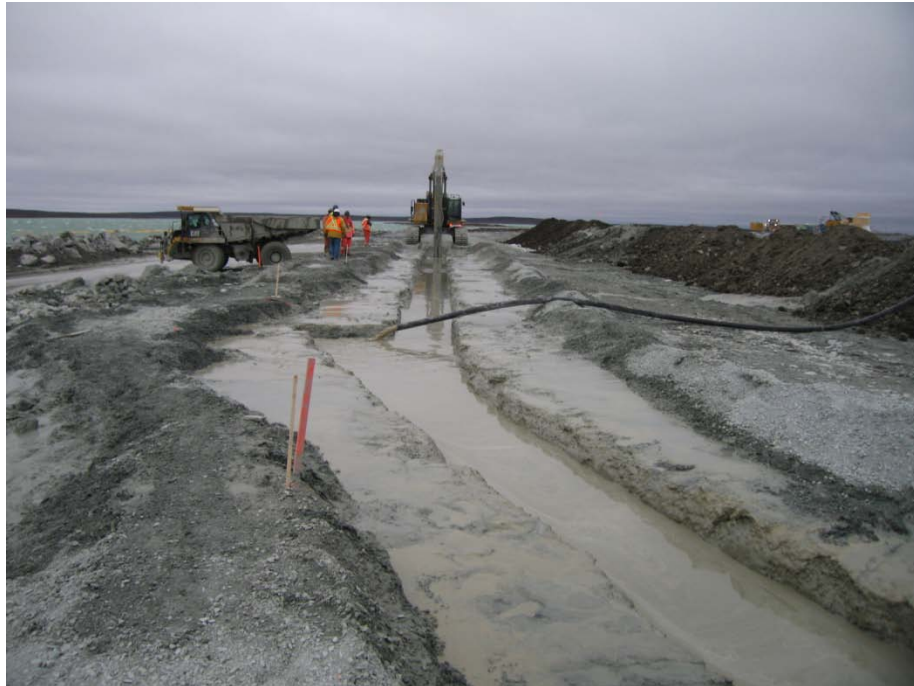
Response: Discussions were held between Golder, AEM, and the contractor prior to slurry wall construction. Turning points in the cutoff wall were successfully constructed by creating a small overlap in the two axes. The photograph below shows one such turning point in the cutoff wall alignment. The alignment was also slightly modified during the construction process near Goose Island.
