**Re: Water License 2AM-MEA0815 Independent Geotechnical Expert Review Panel Report No.4**

**Report No 4  
Meadowbank Mine Dike Review Board  
Meeting July 20-23, 2009**

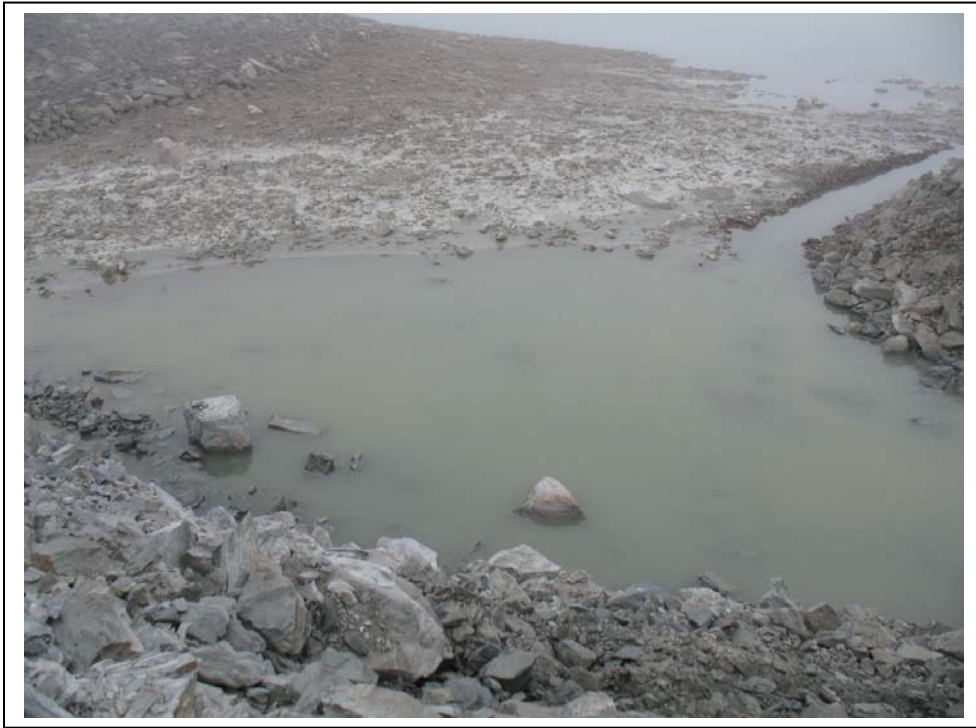
The lake elevation was at 133.1 m and the small impounded pond at the toe of the dike was at 126.75 m. The discharge rate was not known but estimated to be about 30–40 l/s.

Photo # 5      East Dike, pool at toe to west of ramp

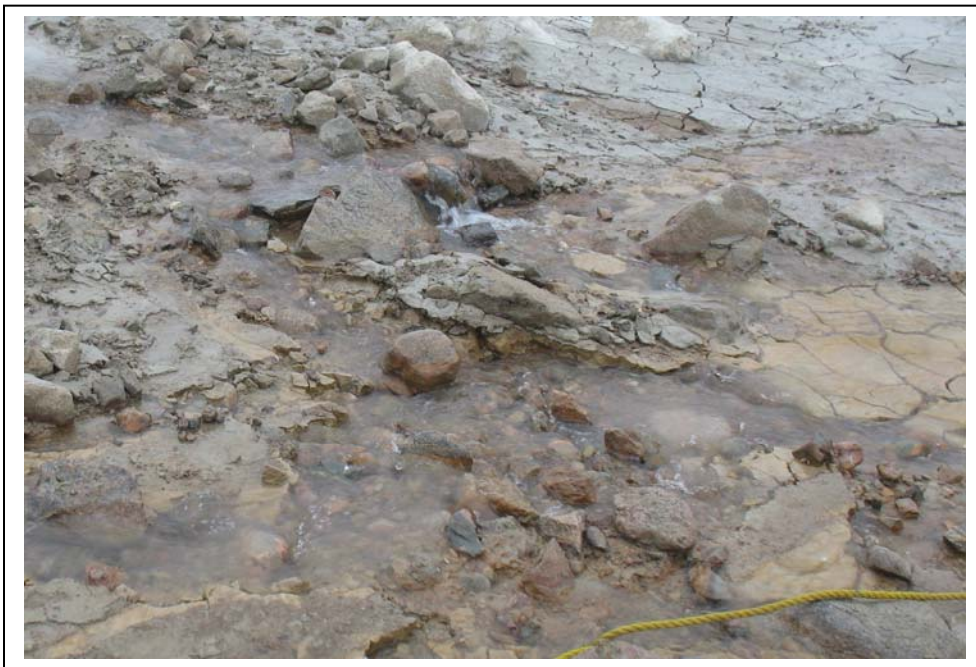
Inspection along the shore revealed a number of smaller discharges; some of which may be from ice thaw. It is likely that several small flows distributed around the perimeter of the basin contribute to the total inflow which, since pumping has been stopped, amounts to something of the order of 75 l/s. The 75 l/s includes the flow from the upper pond so this number also includes thaw water inflows from the upper basin.

Photo # 6      East Dike, seepage to west of ramp, note slightly cloudy

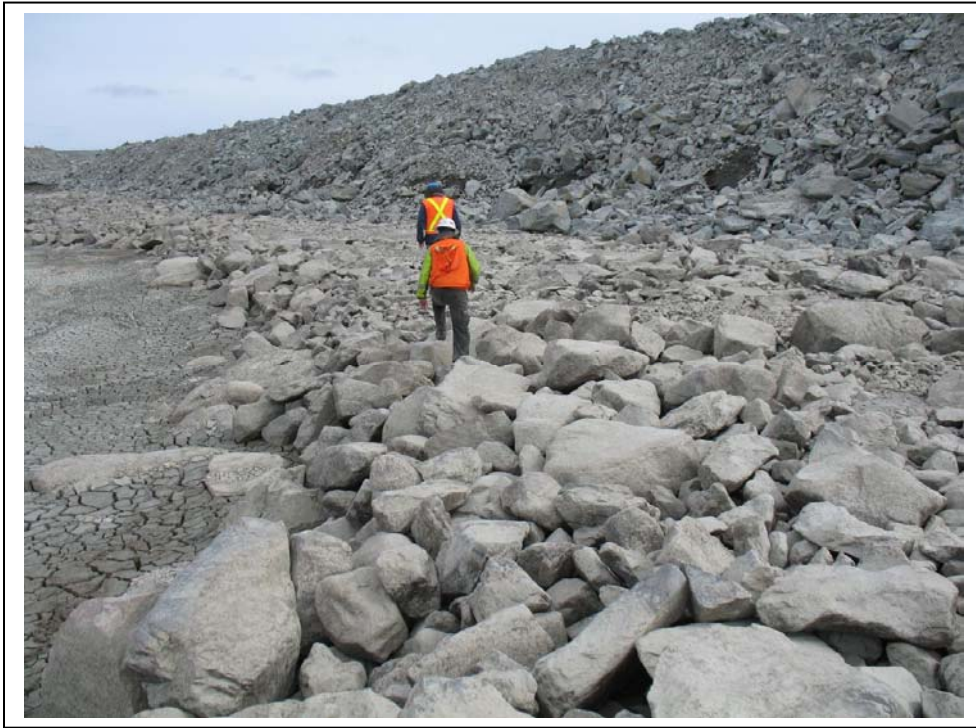
The dewatering of the north arm of 2<sup>nd</sup> Portage Lake has permitted an appreciation of the extent of the boulder fields (photo # 7) which ring the lake shore and surround the islands. The boulders, derived from the till from which the fines have been winnowed away by wave action, are moved around by the ice sheet to form what appears almost as man made fill. The presence of these deposits is of interest in the design of the near shore portions of the dikes built in water.

Photo # 7      East Dike, boulder field along downstream toe of dike

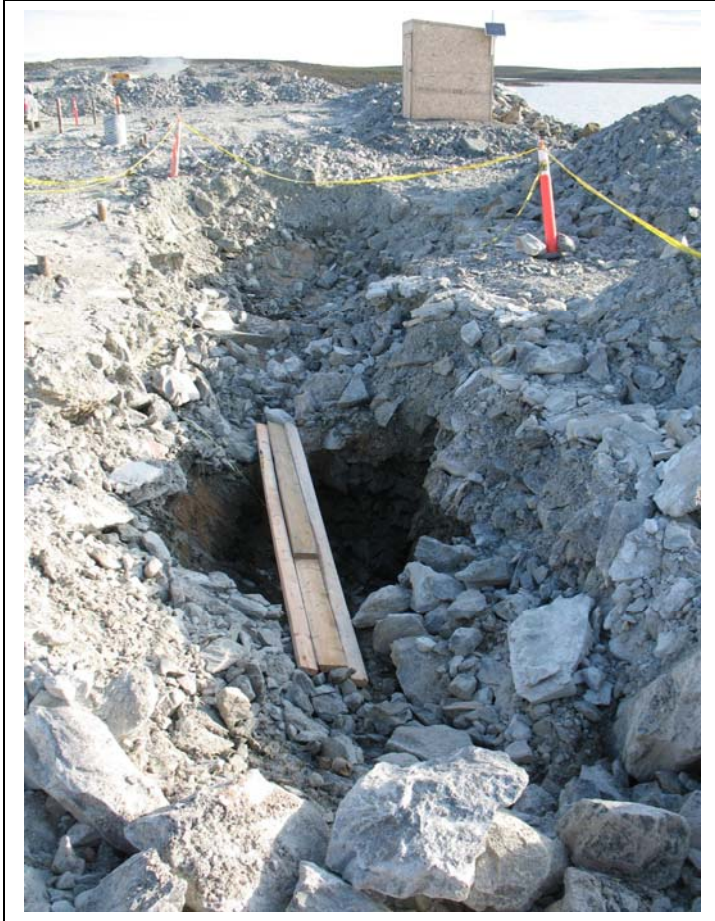
Photo # 9 East Dike,  
Trench in which sinkhole  
was located

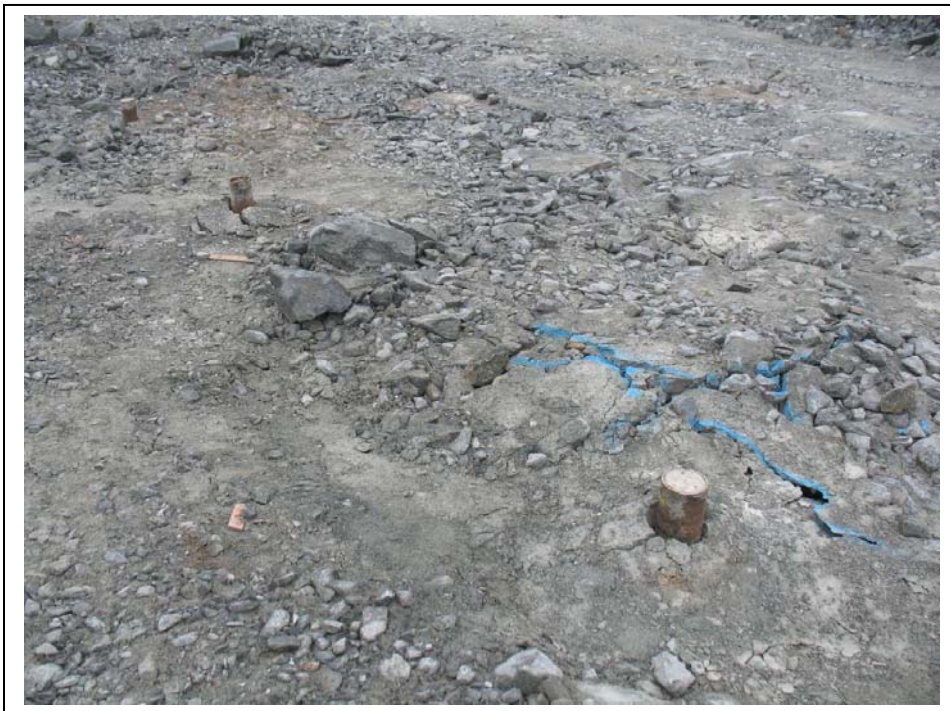
Photo # 10, East Dike  
Punching of crest by  
drill casings

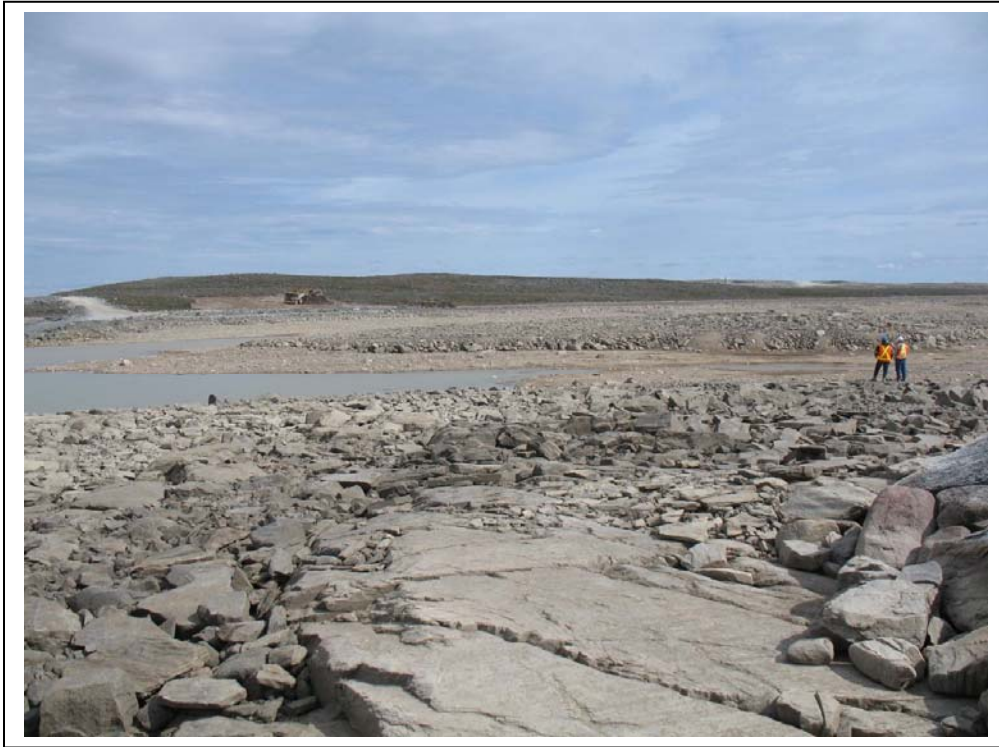
A walkover inspection of the Stormwater Dike foundation was carried out from east to west. The variable foundation conditions from soft lakebed to extensive boulder fields to bedrock outcrops were noted (photos # 11 to 13). The boulder fields, similar to those described for the East dike, are to be addressed in the detailed directives to be formulated to cover foundation preparation. Requirements will vary according to the location across the dike section. Foundation stripping had just started on the East abutment. This will be carried out in stages until the ice rich material is removed.

Photo # 11 Stormwater Dike, variation of foundation conditions

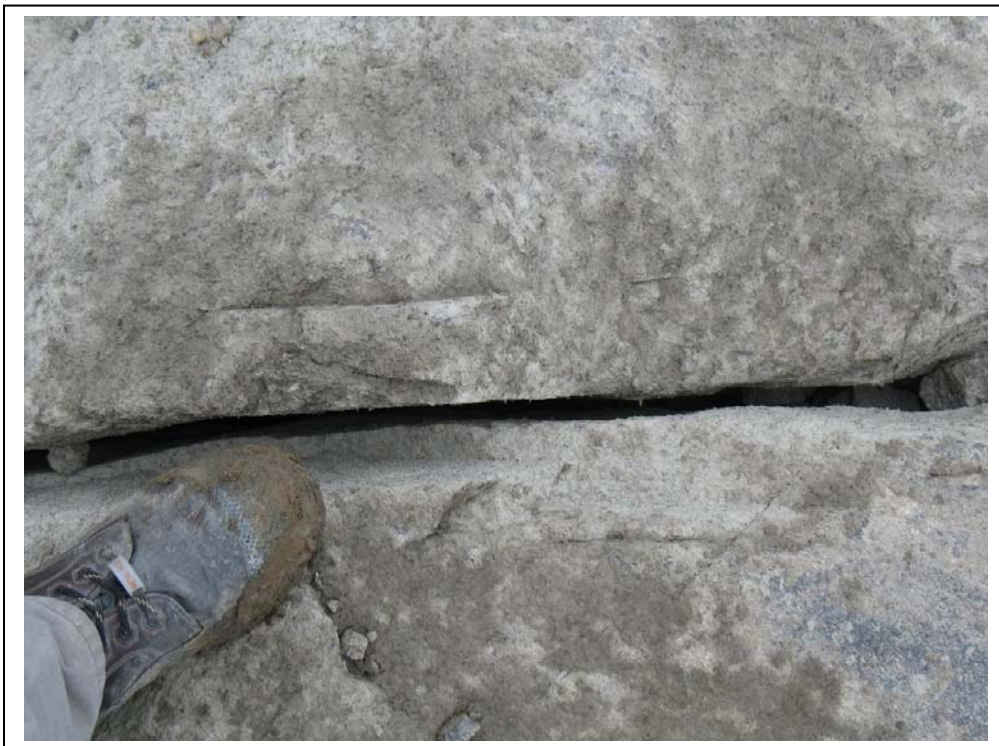
There is a particularly urgent need for investigation of the till/ rock conditions along the cut-off trench alignment. The presence of jointed and frost jacked rock (photo #12) indicates a requirement for an adequate filter between fine grained materials and the

rock wherever the hydraulic gradient could lead to piping. It is to be recalled that no rock grouting is planned for this structure due to its temporary nature.

Photo # 12 Stormwater Dike, open joint in rock foundation

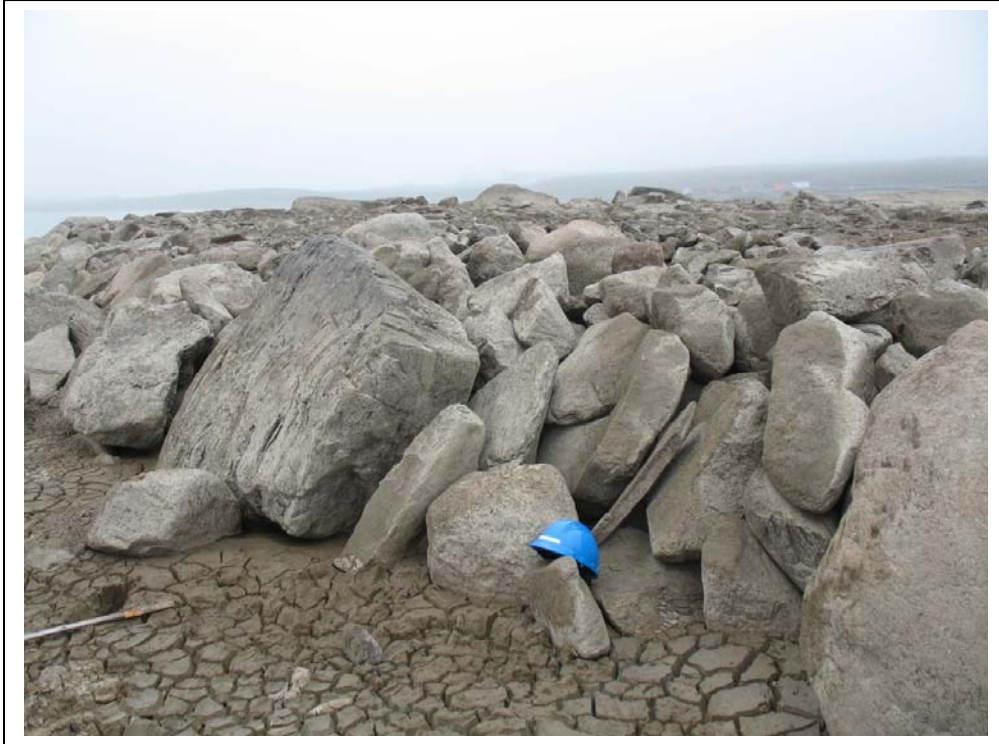
Photo # 13 Stormwater Dike, boulder accumulation along shoreline

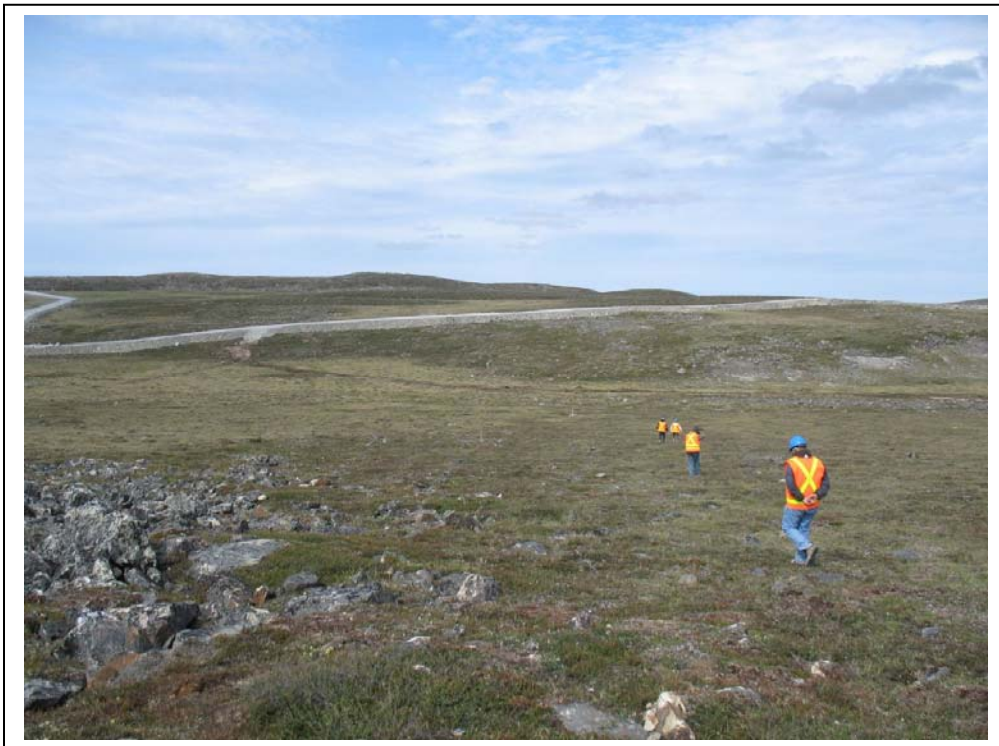
The visit included a walkover along the dike centerline. The steep rock abutments on the right flank transitioning to ice rich frozen soils in the valley bottom were noted (photo # 14).

Photo # 14 Saddle dike No1, view from south to north abutment
