August 26th, 2010

Mr. Dennis Gourde, P.Eng.  
General Manager  
Agnico – Eagle Meadowbank Division  
Baker Lake Office

**Report No 7  
Meadowbank Mine Dike Review Board  
Meeting July 26-29, 2010**

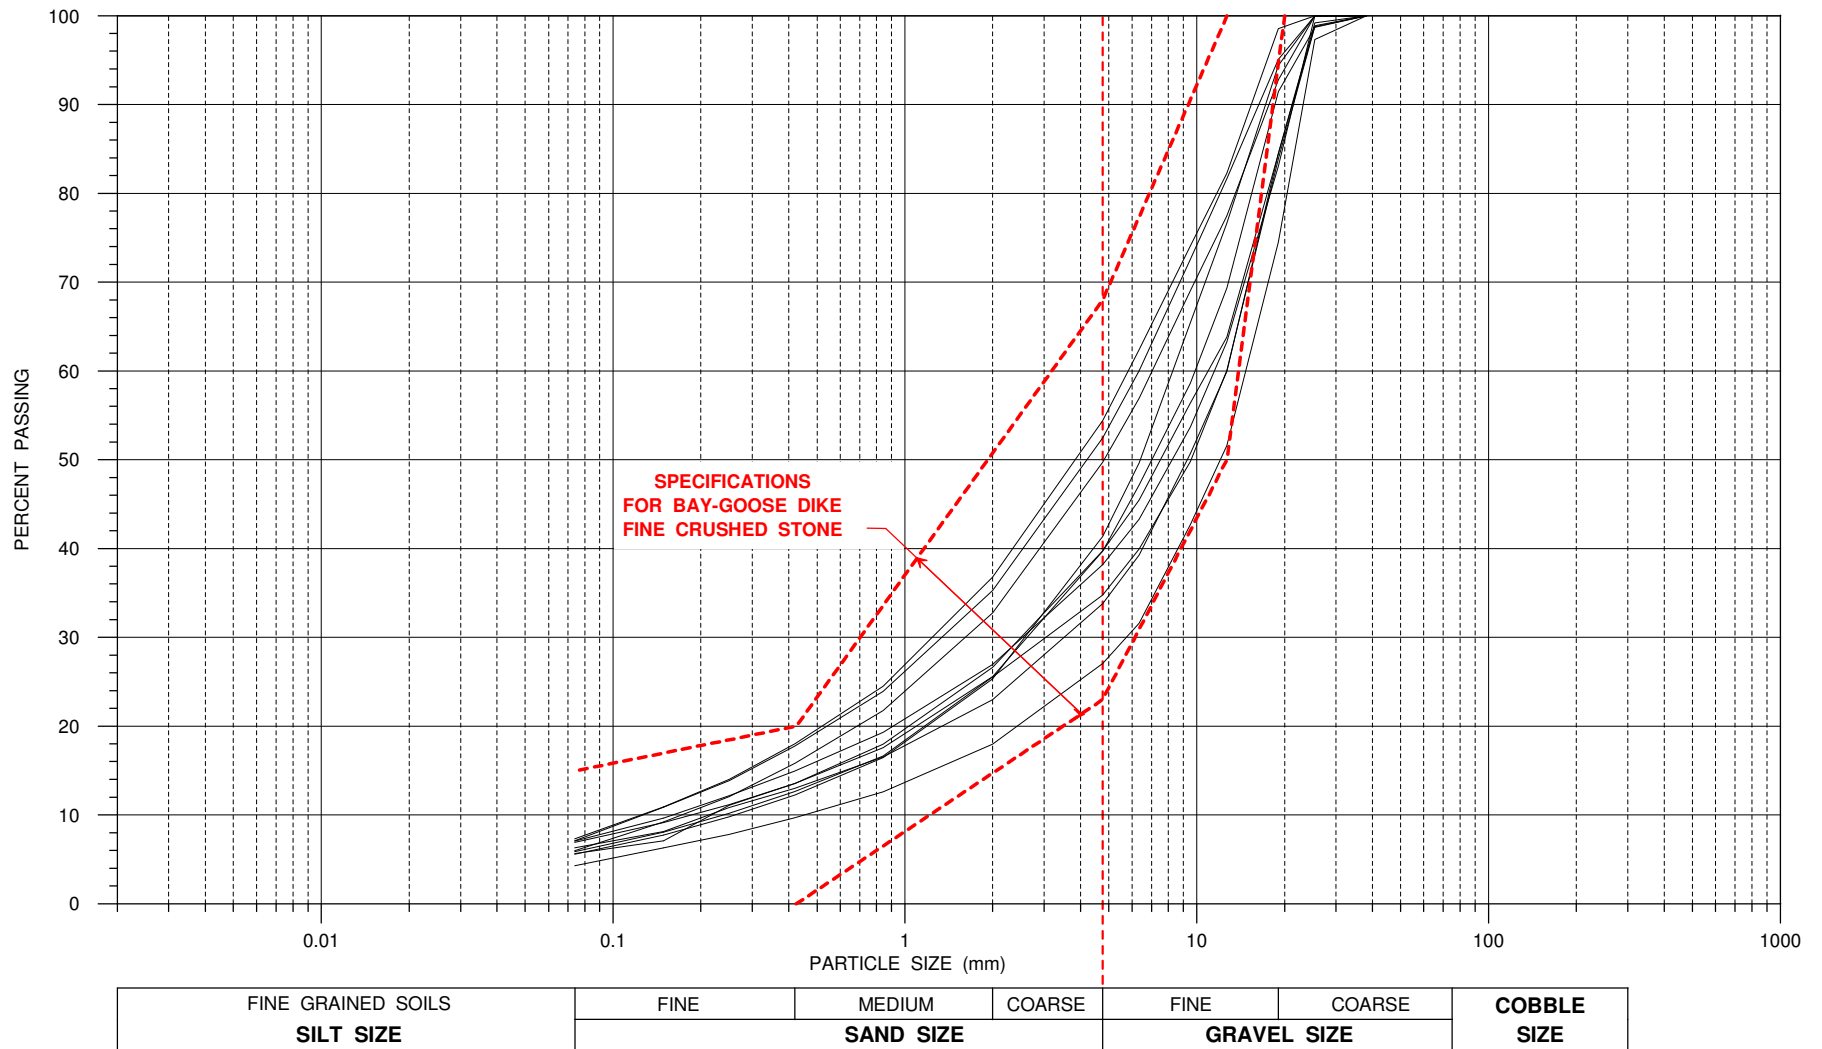
**MEADOWBANK GOLD PROJECT - BAY-GOOSE DIKE**  
**SAMPLES FROM STOCKPILE OF FINE CRUSHED STONE**  
**GRAIN SIZE CURVES**

excessive fines. However, the grain size analyses, transmitted subsequent to the Board meeting and shown in Appendix C, indicate the material to be well graded and within the specified envelope except for a small fraction of oversize particles. As the materials were dry when observed it is possible that some segregation on the outer slopes of the piles may have contributed to the perception of a less well graded product. Nevertheless, it is evident that care is required in the exploitation of the stockpiles, particularly when dry, in order to minimize the segregation.

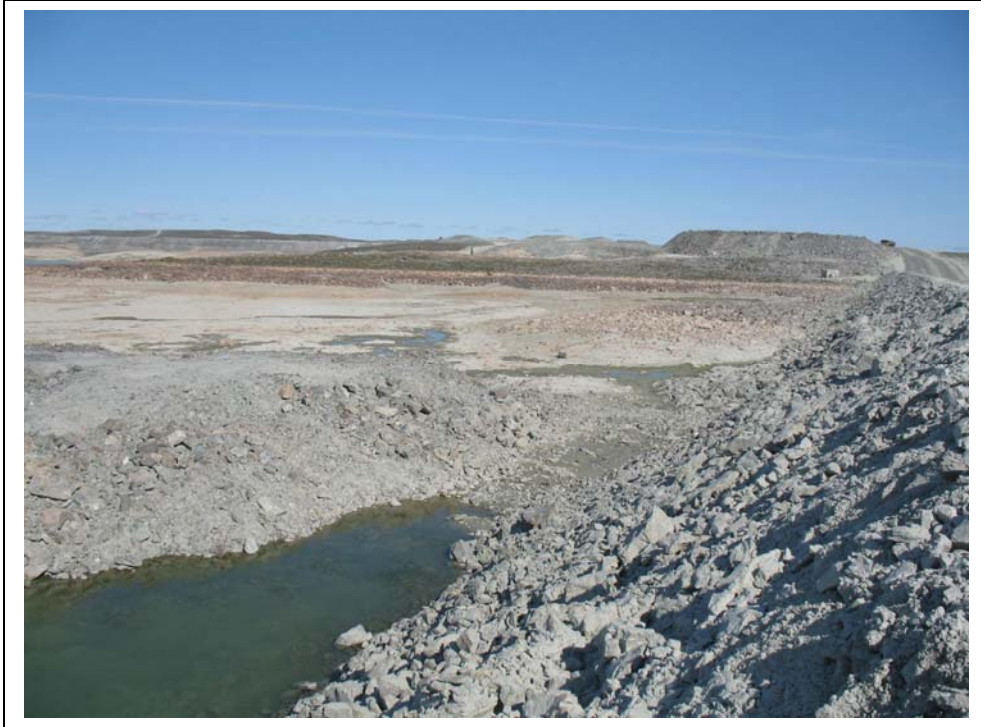
An inspection was made of the entire dike toe to observe the ground conditions and the areas of visible seepage (photos #1 to 6). AEM advised that two weirs are to be installed to monitor leakage more accurately. These will be located in the North and South Channels and will be of a "V"-notch geometry. The existing rectangular weir in the North Channel may give an indication of major change in flow but lacks the precision for more subtle changes. The flow in the South channel is monitored by visual observation. Some turbidity was noted at the time of the visit but this was caused by drainage from an active dump site adjacent to the spring. (Photos # 6). It is understood that the observed seepage situation is stable and the order of magnitude of the flows is similar to those noted in late 2009.

Photo # 1      East dike, seepage areas in North Channel

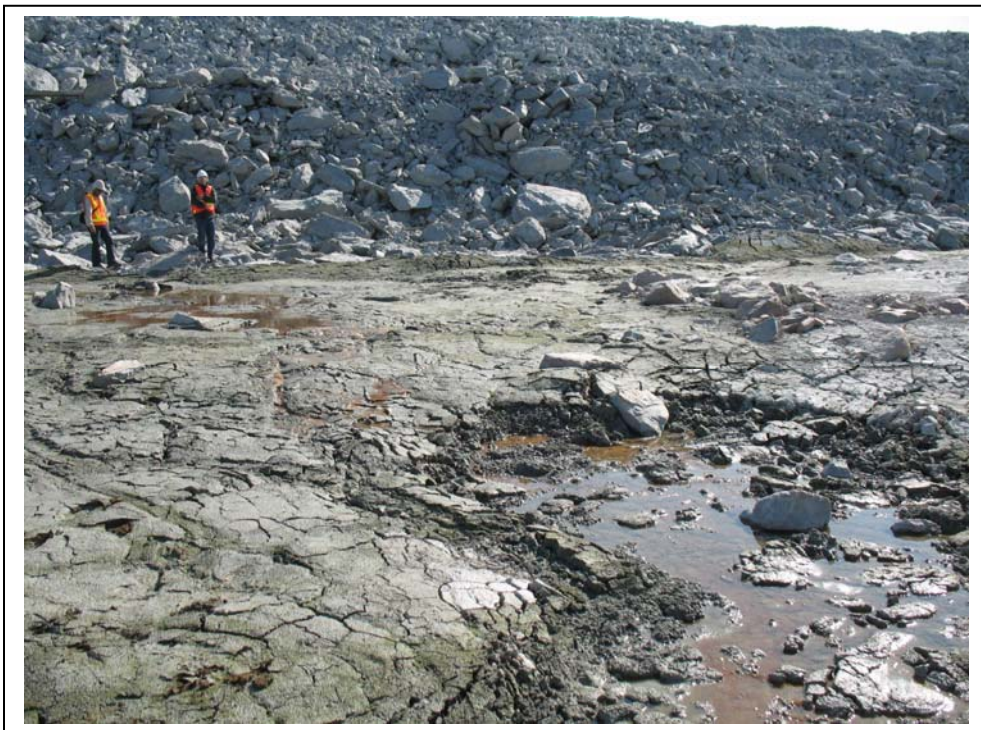
Photo # 2      East dike, seepage circa Stn. 60+550

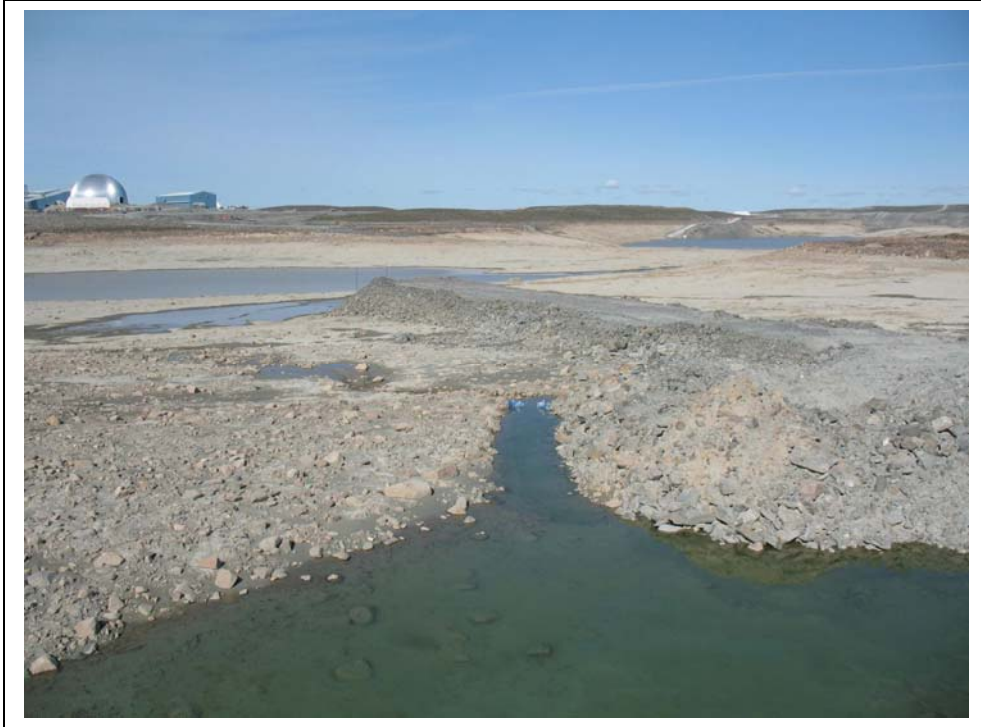
Flow measurement data from the weir in 2010 is limited but consistent with past readings. The existing rectangular installation is to be modified to a "V" shaped weir to improve accuracy. Other weirs are also planned in areas of significant seepage.

Photo # 3 East dike, location of weir circa Stn. 60+490

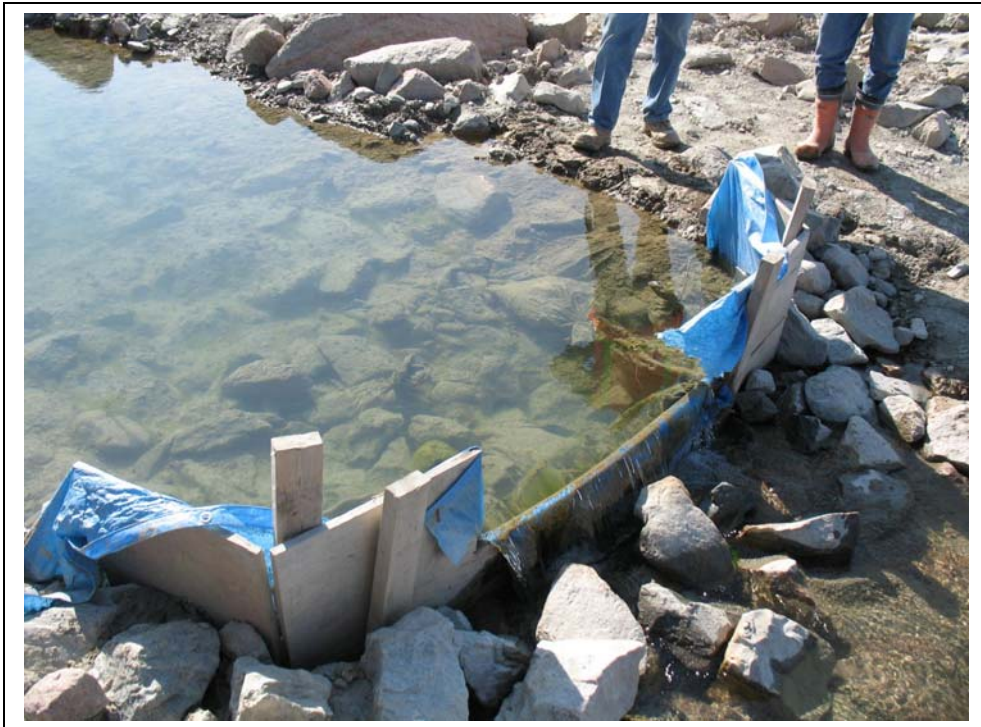
Photo # 4 East dike, weir circa Stn. 60+490

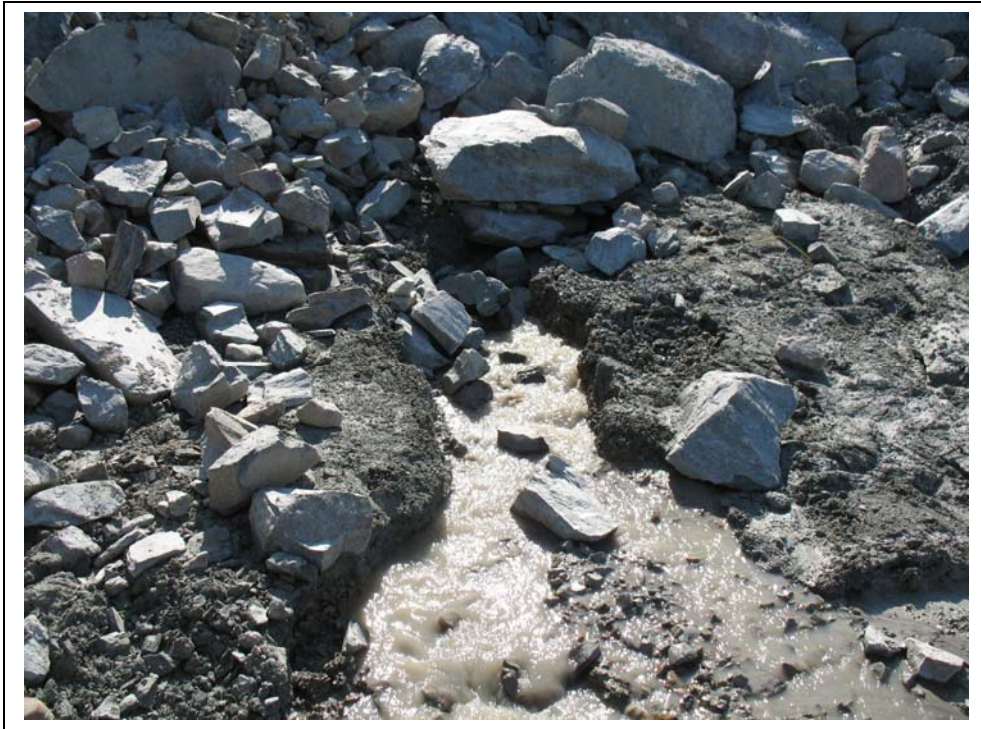
Photo # 5      East dike, flow from toe of dike in South Channel

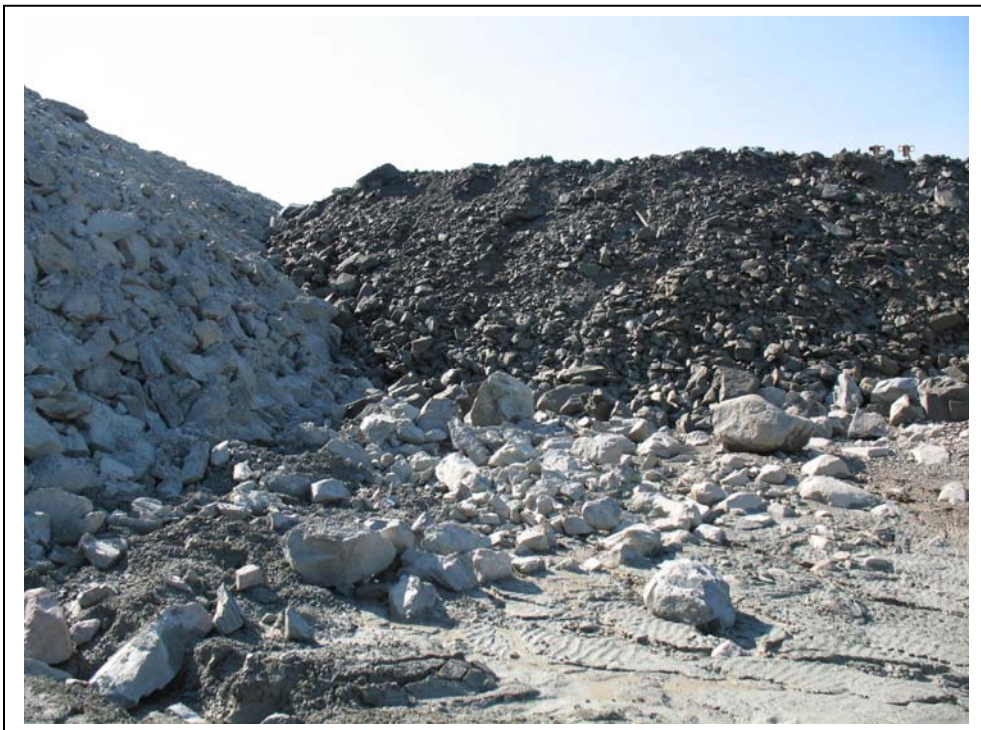
Photo # 6      East dike, active dumping area adjacent to above flow

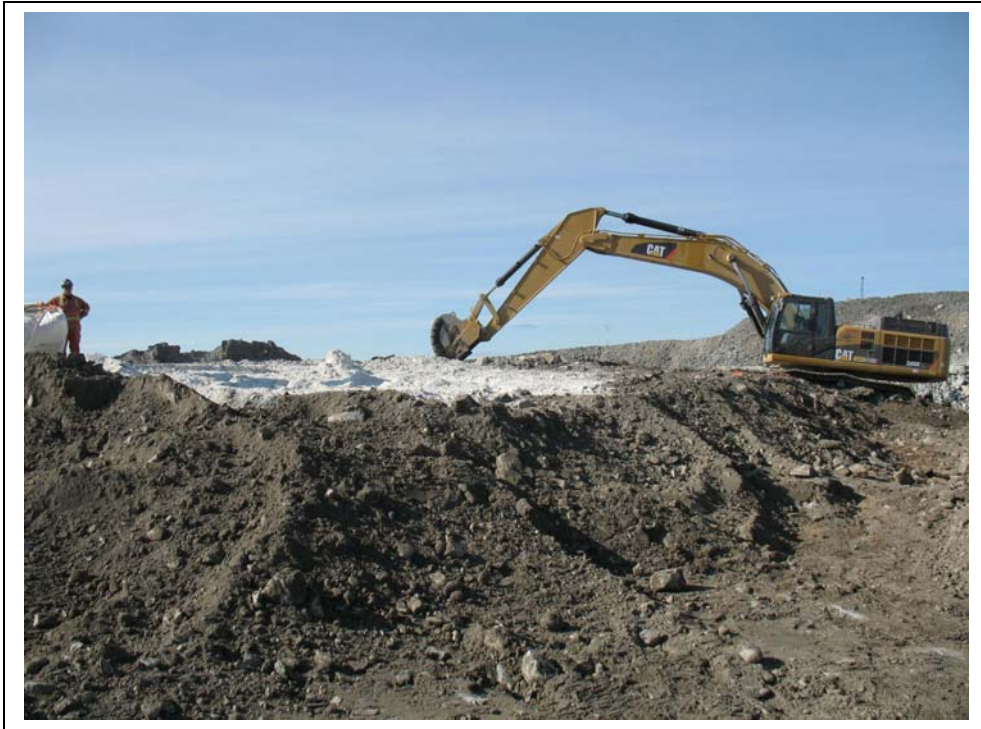
Observations made during the site visit included the Soil-Bentonite (SB) fill preparation (photo # 7); embankment widening, functioning of turbidity barriers, water pumping to assist containment; central trench excavation, fine filter material stockpiles for the Bay Goose Dike. The Board was pleased to see how effective the turbidity barriers, together with the causeway, have been in controlling suspended sediment migration. The stockpile of fine filter material was examined and the Board remarked on the apparent high fines content (photo # 8). This non-PAG material is produced from relatively friable volcanic rock and the crushing and handling may generate

Photo # 7 Bay-Goose, preparation of dry SB mix

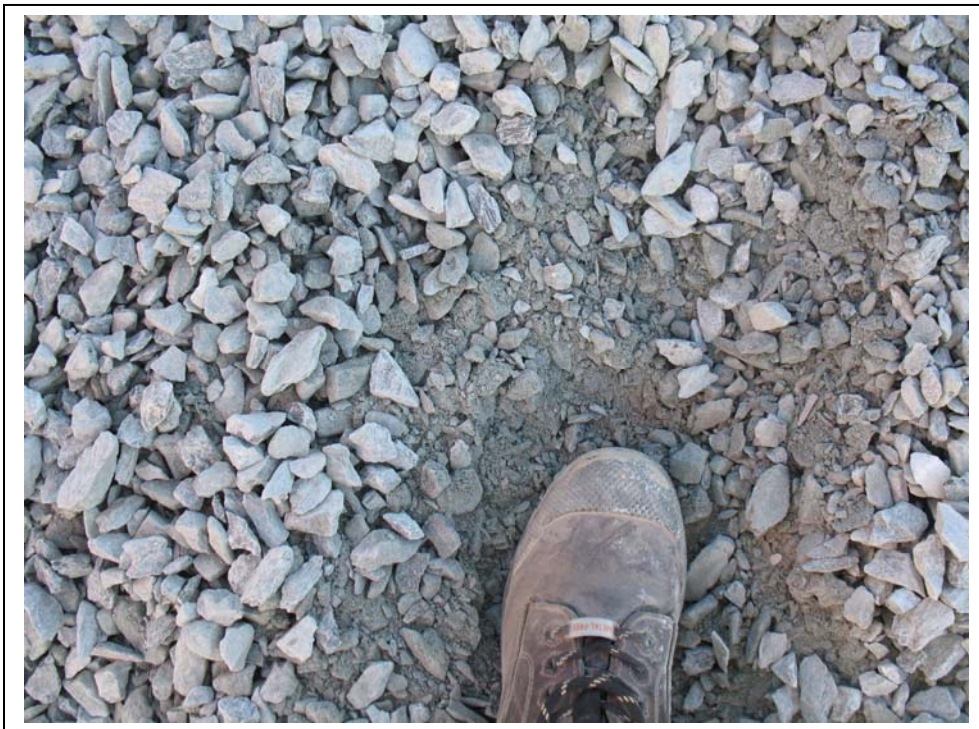
Photo # 8 Bay-Goose, material for fine filter from non PAG rock

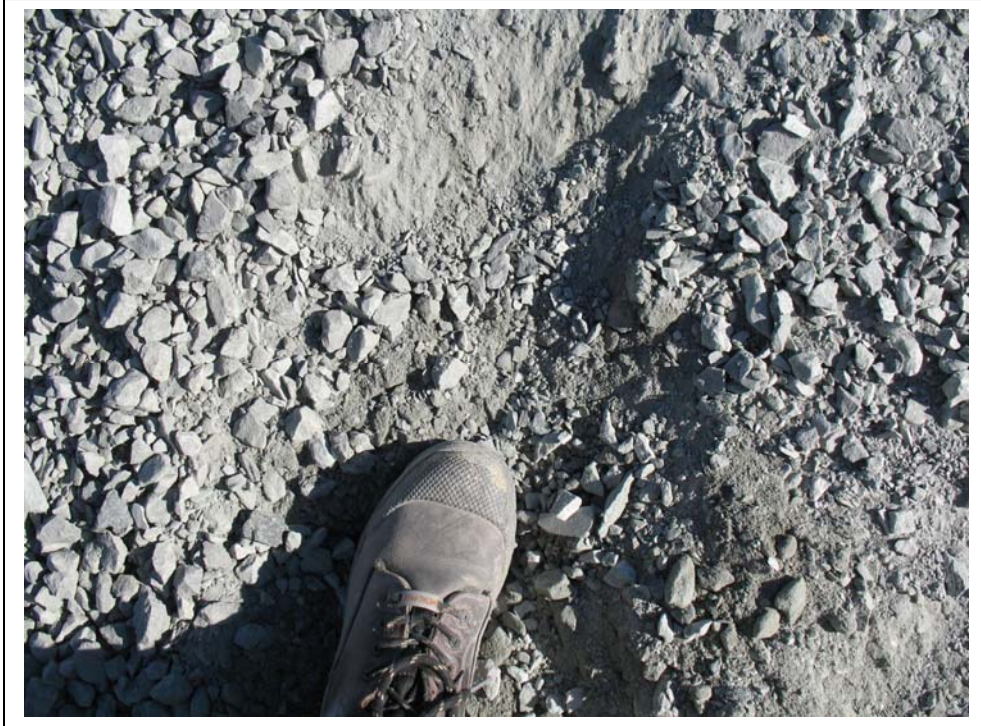
The Board paid a visit to the Stormwater Dyke and inspected the bedding material (photos # 9 and 10), the liner as placed and welded (photos # 11 to 13), though there was no ongoing activity, and the tailings beach (photo # 14). The susceptibility of the liner to damage by construction and operation equipment was noted. The standard of placing is variable and this is apparently due to weather conditions (wind etc) prevailing at the time of installation.

Photo # 9 Stormwater dike, stockpile of bedding material from PAG rock

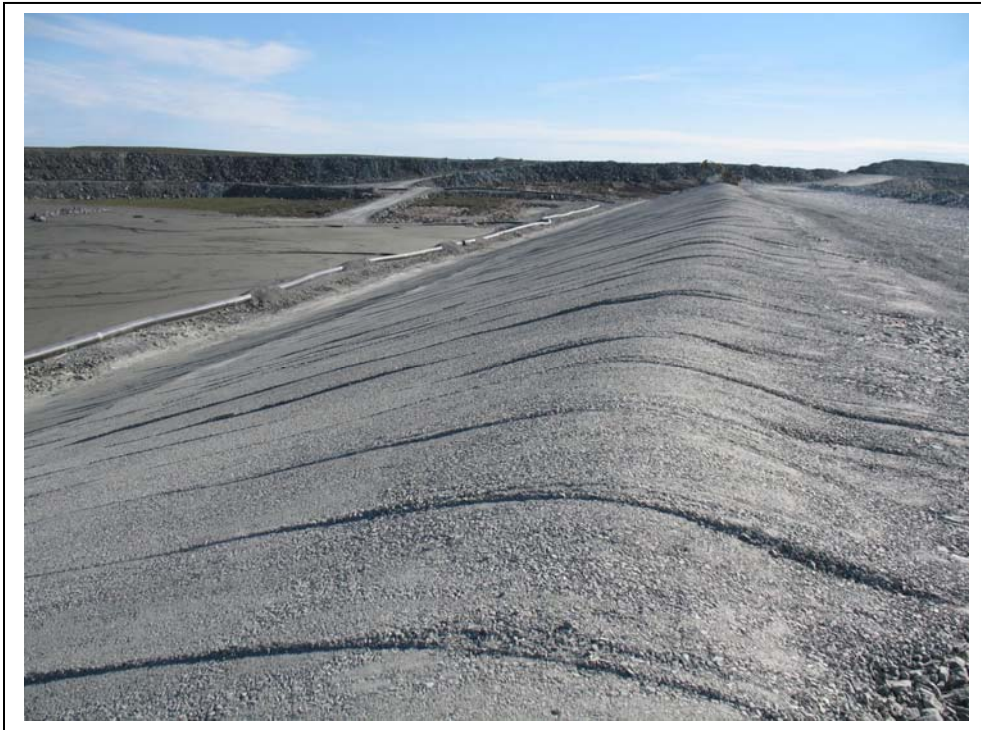
Photo # 10 Stormwater dike, placed and compacted bedding

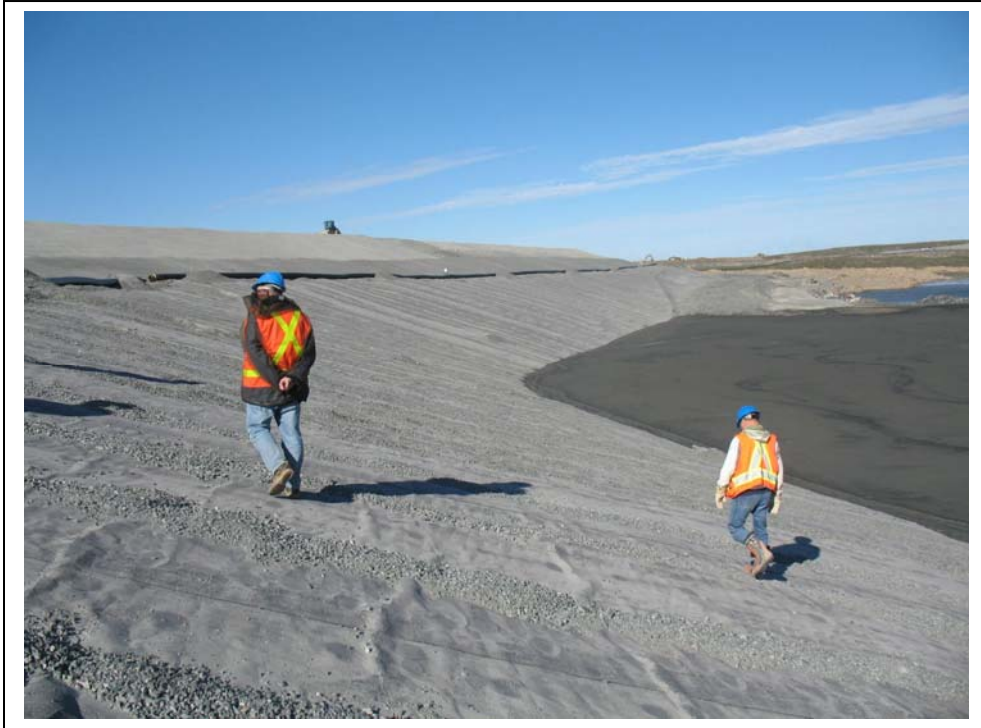
Photo # 11 Stormwater dike, Coletanche liner minor wrinkles

- the bedding material is of good quality materials with satisfactory placing and compaction;
- a comparison should be made with current Diavik practice, with which GAL is familiar, in order to demonstrate the equivalence in scrutiny;
- as the work may be spread over several months with varying weather conditions there is a need for diligence particularly with respect to winter work and snow incorporation. Several wrinkles were noted during the course of the inspection. There is a need to establish whether these are excessive and to provide the inspection staff with clear criteria for acceptance;
- protocols should be established to govern equipment working on liners with mandatory use of check lists and reporting of any event that could lead to damage.

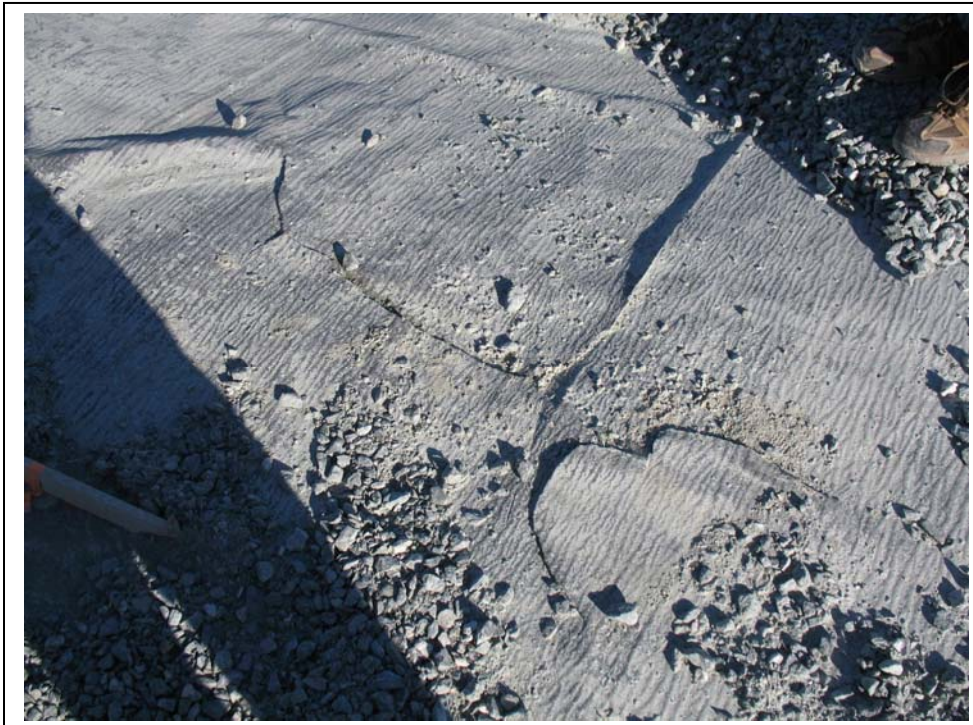
Photo # 12 Stormwater dike, liner damaged by construction subsequent to installation

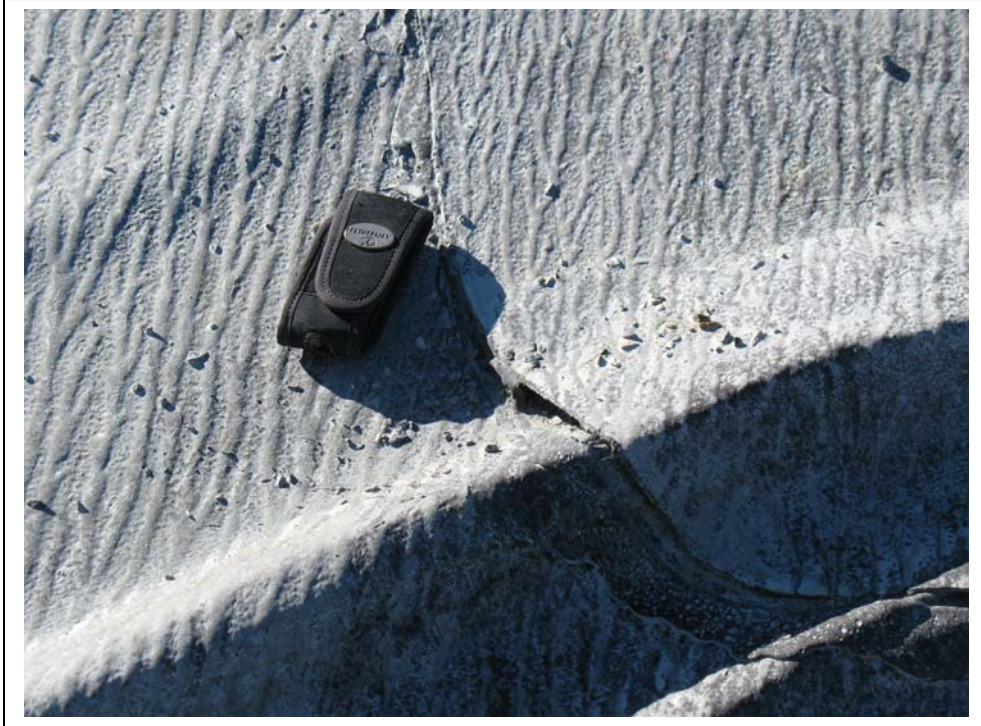
Photo # 13 Stormwater dike, liner weld failure at wrinkle

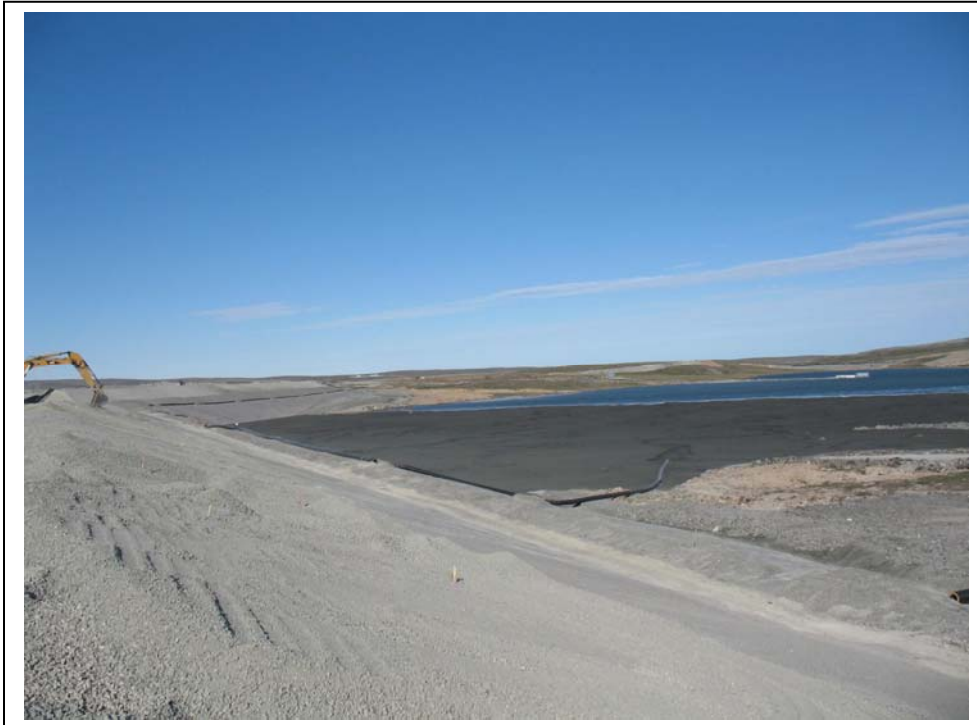
The tailings deposition was observed from the vantage point of the water reclaim jetty. The Board noted the clarity of the decant pond water and remarked that re-use as process water should thus be facilitated.

Photo # 14 Stormwater dike, tailings beach and decant water pond

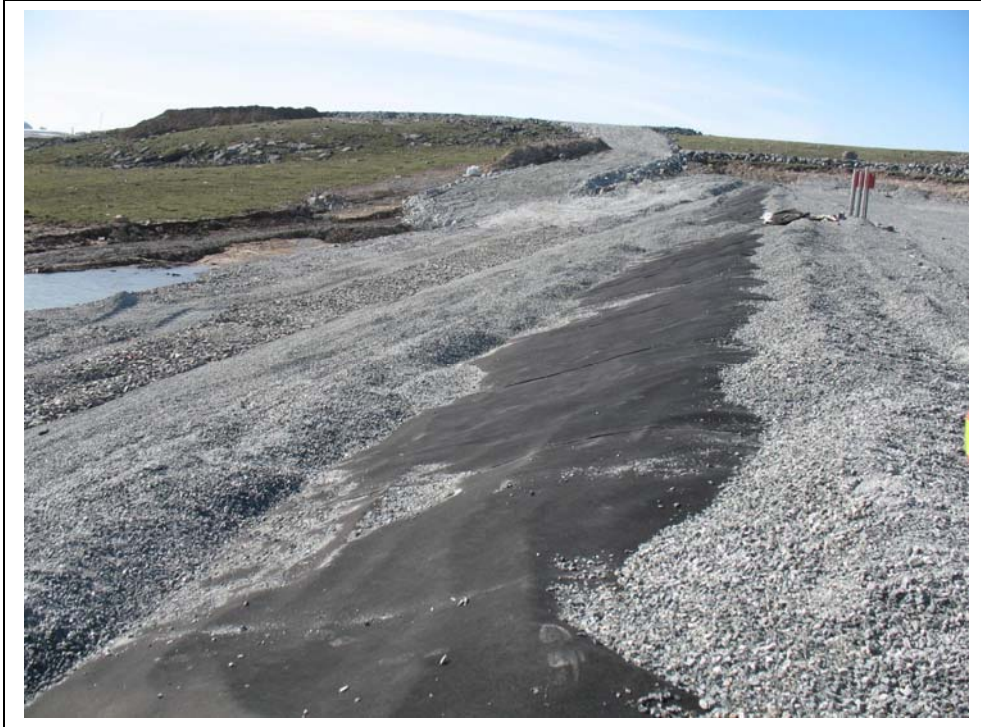
Photo # 15 Saddle dam SD1, LLDPE liner with geotextile cover

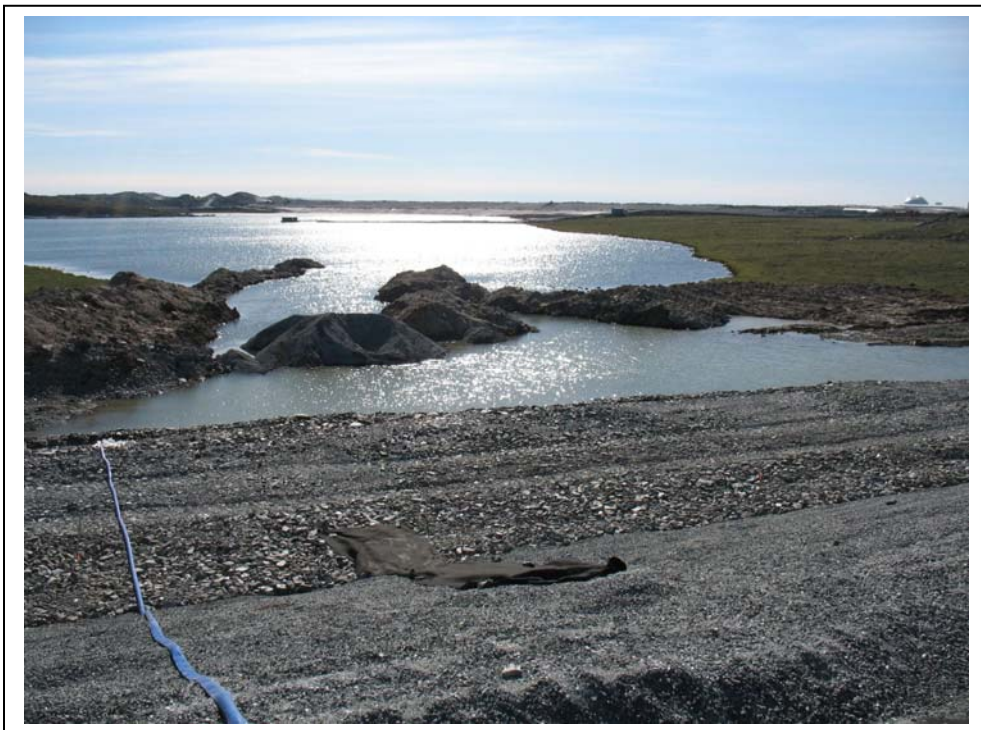
At Saddle Dam SD-1, the plans to increase the cover on the upstream tie-in of the liner and to enhance the protection were described. This will entail the construction of a groin upstream of the dike toe (photo # 16) and the direction of tailings to the enclosure to create a beach in advance of normal deposition in the area. Localised pumping was underway at the downstream toe (photo # 17) to reduce the potential for build-up of pressure under the liner until the aforementioned beach is created. There was also mention of lowering the culverts under the access road which runs downstream of the dike.

Photo # 16 Saddle dam SD1, upstream toe

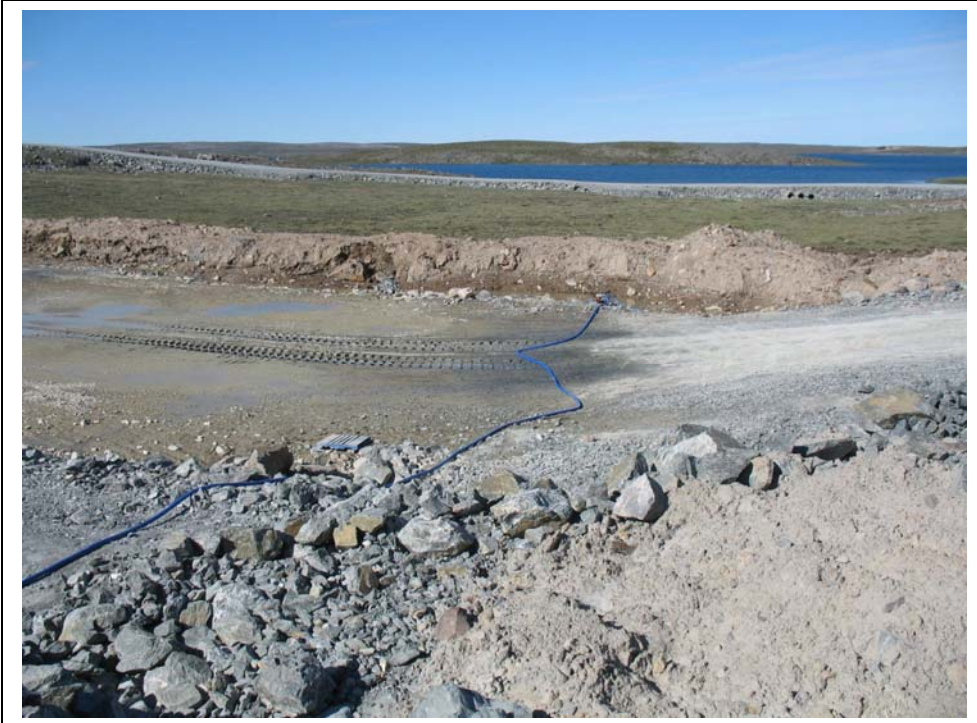
Photo # 17     Saddle dam SD1, downstream shoulder. Note pump and culverts in background

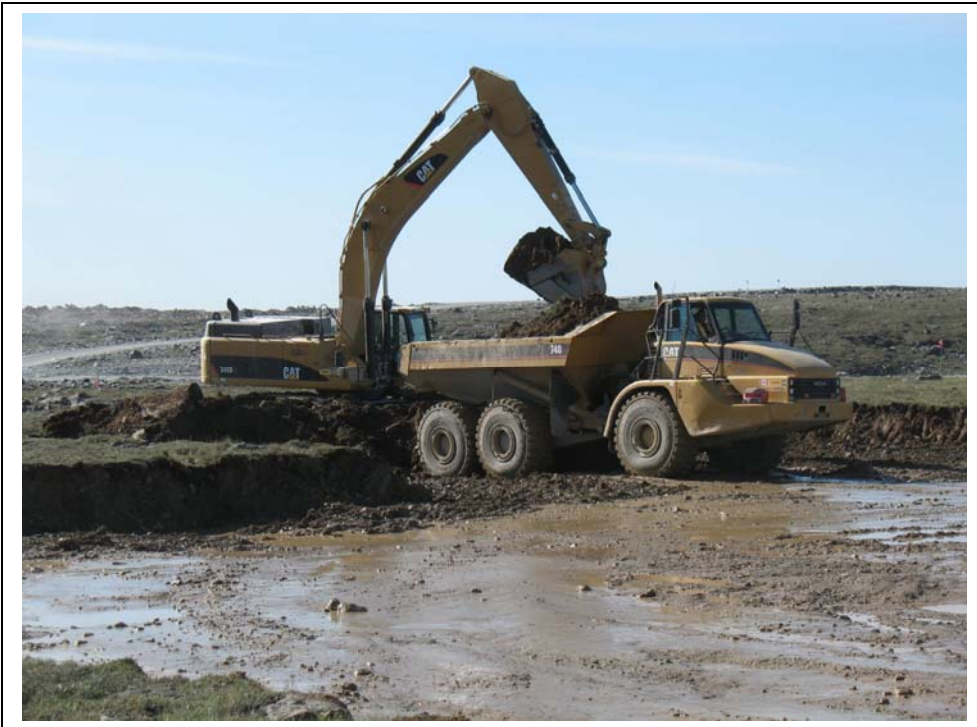
At the Saddle Dam SD-2, foundation excavation was underway on the footprint of the upstream shell where ice rich material requires removal (photo # 18).

Photo # 18     Saddle dam SD2, excavation of ice rich soils

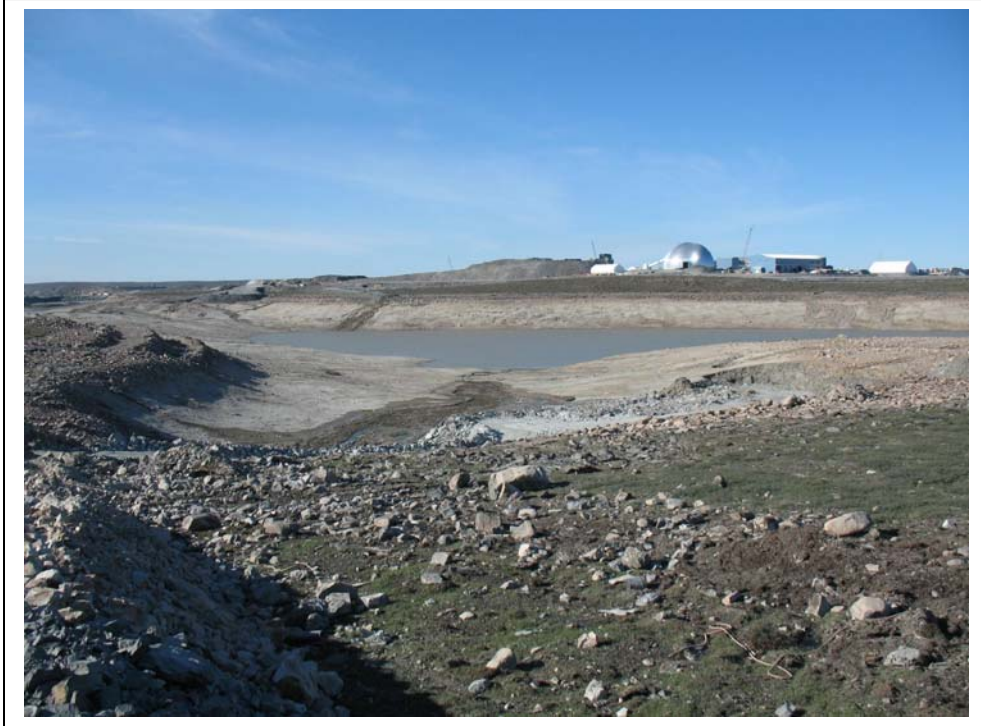
The site of the Center dike was also visited and the liquefaction flow slides in the still saturated lake bed sediments were noted. (photos # 19 and 20).

Photo # 19 Central dike axis, view from North abutment to South

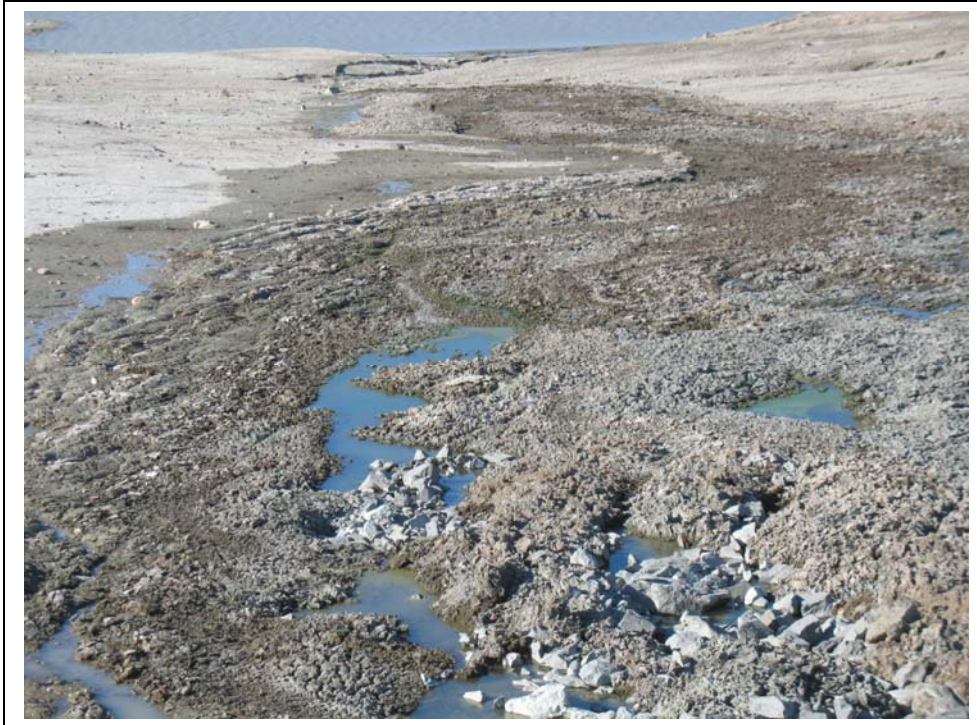
Photo # 20 Central dike axis, flow slide in lakebed sediments
