MEADOWBANK DIVISION

Monitoring Program Summary Report

March 2011

Meadowbank Kitchen Fire Investigation Report

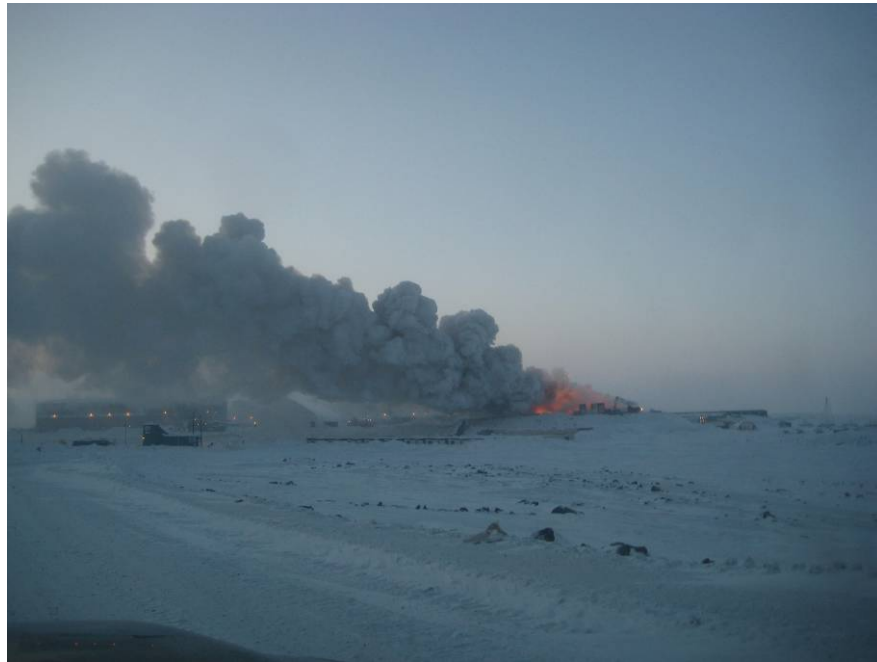
1- General view of the fire around 6h00 AM.

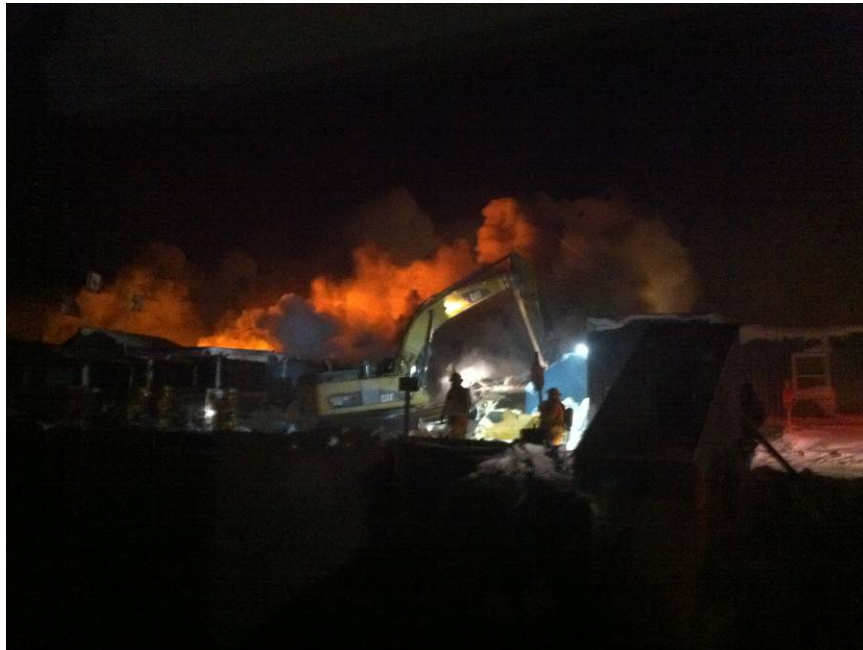
2 - Shovel working to dismantle the kitchen.

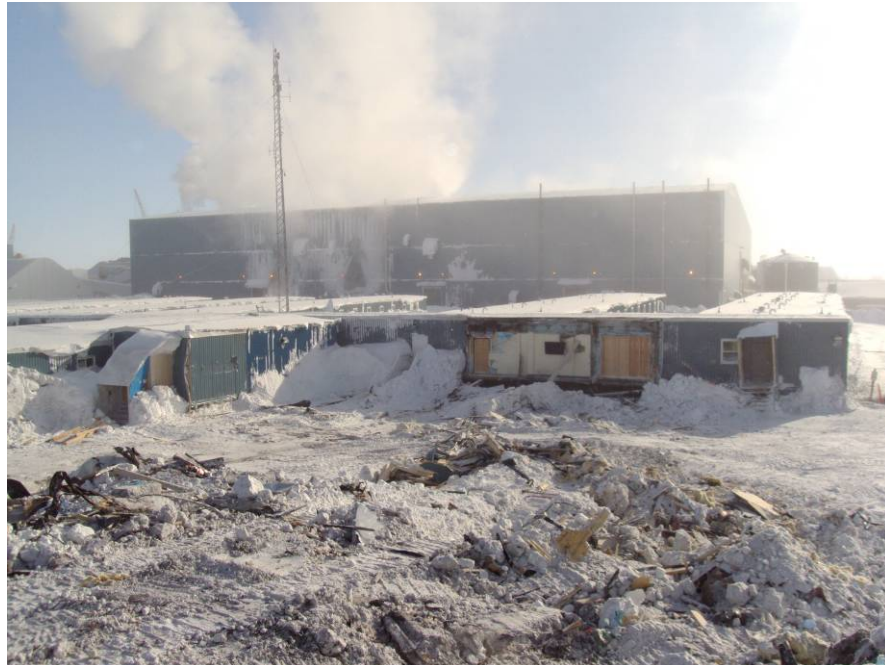
3 - After the blaze, pile of mixed snow and debris.

On March 23th, we received the authorization from the insurance company to clean the debris mixed with snow and ice. The debris mixed was send with the snow and ice to the landfill. It was cover immediately on place with muck rock to avoid odours dispersion and attract scavenger roaming around. The cleaning was completed on March 29th.

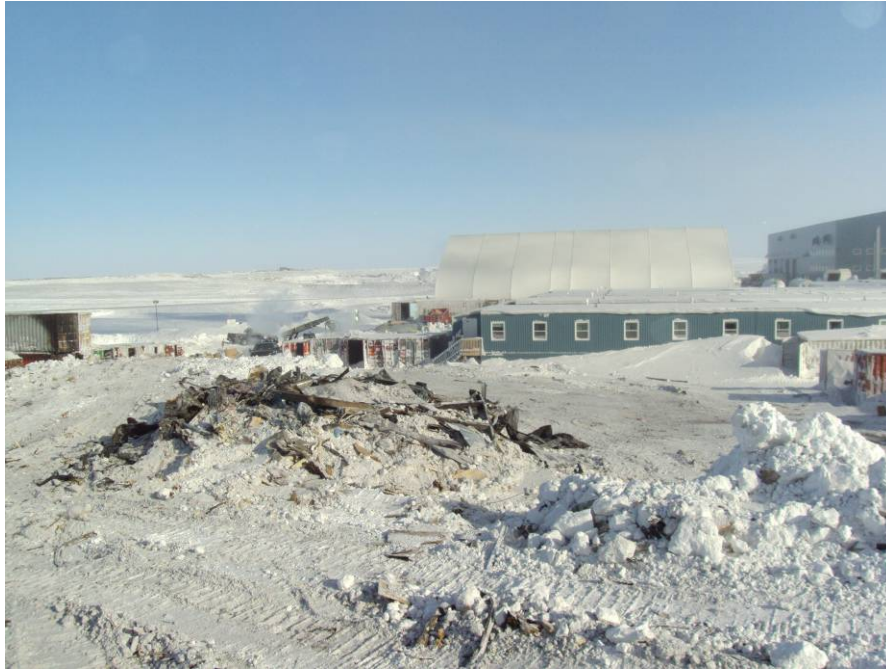
4 – Other view of the after event.
