MEADOWBANK DIVISION

Monitoring Program Summary Report
July 2014

Type A Water License 2AM-MEA0815

MEADOWBANK MINE, ASSAY ROAD SEEPAGE PHASE 2: ENVIRONMENTAL SITE ASSESSMENT AND ENGINEERING QA/QC

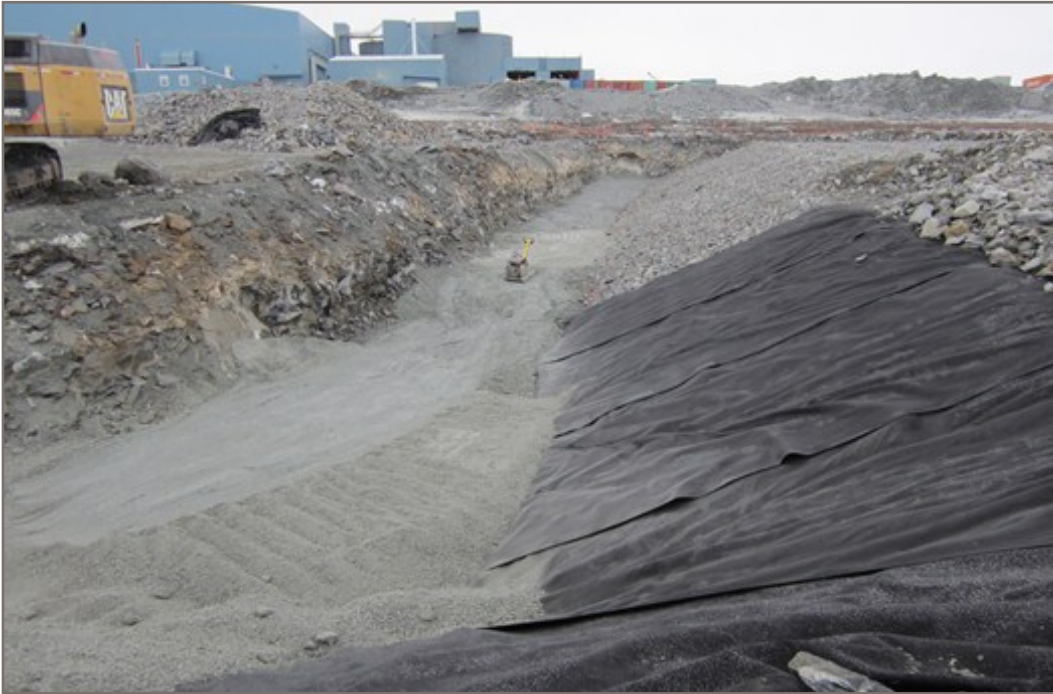
Photo 11: East End of Interception Trench Facing Northeast
Geotextile Placement with Overlap and Tie-in at Top

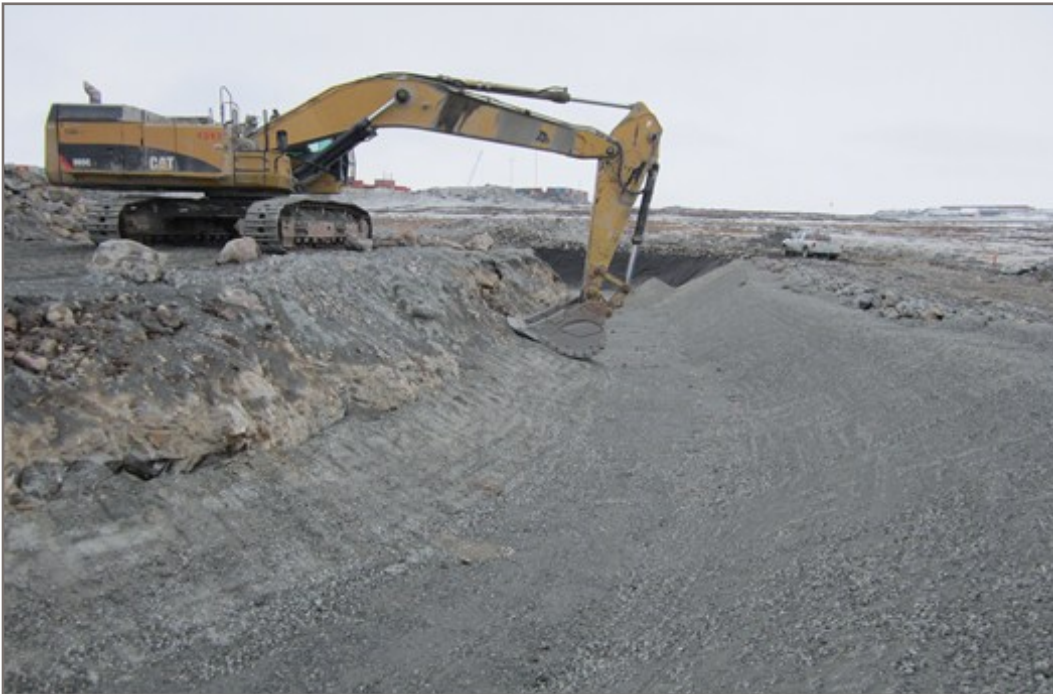
Photo 14: West End of Interception Trench Facing Southeast
CAT 365 Excavator Bucket Compacting Upstream Bentonite Material Slope Below the Bedrock Contact

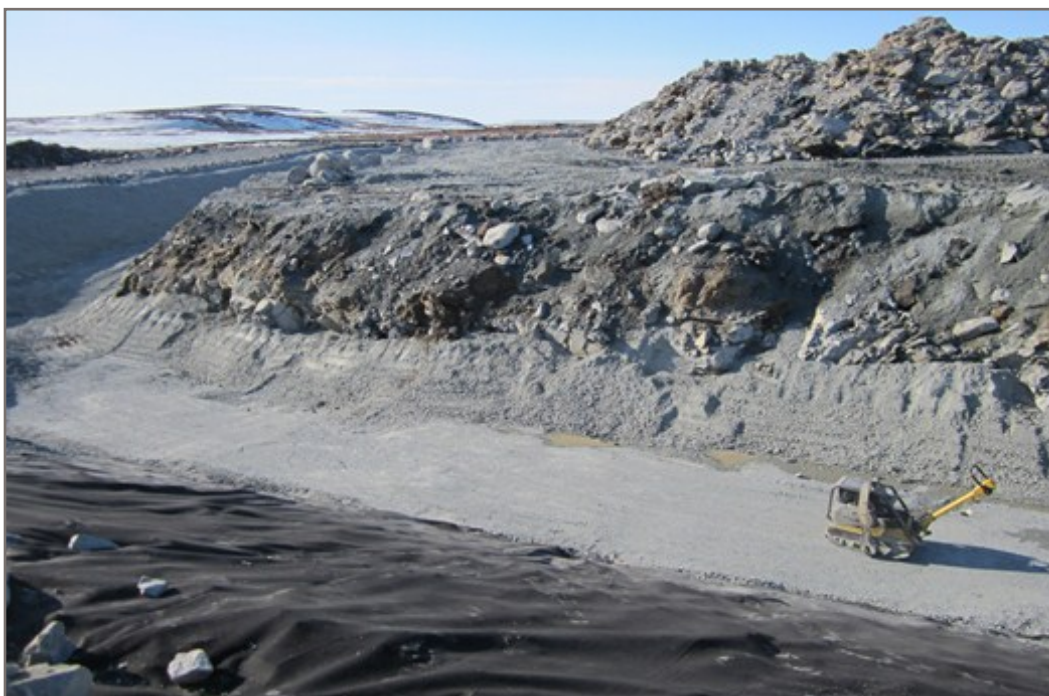
Photo 15: East End of Interception Trench Facing Northwest
Bentonite Material on Upstream Slope Below Bedrock Contact

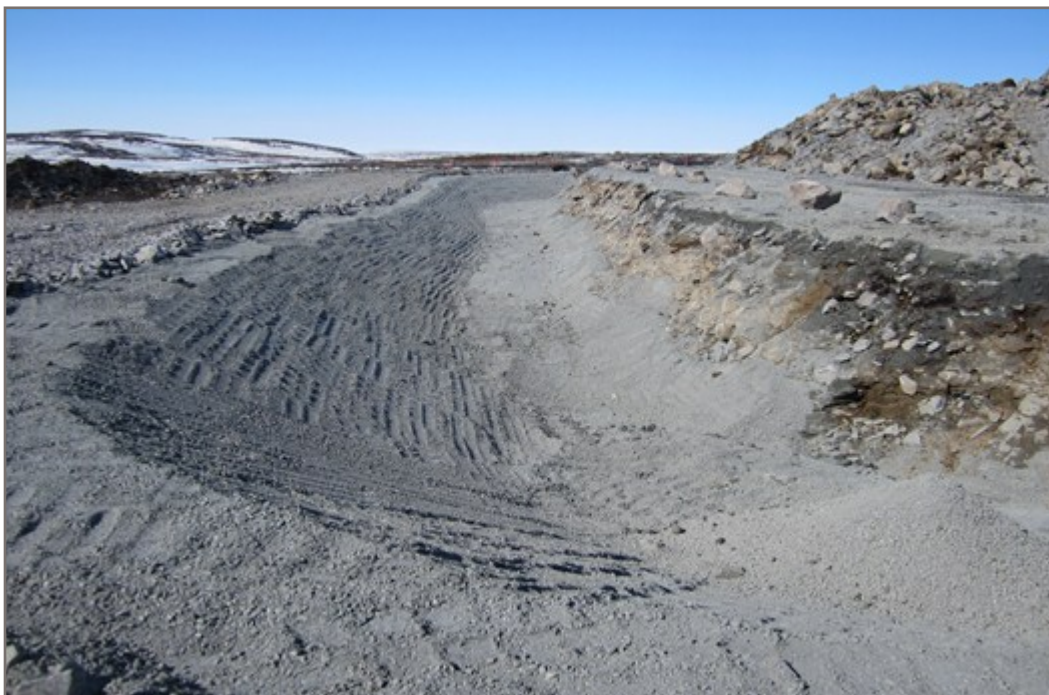
Photo 16: West End of Interception Trench Facing Northwest
Completed Bentonite Placement
