MEADOWBANK DIVISION

## **Monitoring Program Summary Report**

**June 2015**

Type A Water License 2AM-MEA0815

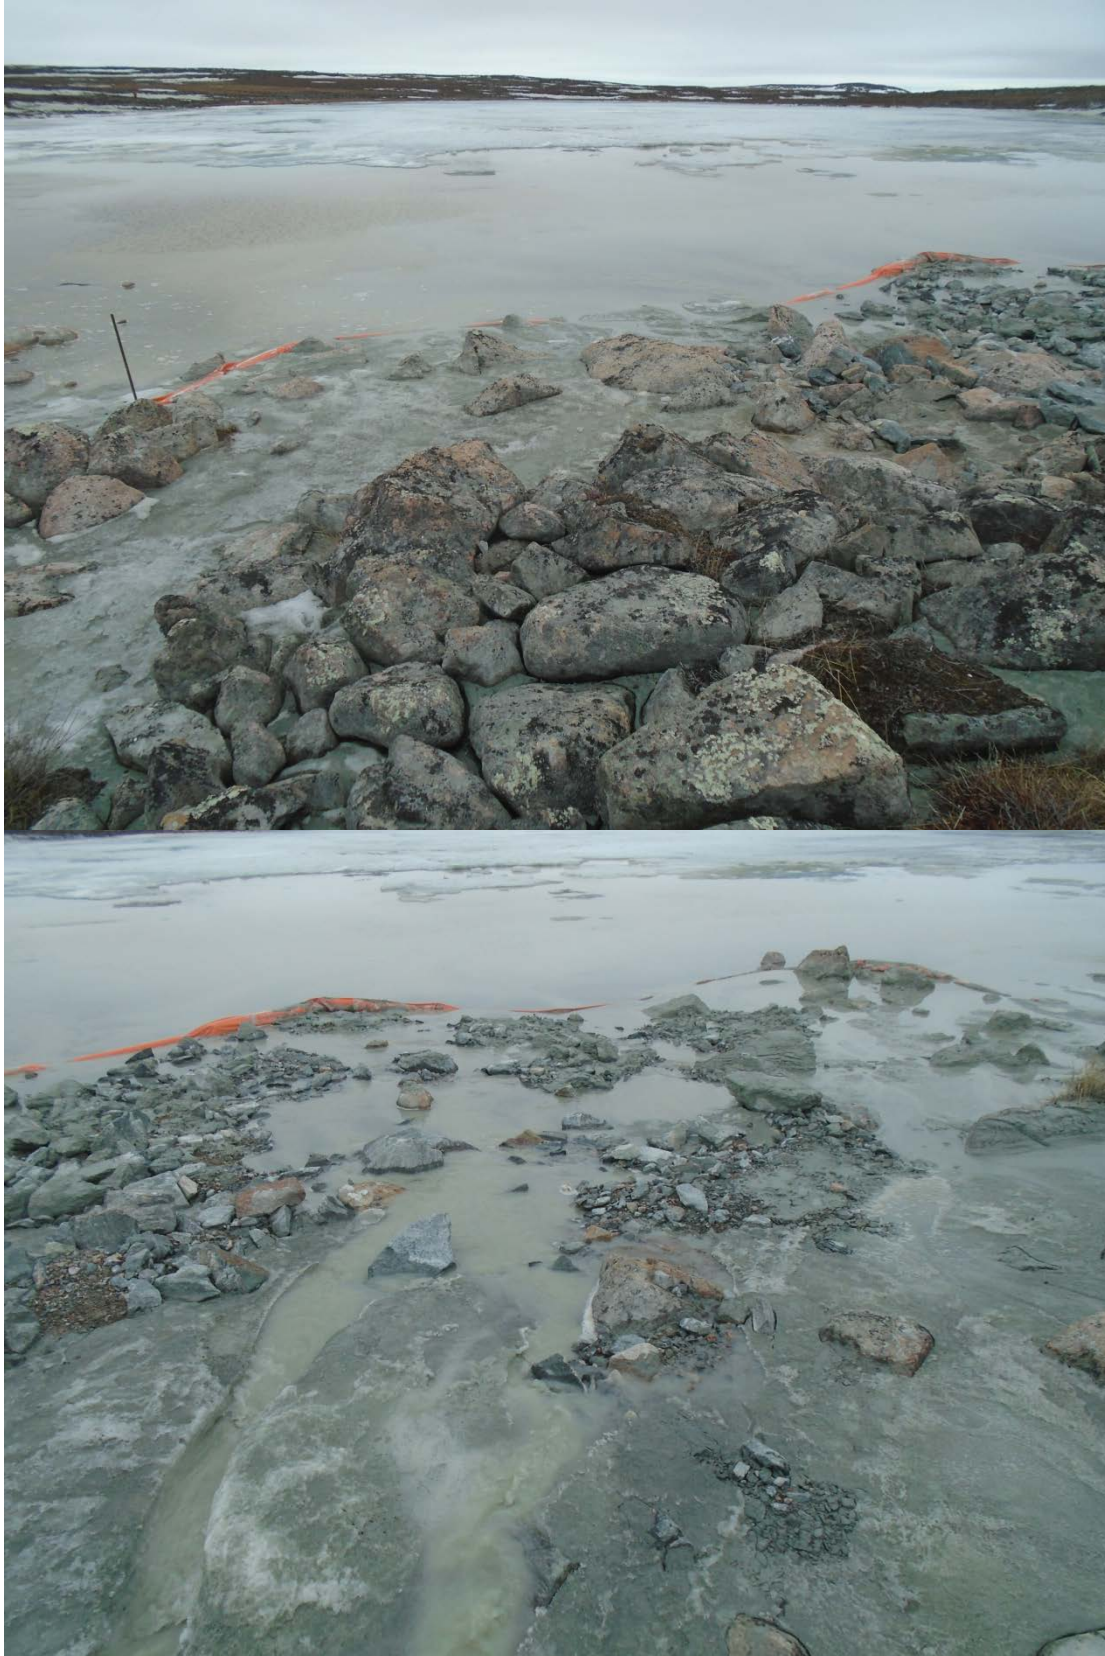
On June 7<sup>th</sup>, 2015, while conducting regular inspections as per the Freshet Action Plan, AEM staff observed elevated TSS in the water running under Vault Road (culvert) toward Lake NP-1. At this time it was observed that there was a very small flow coming from Lake NP-2 toward the Vault Road culvert leading to NP-1. The flow exiting and around the culvert and leading to NP-1 was much greater. This indicated that the flow was largely localized due to a large accumulation of snow in this area, significant snowmelt occurring due to spring freshet and recent heavy rain. NP-1 is a shallow pond - ~ 3.8 m at deepest and was noted as being non-fish bearing in the EIS for the Meadowbank Project. On June 8<sup>th</sup> after some additional melting of ice and snow it was clear that water with elevated TSS was flowing past a turbidity barrier that was in place from last year, onto the lake ice. The excess water and TSS was confirmed to be coming from snowmelt and rain in the area transporting fine material from the road through the course rock of the road and discharging on the NP-1 (east) side of the road and culvert (see Photo 1 and map below). There is a deposition of very fine mud material (from the road) along the shoreline. Evidently, meltwater is transporting this onto the lake ice. As stated, a turbidity barrier was in place and another one has been deployed as a secondary measure (see Photo 2 below). As a precautionary measure, an additional barrier will be placed at the outlet of NP-1 as there is a flow (across tundra) toward Dogleg Lake. Samples will be taken of the NP-1 pond water and submitted to our offsite accredited laboratory.

**Photo 1: Water with elevated TSS flowing into NP1**

Further remedial measures will include removing the fine material on the road and replacing with course rock which will eliminate the source of fines. Other measures may include using our sewage vacuum truck to remove some of the mud but this type of activity could lead to additional loading as any mechanized work in the area could actually release more sediments. This work is scheduled for June 9<sup>th</sup> and 10<sup>th</sup>. Once freshet has subsided an assessment will be made on the deposition of the fine road material along the shoreline.

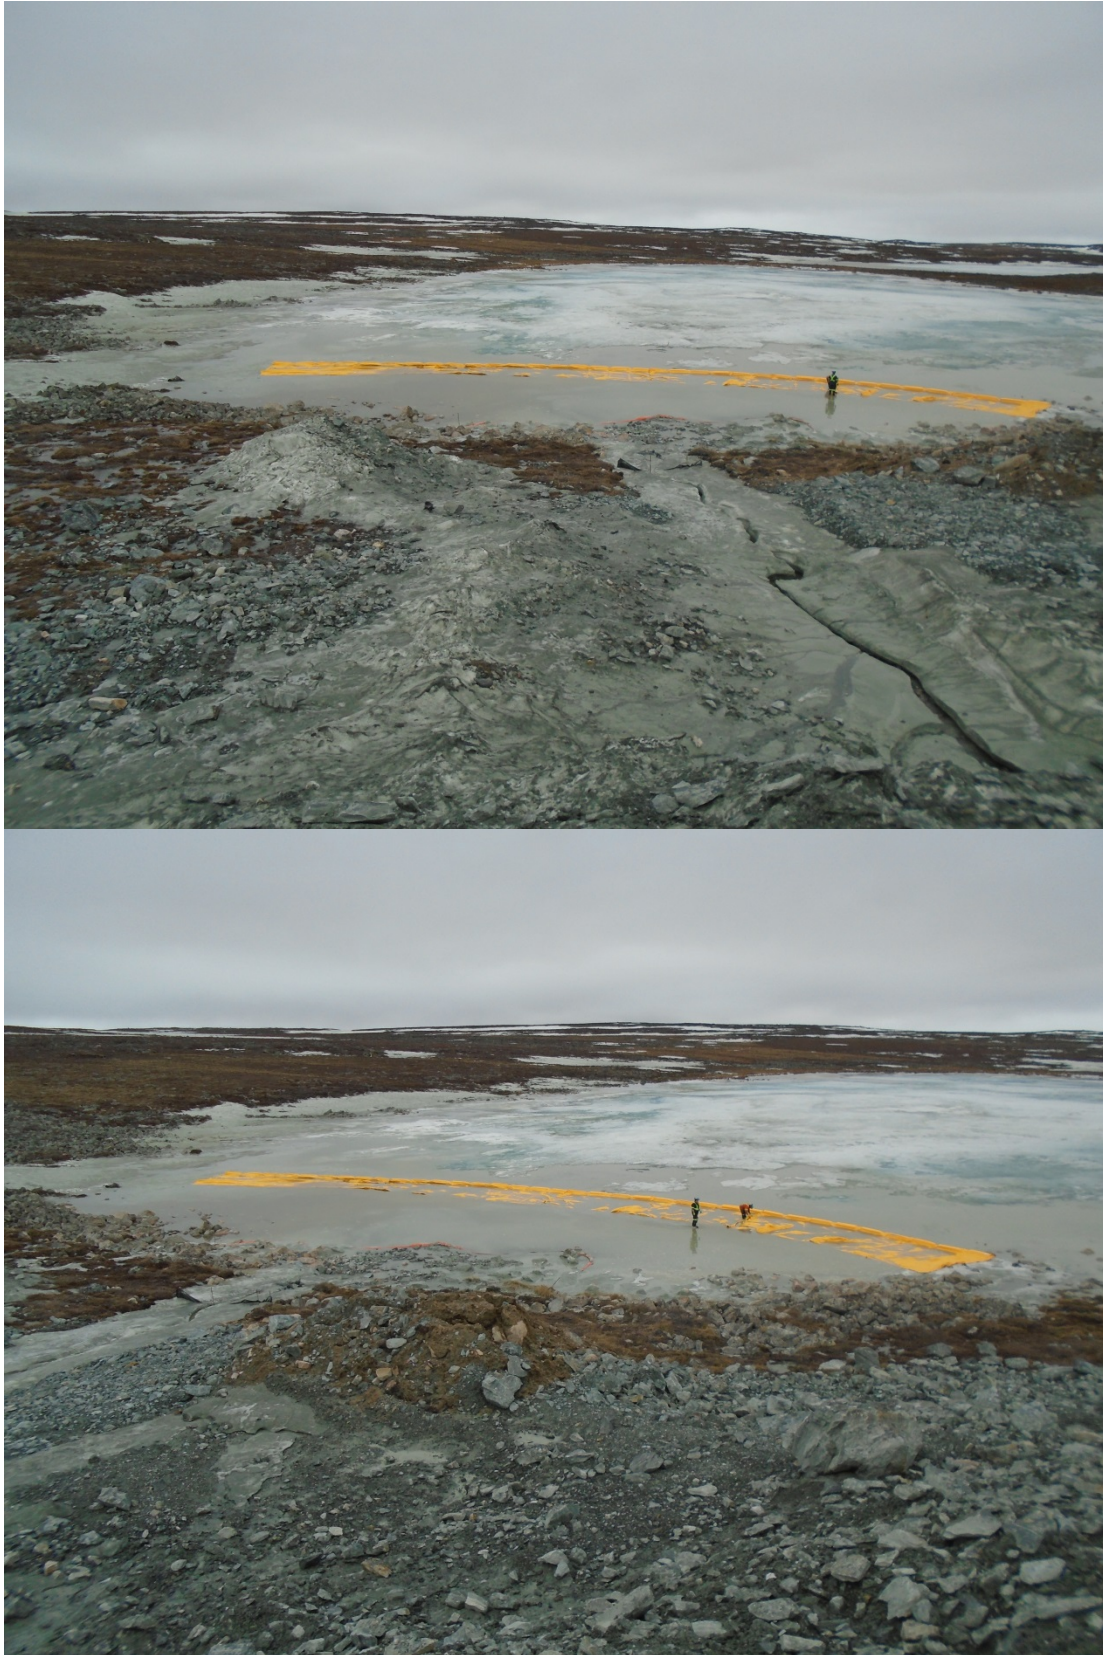
**Photo 2: Second Turbidity barrier installation**

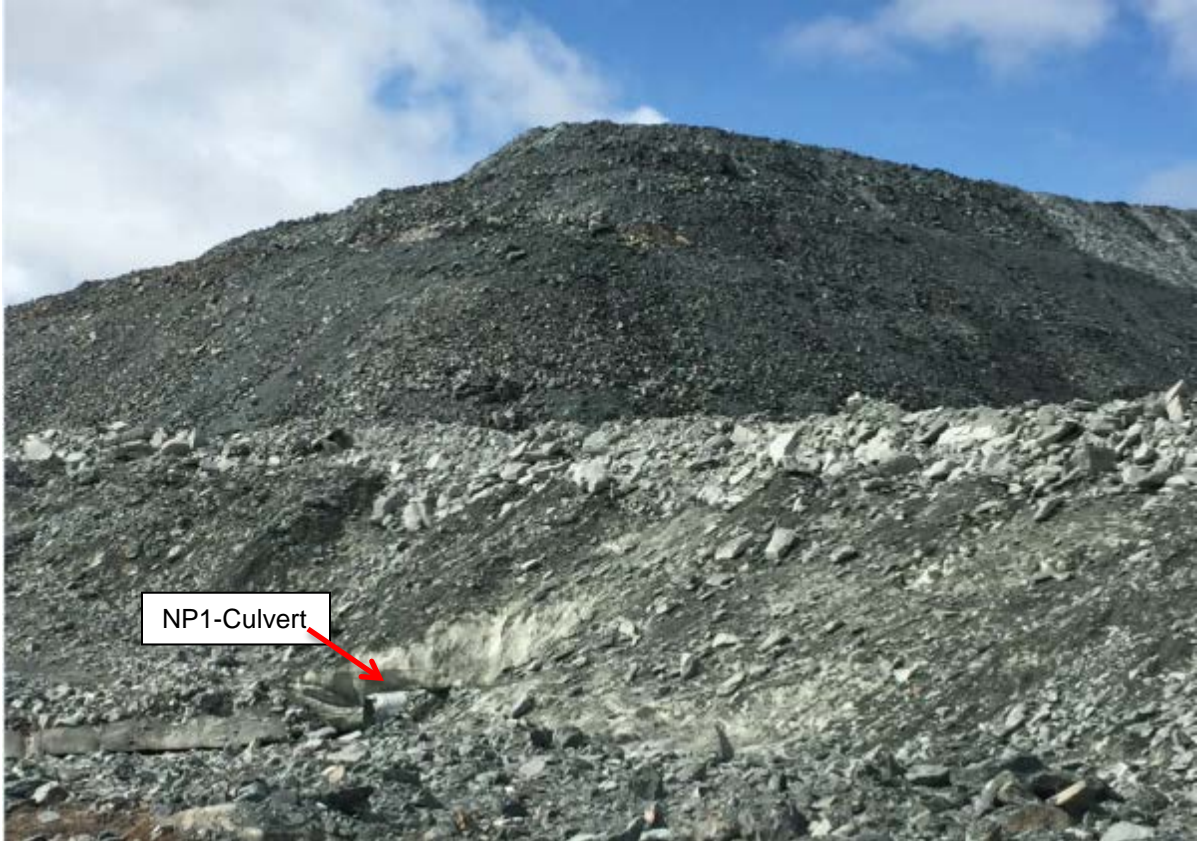
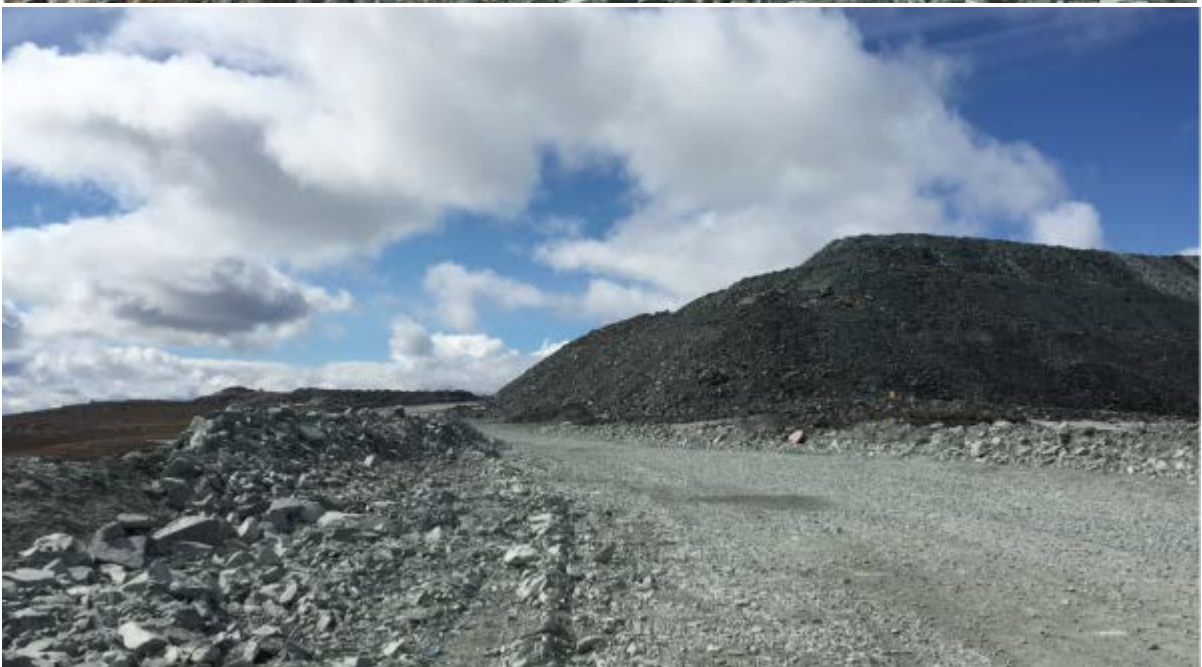
Photo 1: Vault Road Repair

After an investigation – June 8<sup>th</sup> to 12<sup>th</sup>, it was determined that the major source of the TSS was the Vault road above the culverts. During the winter, snow had been ploughed near and around this area. The thawing of this snow caused excess water and fine

sediment runoff which percolated through the road surface and flowed out through the course rocks surrounding the culverts. The road surface was constructed with soft NPAG aggregate (soapstone) which was crushed to a very fine material by truck traffic.

On June 13<sup>th</sup>, AEM proceeded to raise the Vault road near NP-1 culverts (Photo 1). A different source of aggregate – NPAG from Vault was used (harder material) which will prevent an accumulation of fine material and will allow for water to runoff instead of accumulating or percolating through the road.

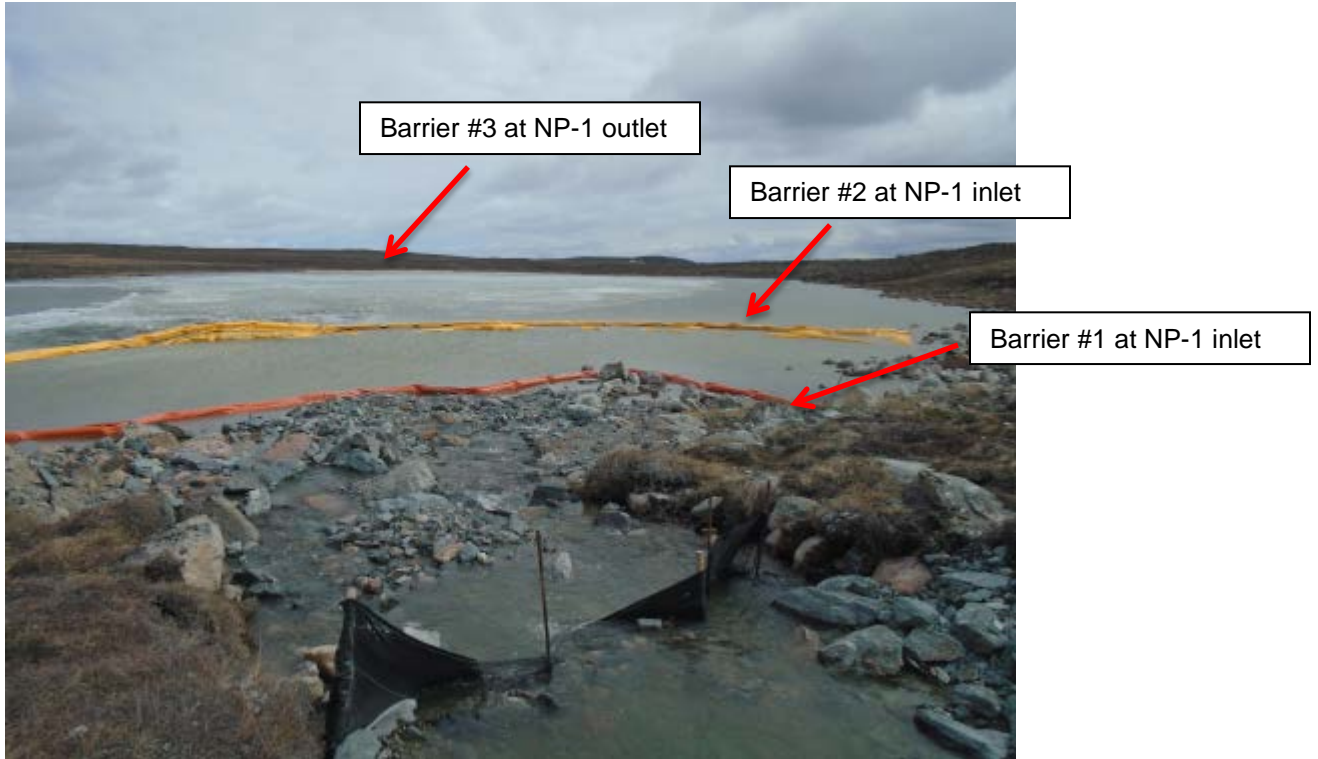
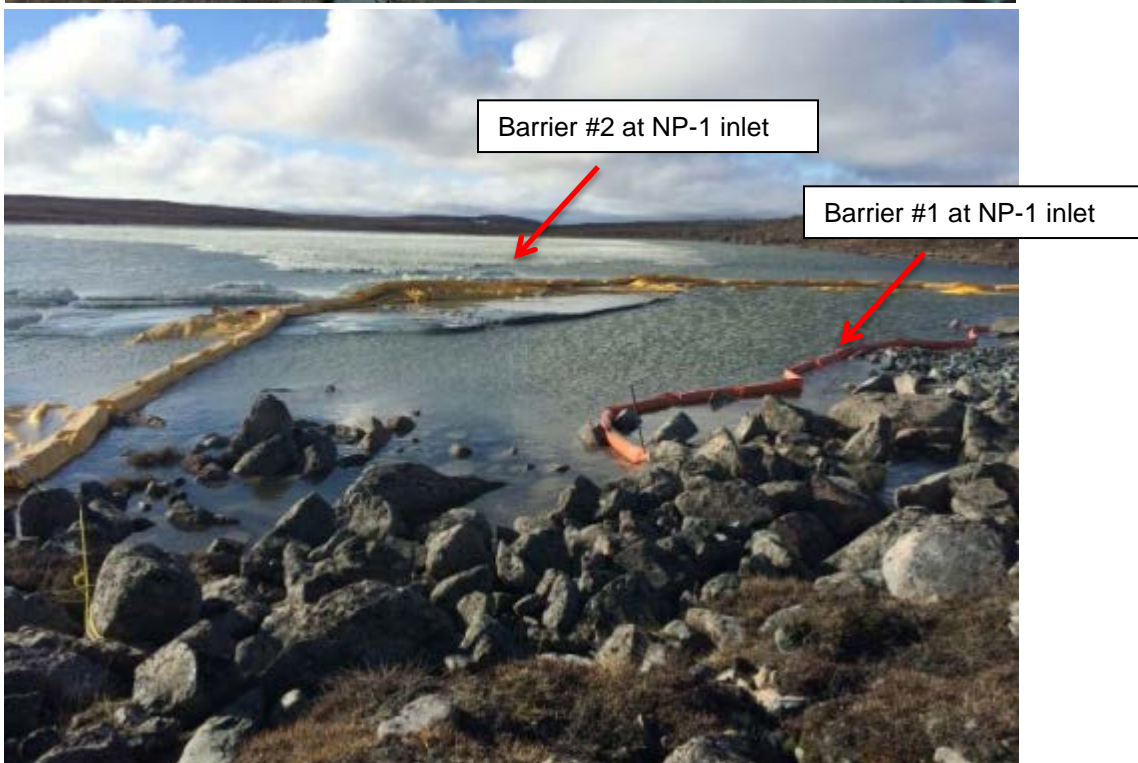
As stated previously a turbidity barrier (orange barrier # 1) was left in place from last year at the inlet of NP-1. A second turbidity barrier (yellow barrier #2) was installed just outside of the first barrier in the early morning of June 8<sup>th</sup> (see Photo 2). Two additional barriers were also installed as a precautionary measure at the outlet of NP-1 (barrier #3) and at the inlet of Dogleg Lake (barrier #4) (see Photos 3 and 4). These were installed on June 9<sup>th</sup> and 10<sup>th</sup> respectively. Cloudy water was not observed at Dogleg Lake. Following the installation of the barriers, samples were taken on June 10<sup>th</sup> at NP1-Culvert, NP1-West (outside barrier #2), NP1-South and Dogleg (outside barrier #4) (Figure 1 below) and sent to our accredited laboratory for TSS analysis (Table 1). AEM also took a weekly sample at NP1-West and NP1-South. These were analysed at the Meadowbank onsite assay lab (unaccredited) and used as indicator samples. All results show levels of TSS at or below our regulatory discharge (NWB, MMER) limit of 30 mg/l. On June 22<sup>nd</sup>, AEM took another set of samples which were analysed at our accredited laboratory, Multilab. The results are located in Table 1 below. As of June 22<sup>nd</sup>, the water coming from NP-1 (Lake NP-2) culvert into NP-1 Lake was visually clear (Photo 5). AEM will continue to monitor and sample locations in NP-1 and Dogleg as per the regular Freshet Action Plan Monitoring (see Schedule 1 below which is the ST-16 RSF Seepage monitoring program). Currently the watercourses referenced in this report are visually clear thus no additional TSS sampling is necessary. It should be noted that the incident was for a short duration and that Lake NP-1 is not a fish bearing lake (FEIS).

Photo 2: Turbidity barrier at the inlet of NP-1 Lake

In addition, the turbidity barriers will remain in place for the duration of the freshet period.

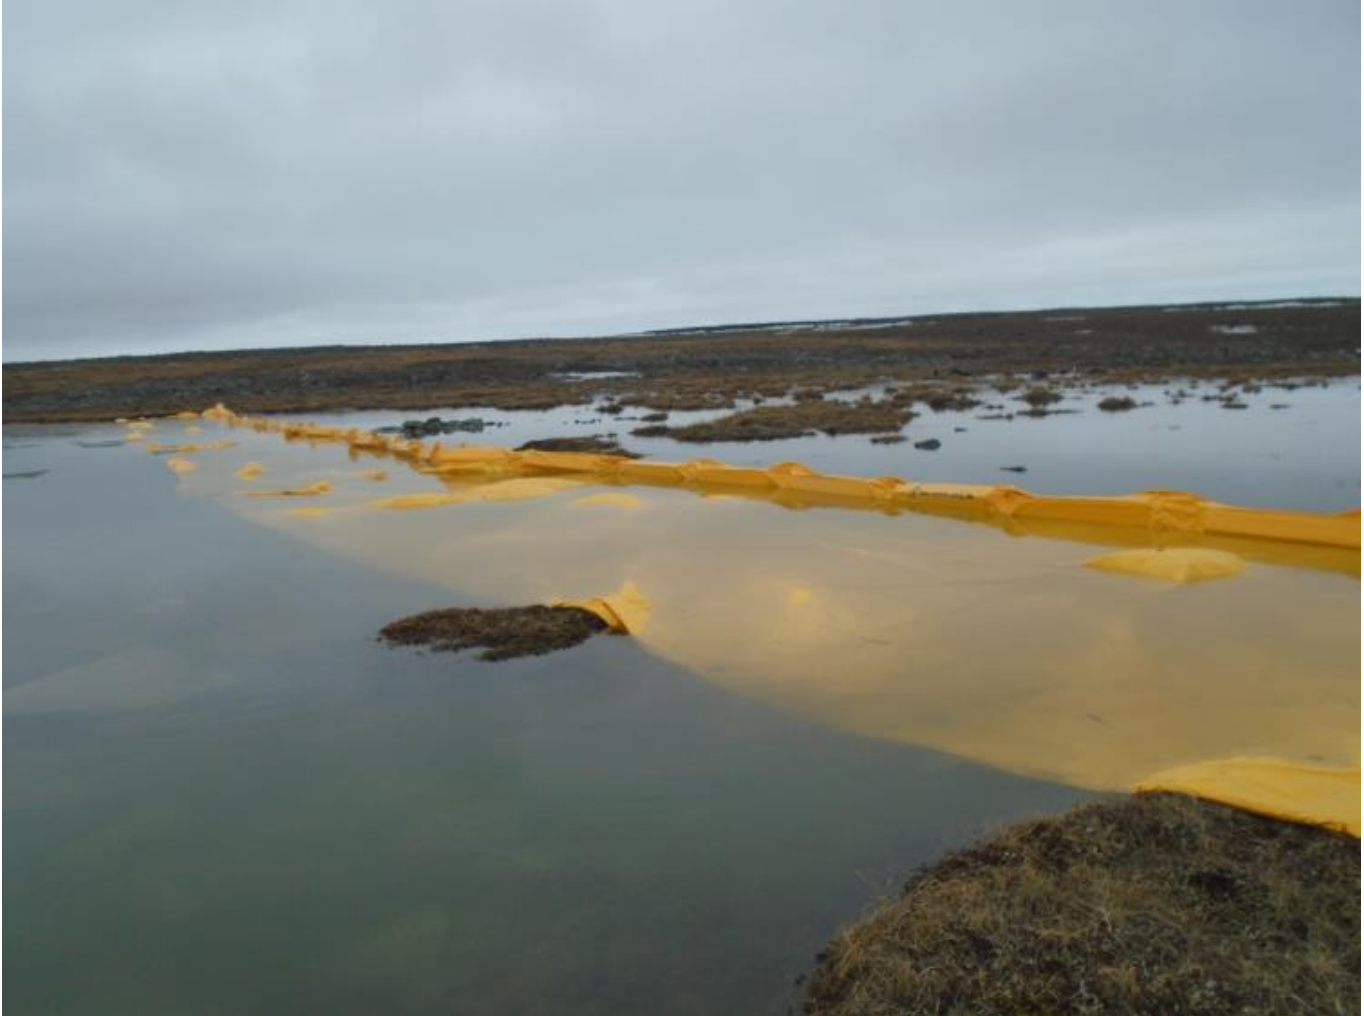
**Photo 3: Turbidity barrier #3 at the outlet of NP-1 Lake**

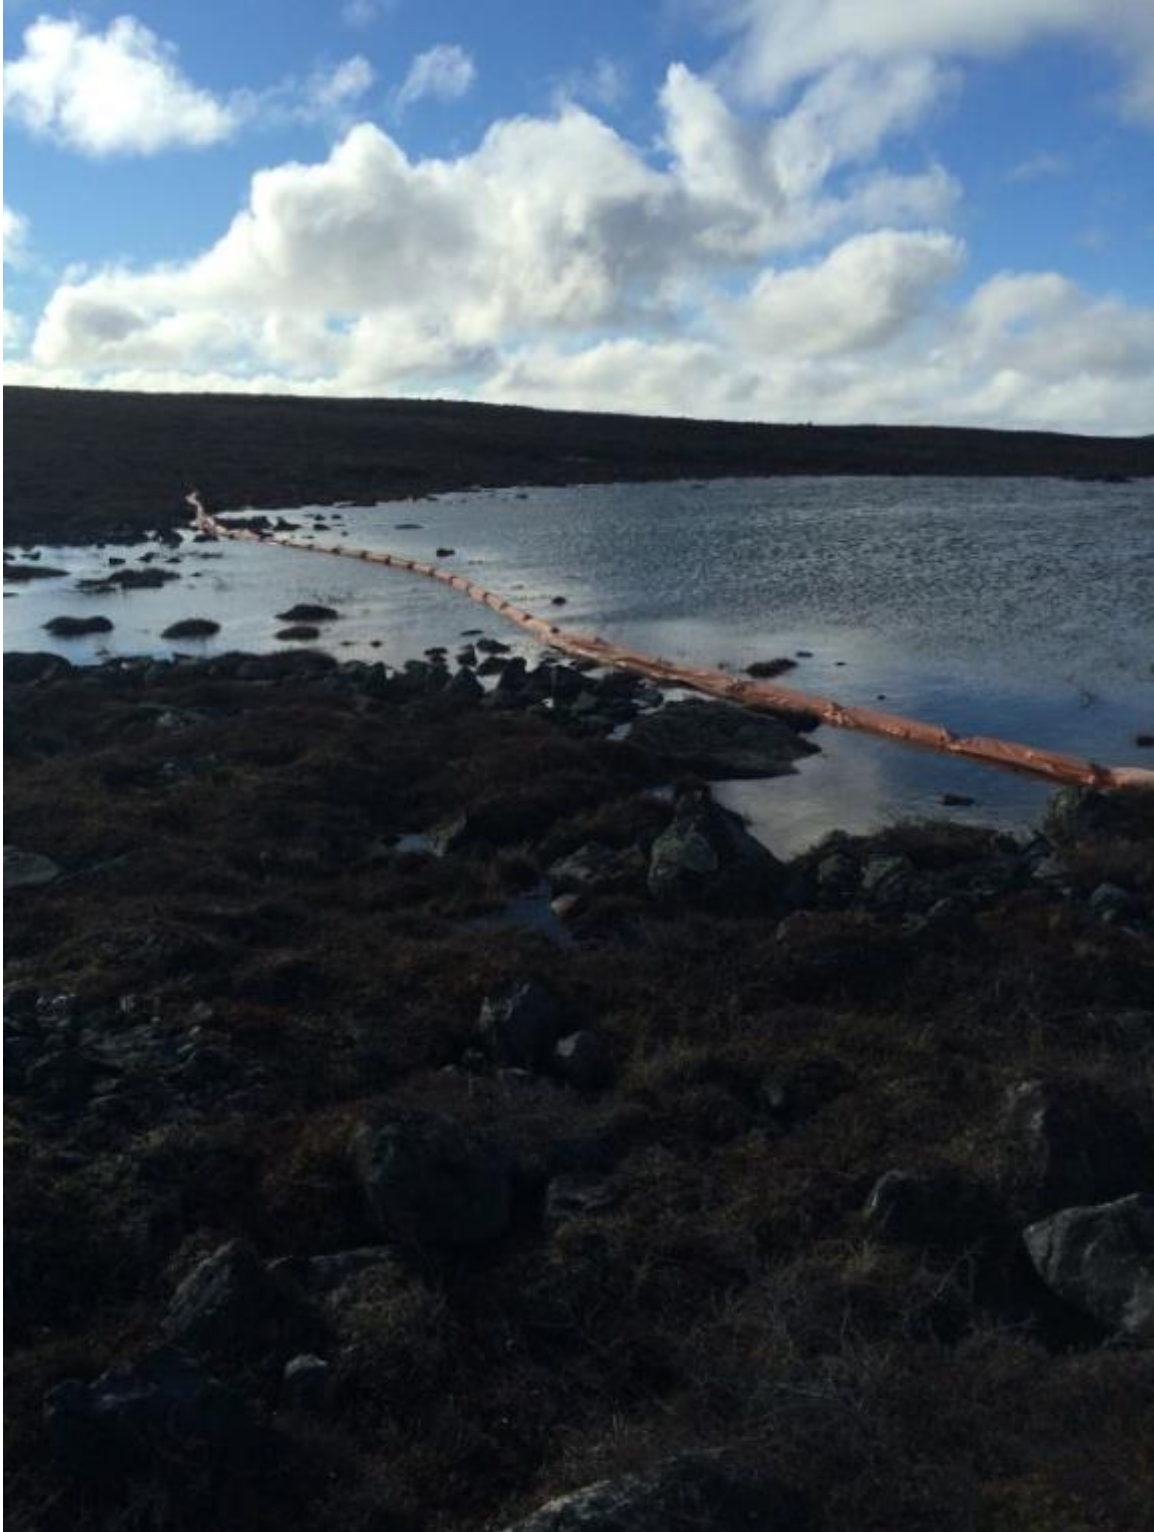
**Photo 4: Turbidity barrier #4 at the inlet of Dogleg**

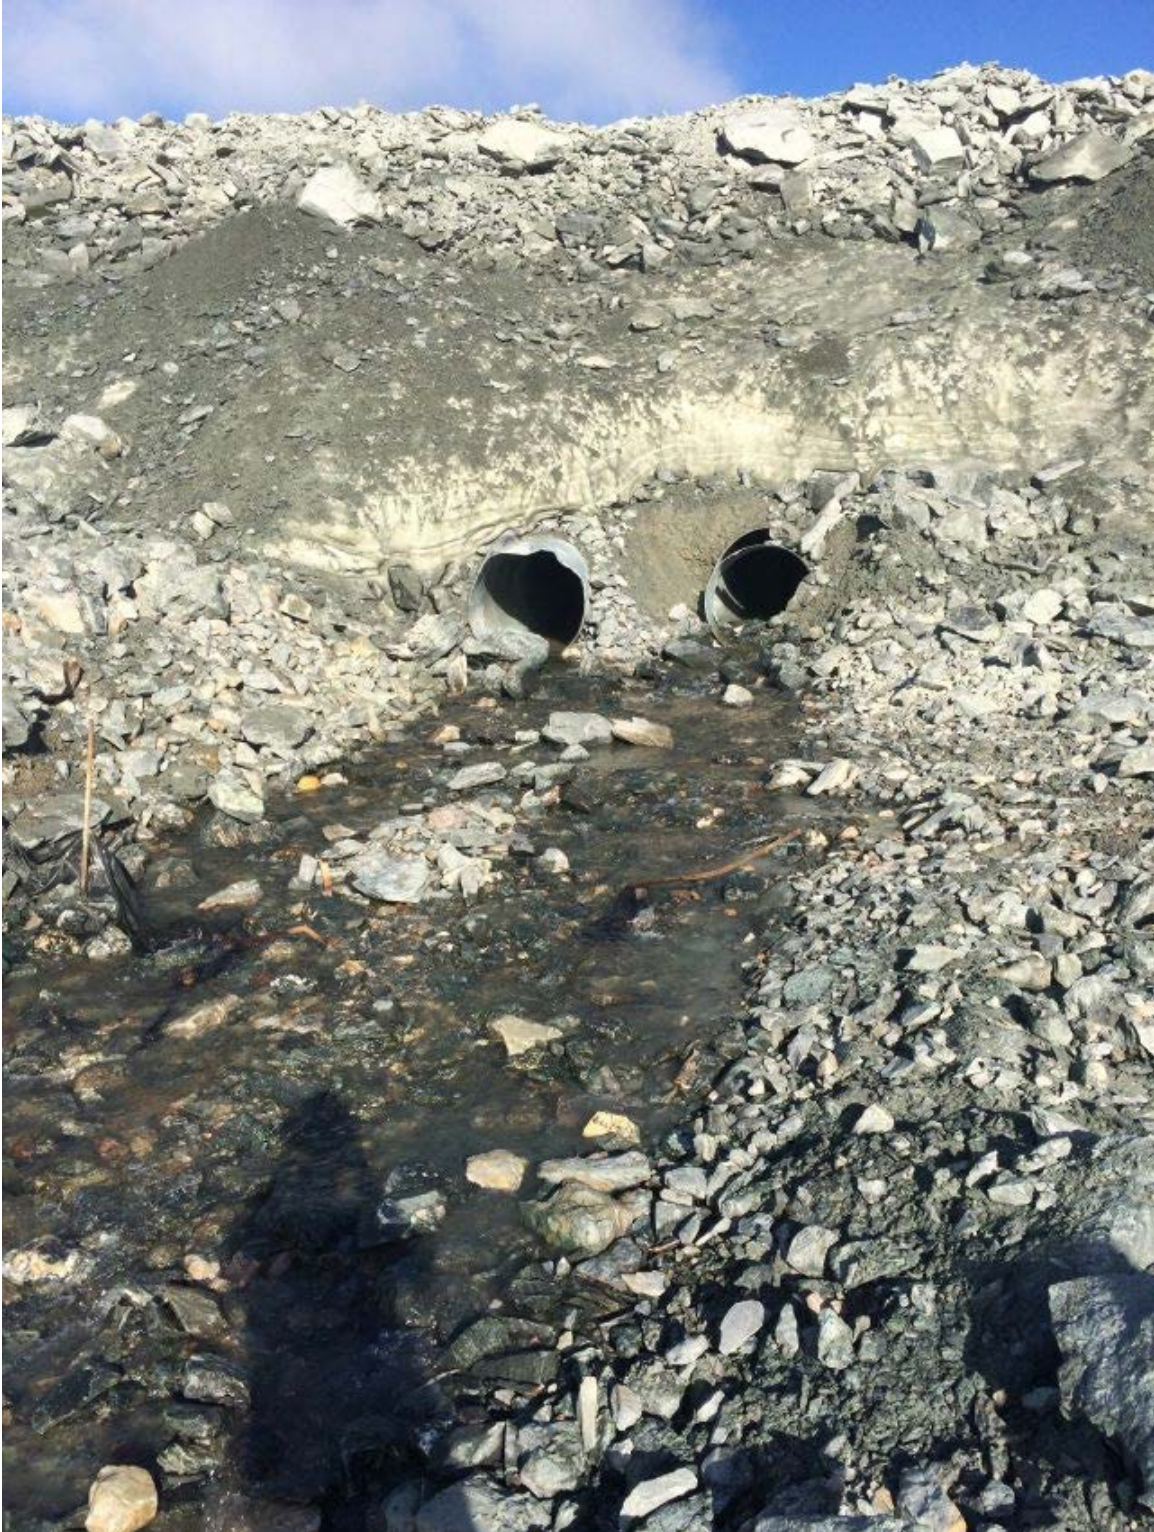
**Photo 5: Water at NP-1-Culvert flowing into NP-1 Lake on June 22, 2015**
