# Nunavut Impact Review Board 2019

## Site Visit Report

### *Meliadine Gold Mine Project*

(NIRB File No. 11MN034)

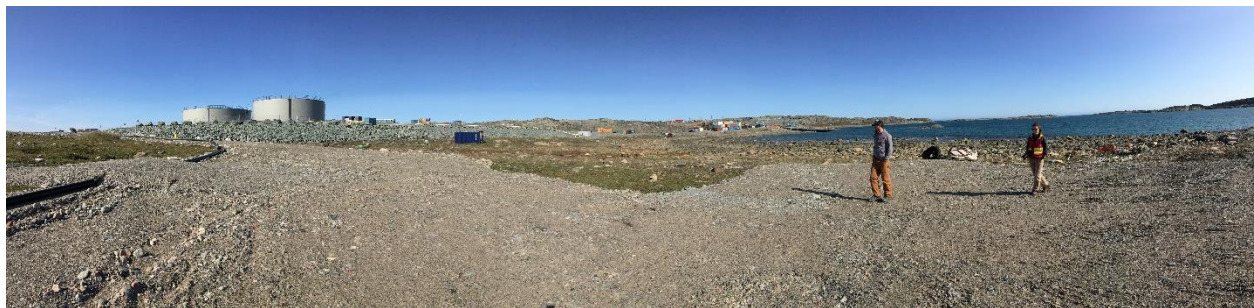
**Photo 2: Overview of Itivia Site**

- a) Container ships that are associated with the Meliadine project anchor just inside or just outside of Melvin Bay and dry cargo is transported to shore on tug-barges, then lightered to shore using the gravel ramp in Itivia harbour. This ramp is also currently used by the Hamlet of Rankin Inlet during the annual sealift (see [Photo 2](#)). :

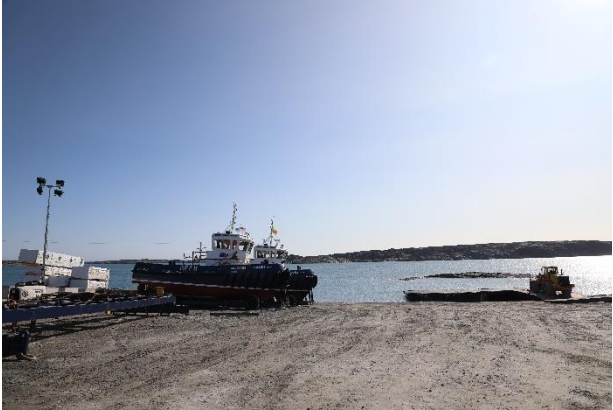
**Photo 3. Barge dock shared by both AEM and the community.**

- b) The Itivia site was busy with equipment and seacans being moved around and preparation for another barge to be arriving with additional equipment for offloading (see [Photo 3](#) and [Photo 4](#)).

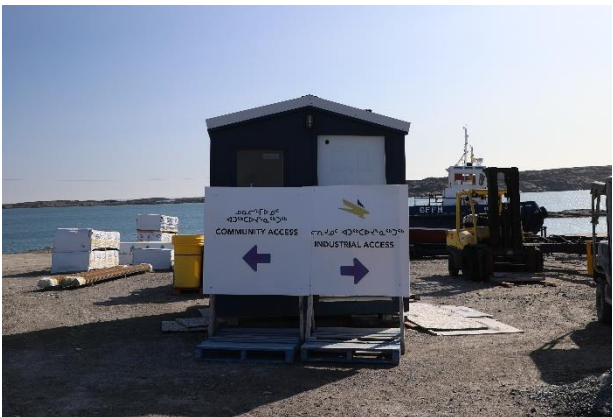
- c) It was observed that the signage on the seacan wall was updated and clearly noted to the community the public dock access and the Agnico Eagle barge area (see [Photo 5](#)).
- d) The Saline Water Discharge tank was installed at the Itivia site and appeared to be in working condition (see [Photo 6](#)).
- e) The snowmobile crossing within Agnico Eagle's Itivia area was also inspected and appeared to be in good repair.
- f) Overall the area appeared to be maintained in good order; however, debris was observed around the Itivia site.

**Photo 5. Seacan wall at Itivia separating public and private areas.**

- Ensure the Meliadine mine site and the Itivia site is cleaned of debris and material to reduce amount of garbage and wind-blown material observed during the site visit.
- Implement a recycling program and a waste reduction program is in place at the mine site to reduce the amount of wastes ending up at the landfill by:
  - Finding alternatives to the use of plastic storage containers for single meals at the Meliadine cafeteria.
  - Working with the community and/or schools to create projects that could recycle the wooden pallets and wood.

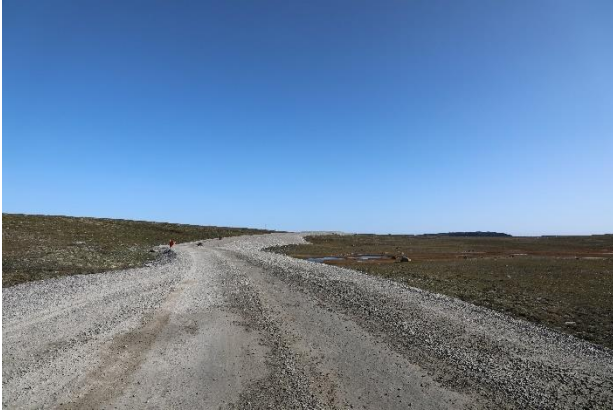
**Photo 7: Bypass Road**

- a) The Bypass road had clear signs noting that the road is private in both English and Inuktitut (see [Photo 7](#) and [Photo 8](#)).
- b) At the snowmachine crossing, there were no signs of extreme slopes or rocks along the side of the AWAR (see [Photo 9](#)).

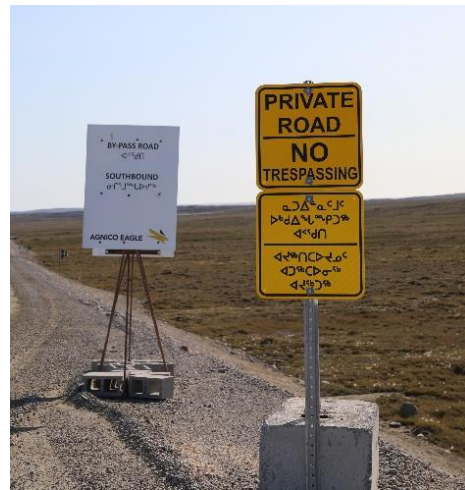
**Photo 8: Signs in English and Inuktitut at the start of the Bypass Road**

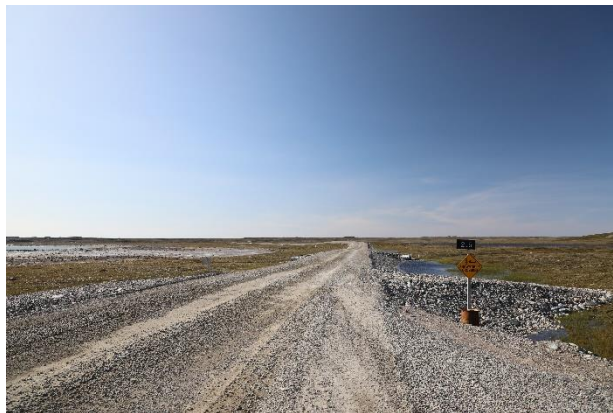
**Photo 9: Slope for snowmobile crossing at bypass road.**

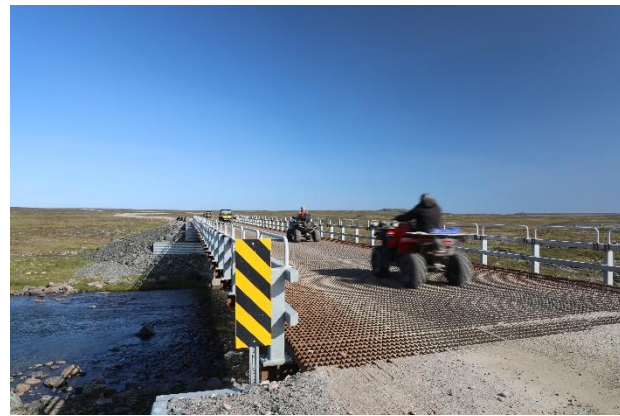
- a) While travelling along the AWAR towards Meliadine, it was observed that the road was extensively used by Rankin Inlet community members (see [Photo 11](#)) along with mine traffic travelling to and from the Itivia area (see [Photo 12](#)).
- b) The NIRB staff requested an update on the plan to build a dedicated ATV/snowmobile connection trail during the site visit and Agnico Eagle staff commented that this trail may not be constructed but discussions are ongoing with the Hunters and Trappers Organization.
- c) The NIRB staff noted that the environmental emergency seacans were located at or near all bridge crossings (see [Photo 13](#) and [Photo 14](#))

**Photo 11: ATV's travelling on the AWAR**

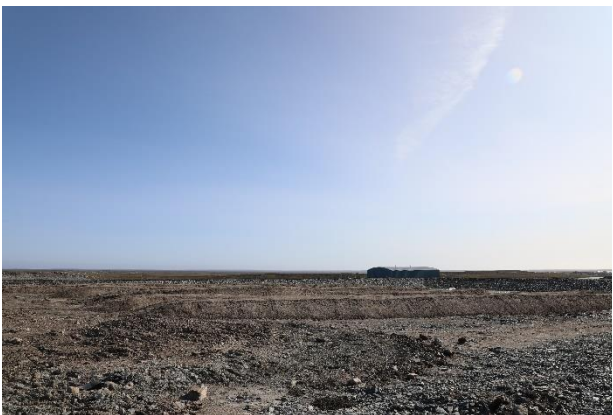
**Photo 15: Landfarm A**

- a) Agnico Eagle constructed a landfarm (referred to as Landfarm A) at the Meliadine mine site in 2018 and it was operational during the NIRB's site visit. Agnico Eagle has started treatment of contaminated hydrocarbon soil on site with nutrients like the Meadowbank Gold Mine site (03MN107) as Agnico Eagle was not having as much success with remediation as it was having at the Meadowbank site. NIRB staff were informed that this landfarm was at capacity (originally designed for a 10-year life) due to the spill that occurred in February 2018 at one of the fuel tank farms (Genset Fuel tank) and an overall increase in spills over the last two years. As such, Agnico Eagle has constructed a temporary landfarm next to Landfarm A which has been developed for overflow of contaminated hydrocarbon soil (see [Photo 15](#) and [Photo 16](#)).

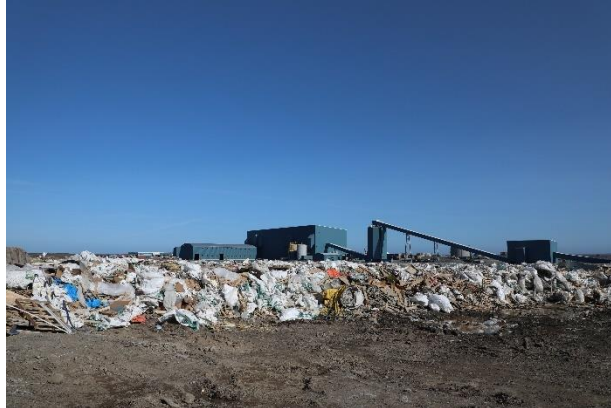
- b) At the landfill NIRB staff observed numerous wooden pallets in the debris and learned that it is due to the amount of materials being brought to site from the barge season. Last year it was noted by Agnico Eagle staff that plans were in place to send the wooden pallets to

the community of Rankin Inlet which has not yet occurred (see [Photo 17](#)). During the site visit, NIRB staff were informed that this landfill was at capacity (originally designed for a 10-year life) as they underestimated the amount of wastes that were produced during the construction and initial operation periods.

**Photo 17. Landfill within the Meliadine mine site.**

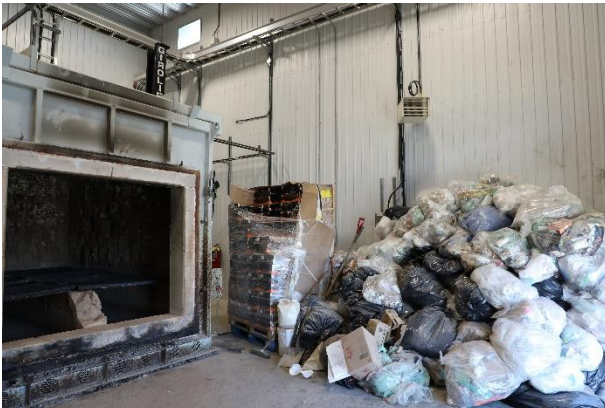
- c) NIRB staff noted that the incinerator appeared to be backlogged as garbage was stacked inside the incinerator building and were informed that the incinerator was not working properly and not reaching the appropriate temperatures for proper combustion and incineration of wastes. Agnico Eagle is working on improving this issue. In addition to the issues, Agnico Eagle has issues with the building that houses the incinerator overheating during incineration employees are required to open the doors. To prevent wildlife from entering the incinerator building, a temporary gate was installed (see [Photo 18](#) through [Photo 20](#)).

**Photo 18: Garbage awaiting incineration**

- Reduce amount of dust created around the tailings storage facility by finding alternatives for dust suppressants or managing the moisture levels of the tailings.
- Incinerator function and building requirements.

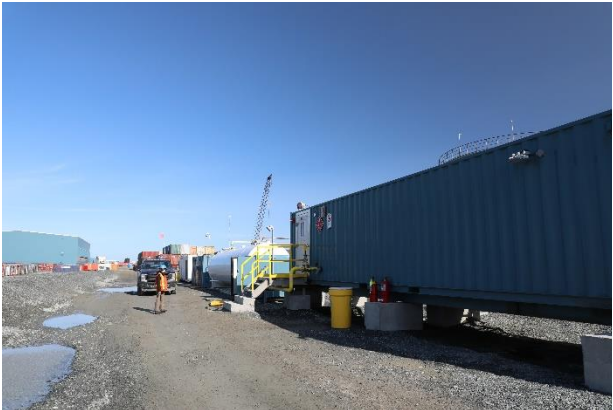
**Photo 21. Fuel Tank Farm #1 transfer station**

- d) During the site visit, NIRB staff noted that both fuel tank farms and the smaller fuel storage tanks located at various locations around the mine site were within appropriate secondary containment. Further, fuel storage tanks appeared to be handled in a safe and environmentally protective manner. Fuel tank farm #1 was not yet in commission during the site visit as final tests were required before it could be used, while fuel tank farm #2 was being used following improvements to the area and the installation of a liner under the transfer station as identified in 2018. At fuel tank farm #2, there was no evidence of the fuel spill that occurred in February 2018 except for some discernable hydrocarbon odours. Both fuel tank farms did not contain any water; however, there were discernable hydrocarbon odours at both fuel tank farms, and the liner at fuel tank farm #1 was exposed (see [Photo 21](#) through [Photo 25](#)).

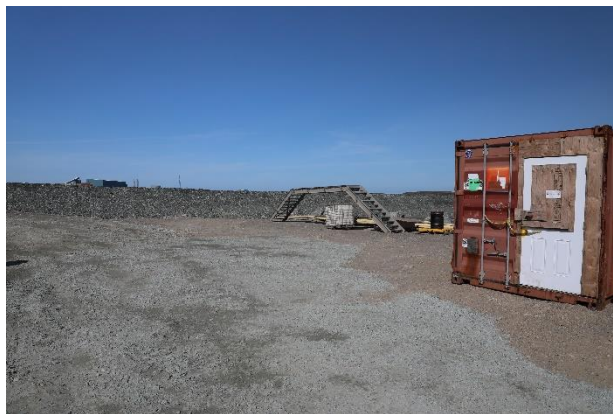
**Photo 25: Site of old fuel transfer station at Fuel Tank Farm #2.  
Area cleaned up following February 2018 spill.**

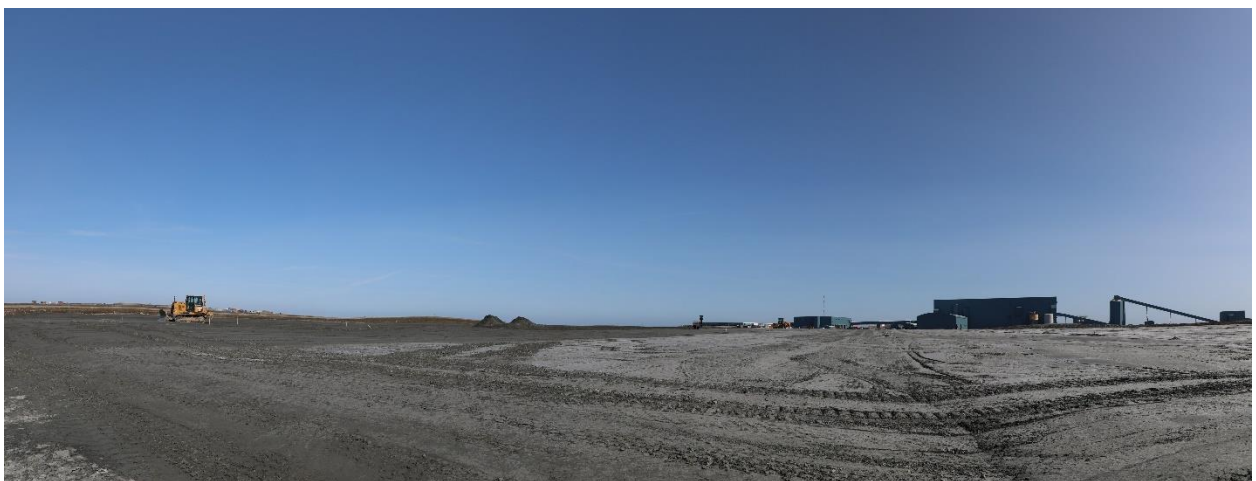
**Photo 26: Meliadine Tailings Storage Facility**

- e) The NIRB staff also visited the tailings storage facility (dry stack) located west of the mine site (see [Photo 26](#)). The site appeared to be well managed but Agnico Eagle staff noted that the dry stack method for the tailings storage facility has had issues during the summer months due to dust related issues (i.e., high winds have blown the tailings dust around).

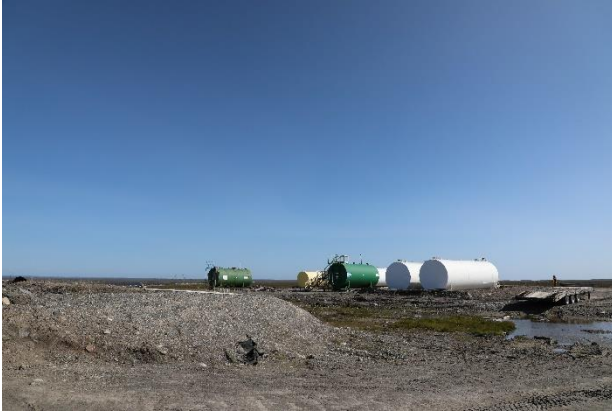
**Photo 27. The temporary exploration fuel storage farm.**

- f) The site visit also included the exploration/temporary fuel tank storage farm and temporary landfarm as following the 2017 site visit, Agnico Eagle noted that both locations would be decommissioned in the summer of 2018. During the current site visit, decommissioning work on the temporary fuel tank farm and temporary landfarm had not started and Agnico Eagle staff stated that remediation of the site had not commenced (see [Photo 27](#)).

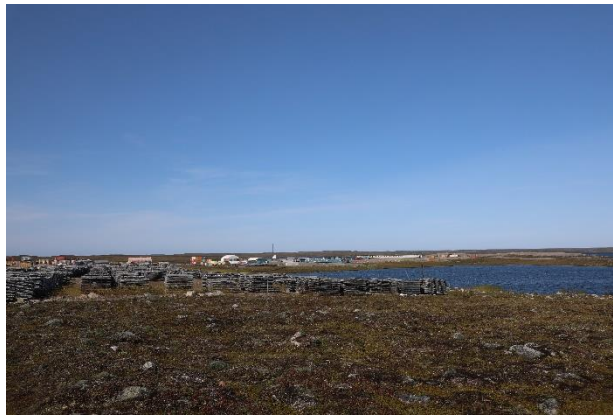
**Photo 29. Exploration mine camp at Meliadine**

- g) Wildlife observed during the site visit included geese (white-fronted, snow, and Canada), loons, siksik (ground squirrel), ravens, arctic hare and tundra swans.
- h) During the site visit, the NIRB staff were informed that the 200 person exploration camp continued to be used but was being slowly decommissioned (see [Photo 29](#)).

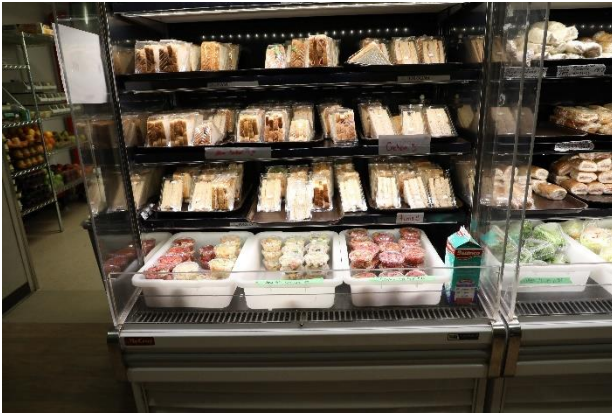
- g) NIRB staff had an opportunity to have lunch at the Meliadine cafeteria and noted that all food was pre-packaged into single serving plastic containers for the lunch crew including salads, sandwiches, and sliced pizza. The NIRB staff noted concern with this setup as it

could create a large quantity of plastic waste. Agnico Eagle staff indicated that they are working on reducing waste overall at the site (see [Photo 30](#) and [Photo 31](#)).

**Photo 30: Sandwiches and salads in plastic containers in the cafeteria**

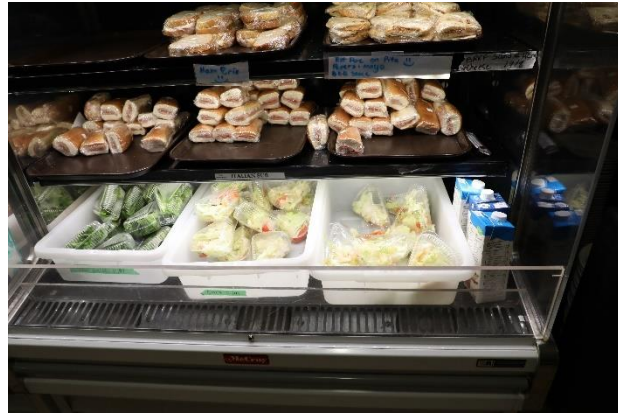
**Photo 31: Salads in single serving plastic containers**

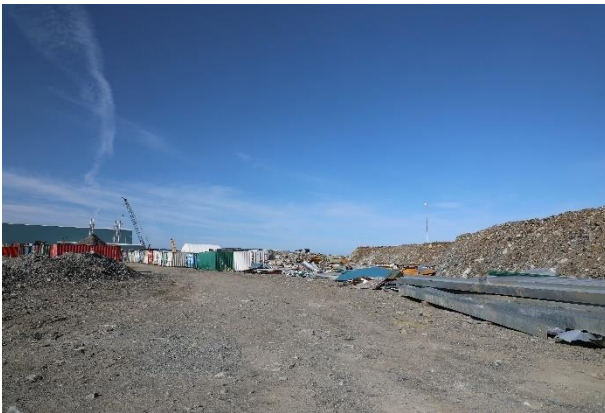
- h) Overall, the Meliadine mine site area appeared to be maintained in good order; however debris including windblown material was observed around the site (see [Photo 32](#) and [Photo 33](#)).

**Photo 32: Construction material and waste material around site**

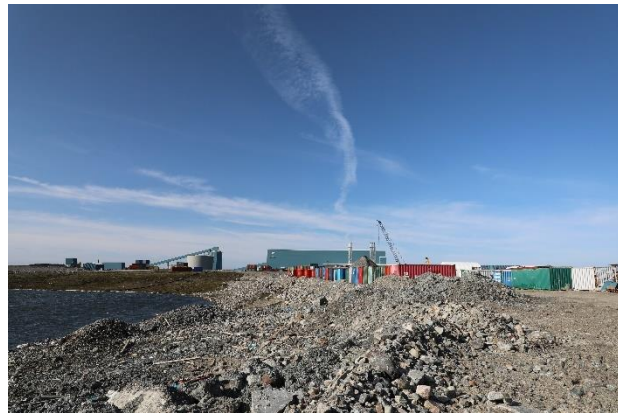
**Photo 33: Debris and garbage observed near CP1**

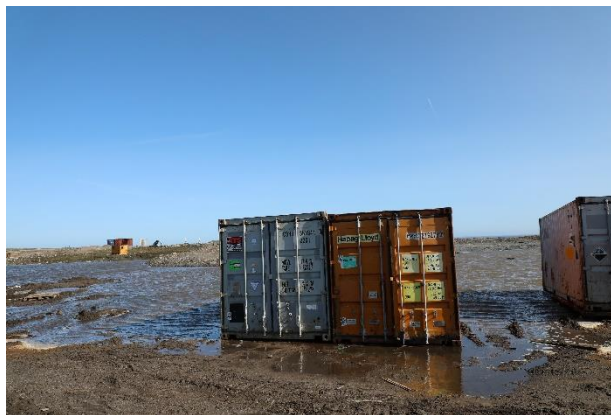
**Photo 34: Seacans and debris observed in water**

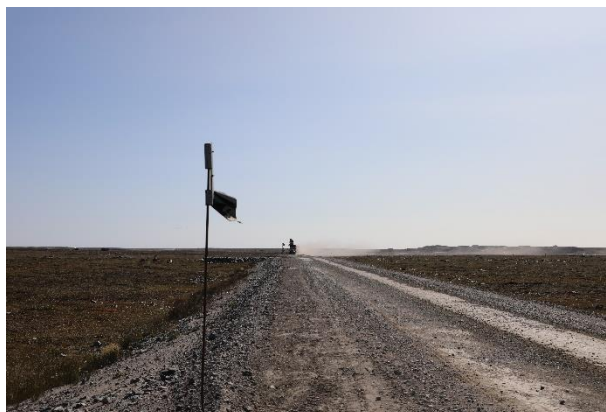
Agnico Eagle staff also indicated that calcium chloride flakes are applied to the areas around the Meliadine Mine site. In addition, water is used as the dust suppressant on the tailings storage facility. During the site visit, NIRB staff noted that dust suppressants were not applied effectively along the AWAR (see [Photo 36](#)).

Photo 36: Haul truck along the AWAR creating dust

Term and Condition 3 requires that the Proponent verify commitments to the utilization of dust suppressants along the AWA, including any associated trails and trails associated with the Project. To date, this condition has not been fully met by the Proponent as dust suppressants have not been employed sufficiently along the AWA as dust plumes were observed during the site visit as trucks were driving along the road.

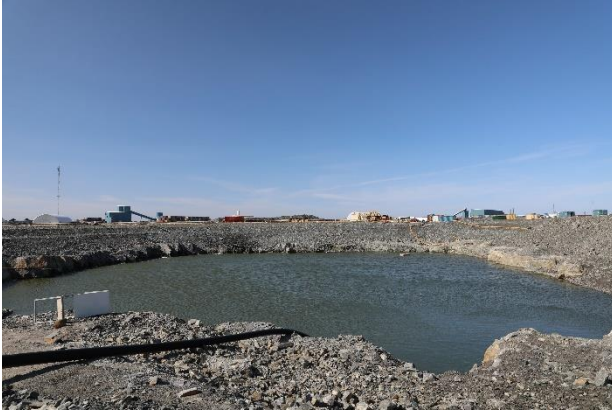
At the saline water management pond, NIRB staff observed the saline water pumped water from the underground to one of the P-Area Containment Ponds. At Collection Pond 5, the three (3) evaporators were not being used to treat water as the saline water is re-used in drilling or trucked to the Saline Discharge Facility at Itivia for eventual release to the marine environment (see [Photo 37](#) and [Photo 38](#)).

**Photo 37: Saline water pond, which stores saline water from underground operations at the Meliadine Gold Mine Project.**

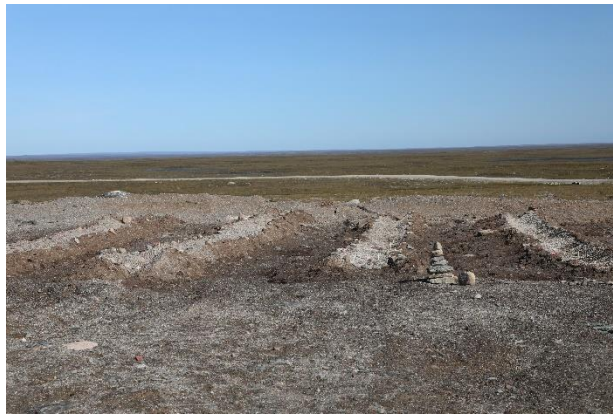
During the site visit, the NIRB staff visited test plots at one of the quarry sites that are being used as part of a revegetation trial in collaboration with Natural Sciences and Engineering Research Council of Canada Collaborative Research and Development grant with the University of Saskatchewan received in June 2019 (see [Photo 39](#)). However, the NIRB staff were informed during the site visit that some of the plots had been destroyed during the removal of soil from the quarry site.

**Photo 39: Test plots as part of the revegetation studies**

Term and Condition 41 requires the Proponent to develop a progressive re-vegetation program for disturbed areas that are no longer required for operations. Unfortunately, due to unforeseen circumstance a portion of the research program were destroyed.

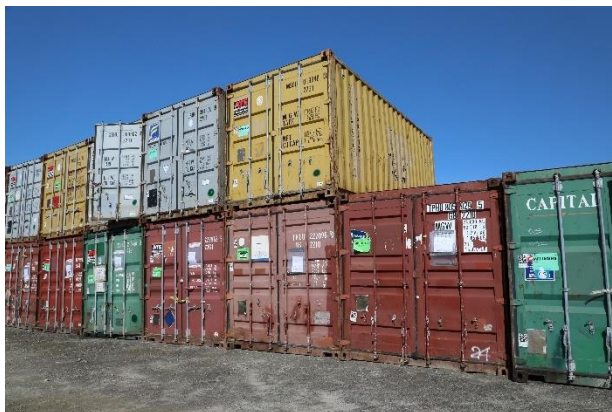
NIRB staff observed waste not suitable for the landfill or for incineration was sorted appropriately (e.g., sewage treatment sludge, batteries, electronics) and was stored in available seacans at the Exploration site for shipment to an appropriate facility in the south (see [Photo 40](#)). These seacans

were appropriately stored to avoid attracting wildlife to the site; however, it was discussed that in 2018 a total of 22 arctic foxes were trapped near the mine site and dispatched by the Government of Nunavut, Department of Environment officers. Agnico Eagle continues to work with the Department to find ways to minimize attracting wildlife to the site.

**Photo 40. Wastes unsuitable for the landfill are sorted and stored in seacans.**
