# Meliadine Gold Mine Project

Agnico Eagle Mines Limited

NIRB File No. 11MN034

**Report Title:** The Nunavut Impact Review Board's 2021 Site Update Report for Agnico Eagle Mines Limited's *Meliadine Gold Mine Project* (NIRB File No. 11MN034)

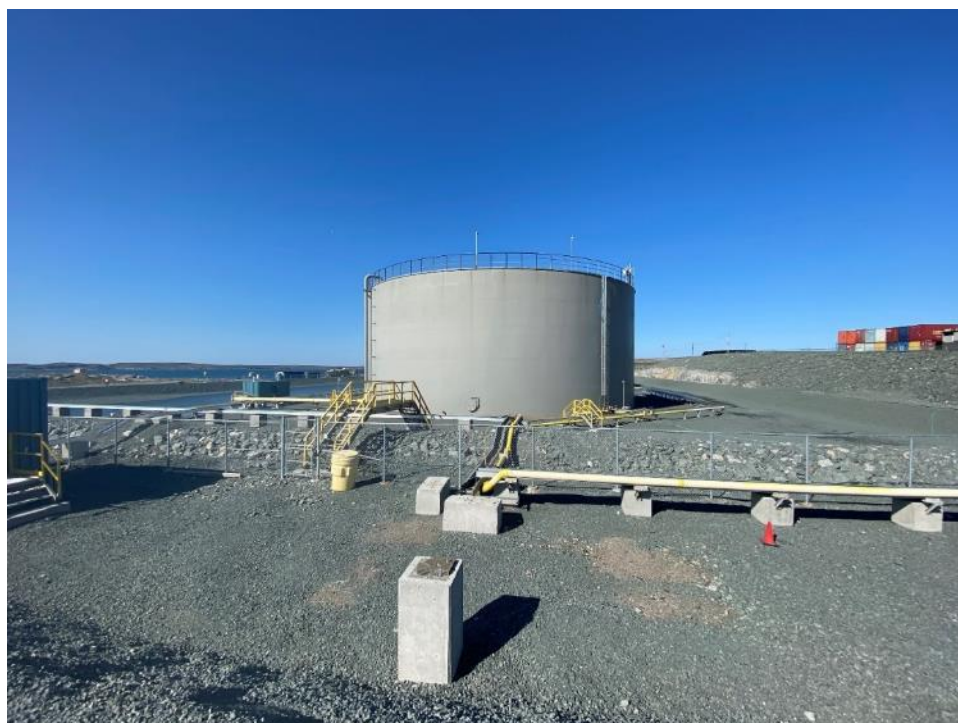
**Photo 2: Fuel Farm 2 and Secondary Containment**

| T&C No. | Category | Observation |
|---|---|---|
| 64, 67 & 77 | Marine Environment - Accidents and Malfunctions | <a href="#">Photo 2</a> demonstrates secondary containment of the fuel farm at Itivia Harbour next to Melvin Bay. |

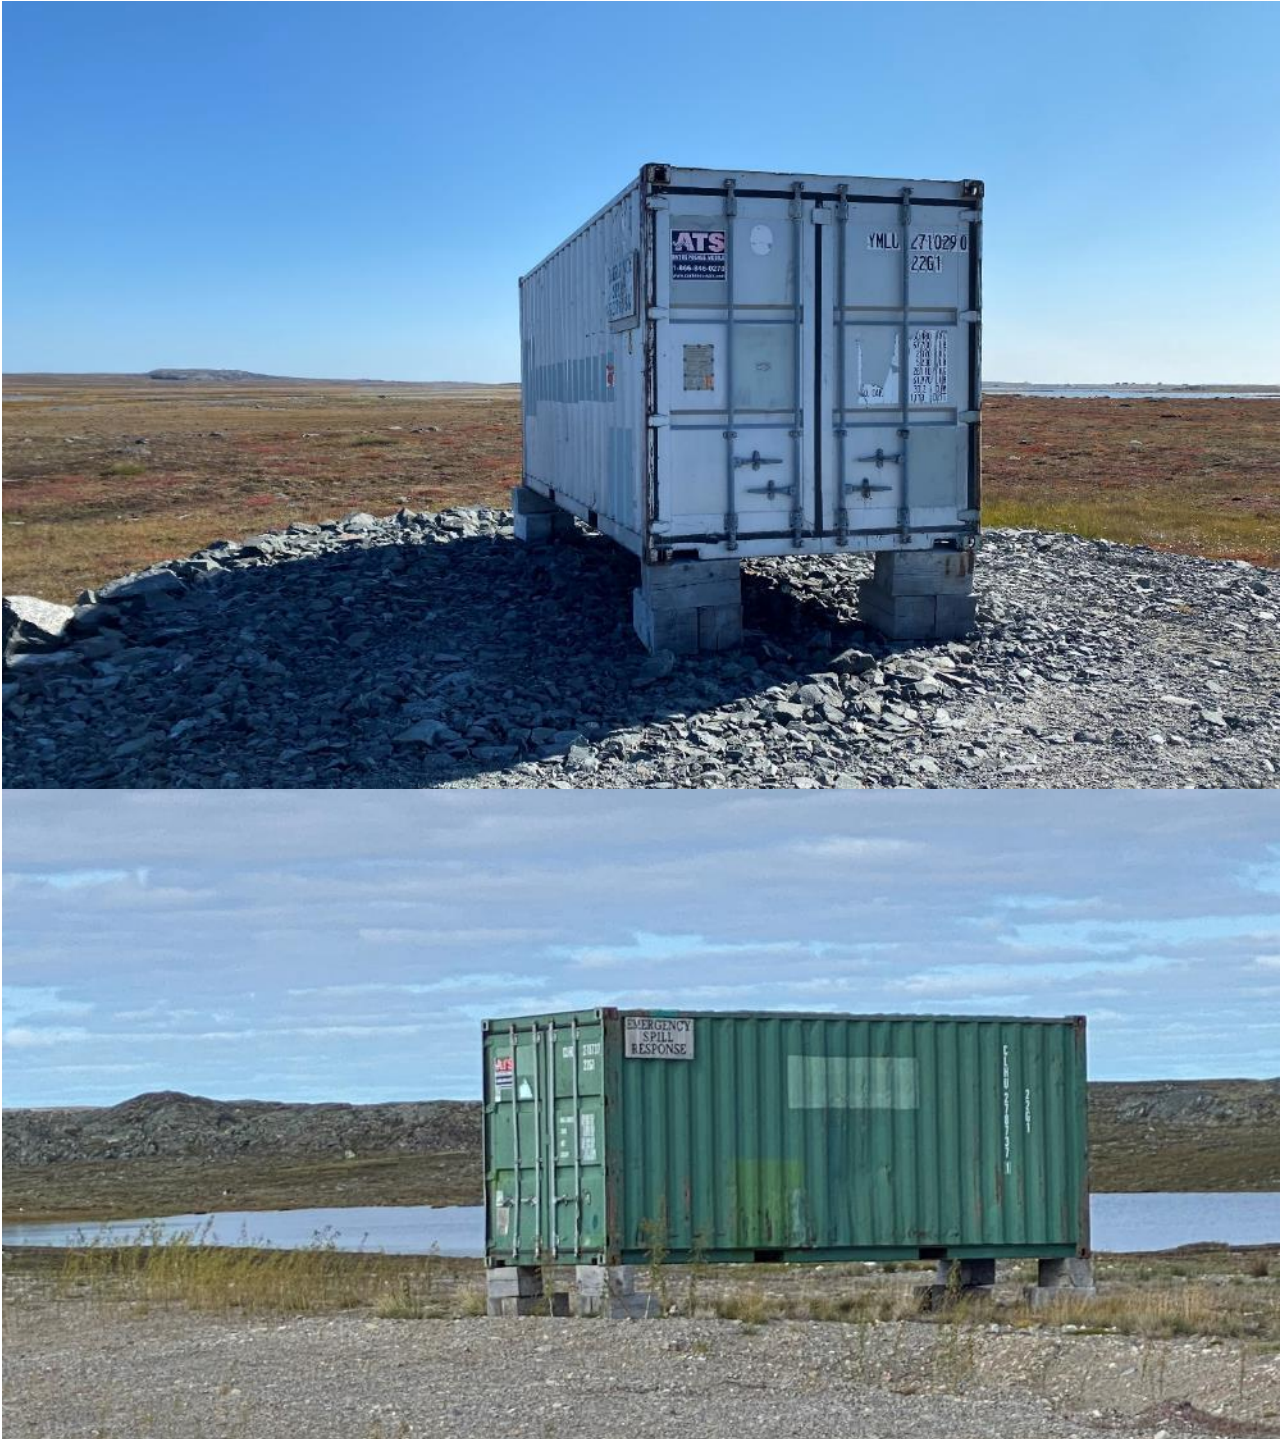
Photo 14: Emergency Spill Response Seacans

| T&C No. | Category | Observation |
|---|---|---|
| 124 | Spill preparedness | <a href="#">Photo 14</a> shows the emergency spill response seacans along the all-weather access road. |

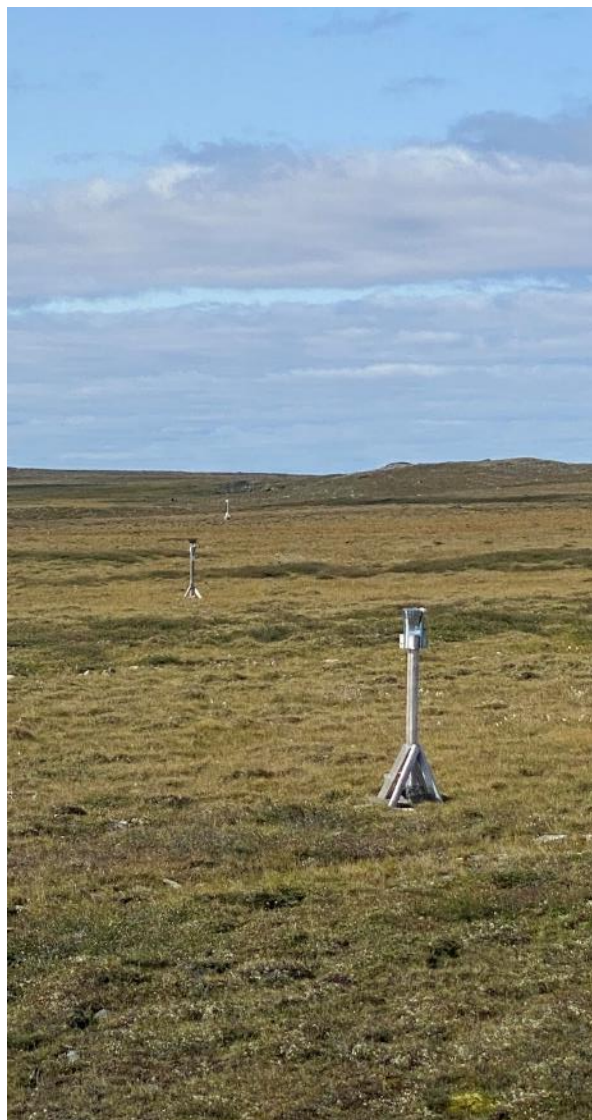
Photo 15: Dustfall Monitoring Transect

| T&C No. | Category | Observation |
|---|---|---|
| 1 & 3 | Air Quality Monitoring Plan | <a href="#">Photo 15</a> and <a href="#">Photo 16</a> provide evidence of dustfall monitoring along the all-weather access road.<br><a href="#">Photo 56</a> shows the equipment used for air quality monitoring. |

- Water and calcium chloride were used along the AWAR to limit dust emissions.
- Agnico Eagle restarted monitoring transects south of the gatehouse which were suspended in 2020 due to COVID-19 restrictions.
- The dustfall stands on the Bypass Road were adjusted at certain distances from the road to reflect the updates made in the Air Quality Monitoring Plan version 3 (June 2020).

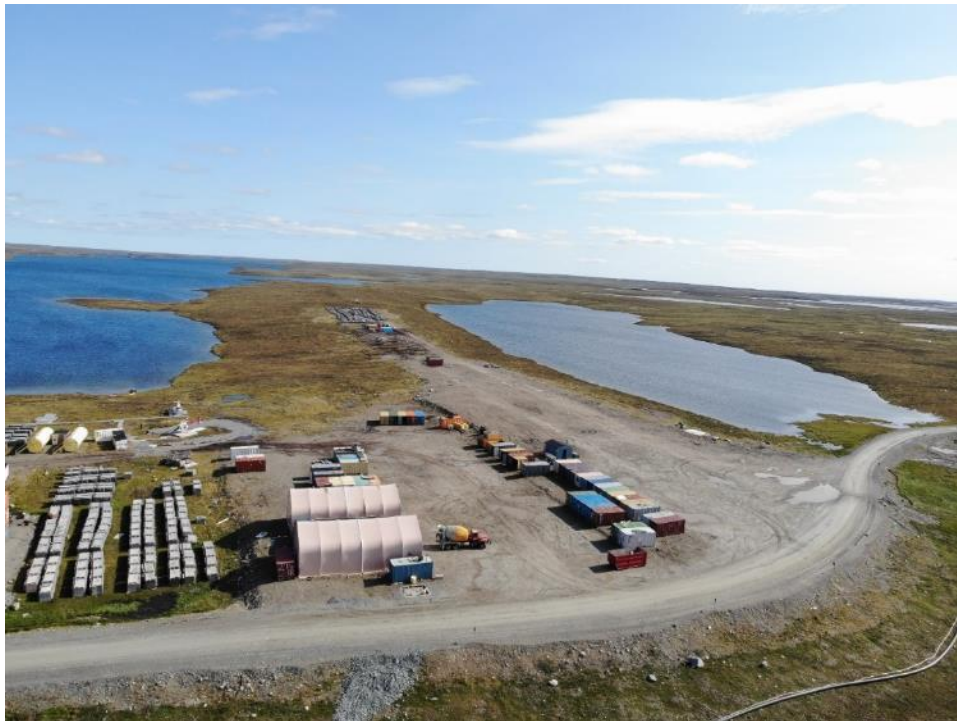
**Photo 20: Exploration Camp**

- In the summer of 2021, Agnico Eagle conducted a site clean up around the Exploration Camp (Photo 20).
- Agnico Eagle is evaluating shipping the empty fuel tanks off site. These tanks contained sewage sludge and had a secondary gravel berm constructed around them in case of spills or leaks (Photo 21).
- The rows of contaminated soil in the landfarm were turned (Photo 22).
- On June 4th, 2021, a 250-litre fuel spill occurred at the Exploration Camp core shack due to the failure of a fuel line. In July 2021, dismantling of the core shack building started, to allow soil remediation (Photo 23).

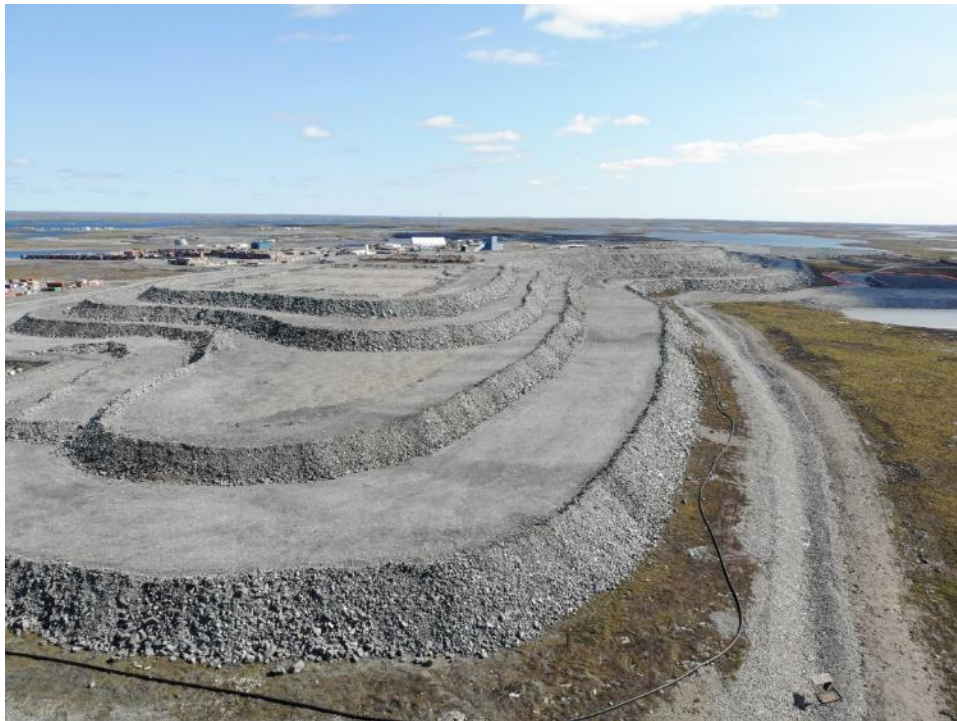
**Photo 38: Waste Rock Storage Facility 1**

- Waste Rock Storage Facility 1 is still active and expected to reach its design capacity in Year 4 (2023; Photo 38).
- Waste Rock Storage Facility 3 received all waste material from Tiriganiaq Pit 2 in 2020 and will accommodate portions of waste rock from Tiriganiaq Pit 1 in 2022 and 2023 until capacity is reached (Photo 39).

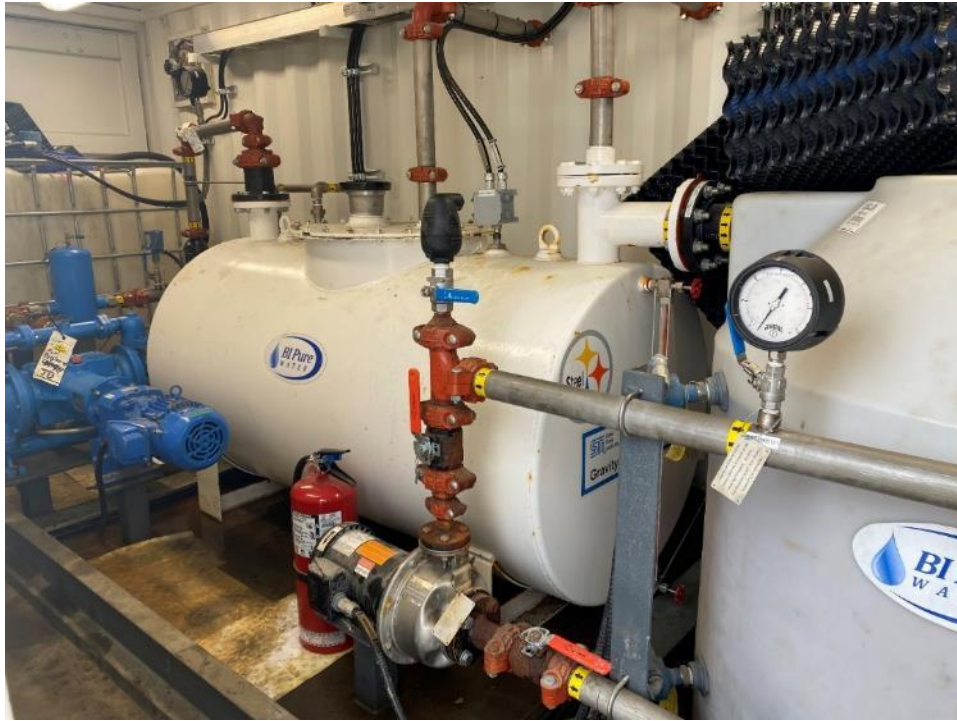
Photo 41: Oil Separator System

- An oil separator system has been installed at the Landfarm A site to treat accumulated sump water (Photo 41).
- A landfill volume survey was completed on August 10, 2021. The current volume is 13,587.7 cubic meters (Photo 42).

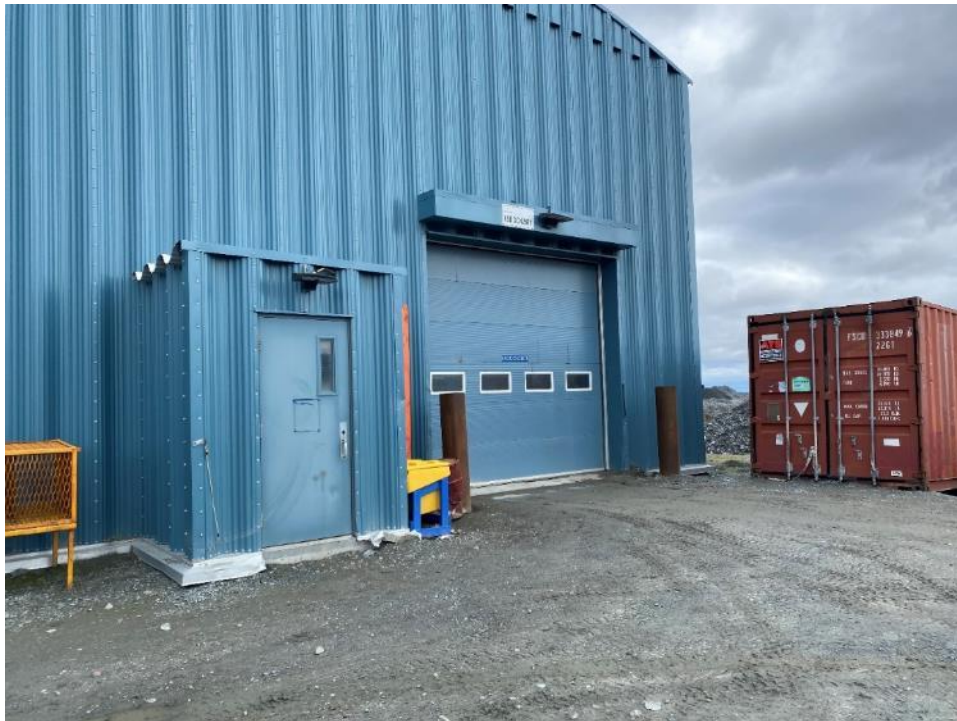
Photo 44: Incinerator

| T&C No. | Category | Observation |
|---|---|---|
| 75 | Predatory Attractants | <a href="#">Photo 44</a> provides evidence that incinerator doors are kept closed to prevent wildlife. <a href="#">Photo 45</a> demonstrates management of food waste. <a href="#">Photo 46</a> , <a href="#">Photo 47</a> , and <a href="#">Photo 48</a> demonstrate improvements to the waste segregation on site. |

- A gate was installed to control access to the landfill in 2020. In 2021, no animal deterrents were placed at the landfill (Photo 43).
- Incinerator doors are kept closed to prevent wildlife. During summer, a steel grating is used to keep wildlife out while the door is open to allow heat to escape (Photo 44).

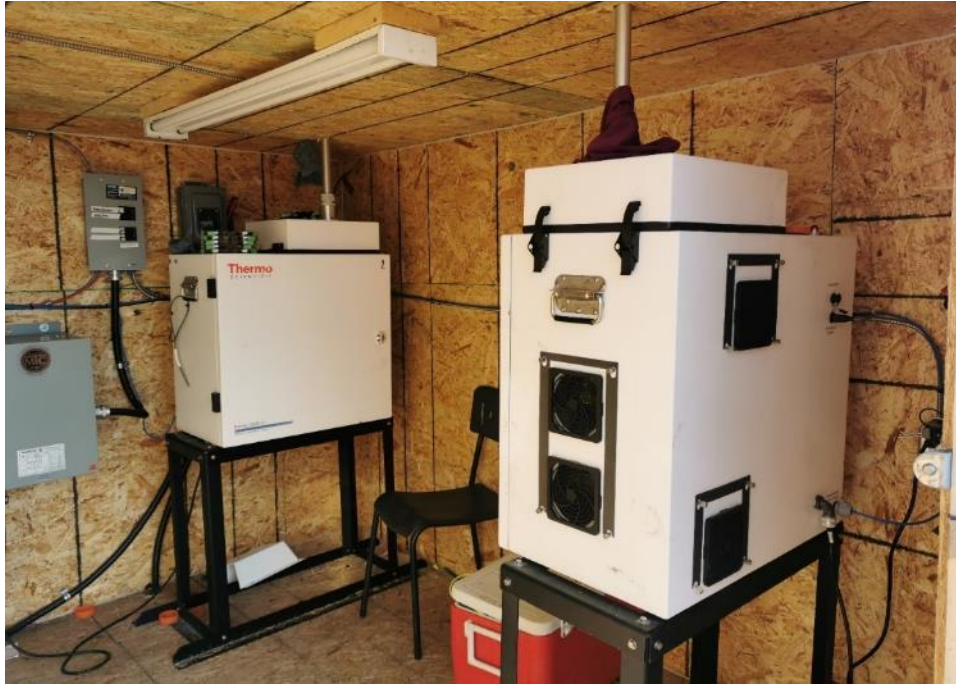
Photo 56: Air Quality Monitoring

- Air quality monitoring units were reinstalled by the supplier in October 2020 (Photo 56). Agnico Eagle has obtained a set of spare parts as recommended and environmental technicians are carrying out a schedule of routine maintenance.
