WATER LICENCE INSPECTION FORM

Licensee	Licensee Representative
2AM-MEL1631	Alexandre Gauthier, Justin MacMillan
Licence No. / Expiry	Representative's Title
July 21st, 2024	AEM Environment
Land / Other Authorizations	Land / Other Authorizations
IOL	2BW-MEL1524, 2BB-MEL1424
Date of Inspection	Inspector
May 25 th , 2016	WRO C. Wilson
Activities Inspected	
<input type="checkbox"/> Camp	<input type="checkbox"/> Drilling
<input checked="" type="checkbox"/> Roads/Hauling	<input type="checkbox"/> Mining
	<input checked="" type="checkbox"/> Construction
	<input checked="" type="checkbox"/> Other: Water Discharge
	<input checked="" type="checkbox"/> Other: Culverts
	<input type="checkbox"/> Reclamation
	<input type="checkbox"/> Fuel Storage

PHOTO LOG

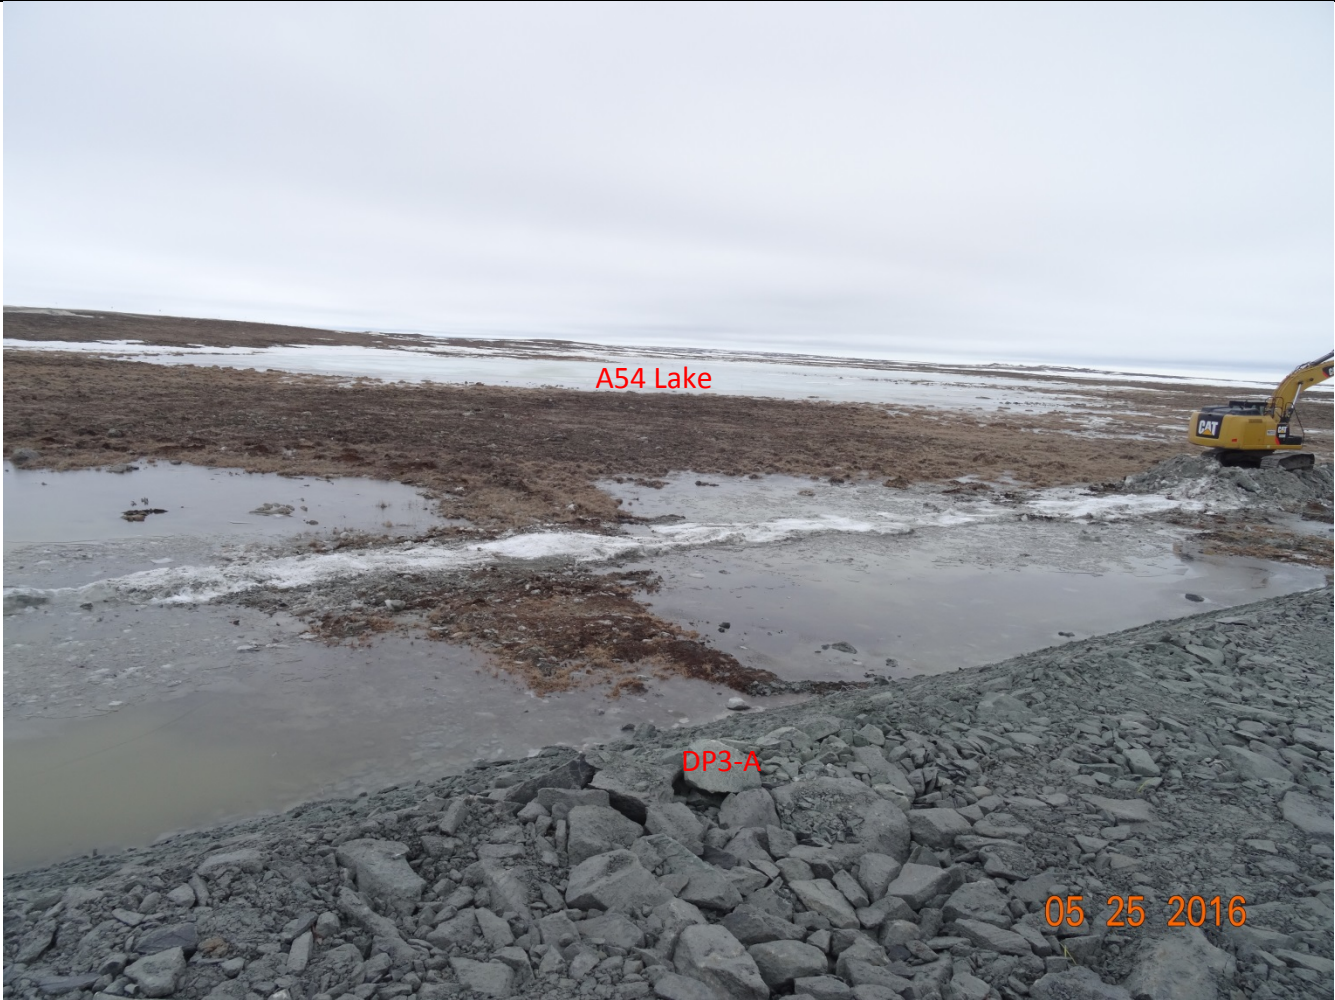
Locations name:
Photo 3

Looking South: Waste material/snow removal from the construction of DP3-A

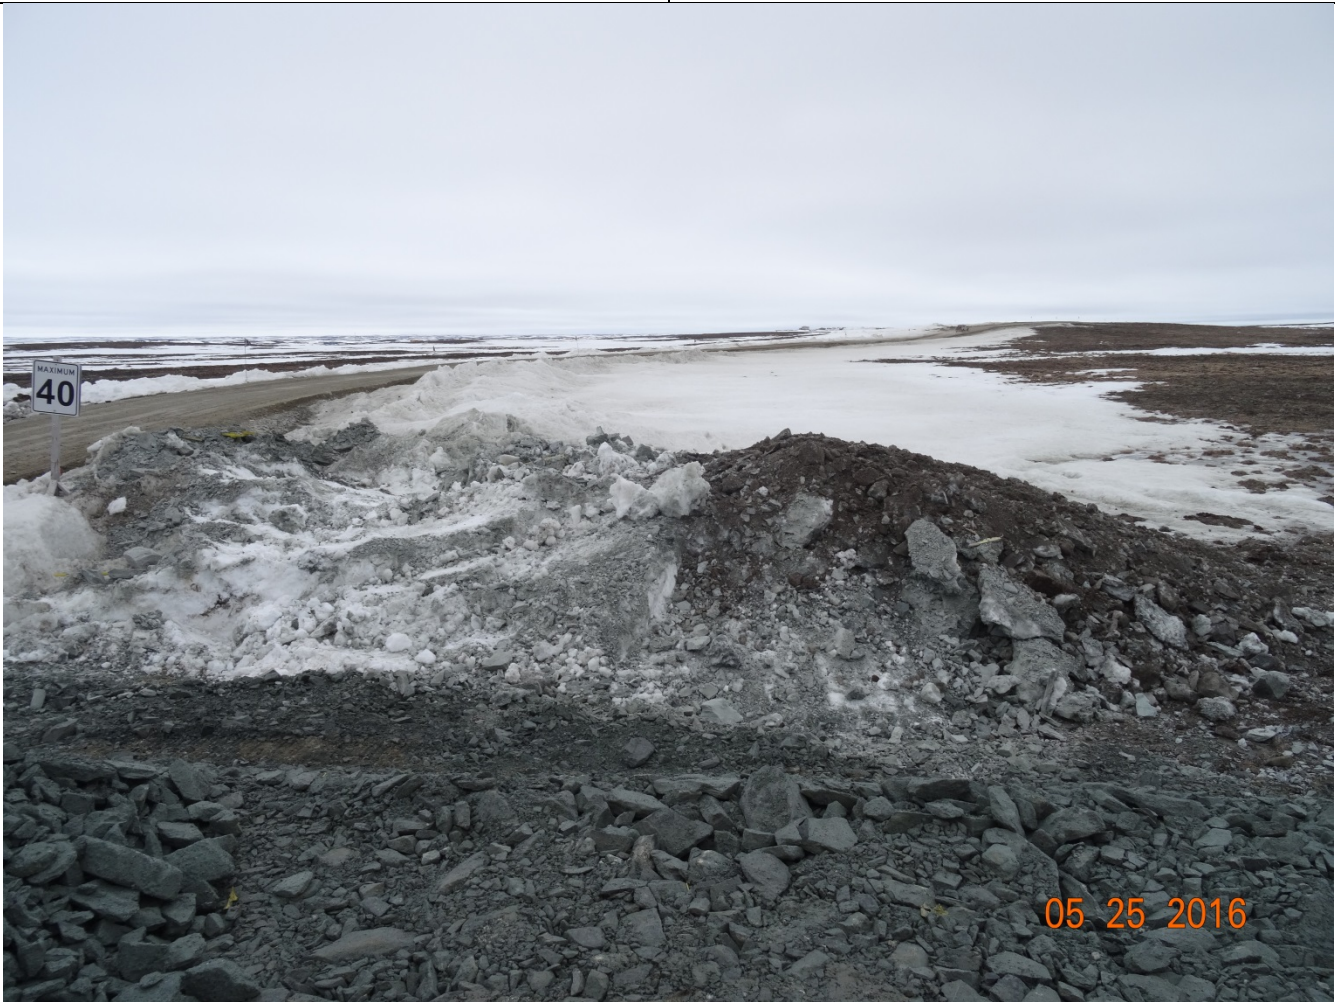
Locations name:
Photo 4

Facing East: Waste material/snow recovered from the construction of DP3-A awaiting removal.
