WATER LICENCE INSPECTION FORM

Licensee	Licensee Representative
2AM-MEL1631	Alexandre Gauthier, Justin MacMillan
Licence No. / Expiry	Representative's Title
July 21st, 2024	AEM Environment
Land / Other Authorizations	Land / Other Authorizations
IOL	2BW-MEL1524, 2BB-MEL1424
Date of Inspection	Inspector
May 25 <sup>th</sup> , 2016	WRO C. Wilson
Activities Inspected	
<input type="checkbox"/> Camp	<input type="checkbox"/> Drilling
<input checked="" type="checkbox"/> Roads/Hauling	<input type="checkbox"/> Mining
	<input checked="" type="checkbox"/> Construction
	<input checked="" type="checkbox"/> Other: Water Discharge
	<input checked="" type="checkbox"/> Other: Culverts
	<input type="checkbox"/> Reclamation
	<input type="checkbox"/> Fuel Storage

PHOTO LOG

AGNICO EAGLE MELIADINE GOLD PROJECT

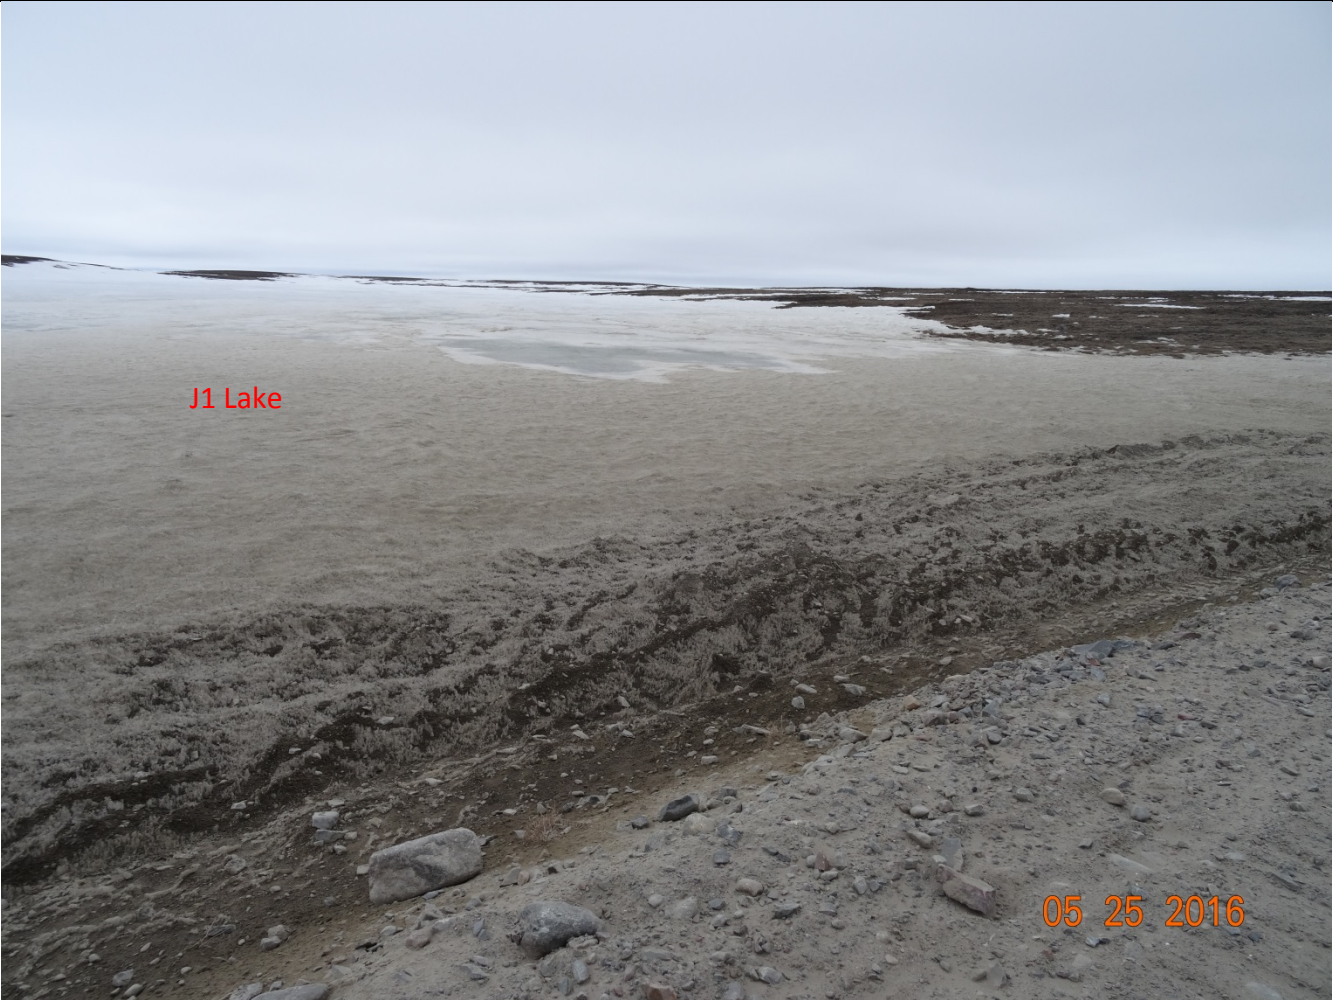
Date:	Authorization Number:	Camera/Model:	Inspector
May 27th, 2016	2AM-MEL1631	Sony DSC-HX50V Cyber shot	WRO Wilson
Photo No.	Lat/Long (DD.MM.SS.SS, NAD83)		
Photo 1	N 63° 01' 34.6", W 92° 10' 27.3"

Description:  
Looking south: Lake J1

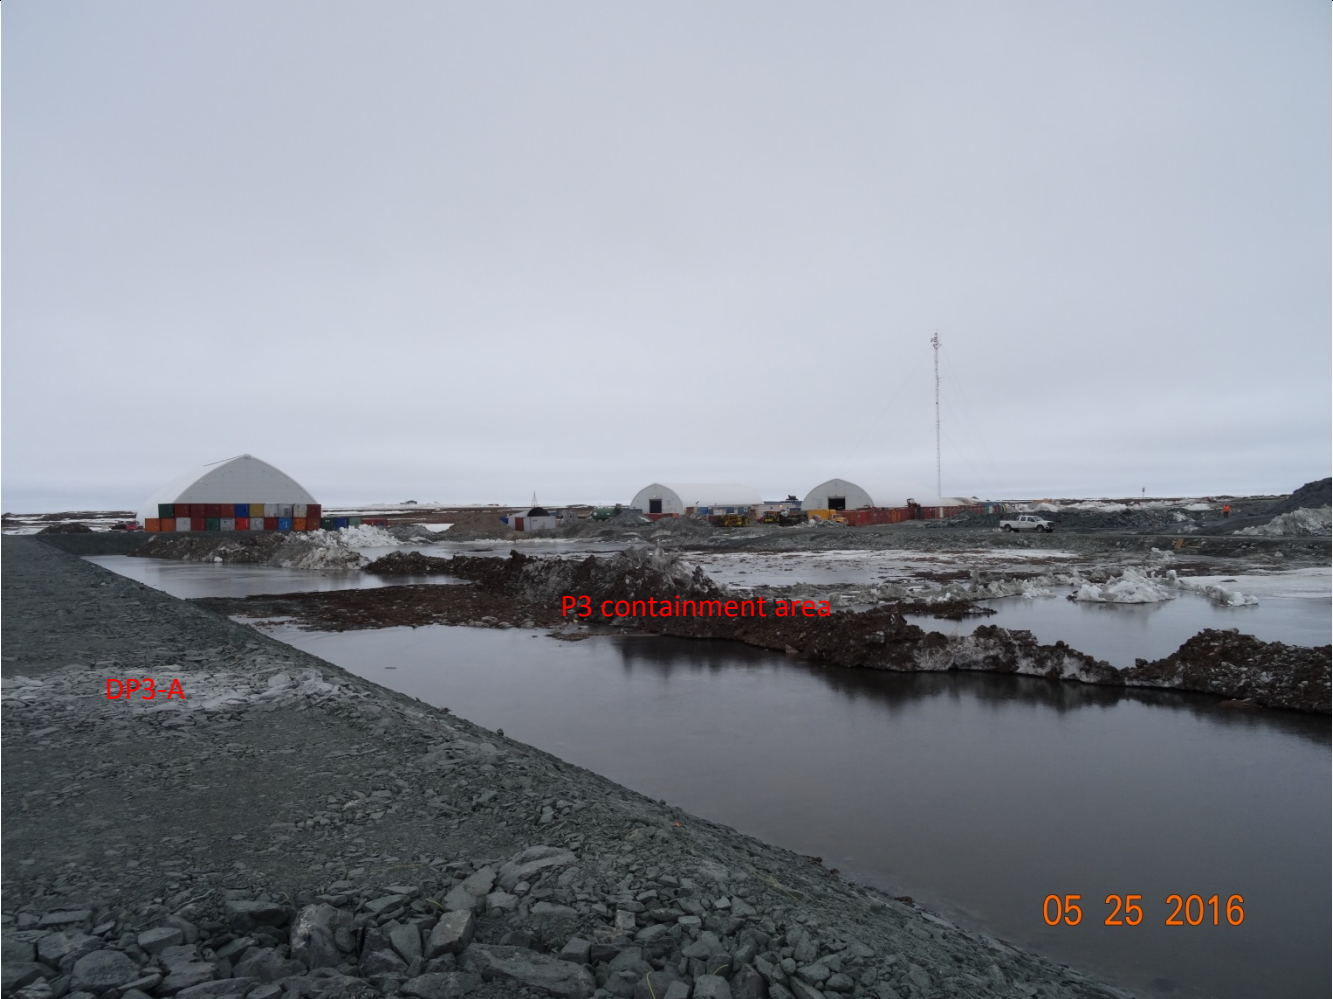
Locations name:	Lat/Long (DD.MM.SS.SS, NAD83)
Photo 2	N63° 1' 40.29", W 92° 12' 27.73"

Description  
Facing South West: P3 containment area

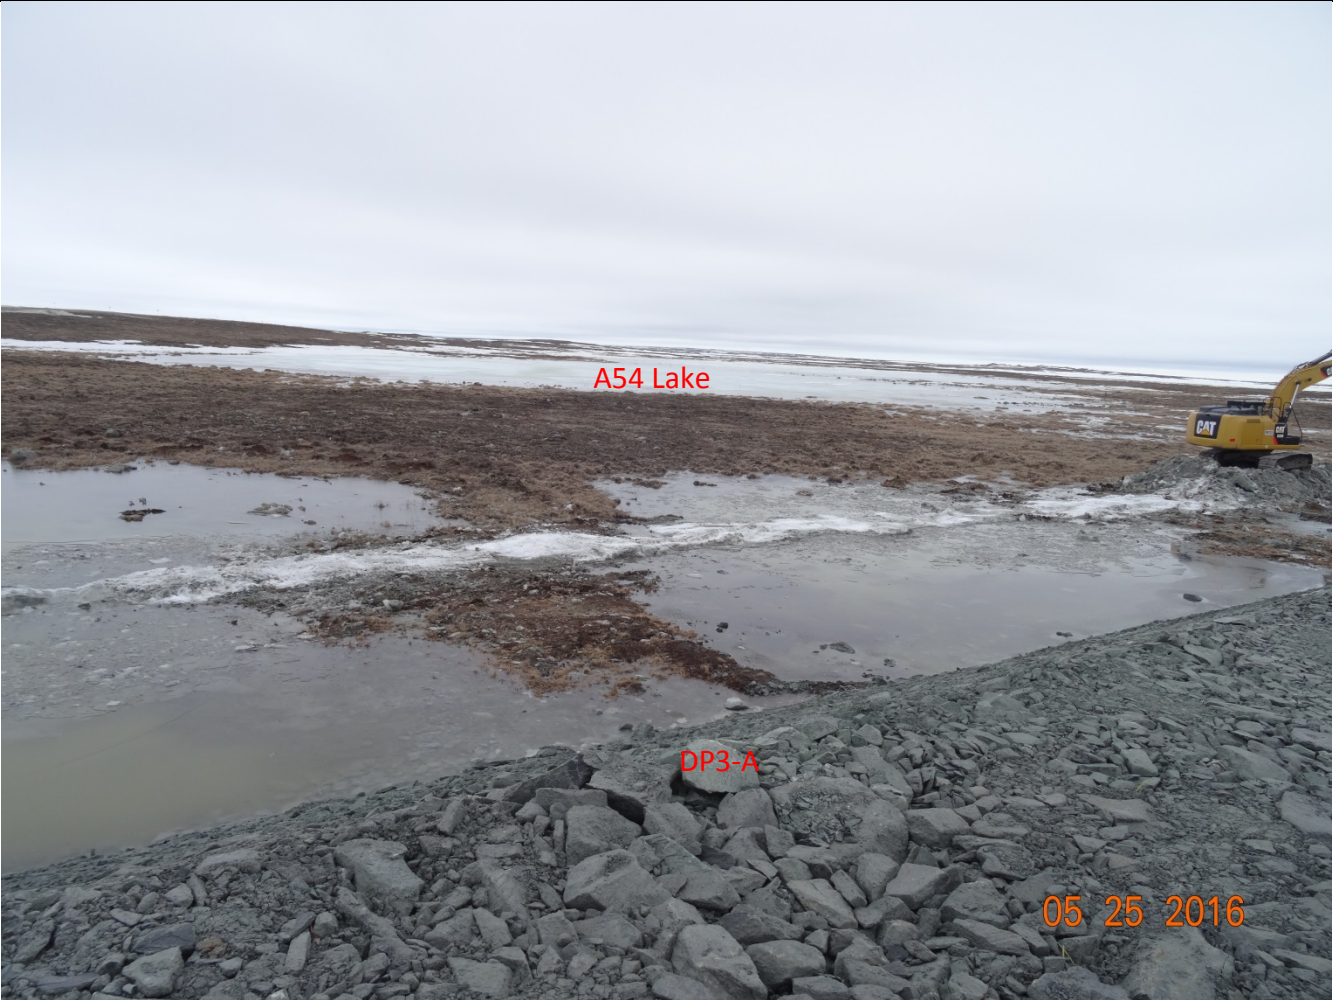
Locations name:  
Photo 3

Looking South: Waste material/snow removal from the construction of DP3-A

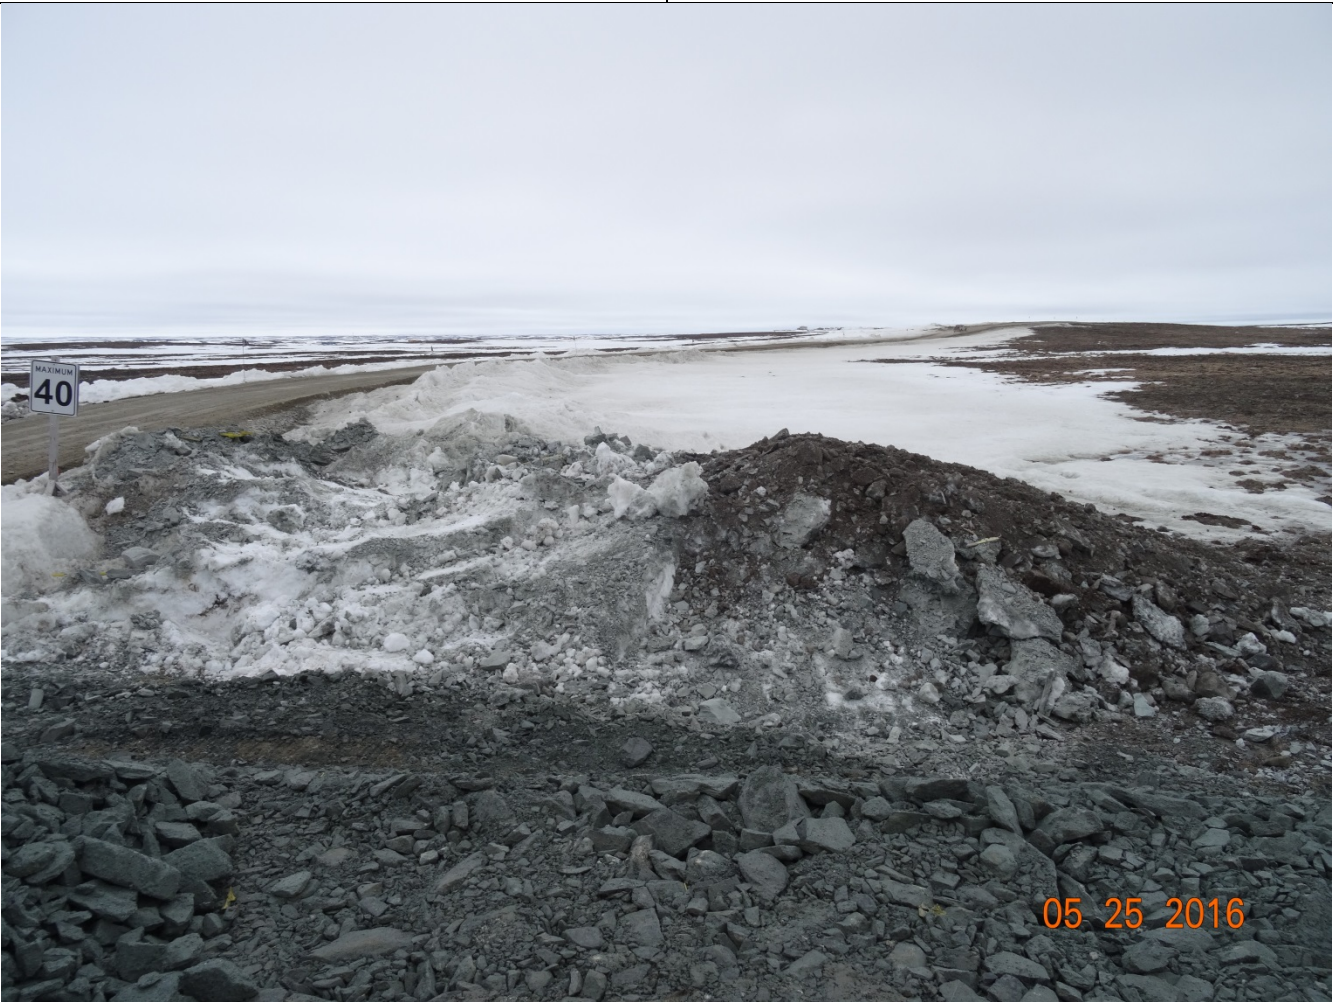
Locations name:  
Photo 4

Facing East: Waste material/snow recovered from the construction of DP3-A awaiting removal.

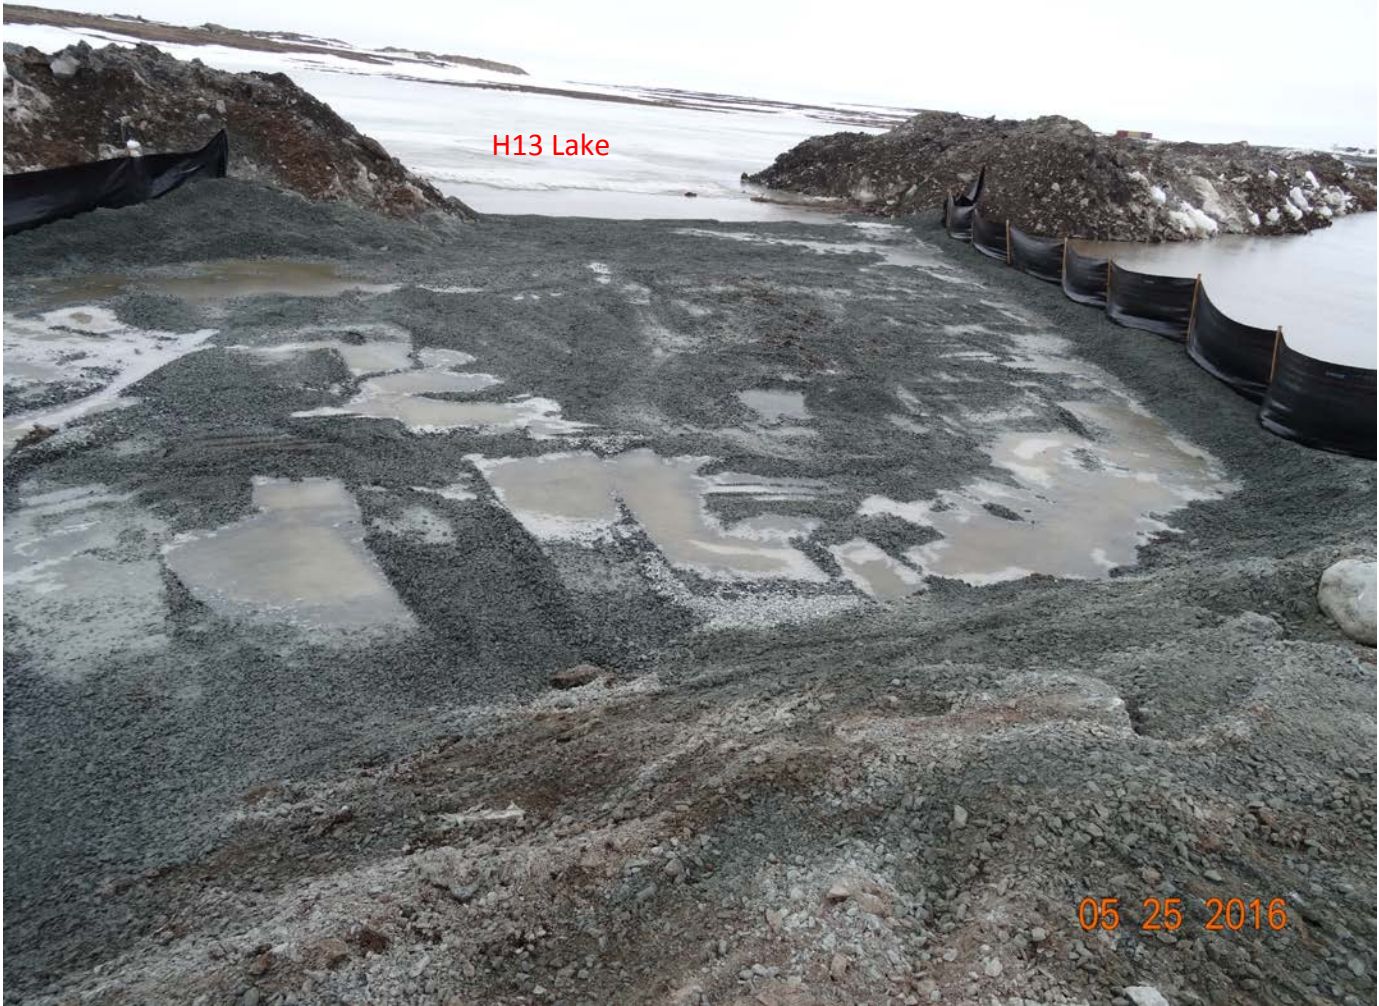
Locations name:  
Photo 9

Description  
Facing West: Gravel at culvert no. 2 ( culvert no.2 is slightly out of frame located at the bottom left corner of picture)

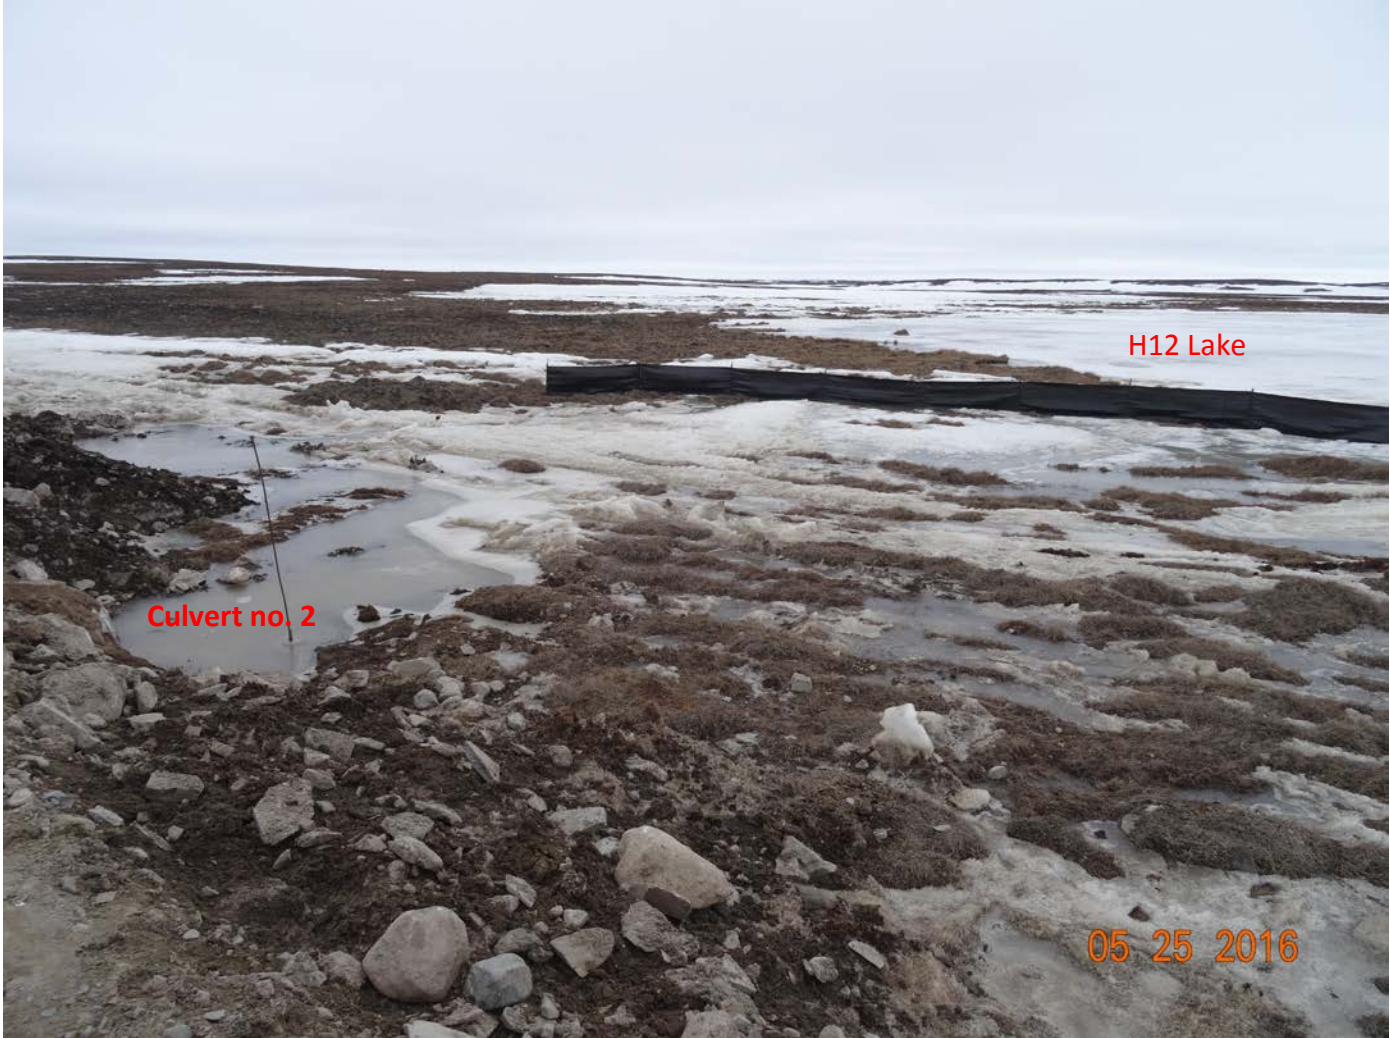
Locations name:  
Photo 10

Description  
Facing North East: Culvert no. 2 outlet to H12 Lake; silt fence at H12 Lake
