Record of Water Licence Inspection

Licensee	Licensee Representative
Agnico Eagle Gold Mines Ltd.	Jeff Pratt, Justin MacMillan
Licence No. / Expiry	Representative's Title
2AM-MEL1631/ July 21st, 2024	AEM Environment
Land / Other Authorizations	Other Authorizations/ Expiry
IOL	2BB-MEL1424/ July 14 <sup>th</sup> , 2024
Date of Inspection	Inspector
10/11/16	WRO C. Wilson
Activities Inspected	
<input type="checkbox"/> Camp	<input type="checkbox"/> Drilling
<input checked="" type="checkbox"/> Roads/Hauling	<input type="checkbox"/> Mining
	<input checked="" type="checkbox"/> Construction
	<input type="checkbox"/> Reclamation
	<input type="checkbox"/> Fuel Storage
	<input checked="" type="checkbox"/> Other: Culverts

Photo Log, November 10th, 2016

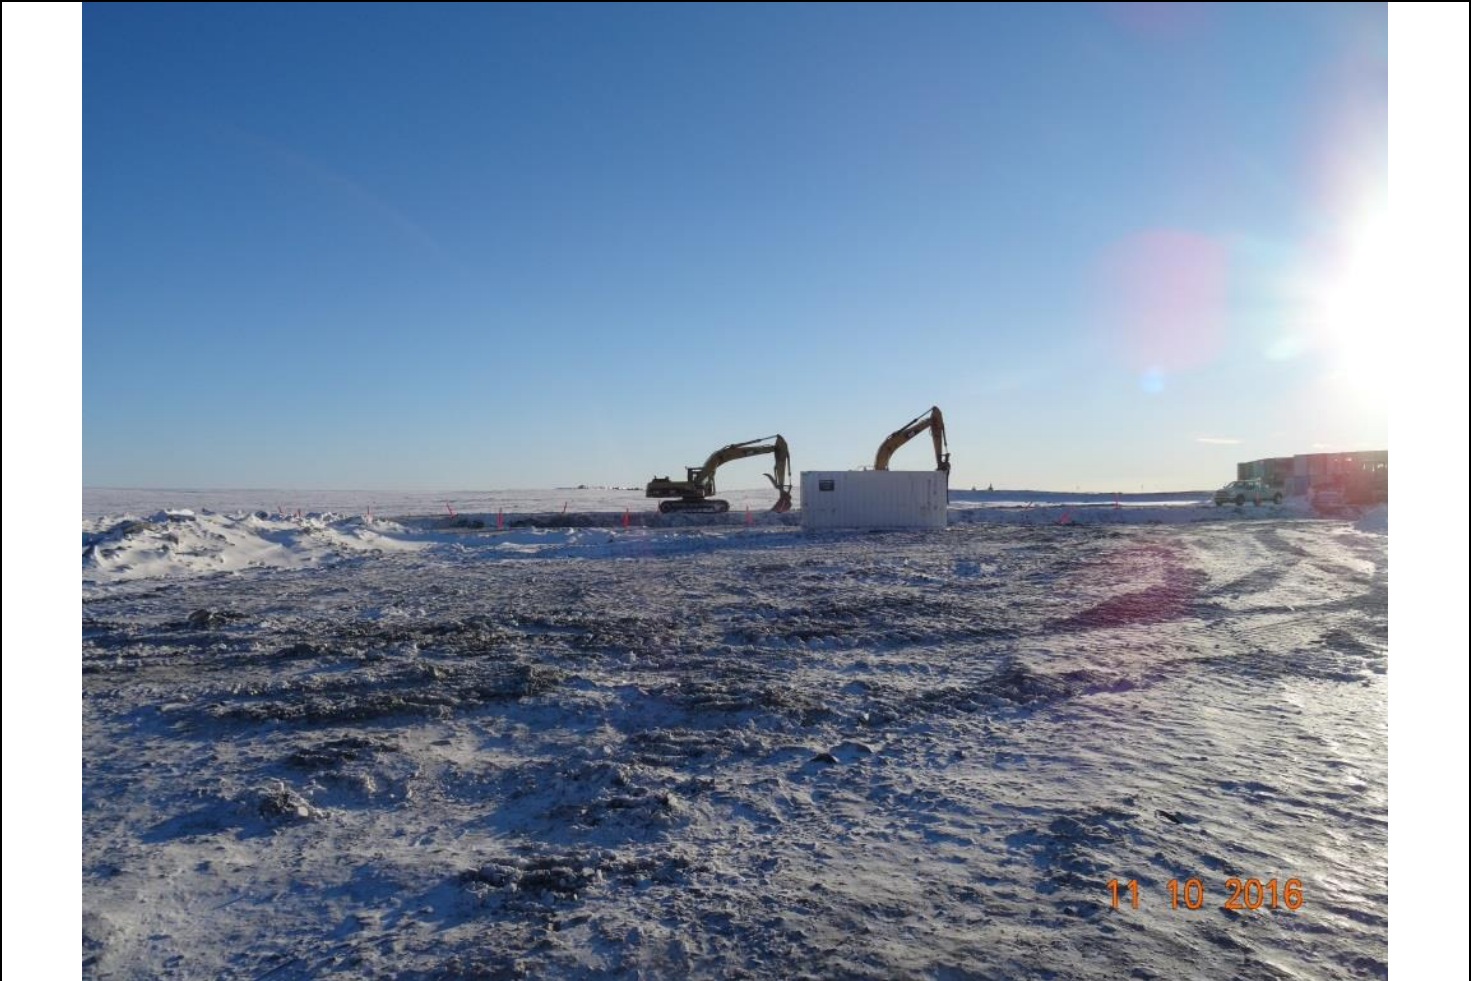
Description:  
Looking south: Keying in D-CP1

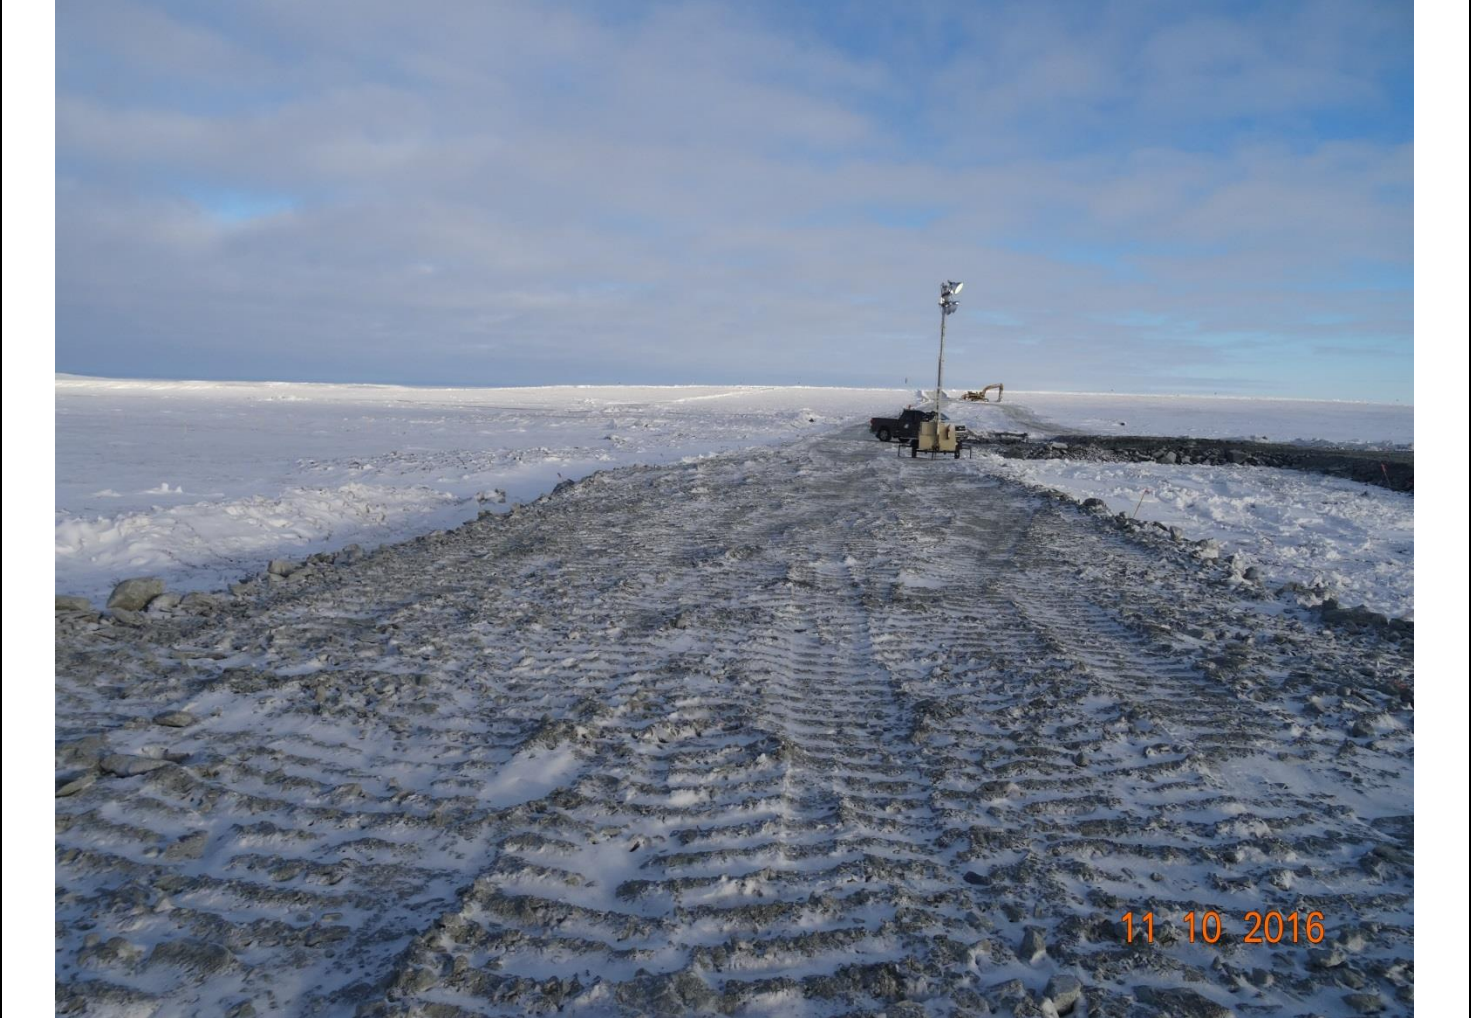
Description  
Facing East: D-CP5 construction

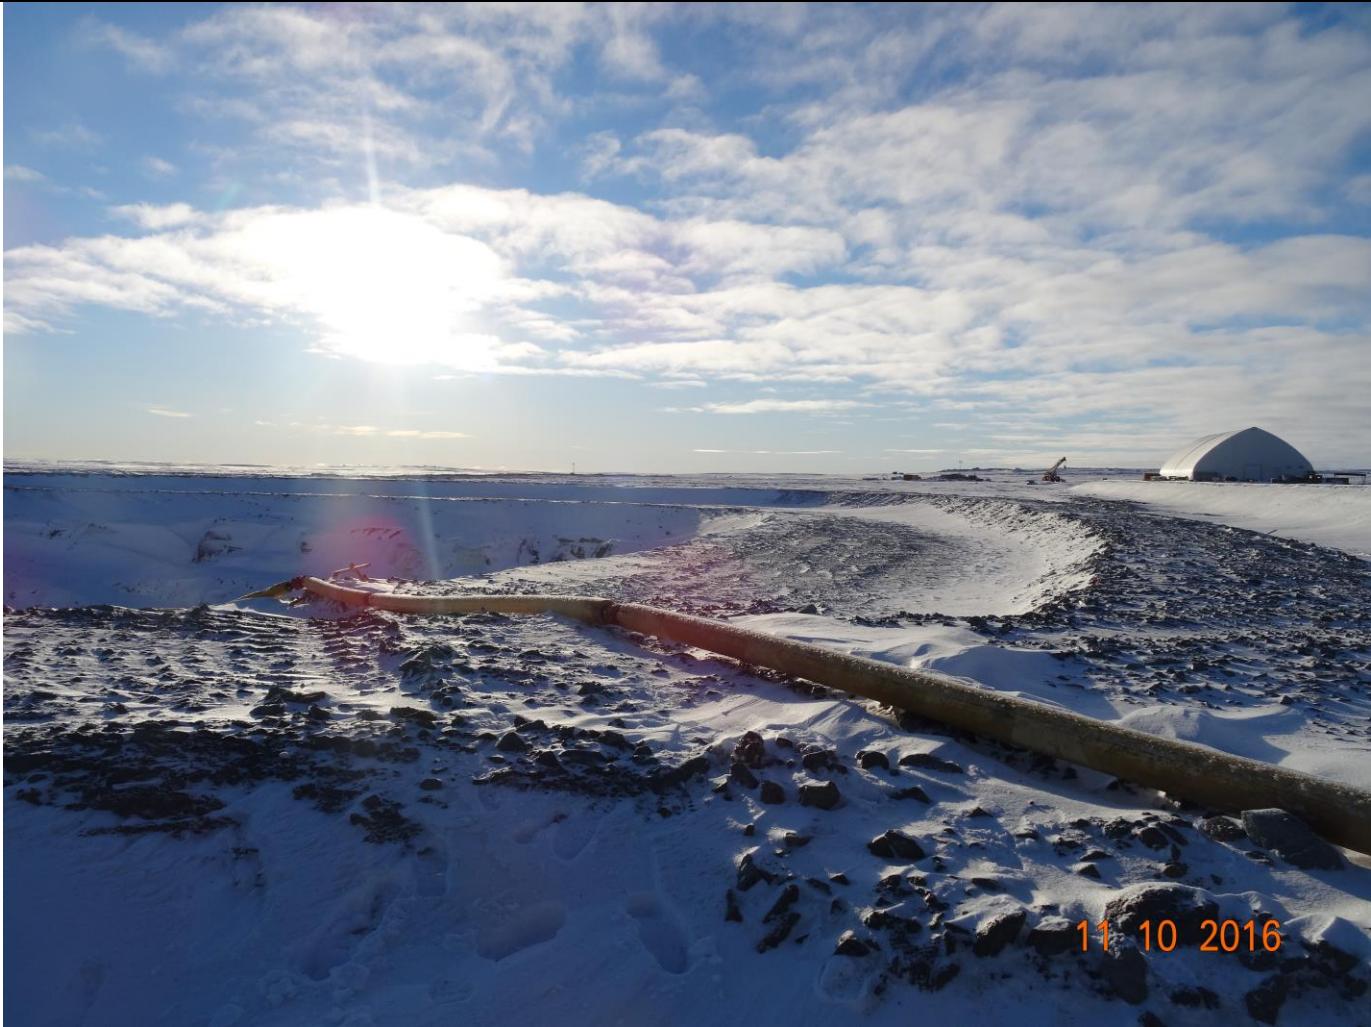
Photo 3

Looking West: Saline Water Pond

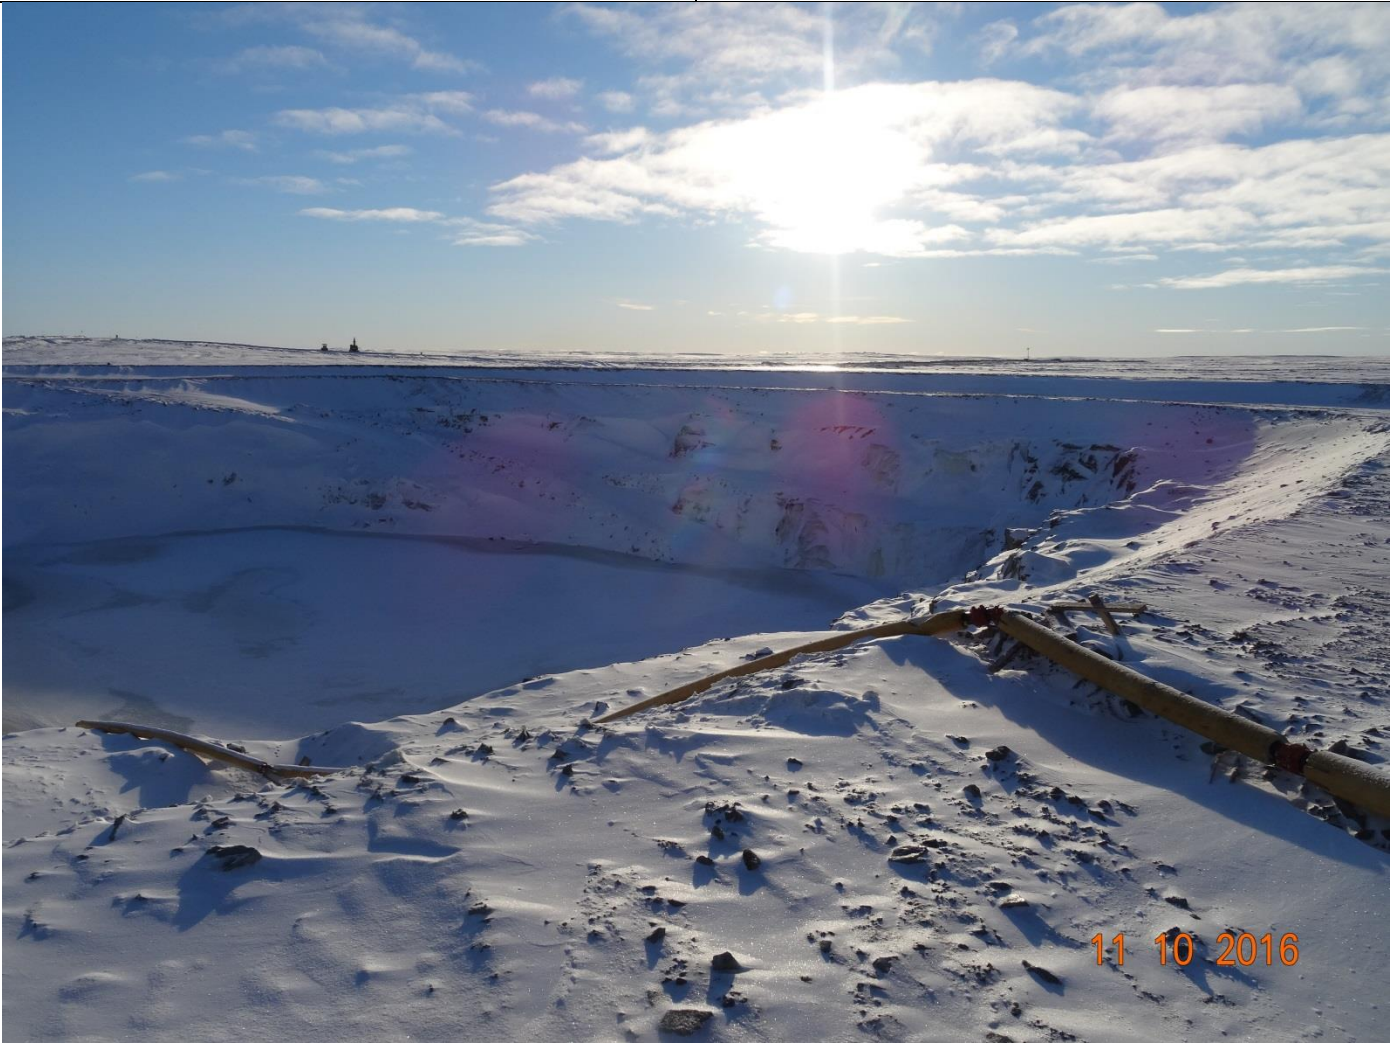
Photo 4

Looking West: Saline Water Pond
