WATER LICENCE INSPECTION FORM

On September 20th and 21st, 2018 an inspection was conducted of the Agnico Eagle Mines’ (‘AEM’) Meliadine Mine site, authorized under water licence no. 2AM-MEL1631. The inspection was completed by Water Resource Officer Tim Morton and was conducted to ensure compliance with the above stated water licence and approved management plans.

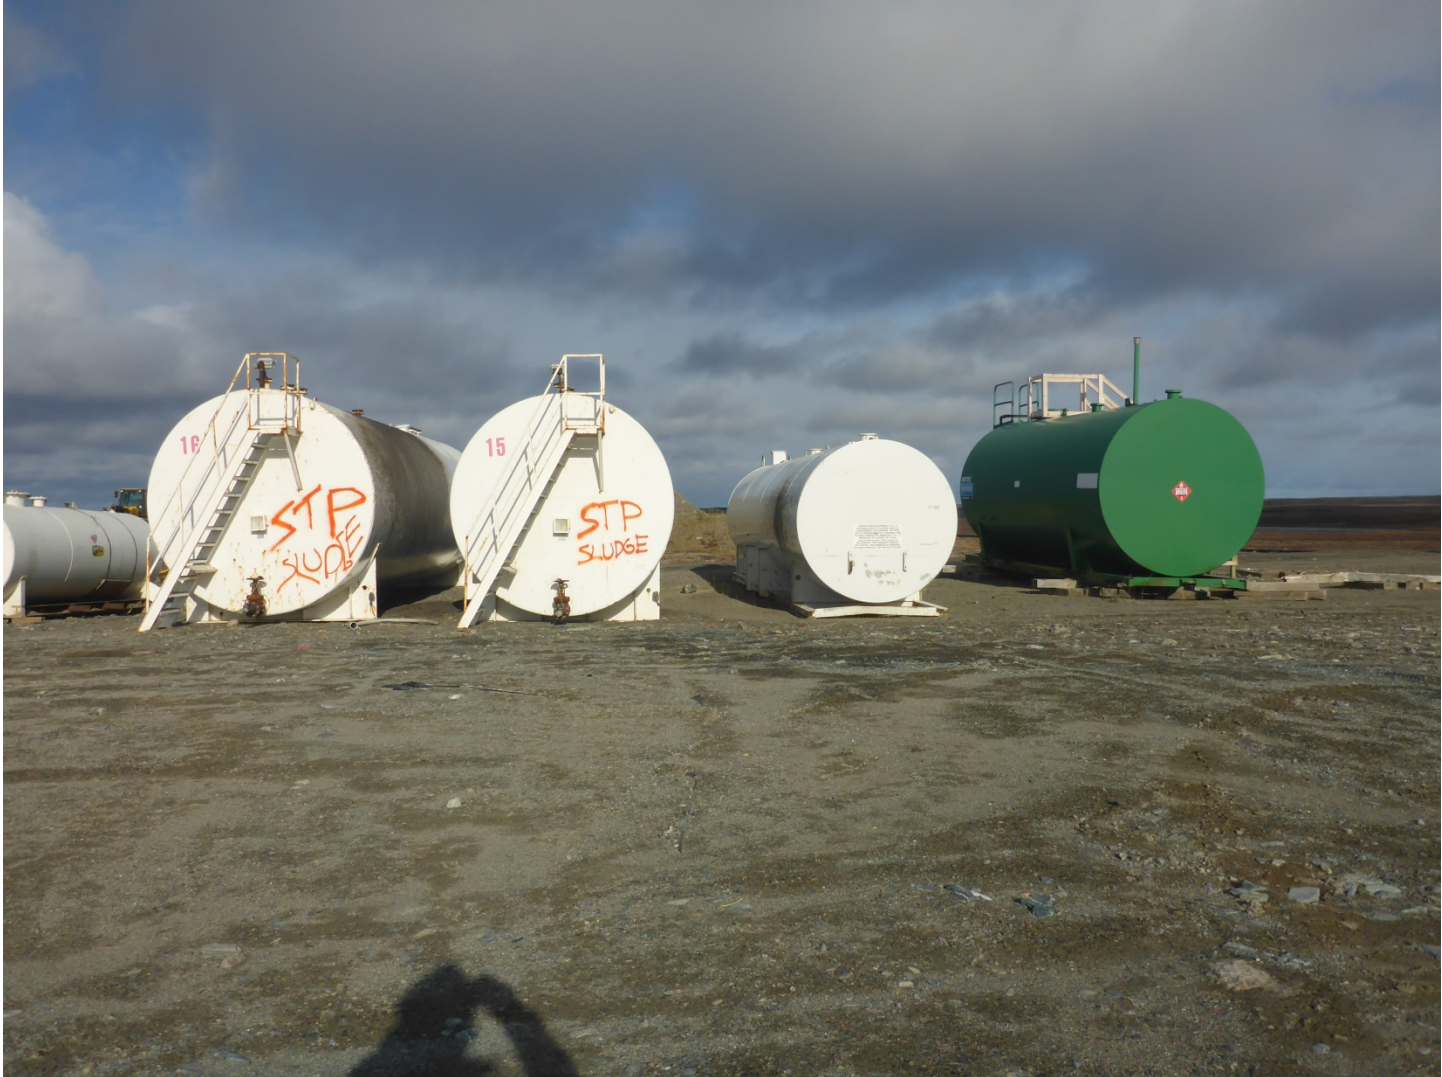
3. The old fuel farm located between the exploration camp and main camp contained 15 fuel storage tanks that were no longer in use. Three of the tanks were labeled “STP Sludge” (Photo #1). Sewage from the STP was placed within these three tanks which appeared to be overfilled during the transfer (Photo #2). The sewage had spilt under the tanks which was not reported by AEM staff. The NWT/NU spills agreement states that all spills of sewage regardless of quantity must be reported. Part H Condition 8(a) states that all unauthorized deposits of waste must be immediately reported to the spill line and to the Inspector. The Inspector explained that this spill must be reported immediately. Ms. Brown reported the spill on September 20th 2018 under spill#18-396. The contaminated material will need to be removed and disposed of in accordance with the approved waste management plan.

Description:
Overview of the old tank farm area. Note the tanks labeled “STP Sludge”

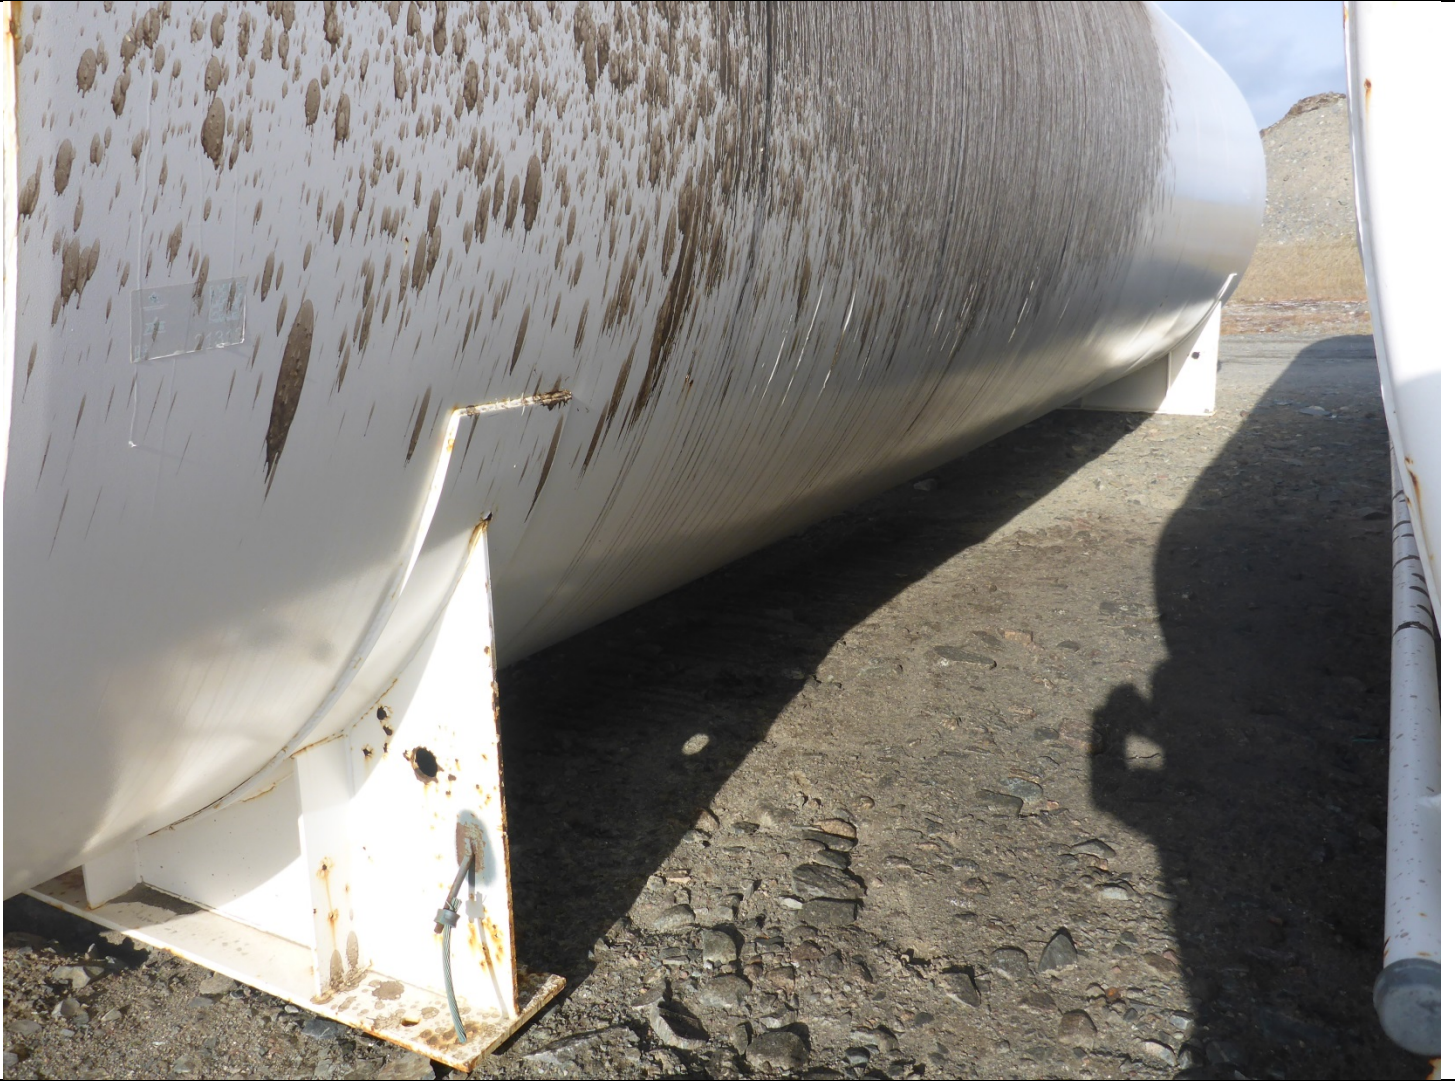
Description:
Tank locaed within the old tank farm that has been overfilled with sewage.

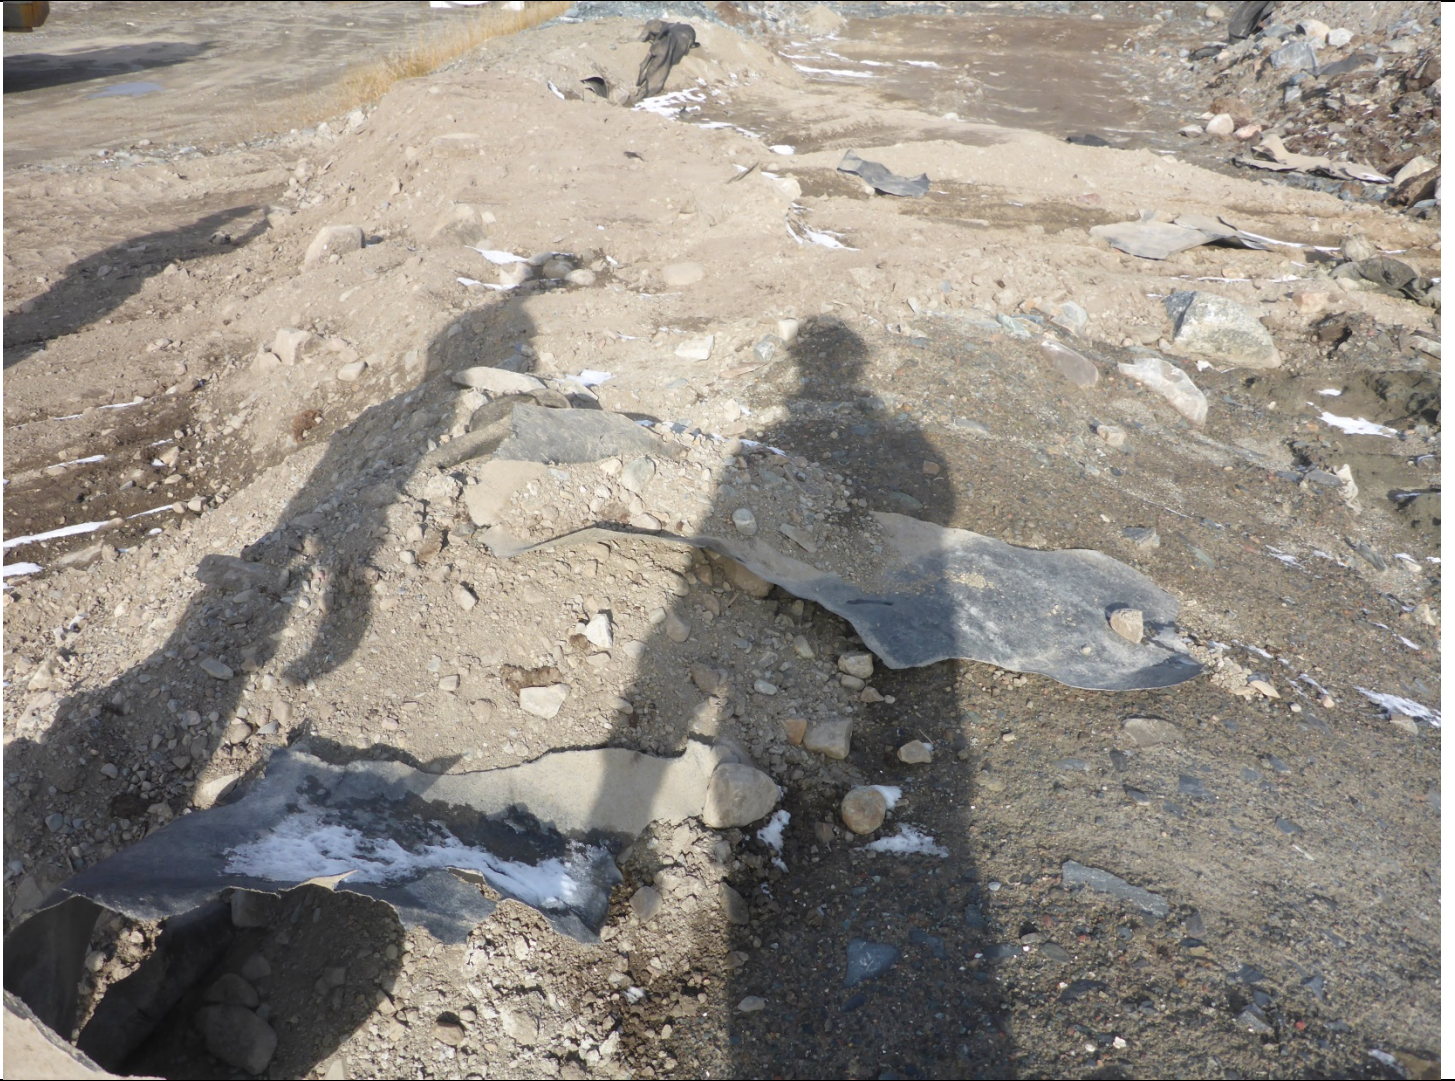
Description: Landfarm B liner appears to be torn and discontinous.
--

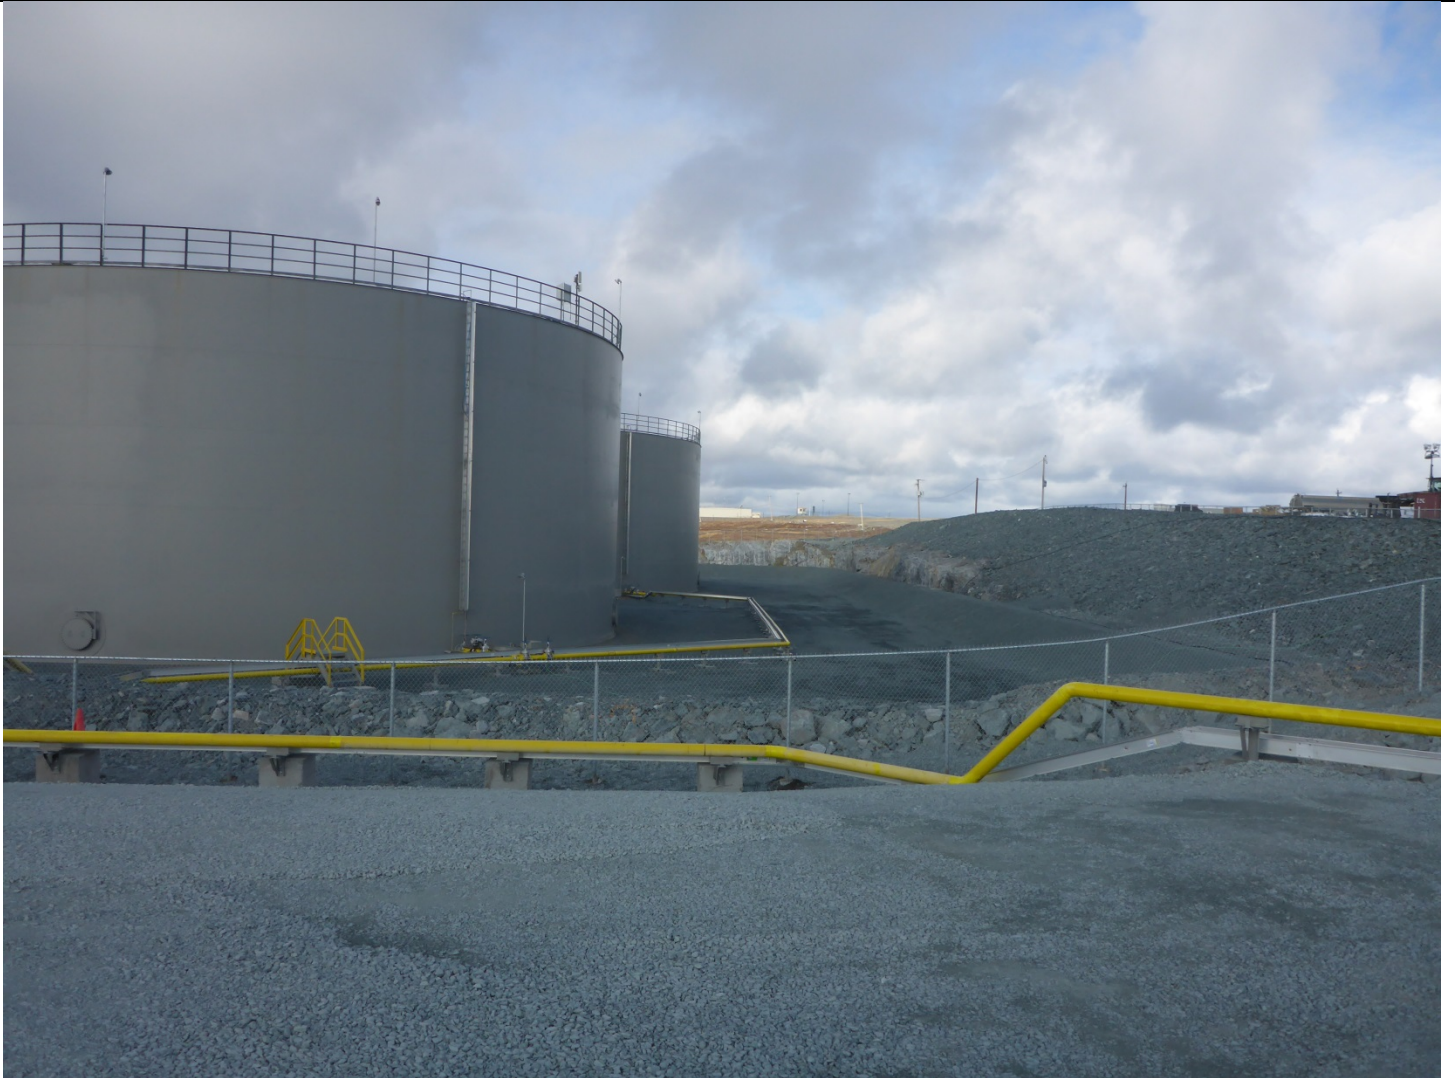
4. The Itivia tank farm located in Rankin Inlet contained one 13.5 and one 20 million liter fuel storage tanks (Photo #4). The section of piping at runs from the tank farm, under the road then to the shoreline where it connects to the offloading vessels had one 90 degree elbow that was not double walled. AEM had excavated around the piping to ensure that the piping did not come into contact with the ground. The Inspector was notified on October 9th 2018 that the piping is now double walled and pictures were received to confirm the work.

Description:
Overview of Itivia tank farm.

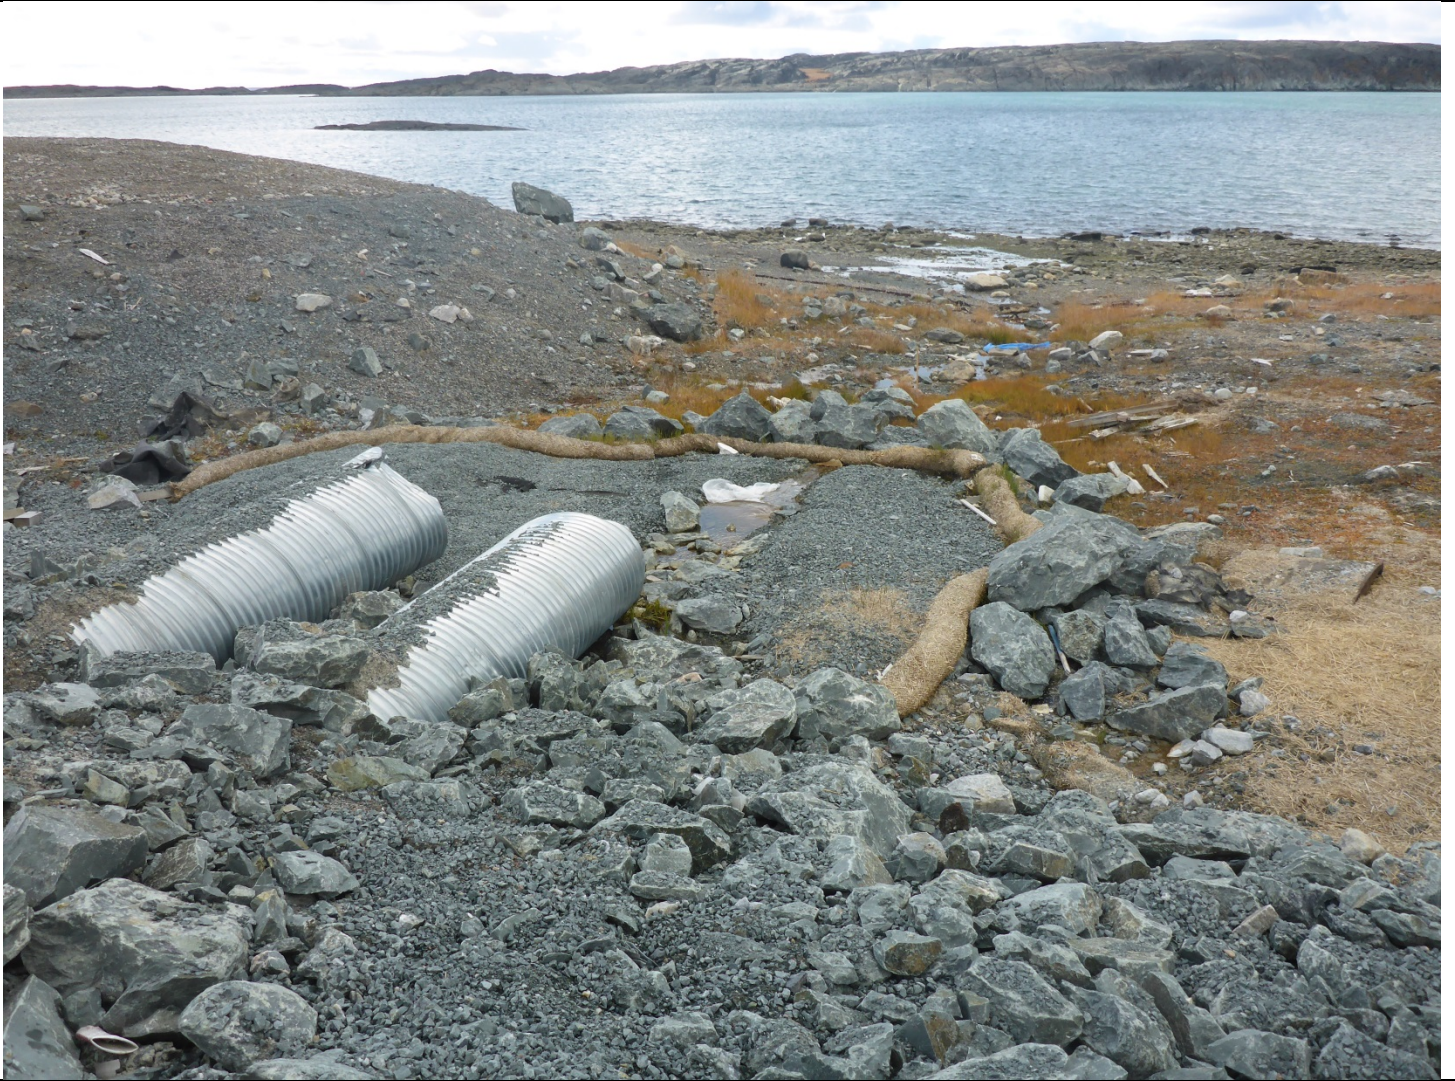
Description:
Freshet discharge location located east of the Itivia tank farm.

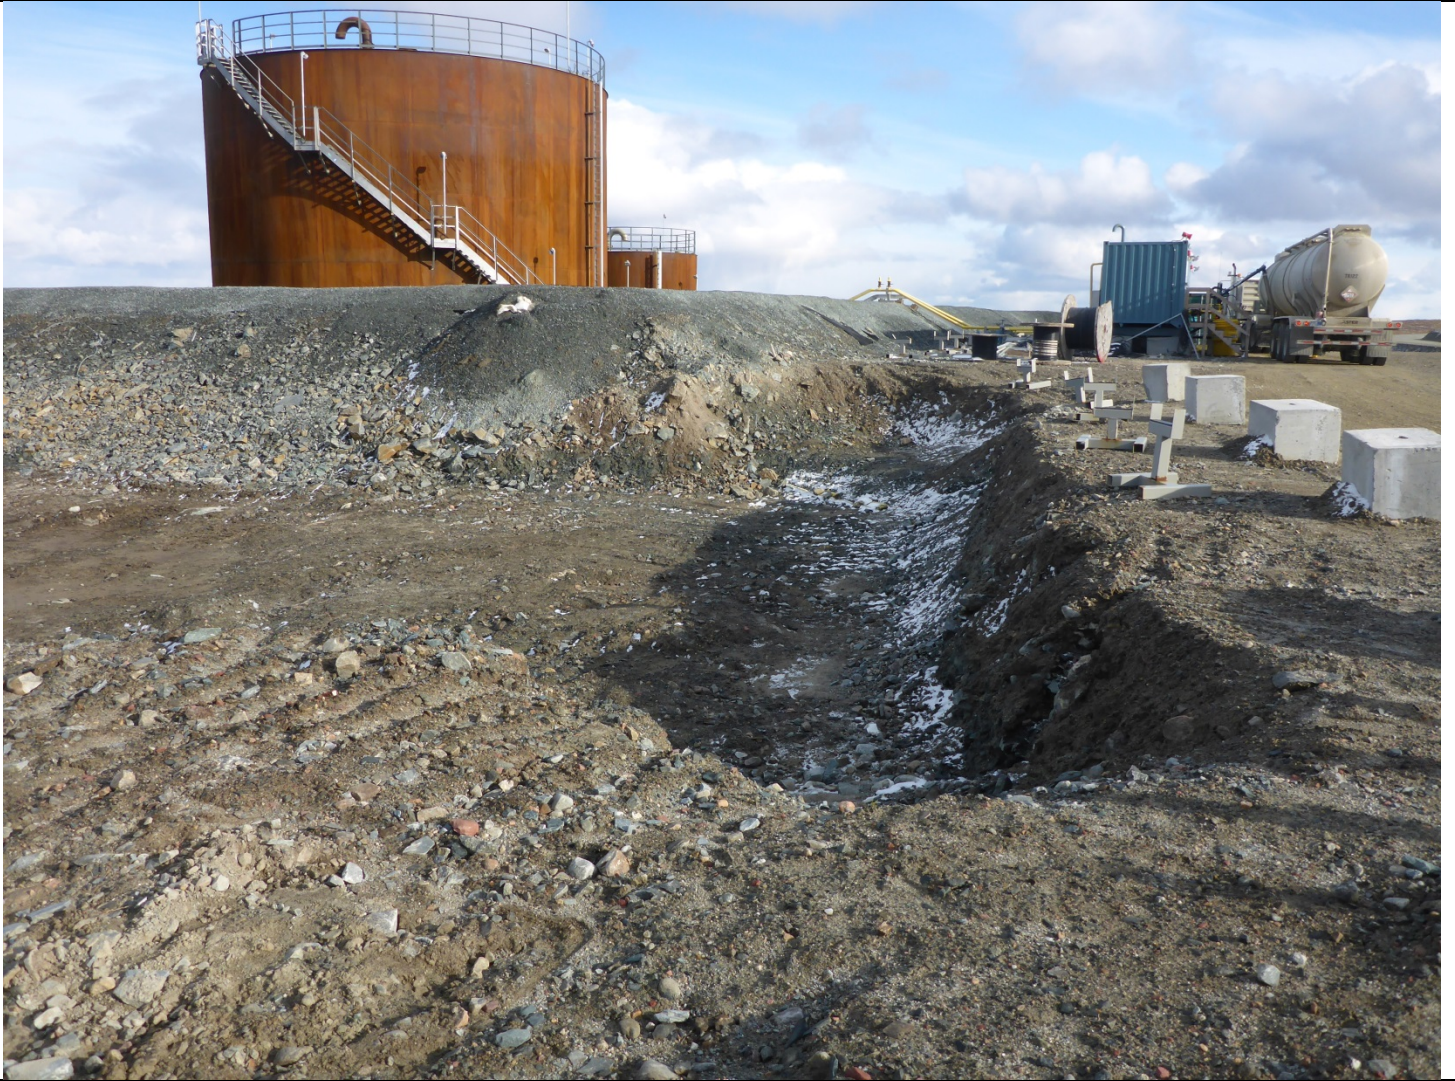
5. The Portal 1 tank farm excavation of the contaminated material was not complete at the time of the inspection (Photo #6). The spill occurred on January 2018 when 6,000 liters of fuel was released outside of the secondary containment berm. Ms. Brown explained that the water entering the excavated area is monitored daily and sent to the oil water separator.

Description:
Location of the Portal 1 tank farm spill excavation.

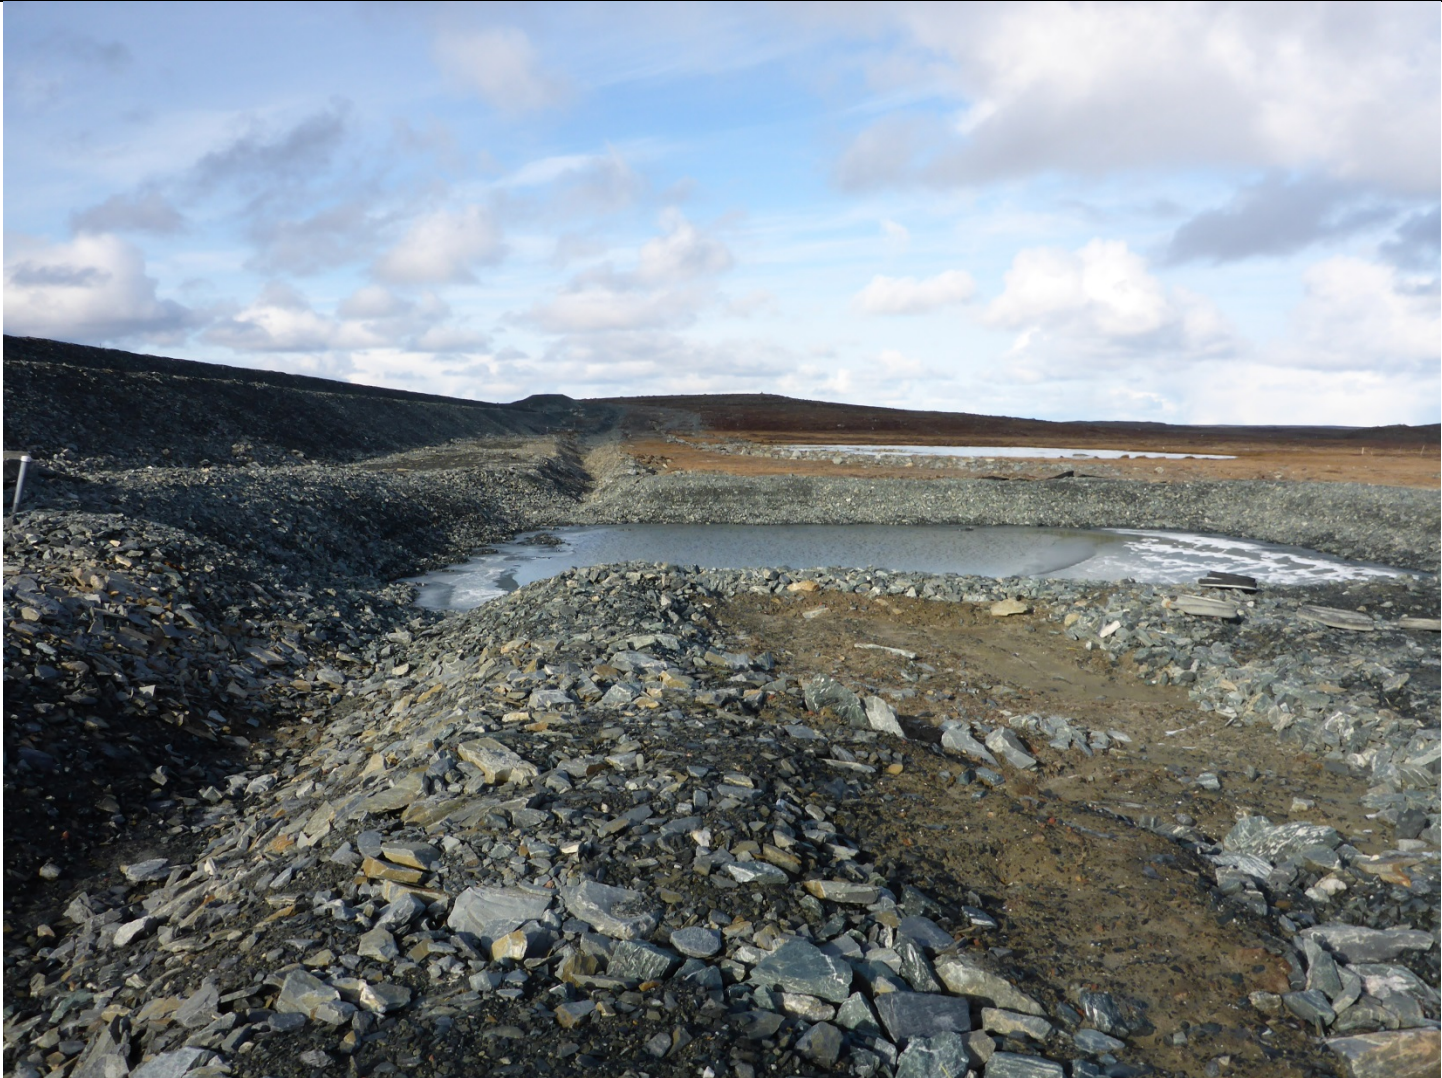
6. The D-CP1 trench is designed to collect all seepage from CP1 and includes a sump where any seepage is pumped back into CP1 (Photo #7). No seeps from CP1 were noted during the inspection and the sump appeared to have at least two meters of freeboard.

Description:
Overview of the D-CP1 trench.

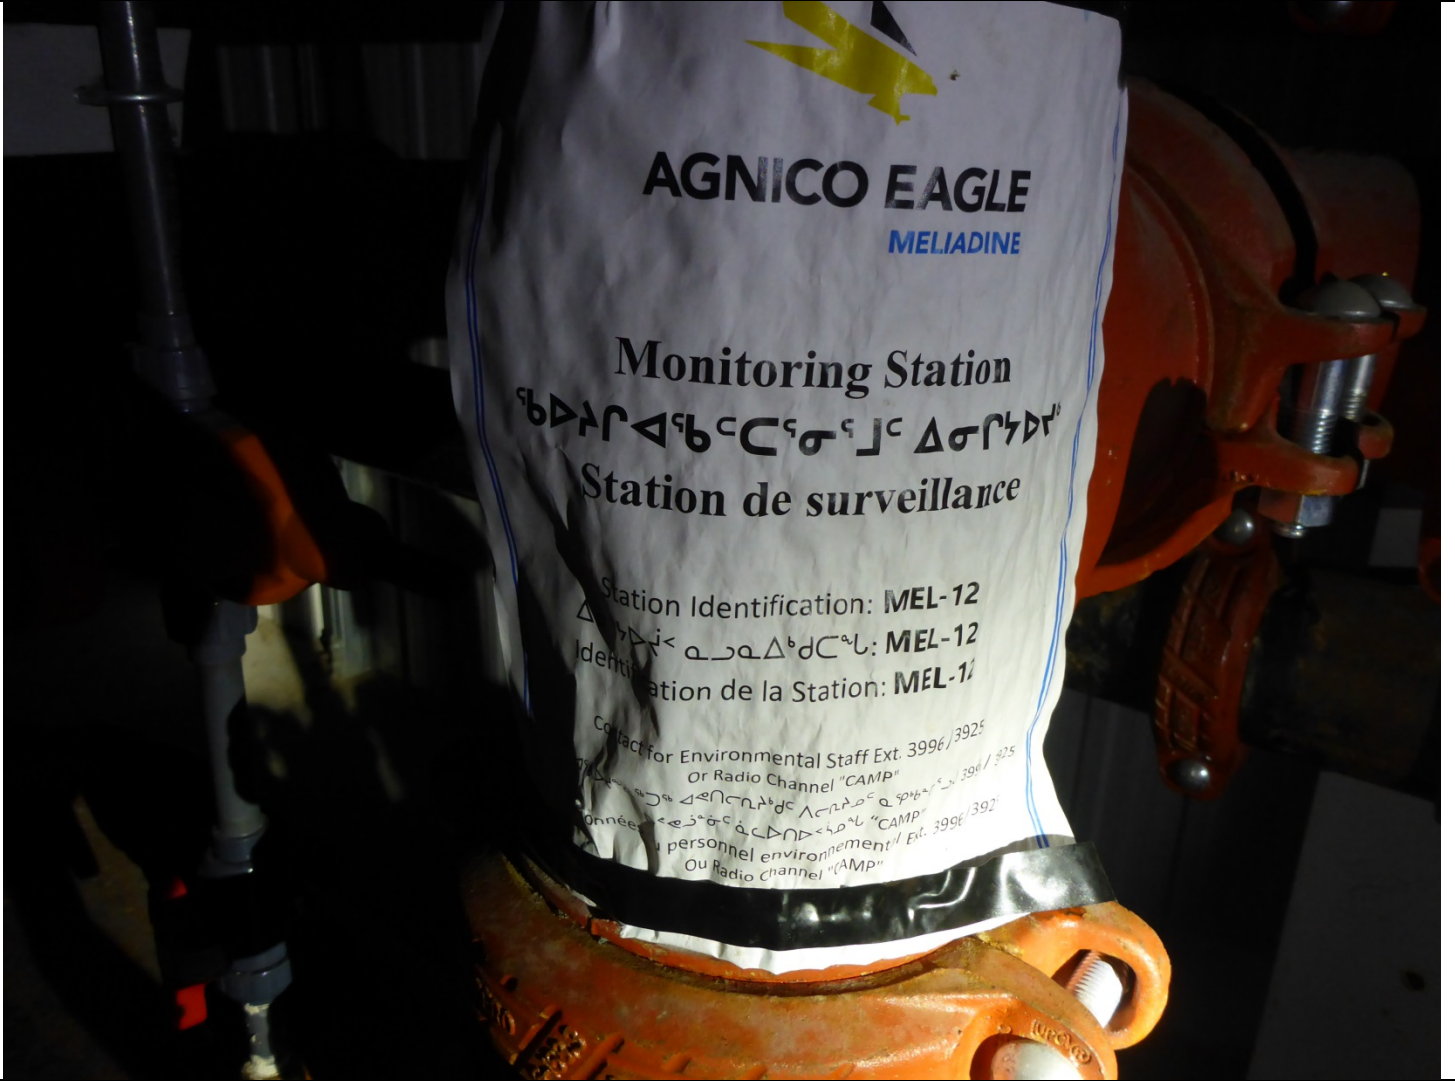
7. No samples from MEL-14 were taken during the inspection as the discharge ceased on September 3rd 2018. The sampling locations were appropriately labeled (Photo #8).

Description: MEL-12 discharge location signage.

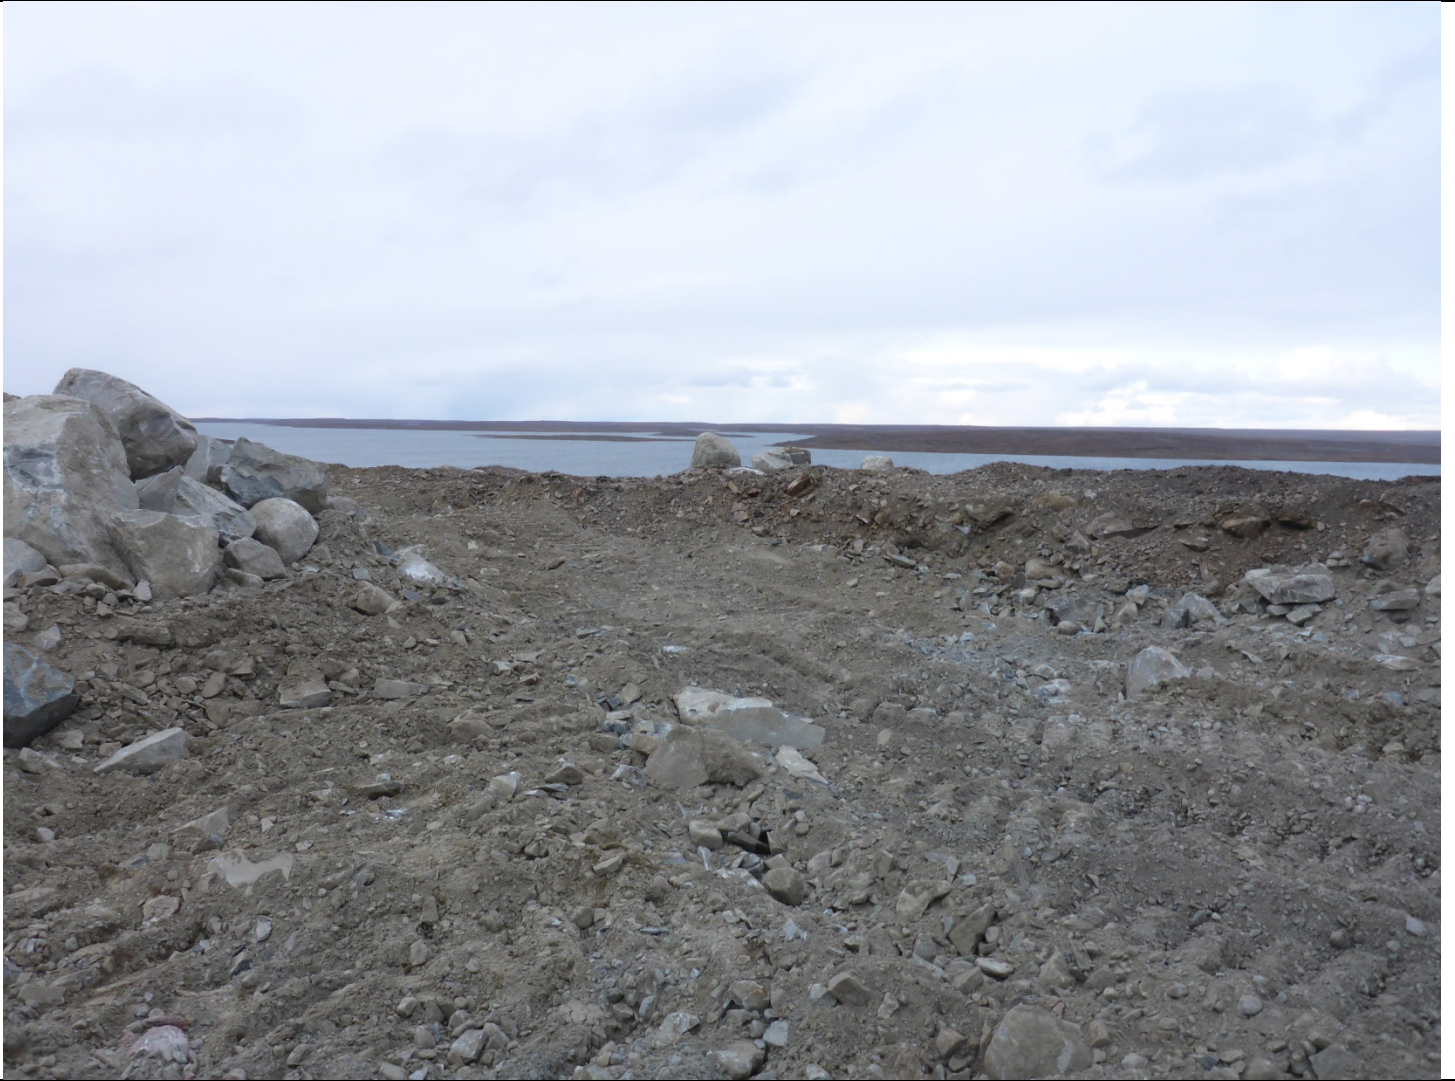
10. There were no concerns noted with Mel Esker quarry at the time of the inspection. The quarry itself was set well back from G2 and Meliadine Lakes and contained no standing water (Photo #9).

Description:
MEL esker quarry overview.

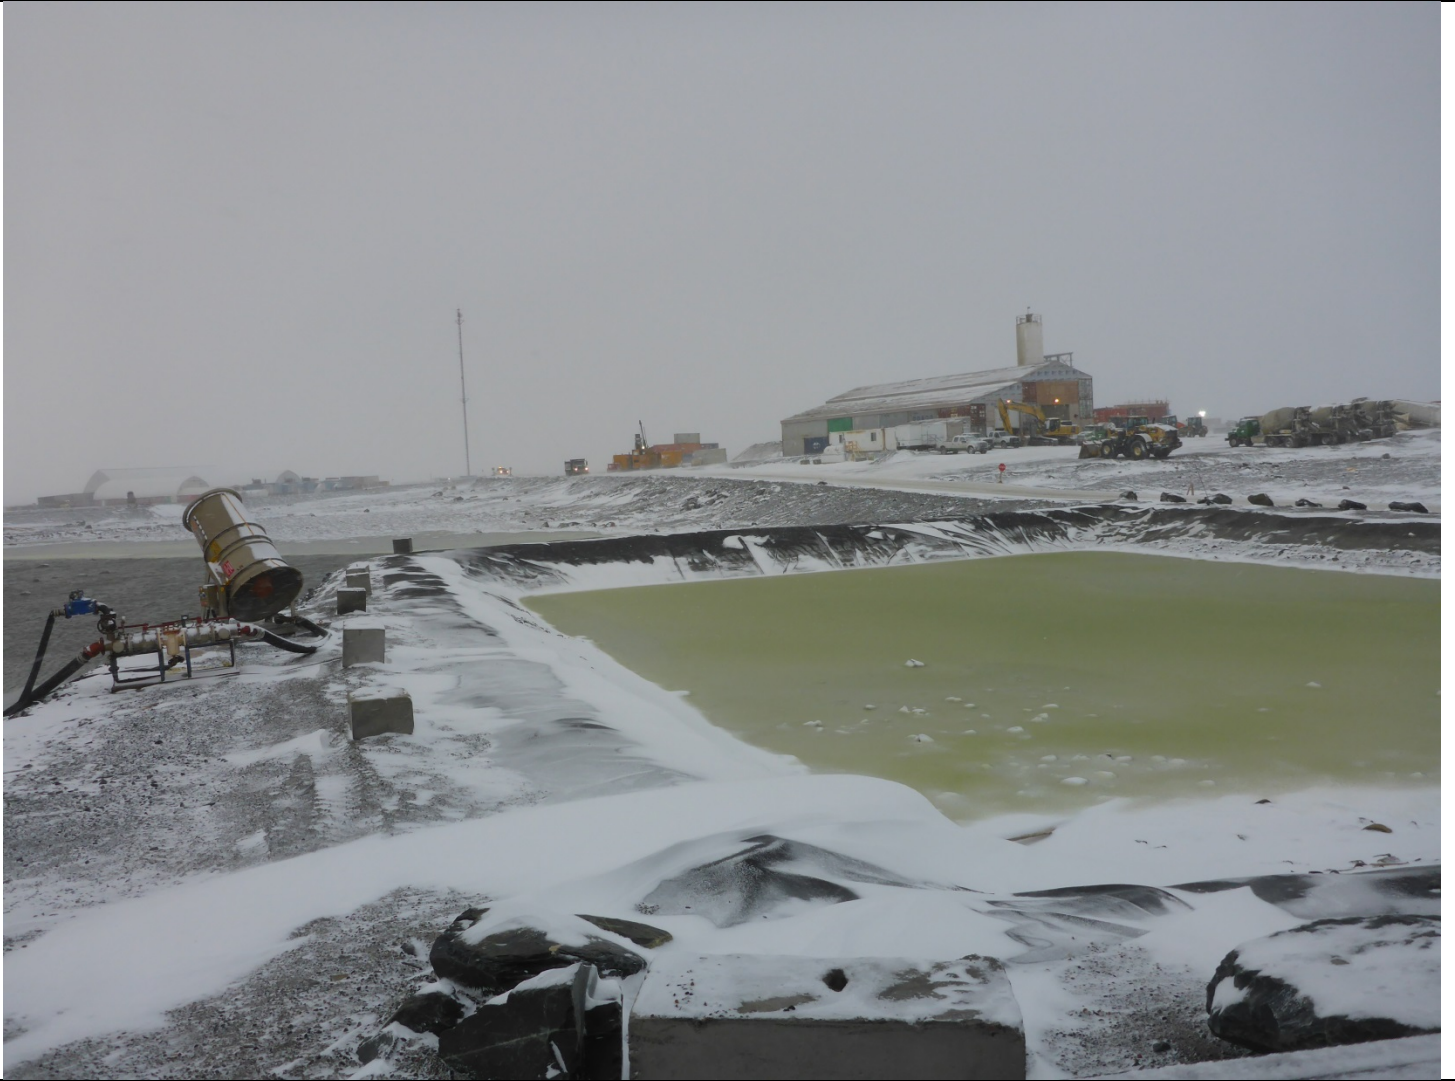
12. Any contact water from the site that is high in TSS is reported to P1 and any water that is contaminated with hydrocarbons is sent to the snowcell (Photo #10). The salt treatment plant will be completed in December 2018 and will discharge to CP1.

Description:
Overview of the snowcell and P1 pond.

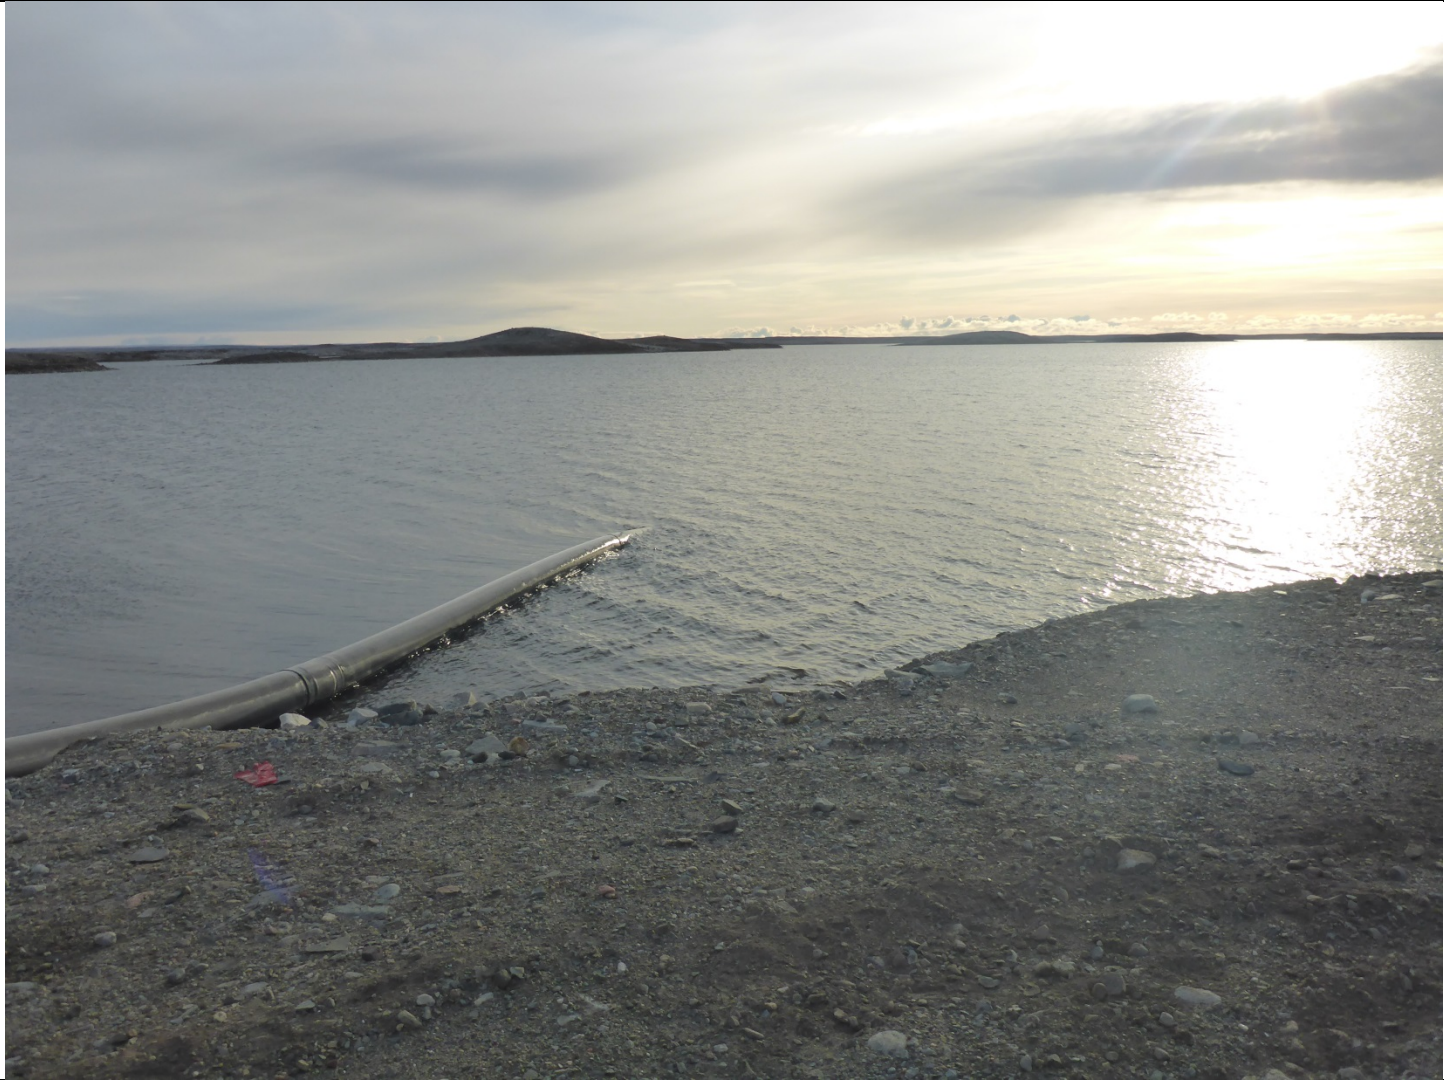
1. The effluent diffuser ceased discharge on September 3rd 2018 and is not expected to resume until the spring/summer of 2019 (Photo #11). The diffuser is located in the middle of Meliadine Lake east of the exploration camp. The discharge line runs from EWTP MEL-14 along the all season access road past the exploration camp and out to Meliadine Lake.

Description:
Overview of MEL-13 discharge line entering Meliadine Lake.
