WATER LICENCE INSPECTION FORM

Licensee	Licensee Representative
Agnico-Eagle Mines Limited	Jennifer Brown
Licence No. / Expiry	Representative's Title
2AM-MEL1631 / March 31st 2031	Environmental Coordinator
Land / Other Authorizations	Land / Other Authorizations
--	--
Date of Inspection	Inspector
April 10-11, 2019	Jonathan MESHER
Activities Inspected	
<input checked="" type="checkbox"/> Camp	<input type="checkbox"/> Drilling
<input type="checkbox"/> Roads/Hauling	<input checked="" type="checkbox"/> Mining
	<input type="checkbox"/> Construction
	<input type="checkbox"/> Reclamation
	<input checked="" type="checkbox"/> Fuel Storage
	<input type="checkbox"/> Other:

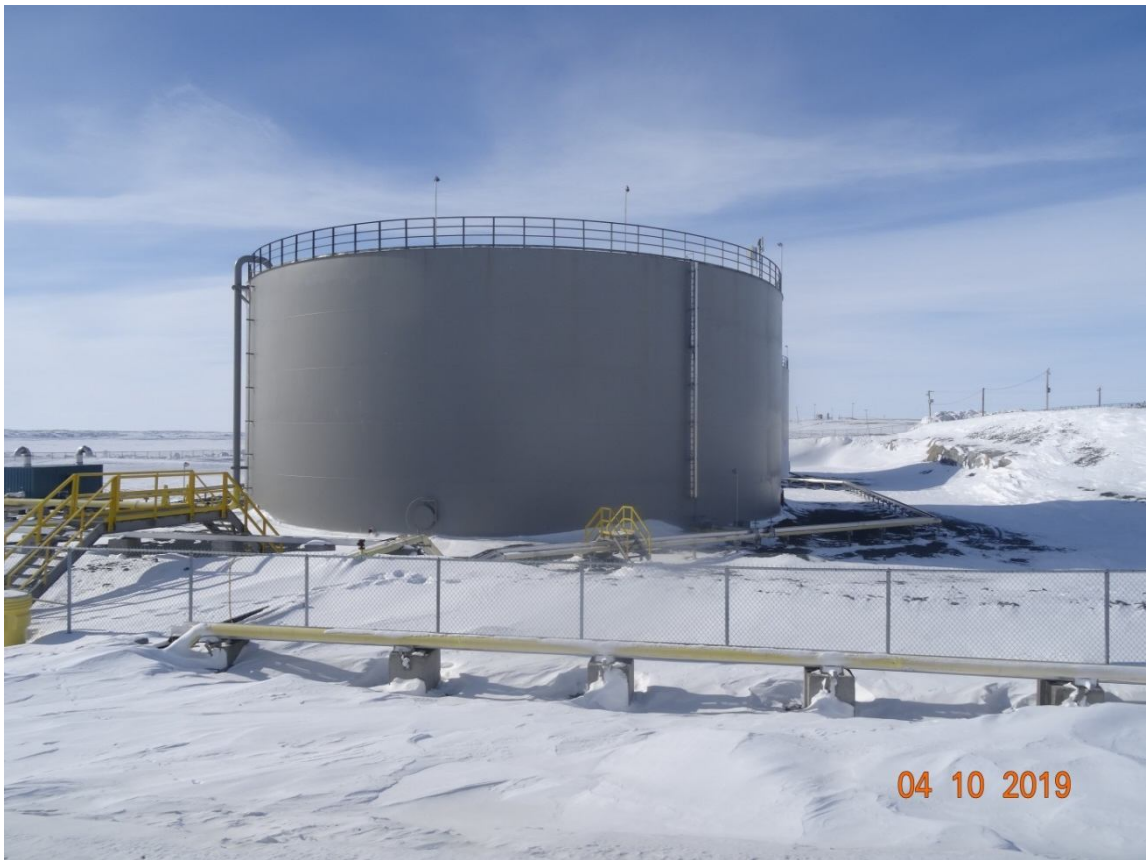
Photo #1: Itivia Fuel Storage

Inspection			
1. Itivia Fuel Farm			
a) At the time of the inspection the Itivia fuel farm was mostly snow covered, making it difficult to determine if the facility was built to the approved design and identify any potential issues, see Photo #1 for a picture of the Itivia fuel farm.

b) While at site the inspector questioned the licensee about where they deposit the water that accumulates in the facility. The licensee deposits the water approximately 25m from the Arctic Ocean. Due to the deposits location to the ocean, the licensee was made aware of the prohibitions and the required approvals described in the Arctic Waters Pollution Prevention Act regarding deposits to the Arctic Ocean.

c) No concerns were noted at the time of the inspection, a freshet inspection will be conducted to the see the facility at peak flow and to identify any potential concerns.

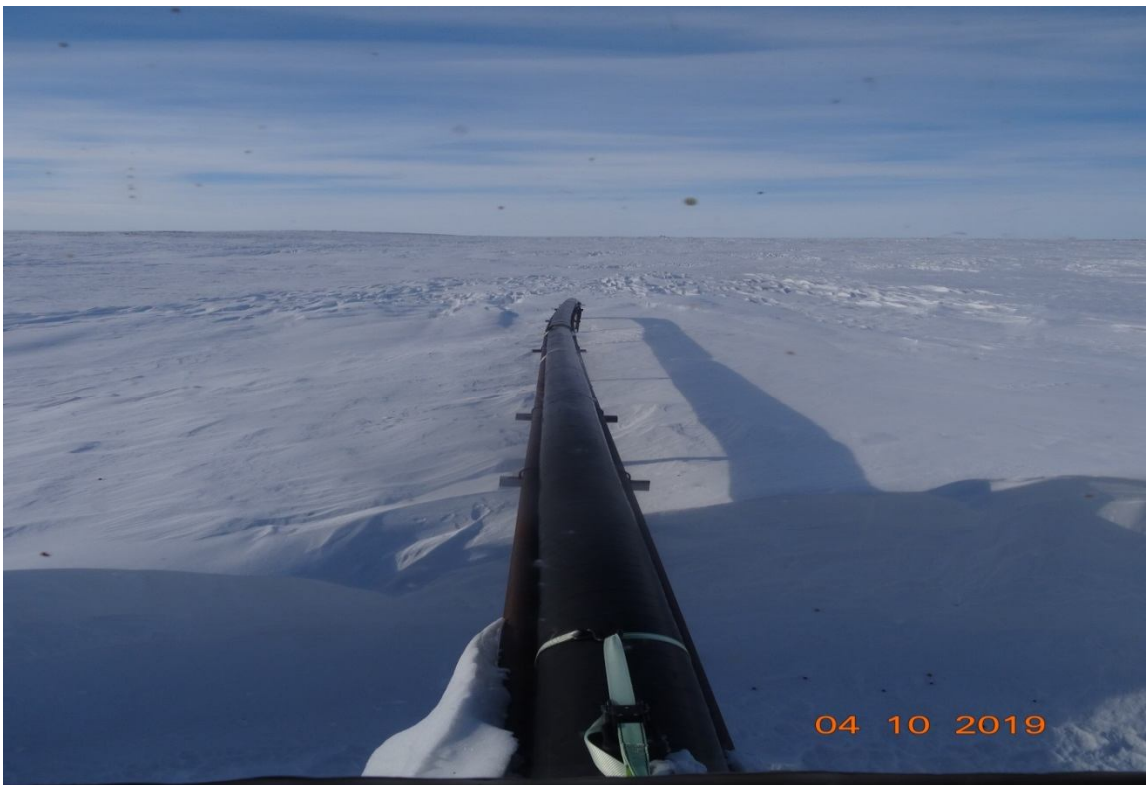
Photo #2: Raw Water Intake

3. Raw water intake (MEL-11)
 - a) The facility and the sampling location were both clearly labeled.
 - b) The flow meter appeared to be operating as intended and water usage records were made available to the inspector.

- c) No concerns were noted at the time of the inspection; see Photo #2 for a picture of the intake pipe.
4. Landfill
 - a) During the inspection it was noted that used coffee cups were located in the Landfill, Section 4.4 (Waste Unacceptable for placement in the landfill), page 12, of the document labeled Landfill Waste Management Plan- 2015. The list in section 4.4 includes cardboard, food containers and wrapping as unacceptable food waste.

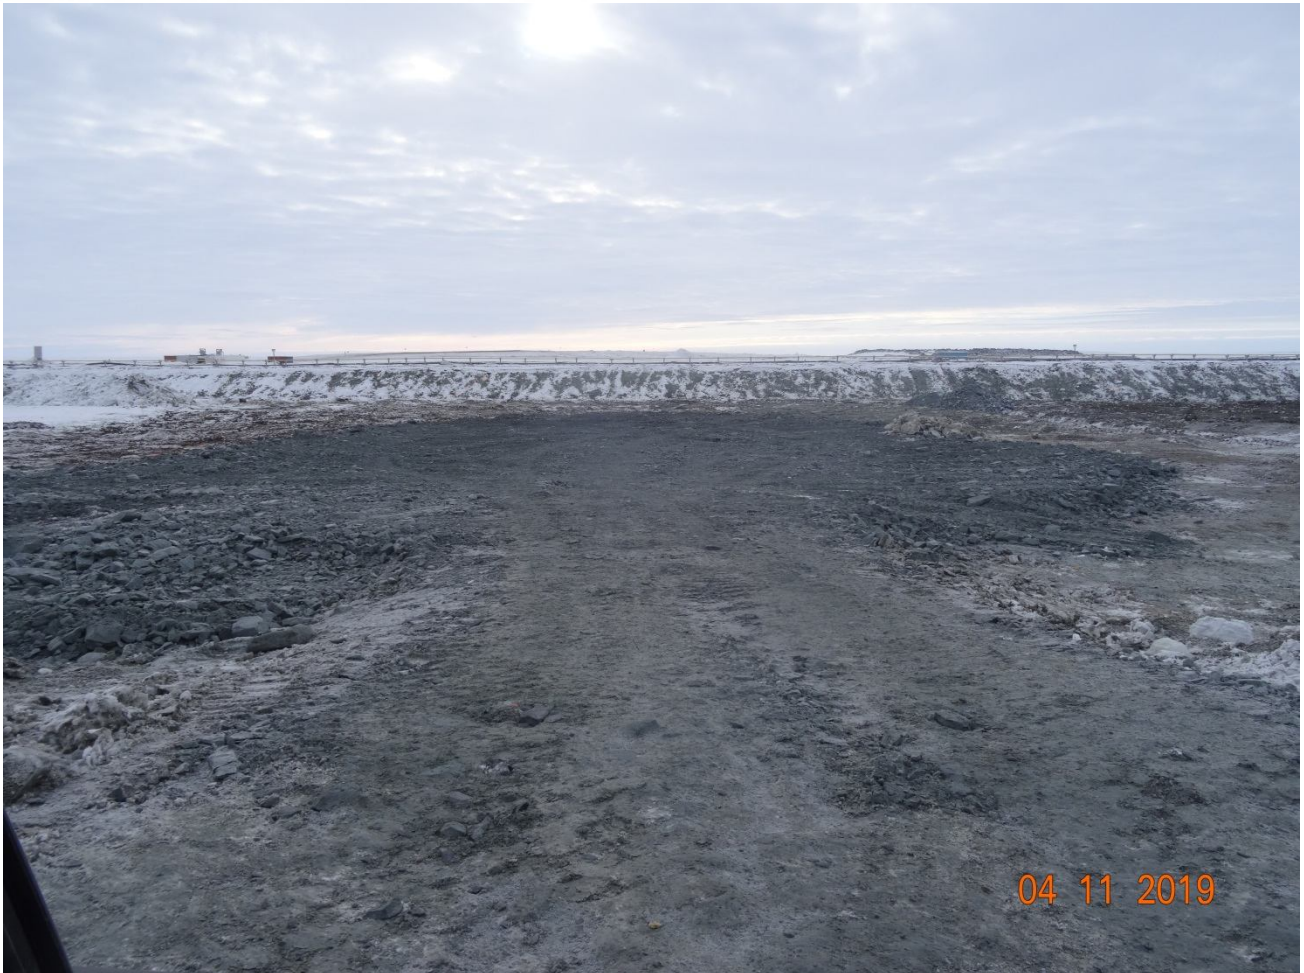
Photo #3: Waste Rock Stockpile Pad Construction.

7. Waste Rock Stockpile Pad
 - a) At the time of the inspection the licensee was constructing the Waste Rock Stockpile Pad; no concerns were noted regarding the construction of this structure. See Photo #3 for a picture of the Waste Rock Stockpile pad.

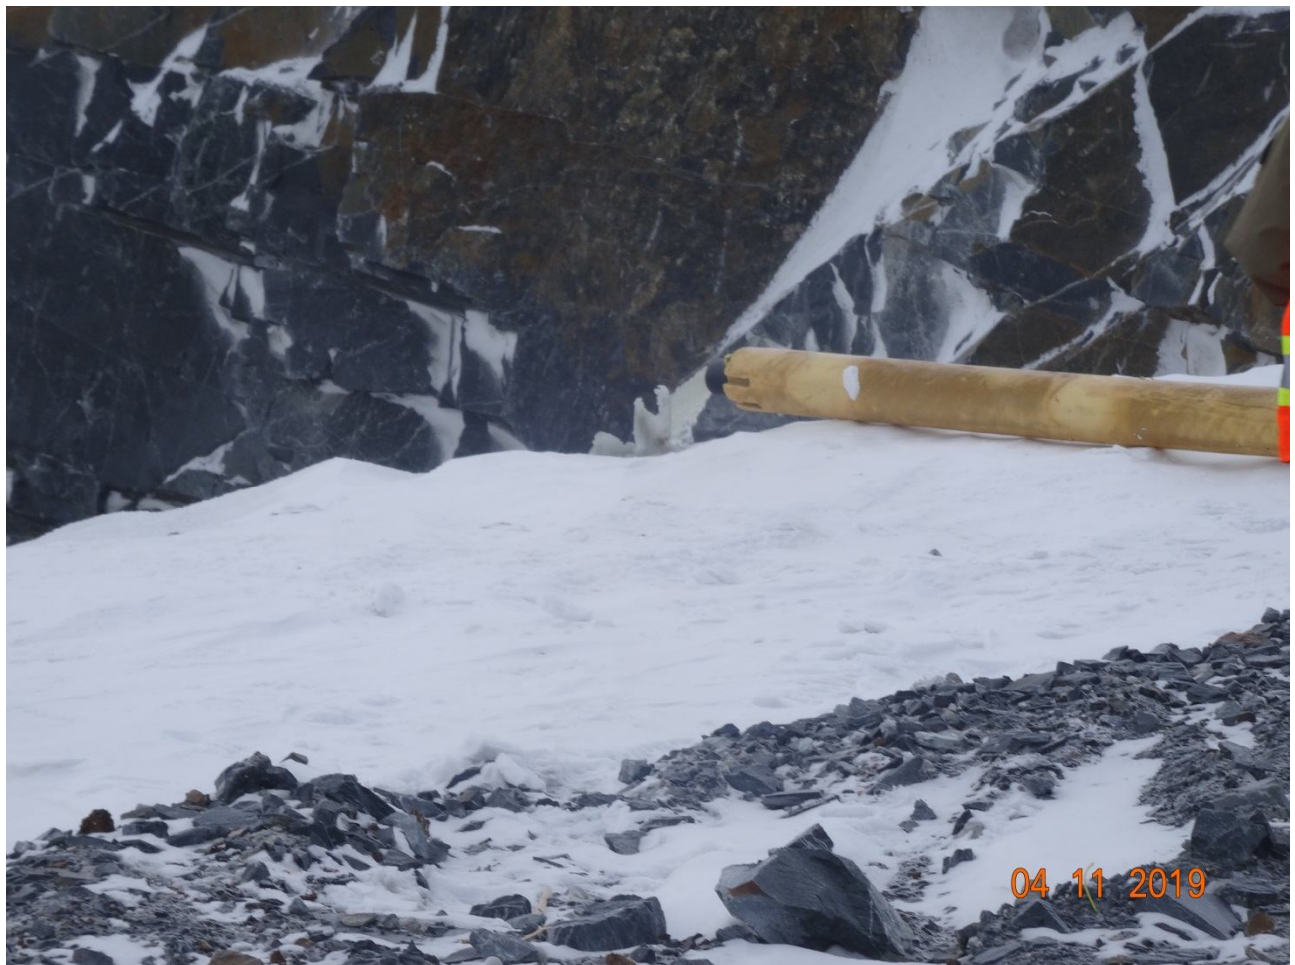
Photo #4: Saline Water Deposit.

5. Saline pond
 - a) During the inspection the Saline pond was receiving water from the underground mine. No concerns were noted, the snow cover made it difficult to identify any potential issues or concerns. See Photo #4 below for a picture of the saline water being deposited
