Freshet Inspection Report

Location: Itivia, Bypass Road, AWAR, Mine Site, Exploration Camp

DATE : 2019-04-19

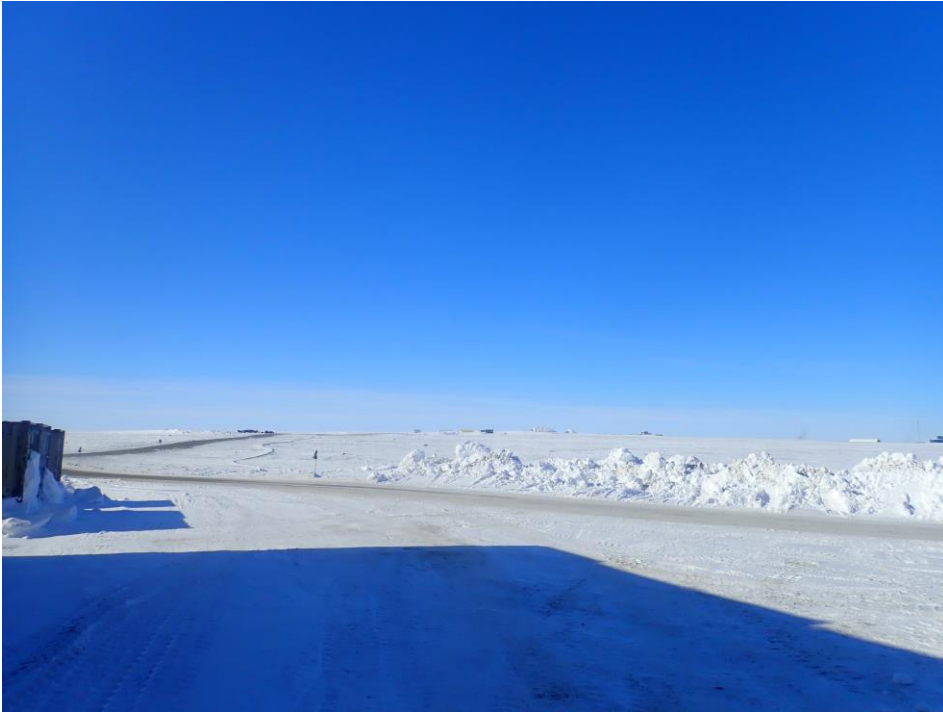
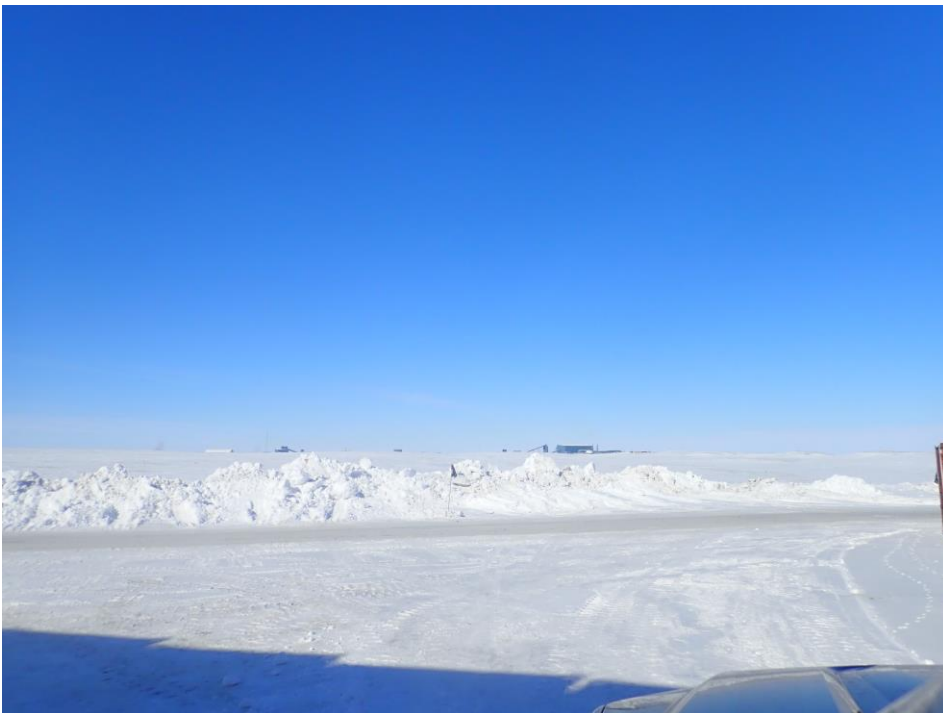
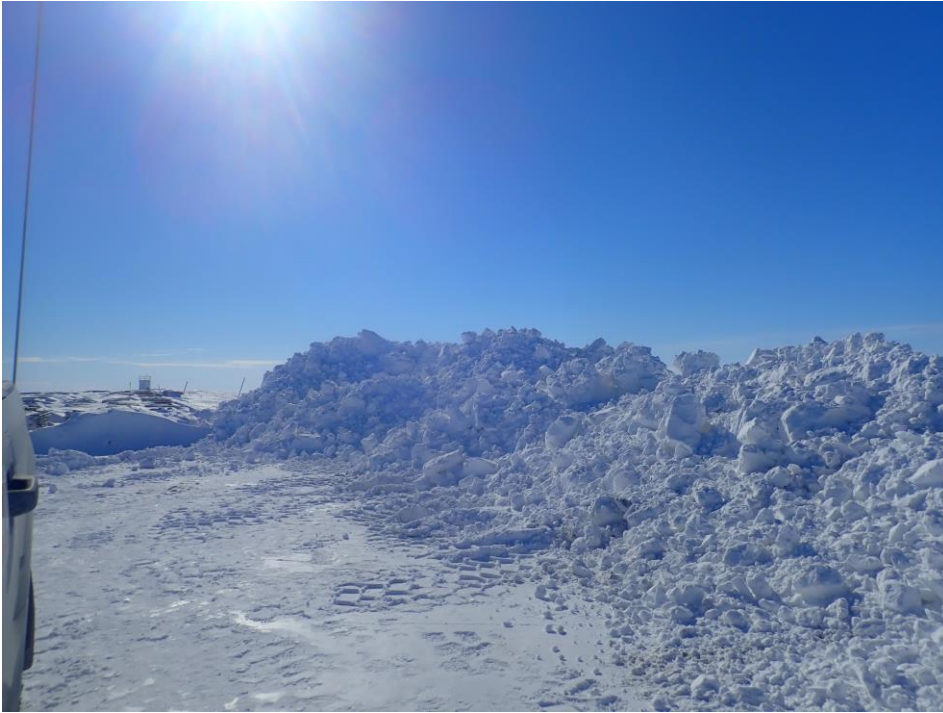
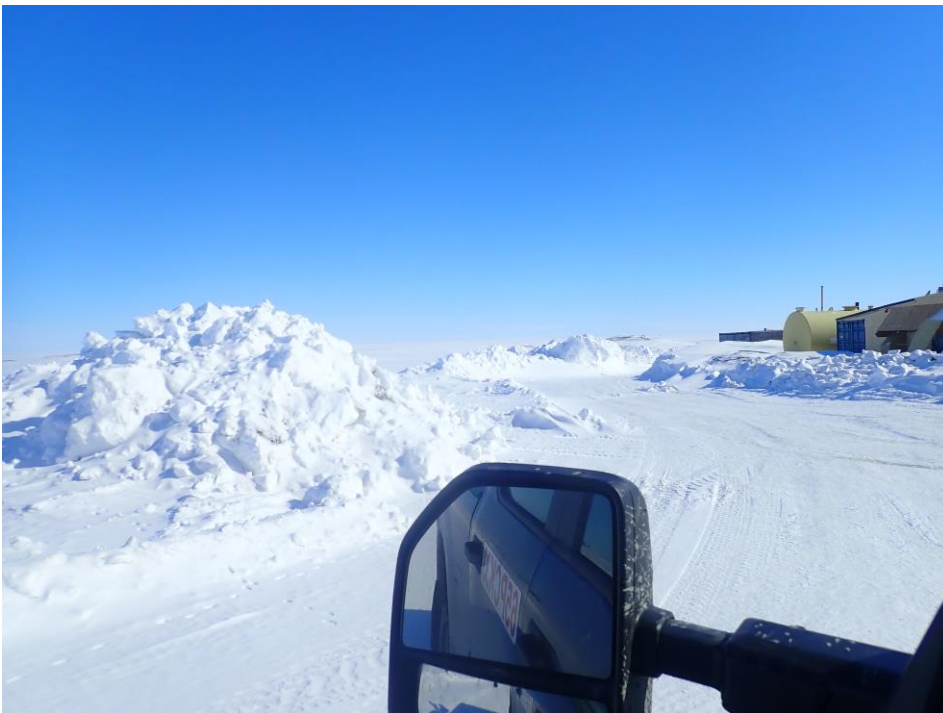
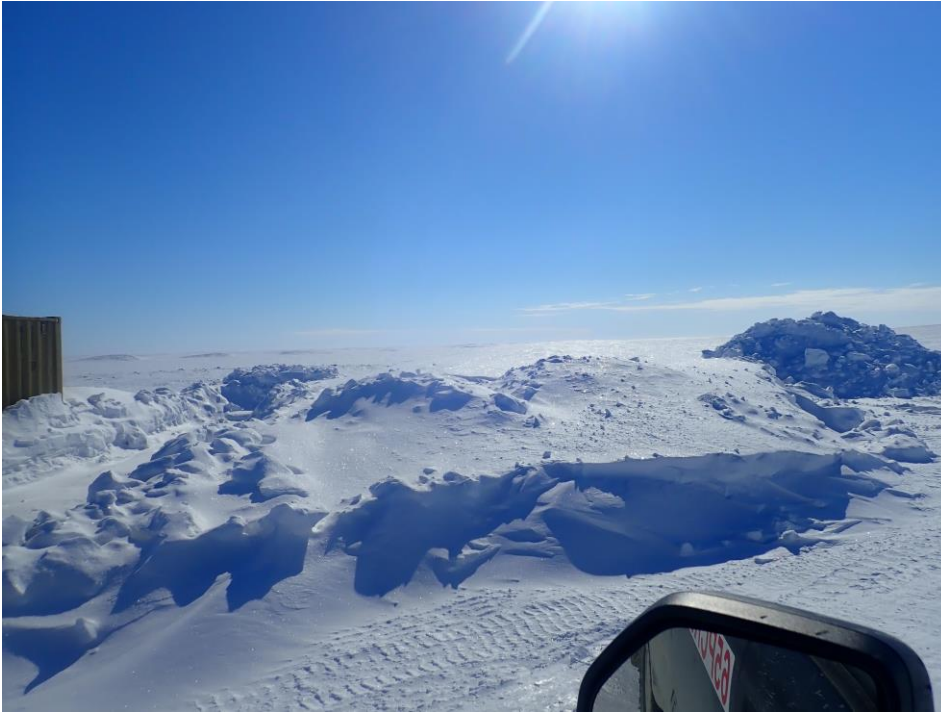
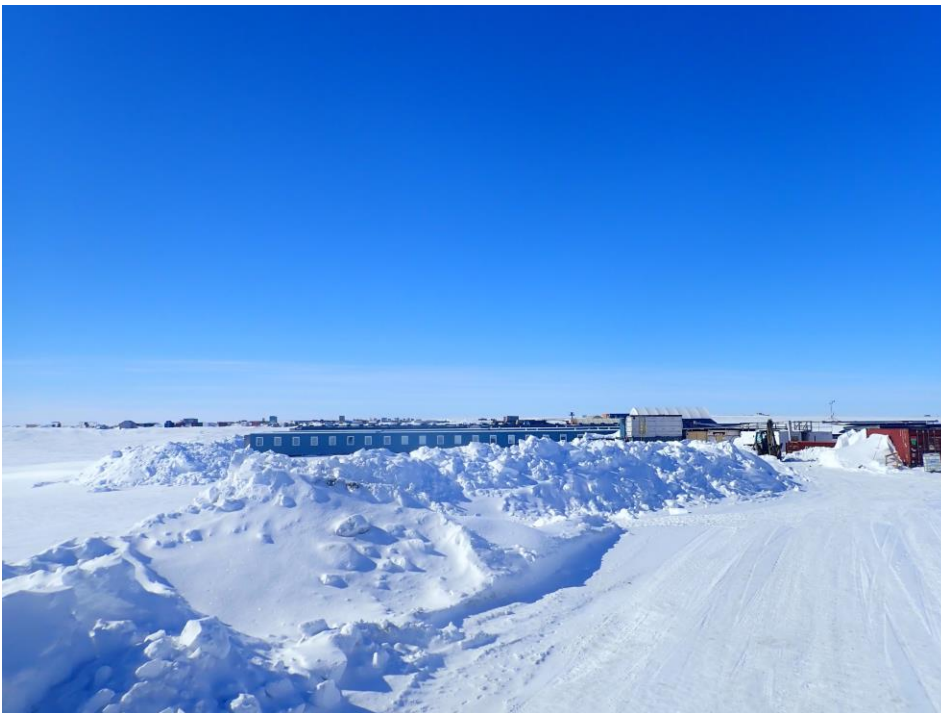
- Snow-piles: North side of explo laydown road; core box road; all areas surrounding camp; generator area
- Snow drifting against most structures on interior side of road, poses risk of draining across road towards Mel Lake
- Good padding at tire laydown

- Flatten snow-piles into pads
- Clear snow drifts next to structures
- Monitor areas for high instances of drainage across access roads

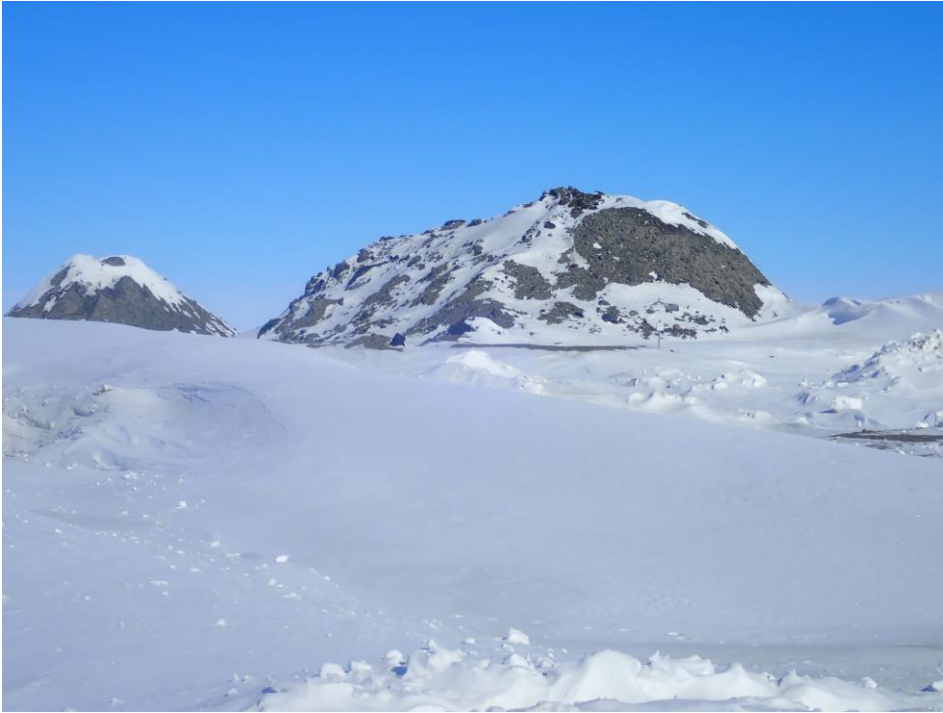
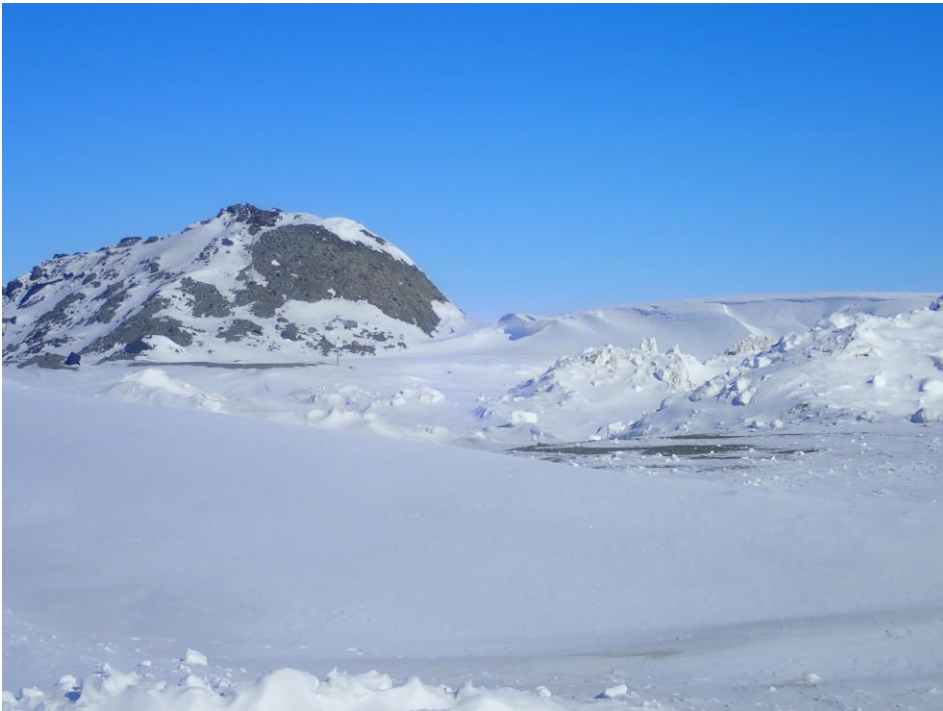
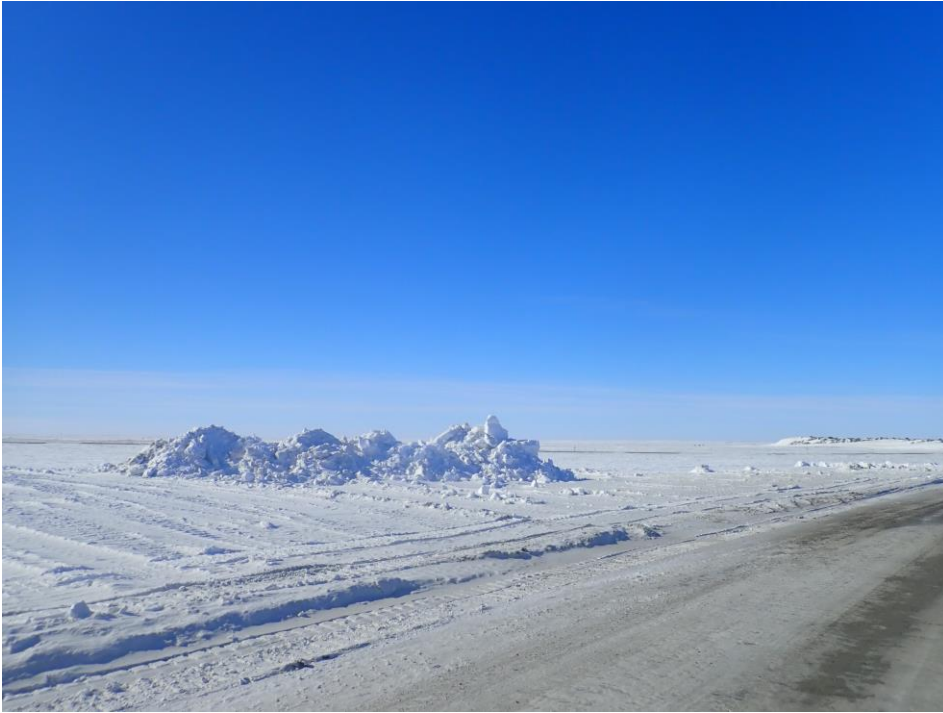
Observations: Some snow in in landfarm B? Large drifts between tanks.

- Large drifts between fuel tanks and adjacent/connecting to Landfarm B pile
- Lone stockpile across road

- Remove excessive drifting with small equipment, flatten into pads across road or adjacent to Landfarm/Fuel Farm
- Continue monitoring for runoff and inundation within containment

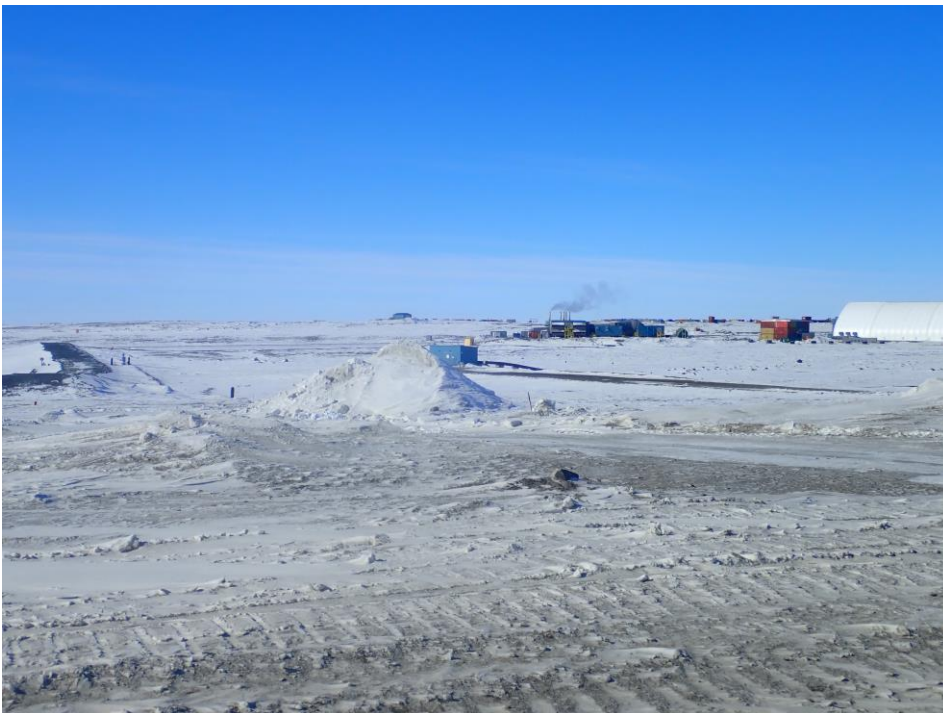
Figure 10

- Small stockpile of snow to the east of D-CP5, next to access road
- No water observed
- Large snow drifts on downstream D-CP5 toe

- Flatten snow piles into pads
- Remove snow accumulation on downstream D-CP5 toe

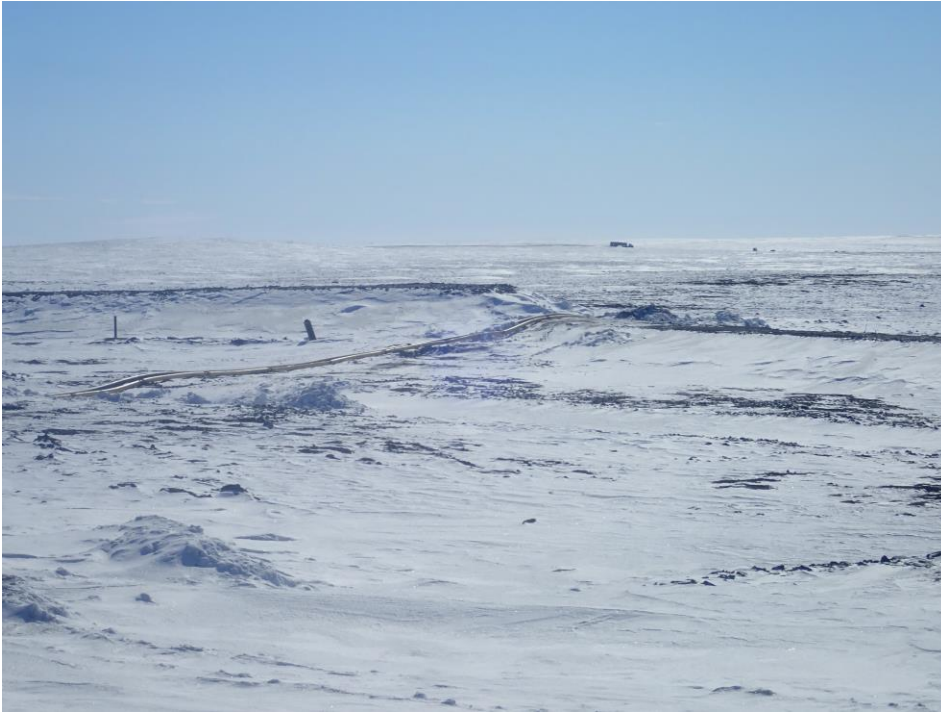
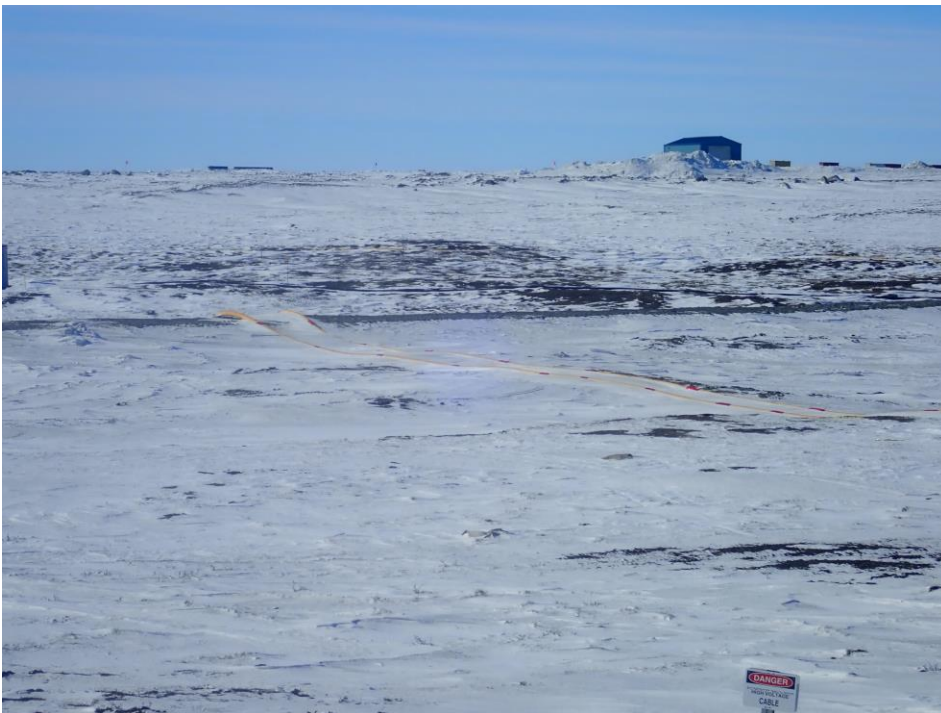
- 2 Sets of yellow lay-flat lines running across Channel 5/Berm 3
- No water observed or blockage risks

- Determine if lay-flats are acceptable in their location and won't generate snow/ice-damming

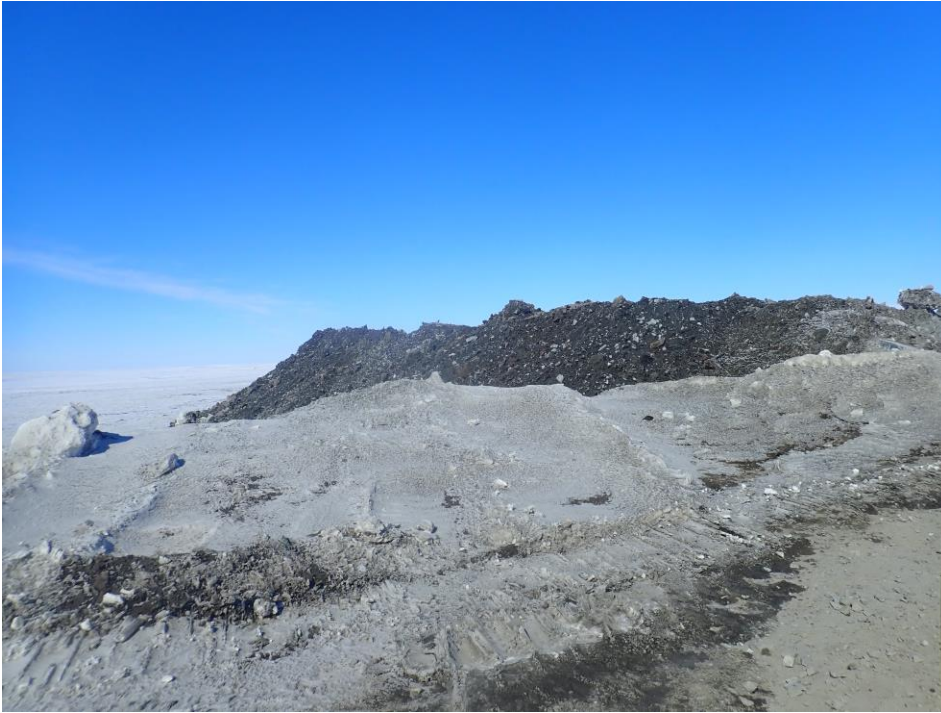
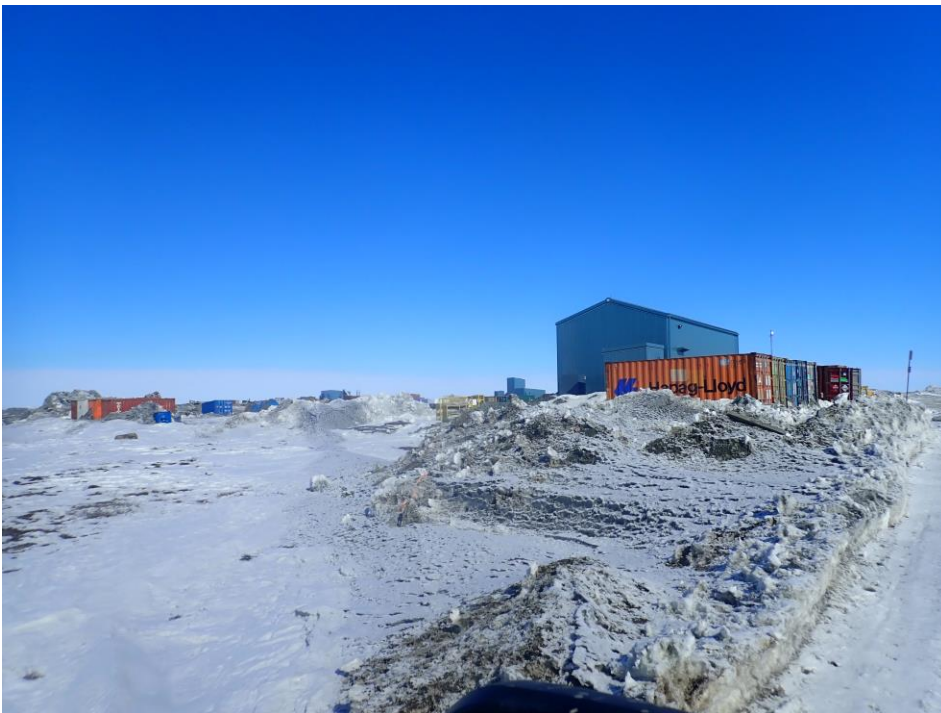
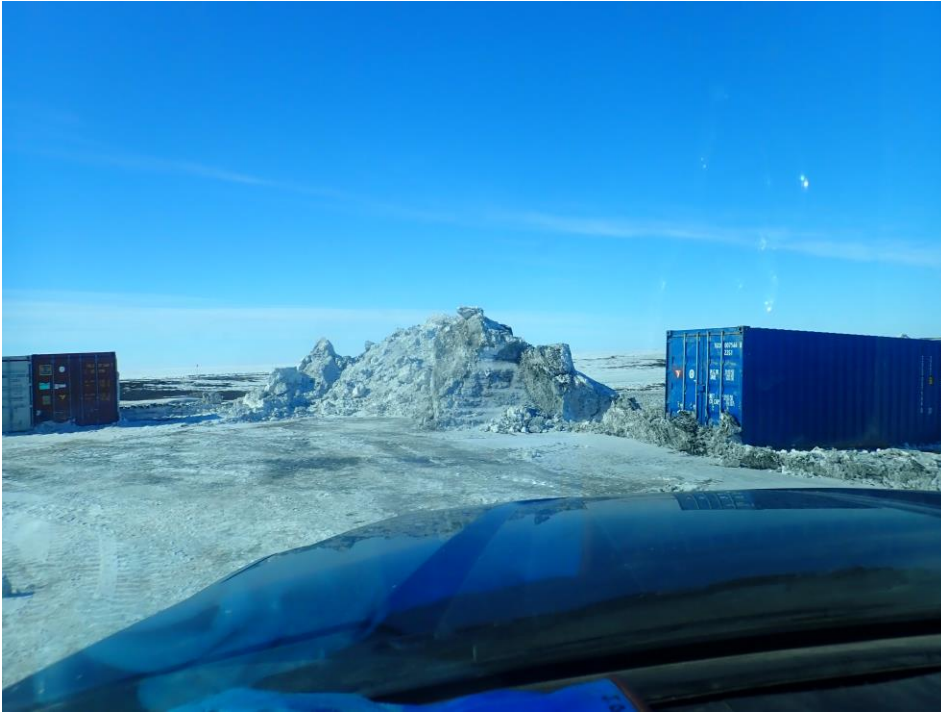
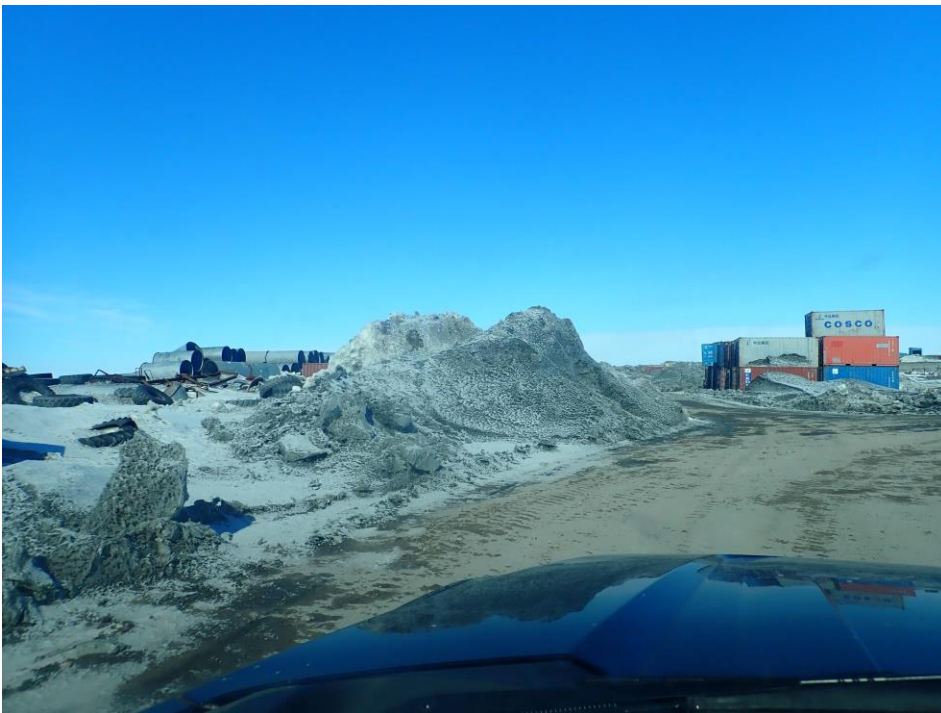
- Large pile of overburden/snow on North side of Anflo Plant road, high TSS runoff potential
- Numerous snowpiles with high sediment content

- Monitor runoff from piles, implement TSS logs as required

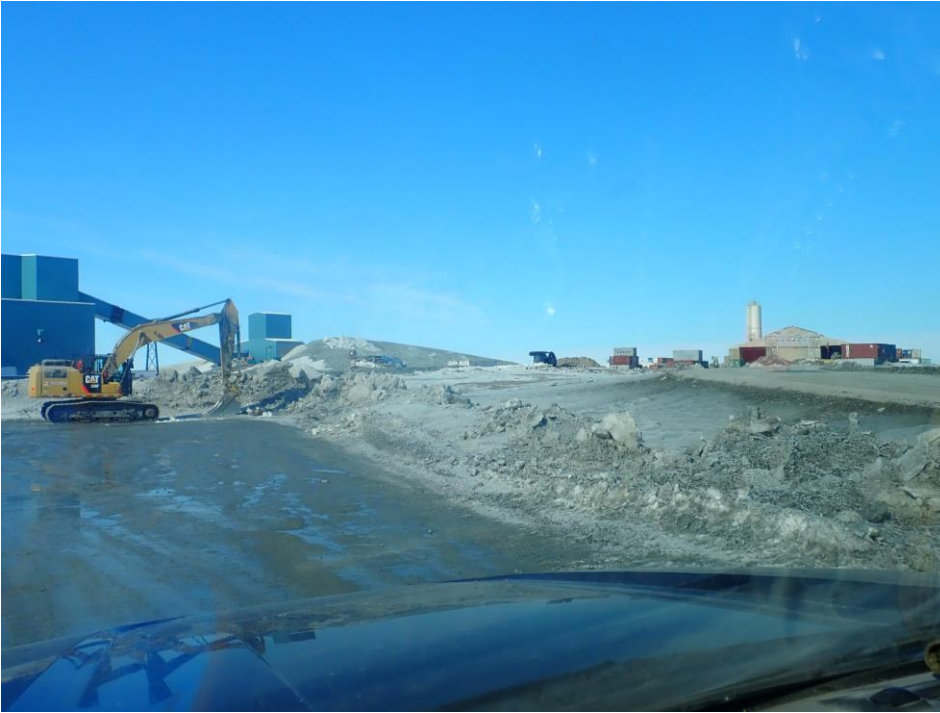
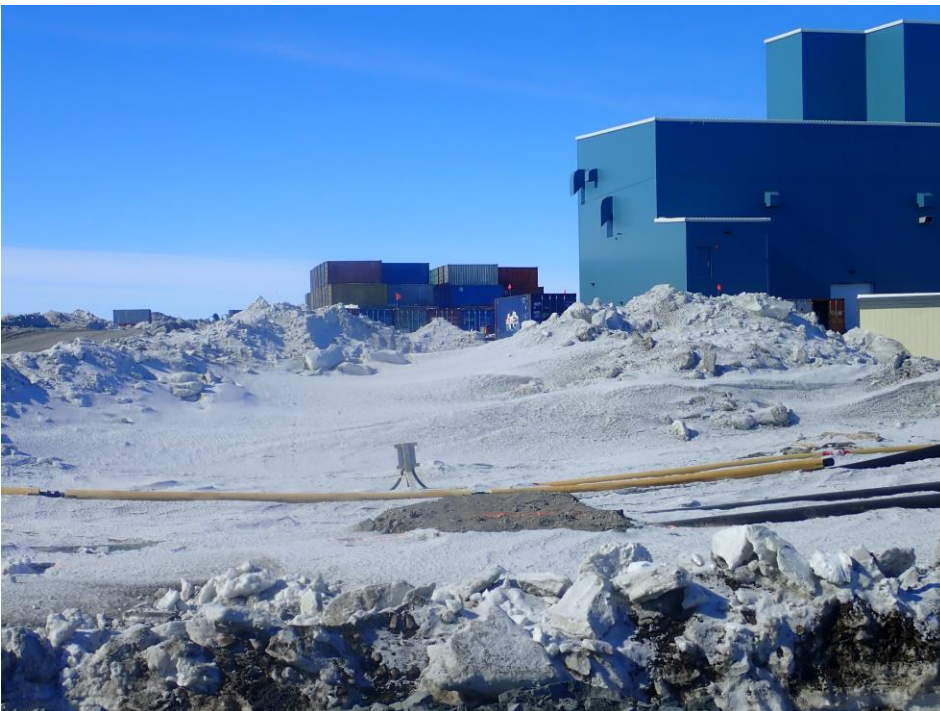
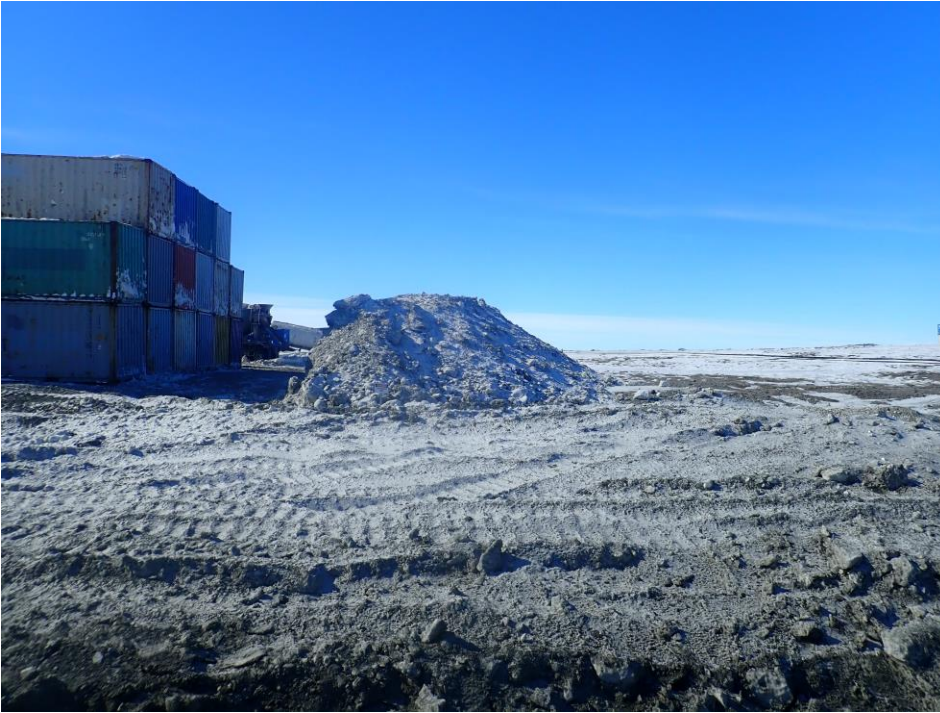
- Numerous snow piles observed beside Paste Plant, large snow pile north of Batch Plant, snow piles adjacent to esker padding along esker road

- Remove snow piles and deposit to P1/P2

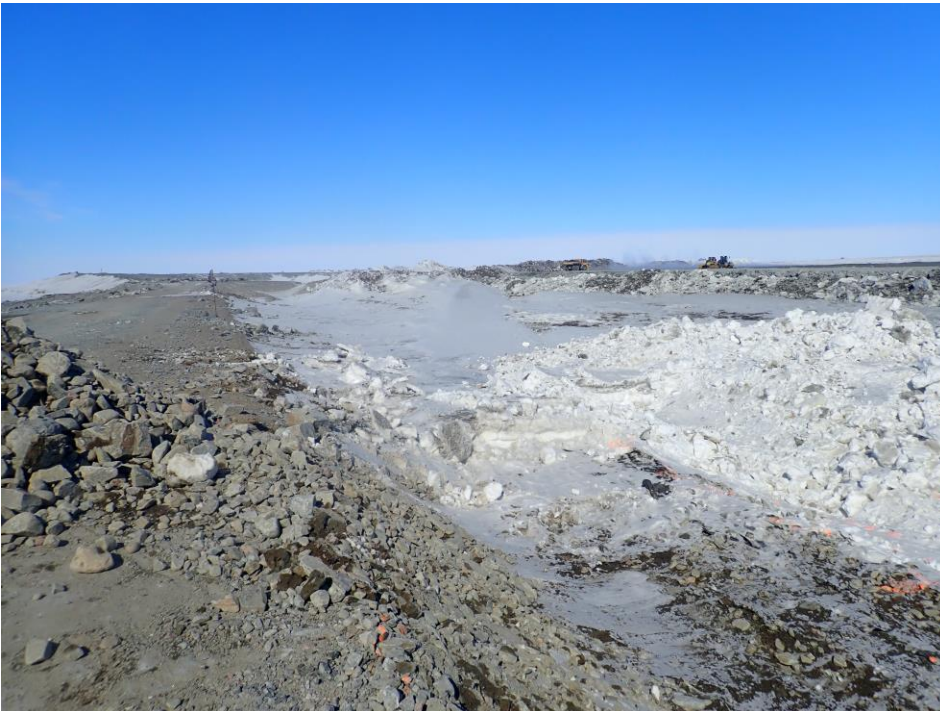
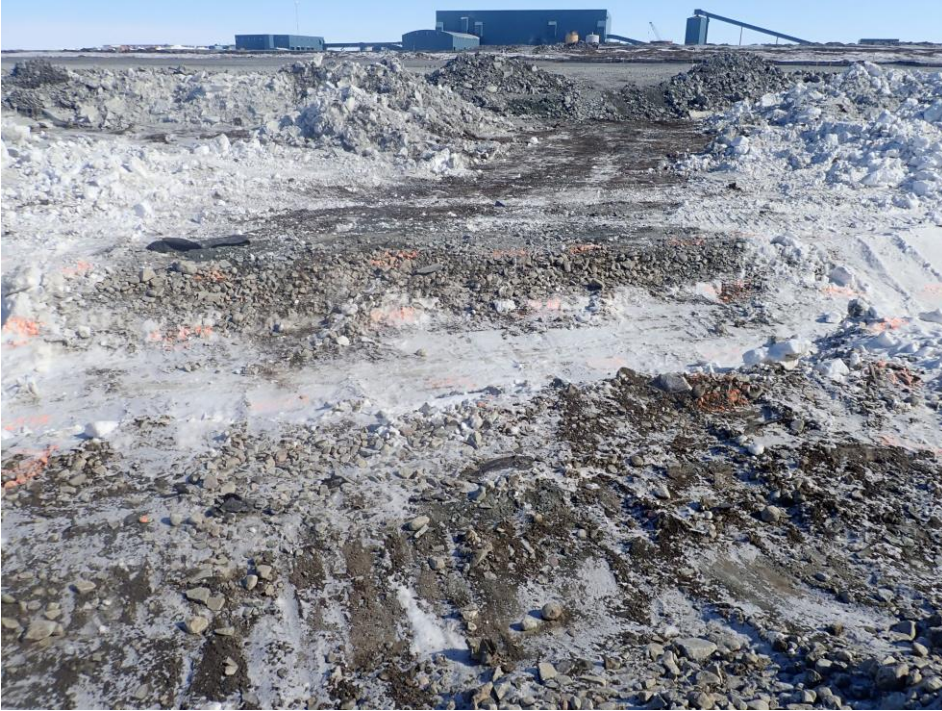
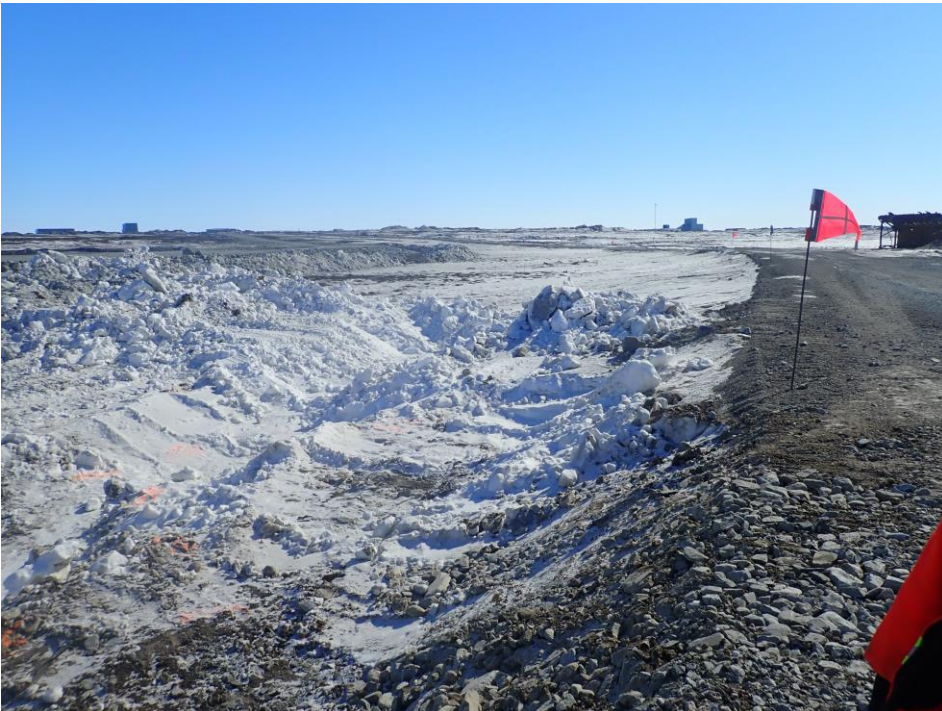
- Portion of channel 3 was filled in and subsequently cleared – potential source of TSS and slumping

- Monitor “repaired” area of channel 3 for TSS or erosional issues

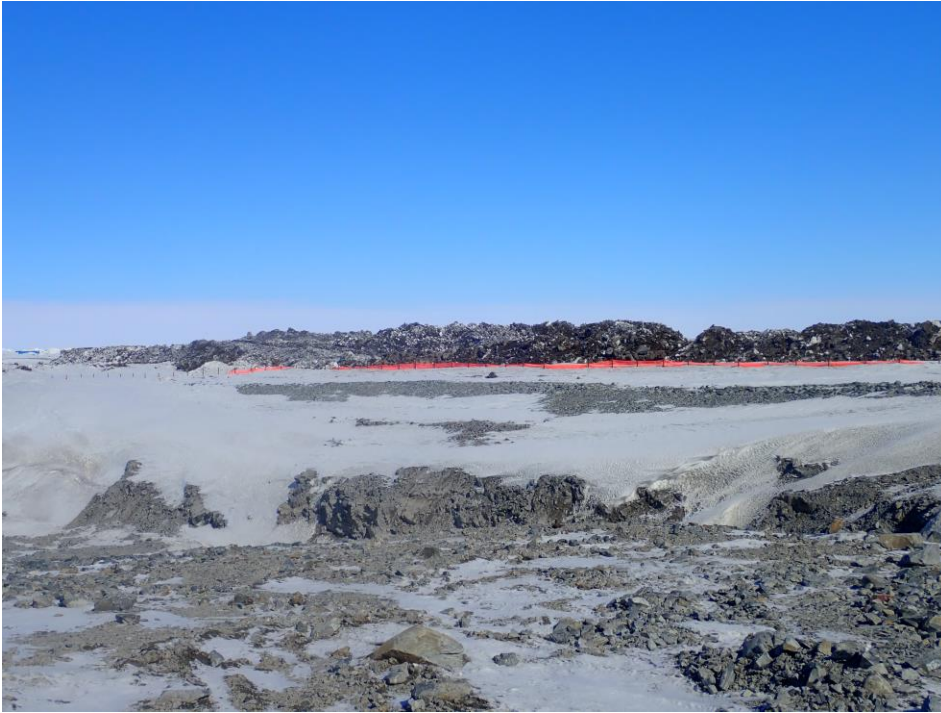
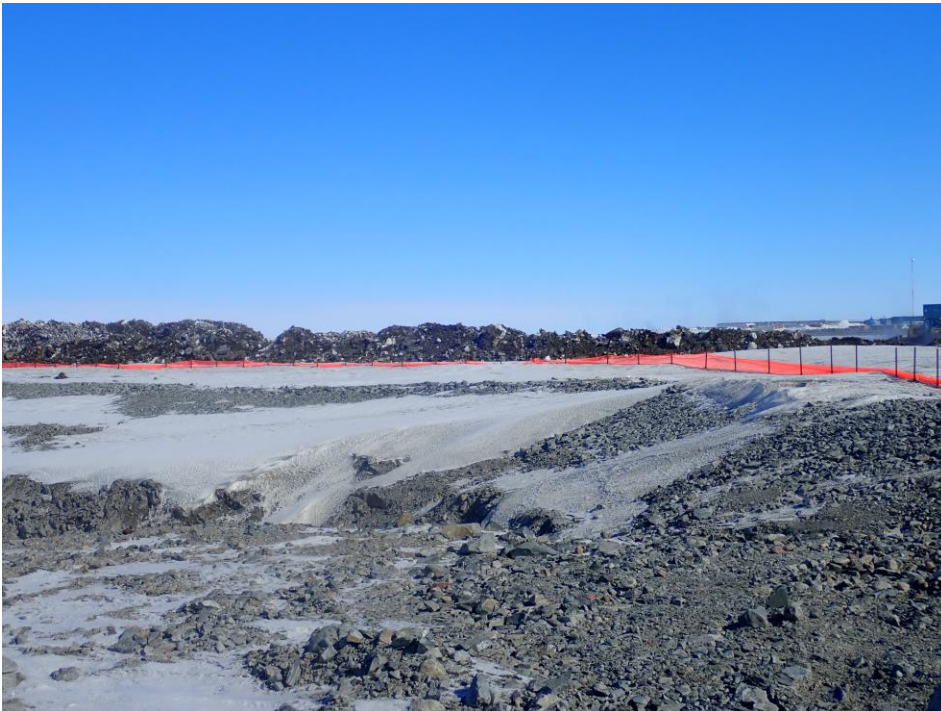
- Cell 1 free of excessive snow
- Cell 2 has large snow pile – drainage to CP3 blocked by overburden

- Remove overburden and deposit on opposite side of snow pile, flatten snow pile into pad

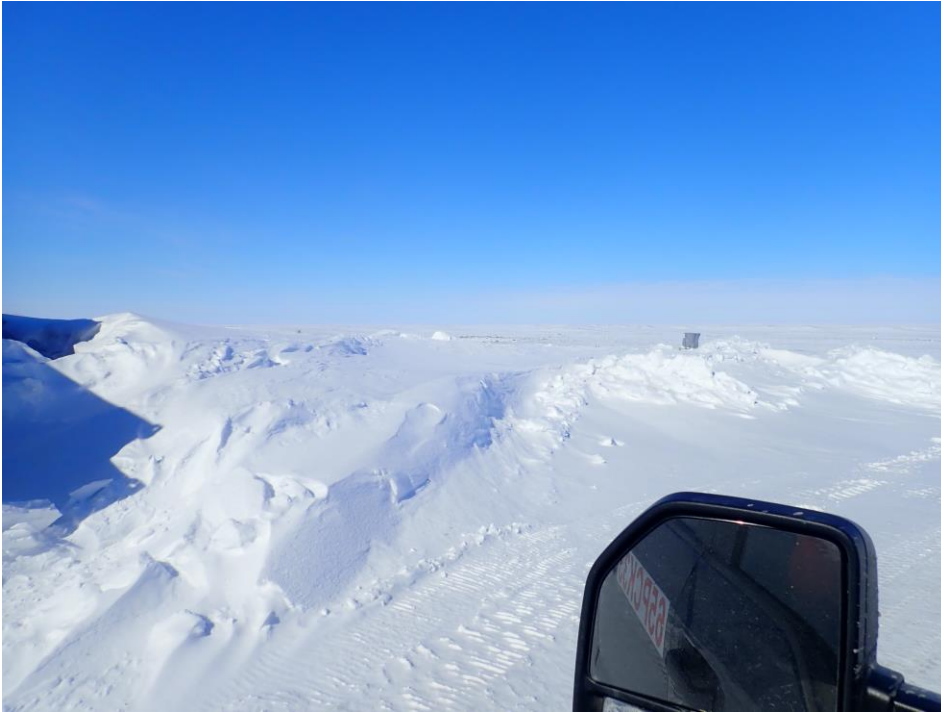
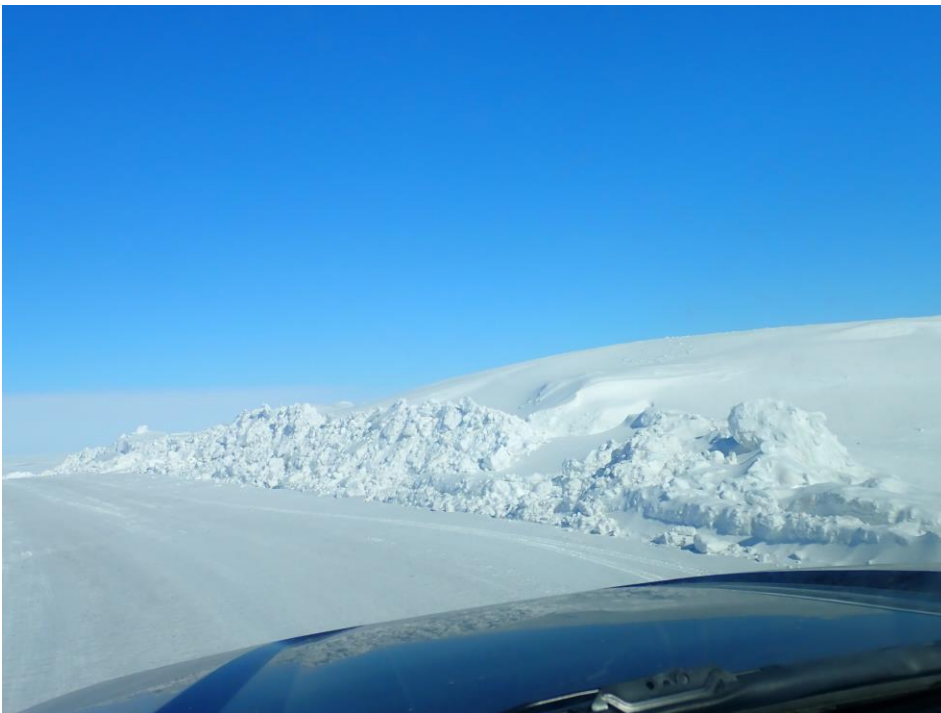
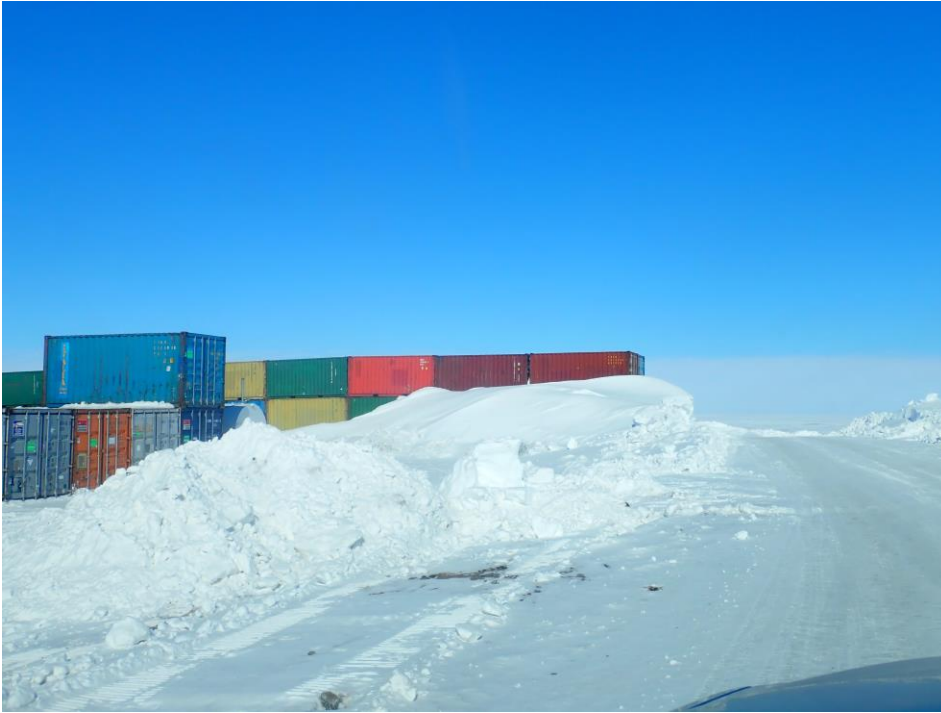
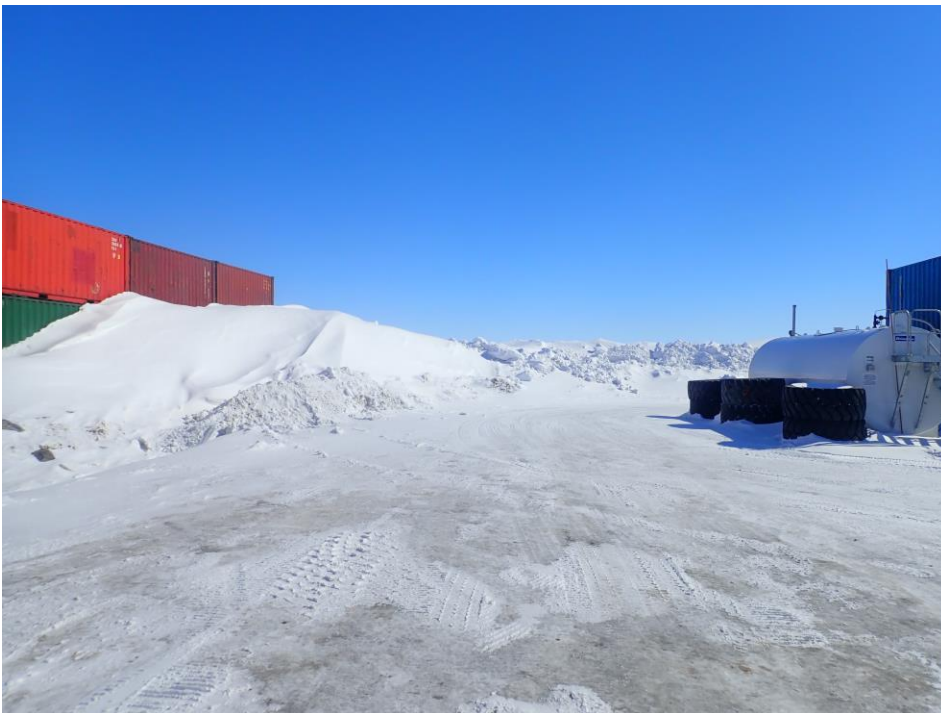
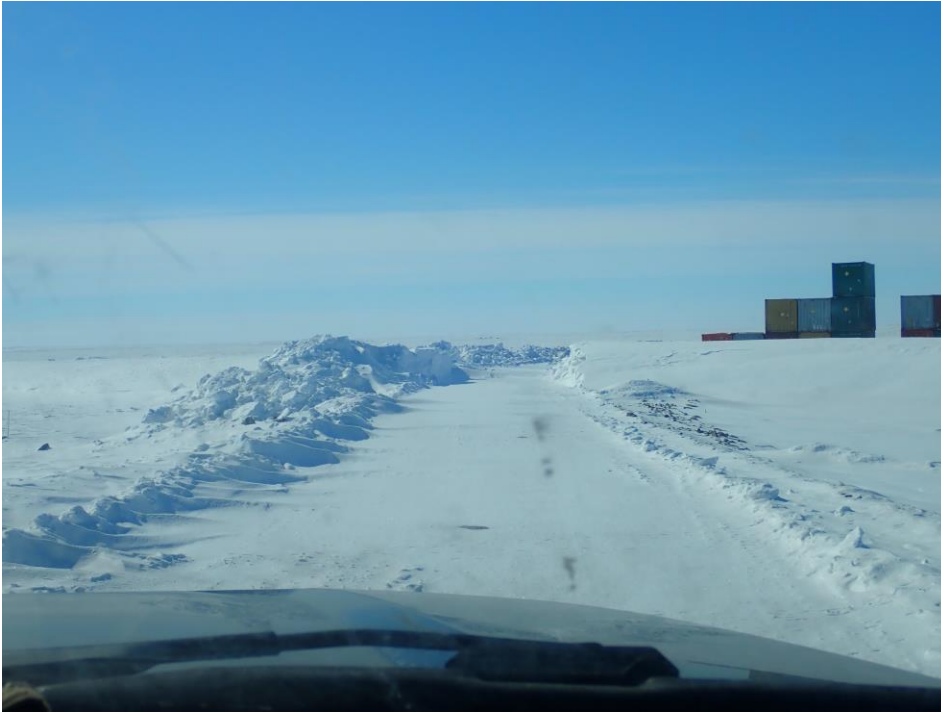
- No issues observed along road
- Large quantities of snow piling in first laydown and at site pad
- Large drifts along sides of emulsion plant pad and roads
- Snow within drainage channel

- Flatten snow piles into pads, perform additional clearing on site
- Keep snow out of drainage channel

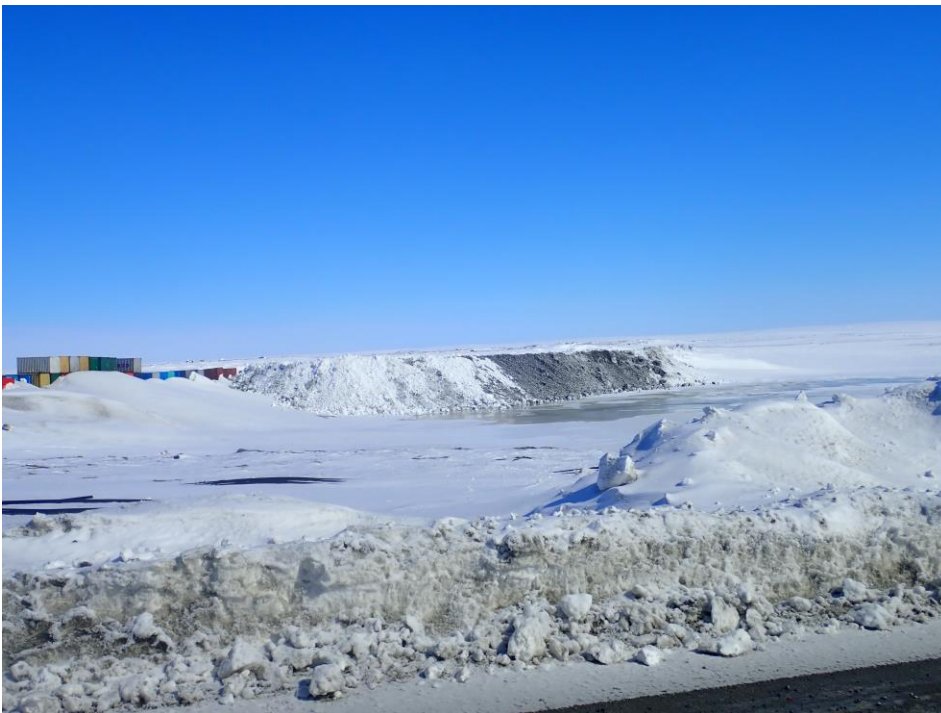
Figure 30

- Numerous snow buildup and snowpiles along structures and sea cans

- Additional snow removal required to be moved to snow dump (CP1)
