Agnico Eagle Mines
Meliadine Environment Department

Freshet Inspection Report

Location: Mine Site, Exploration Camp

DATE :	2019-05-04	Inspected By :	MG, RS
--------	------------	----------------	--------

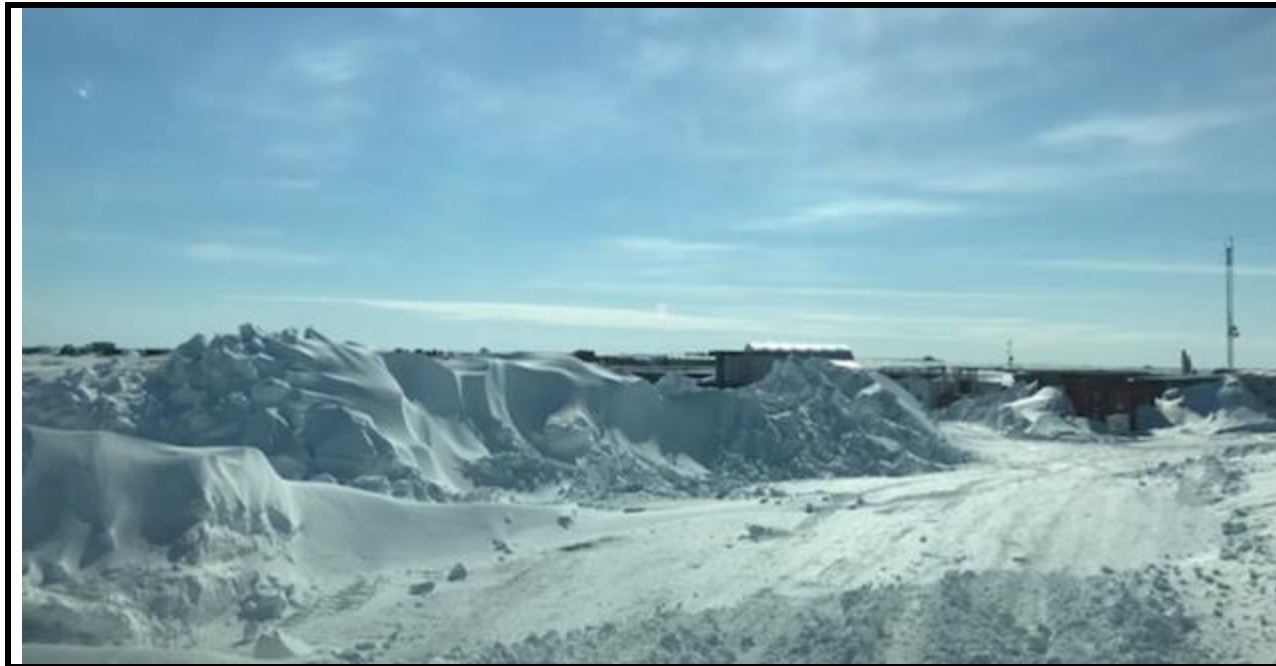
Picture 1:

- Snow piles located around exploration camp wings.

- Snow piles located around exploration camp wings should be padded out as per the Snow Management Procedure. This will prevent drifting upon the unlikely occurrence of a blizzard and will encourage sublimation and minimize potential for incision into the tundra upon runoff. This is a low priority item relative to others on this inspection.

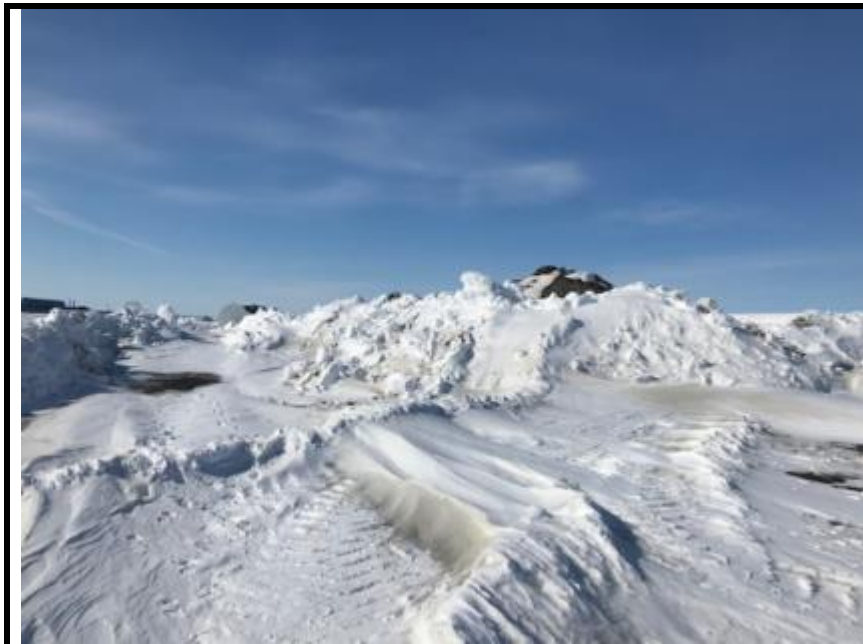
Picture 2:

- The large snow banks located in front of Landfarm B (photo 2) will likely flow across the road and may result in a washout and TSS movement to pond J5.

- To prevent this, the snow should be moved across the road and padded out in the current snow pad. Moving this snow will also provide access to the Landfarm B containment area, which will require pumping the same as it did last year. **The pumping will need to be carried out to ensure that water levels do not exceed the top of the berm.**
- In order to prevent the volume of pumping required from the Landfarm B berm, we suggest removing the snow drifted within the bermed area (photo 3). As this snow is not in contact with contaminated material, it could be deposited in the snow pad area across the road. Once water is melted within the bermed area it will need to be pumped and transported to the snow cell (or Landfarm A if the snow cell becomes full).
- These actions are a **high priority** relative to others on this inspection.

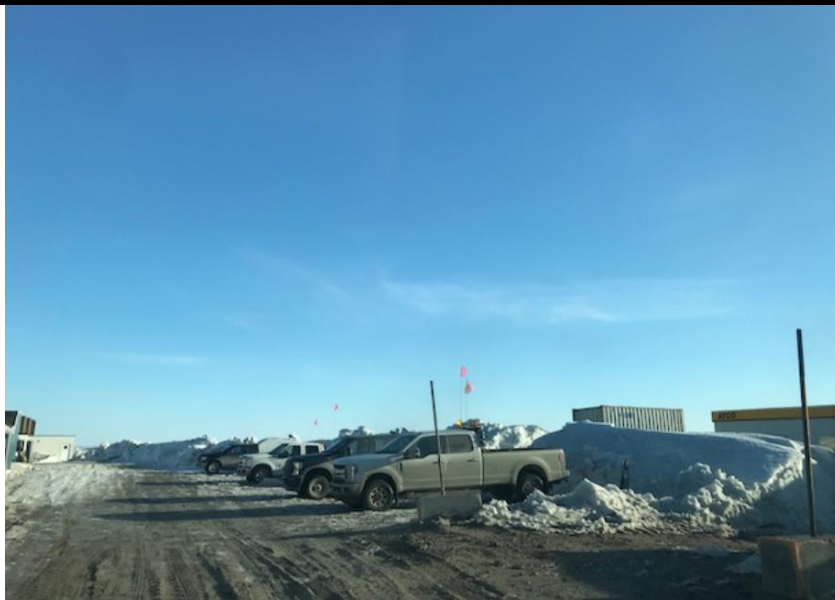
Picture 4:

- Snow piles around camp and camp parking lot. Producing runoff downslope towards the industrial pad and resulting in erosion.

- We suggest to remove snow to the CP1 snow dump to minimize the amount of runoff and damage to road/pad.

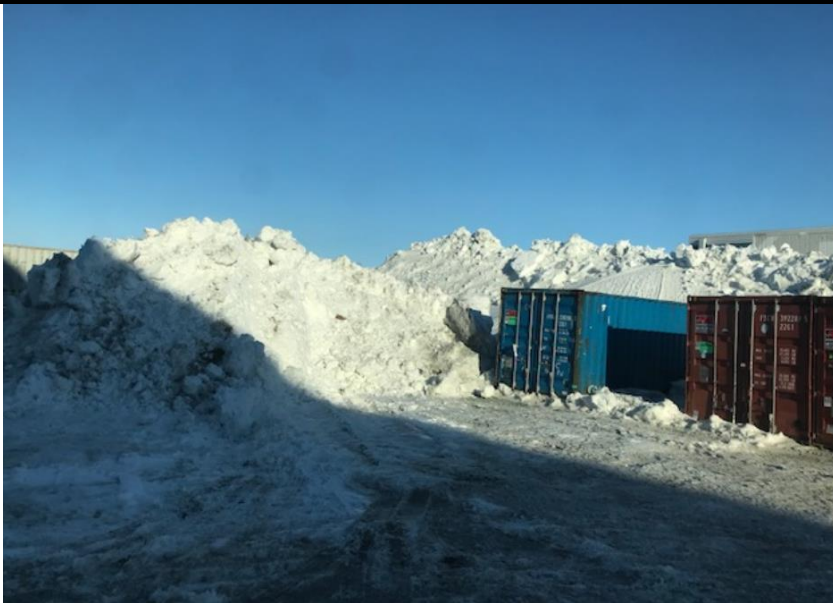
Picture 5:

- There are many snow banks around the industrial pad which are currently and will continue to runoff along the road and pad. This includes snow beside the construction offices and main camp parking lot and to the northwest of the warehouse/MSB (photo 5). The main impact here will be damage to the roads and industrial pad. There will also be TSS movement here but it will remain on site.

- Move snow to CP1. This correction will prevent damage to the road and associated repairs that would be required. There are many other small snow piles which could be removed to further reduce runoff, if it is decided that clean-up of the industrial pad is possible with available equipment.
