Freshet Inspection Report

Location: Itivia, Bypass Road, AWAR, Mine Site, Exploration Camp

DATE : 18-May-19

Agnico Eagle Mines
Meliadine Environment Department

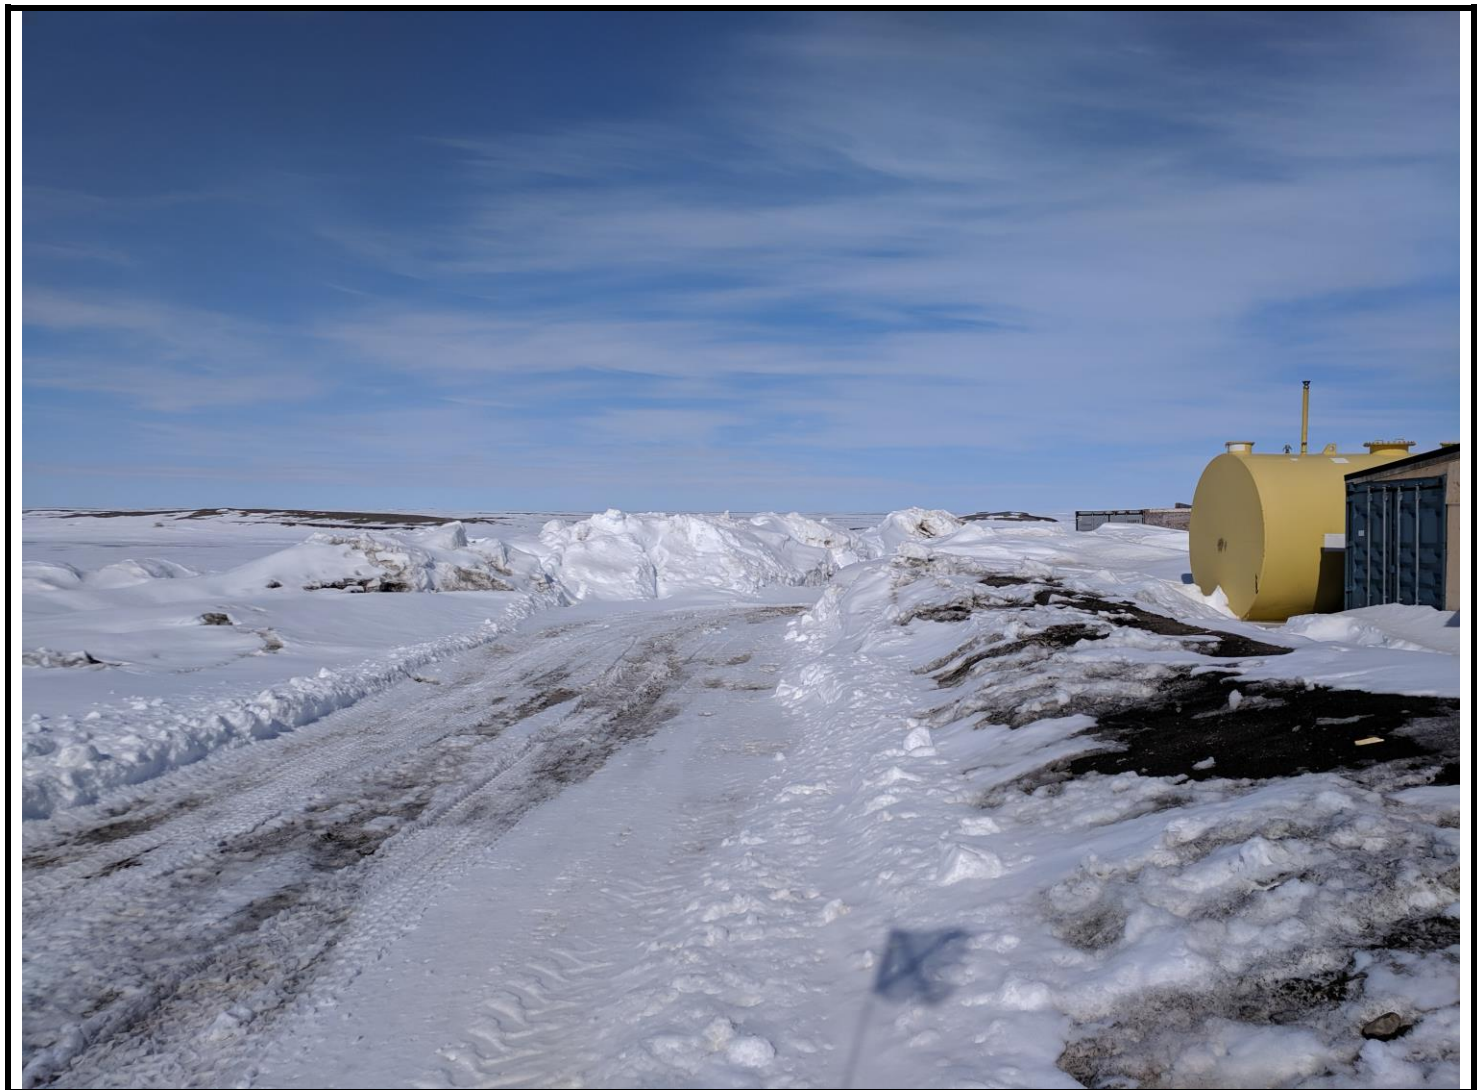
- Good padding along North side of camp.
- Large snow piles behind old genset area.
- Large snow piles behind camp (south and east).

Picture 1: Snow piling behind Explo camp and genset.

- Snowpiles should be padded to aid in sublimation at the onset of warmer temperatures.
- Remove snow from old genset area (pad with other snow).

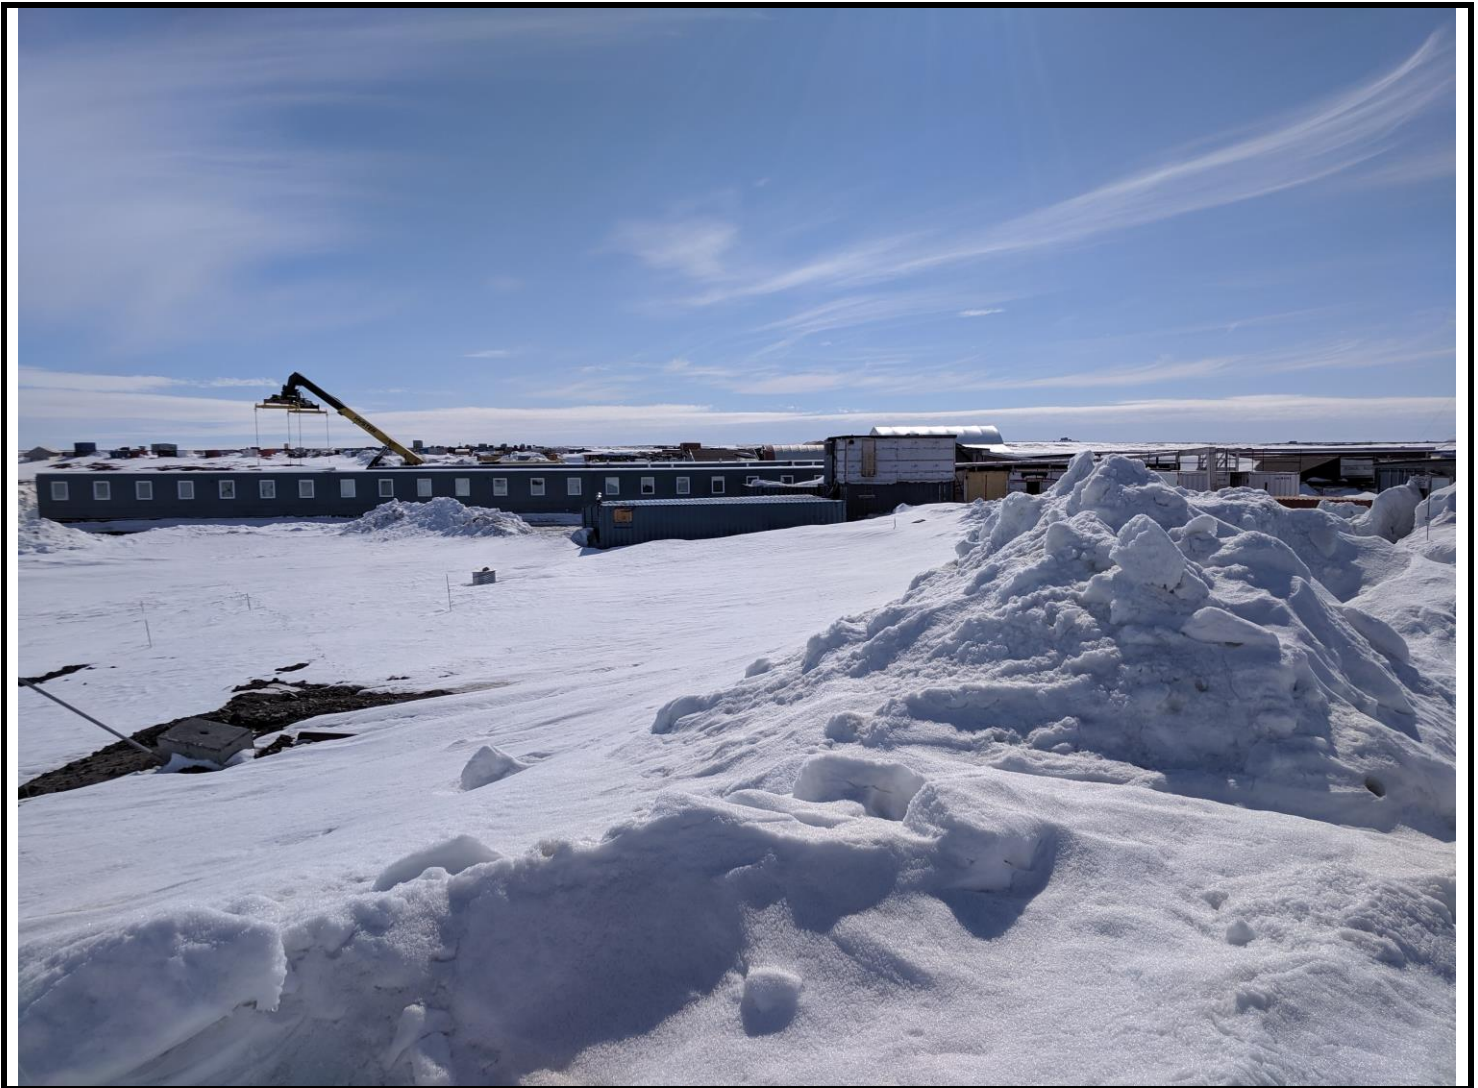
Picture 2: Snow piling behind explo camp and overtop of old genset spill.

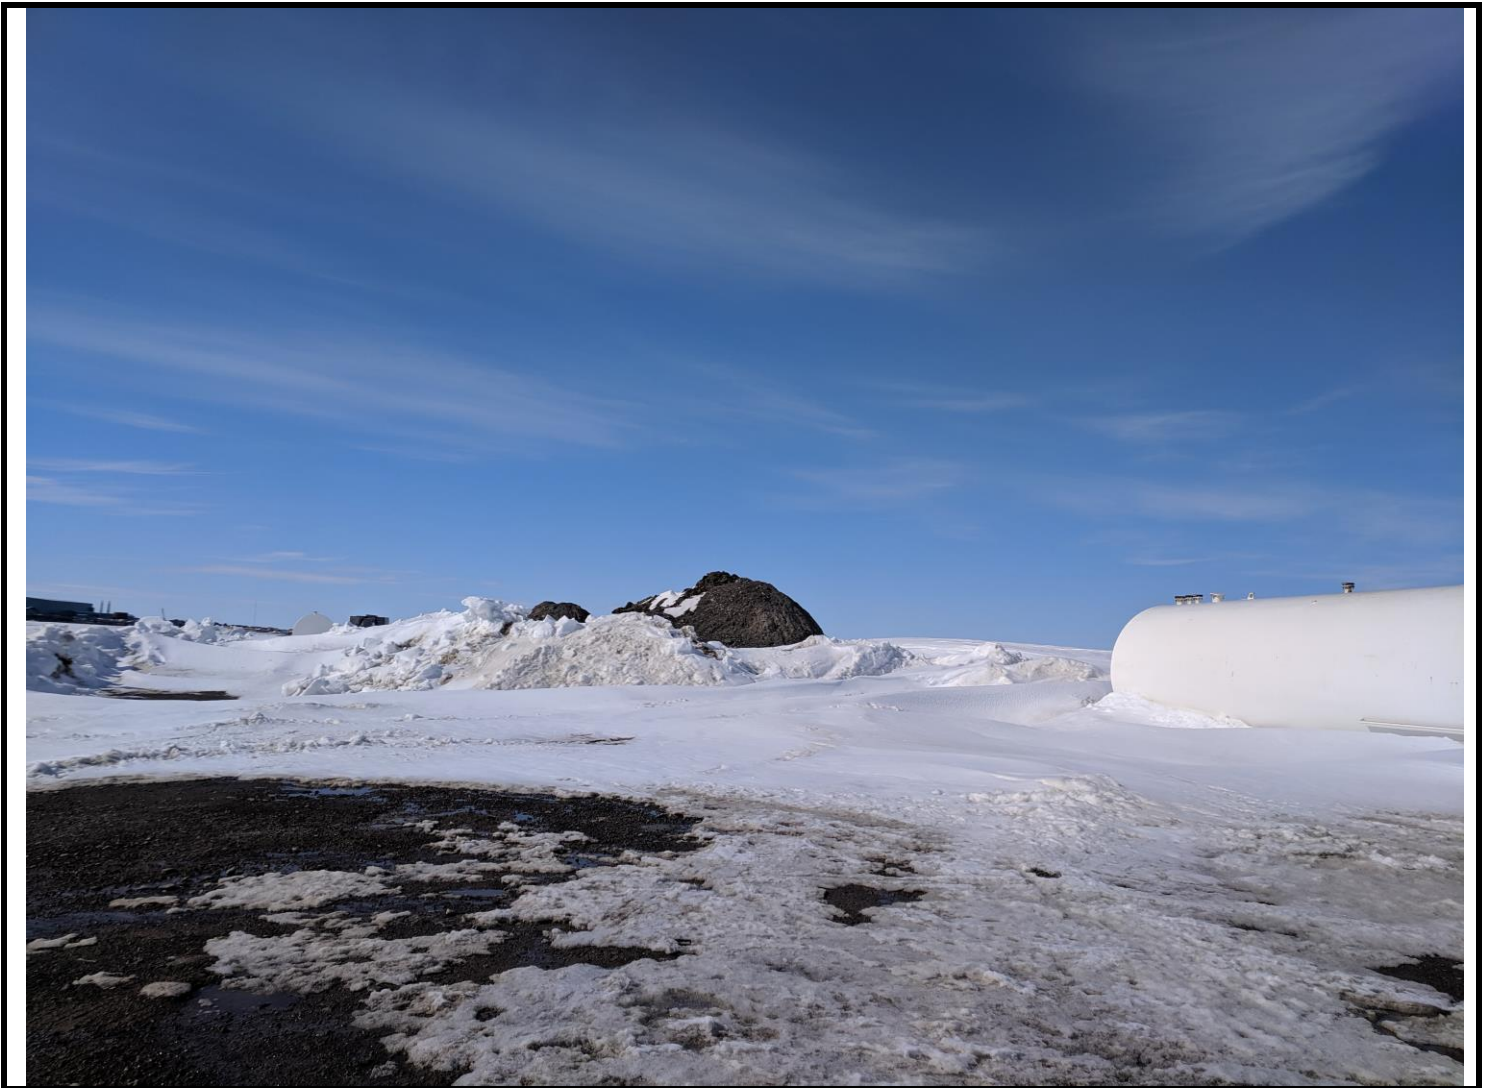
- Snow piling in front of Landfarm and drifting within adjacent Landfarm containment.

Picture 3: Snow piling in front of Landfarm B

- Remove snow from front of landfarm, granting access to containment. This snow should be removed and padded across the road (south of explo road).
- Snow drifting within the containment that has not made contact with the Landfarm material or base of the pad should be removed and padded along with the other snow across the road. This will reduce the volume of water that will have to be removed from the containment during melt – contained water must *not* exceed the top of the containment berm.

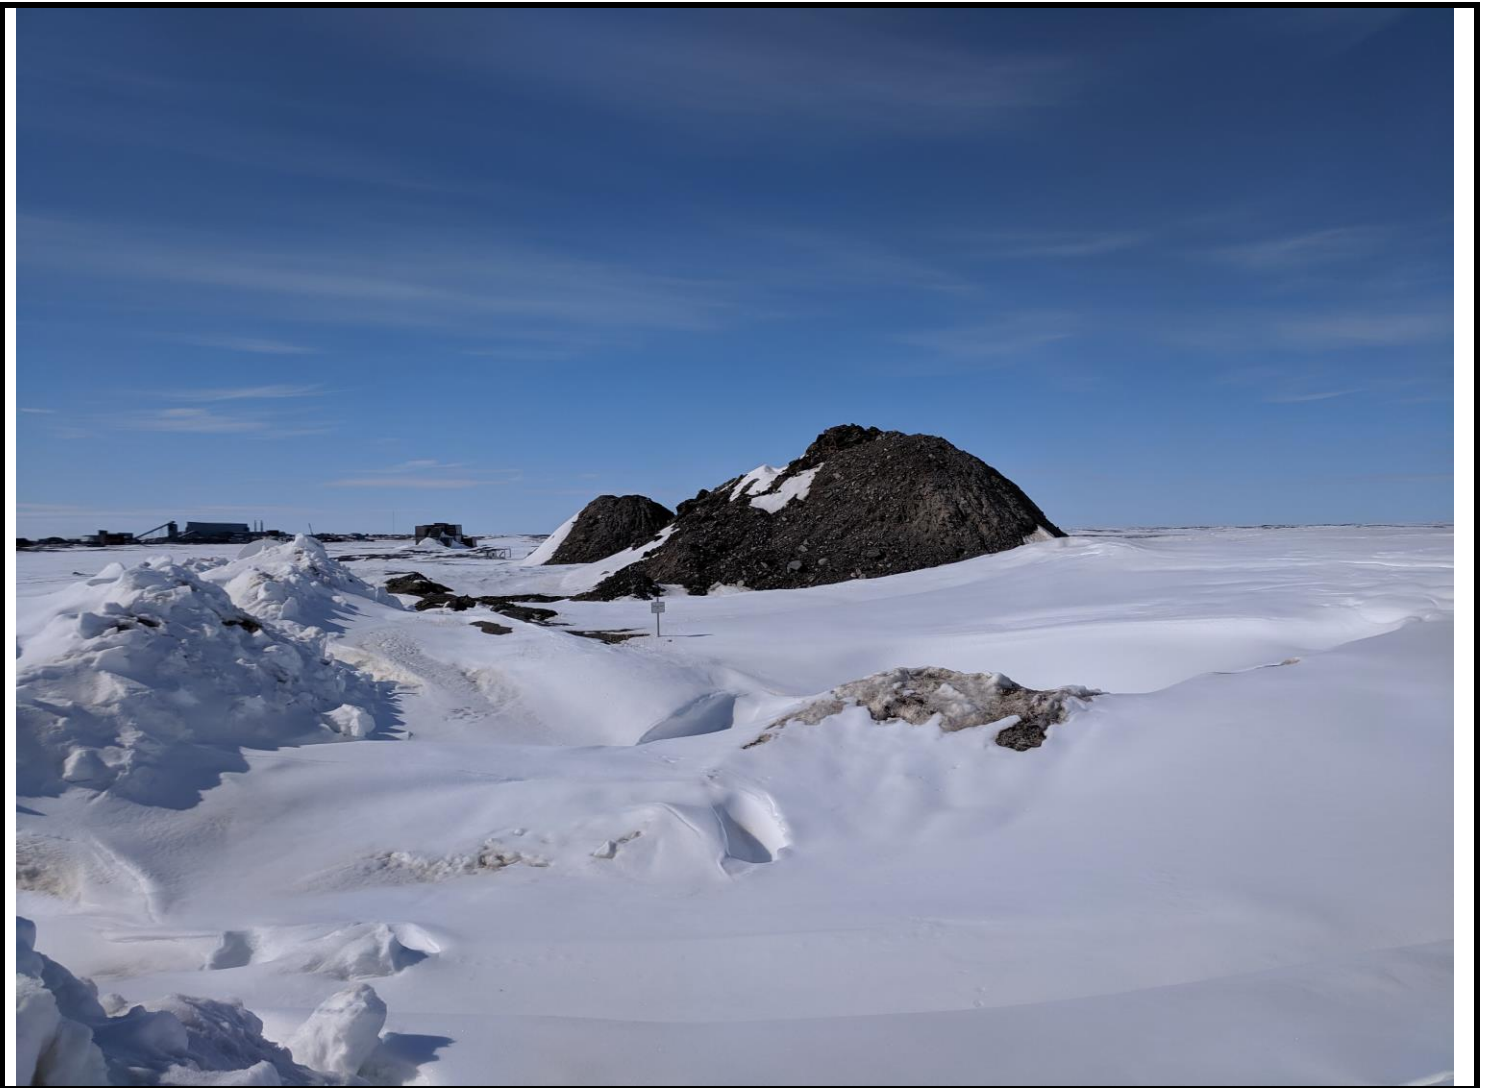
Picture 4: Snow drifts within Landfarm B containment

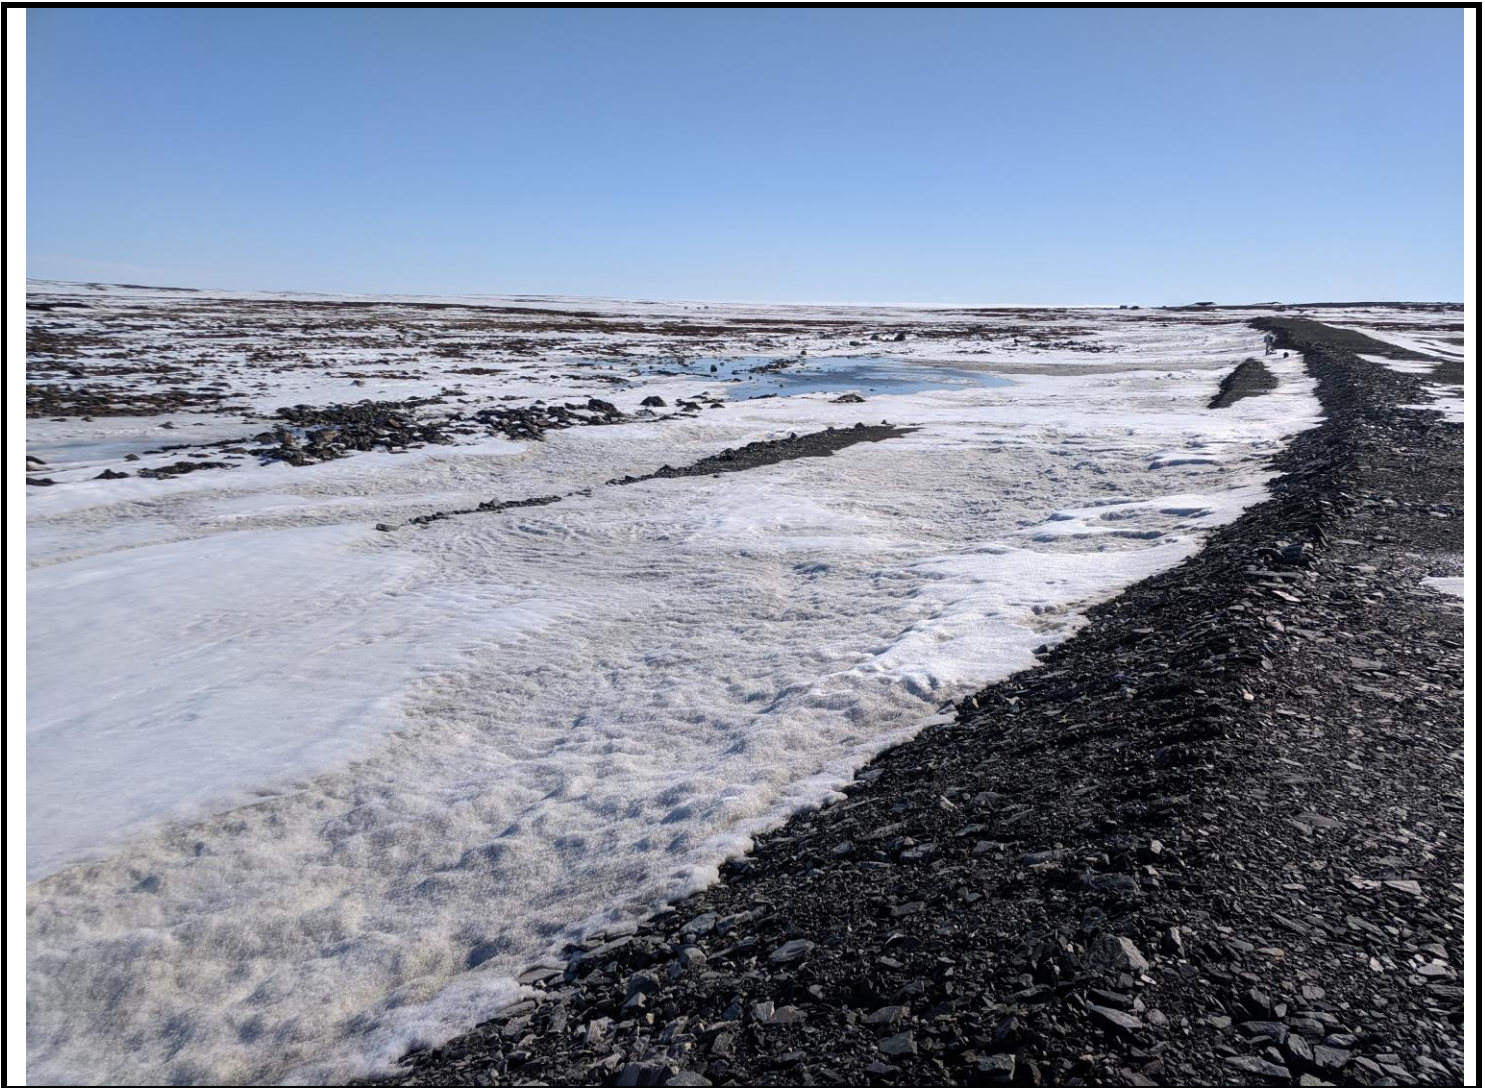
- Snow drifting along downstream toe.

Picture 5: Snow drifts against the downstream of D-CP5

- Snow that has drifted along the downstream (south) toe of D-CP5 should be removed and padded along the main site access road (with other padded snow). The down-stream toe must be clear to prevent any potential of water infiltration to the dike keytrench, and to assist with the early installation of the sump/trench pumps that will be required for freshet.

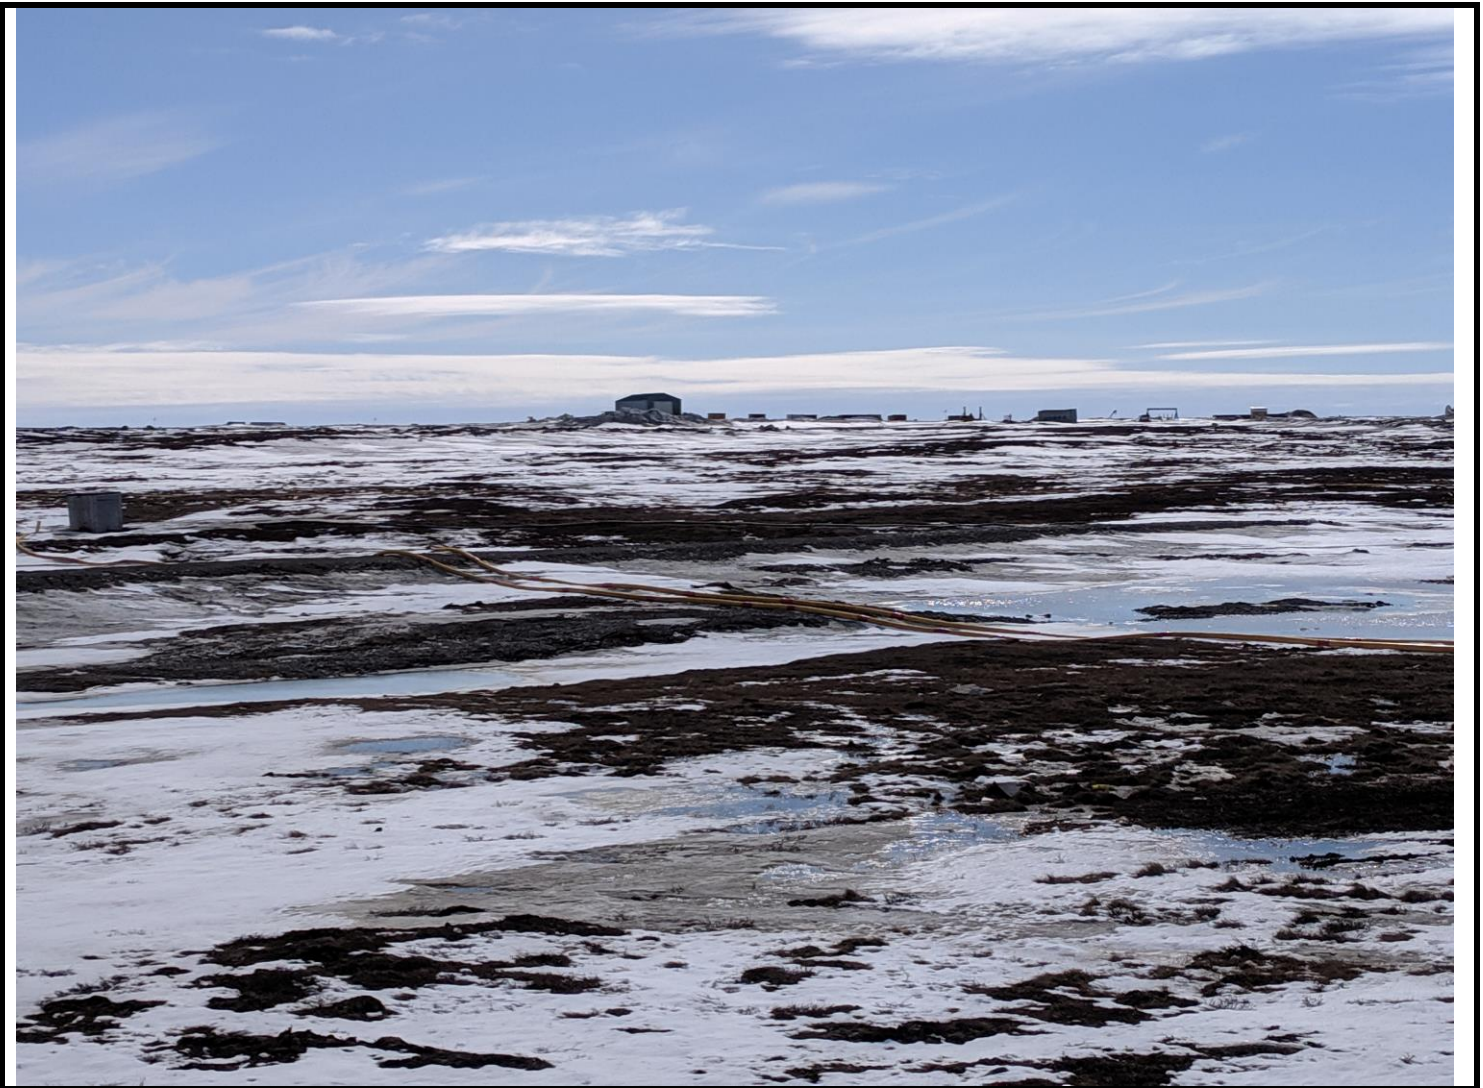
- Pipes crossing channel at 2 locations.
- Pooling of water behind north pipe crossing – may be caused by pipe blocking flow.

Picture 6: Pipes crossing Channel 5

- Pipes originating from the SWTP pad/laydown travel across the channel at 2 locations. Ensure piping is not impeding flow or damaged by flow during freshet. Continue to monitor.

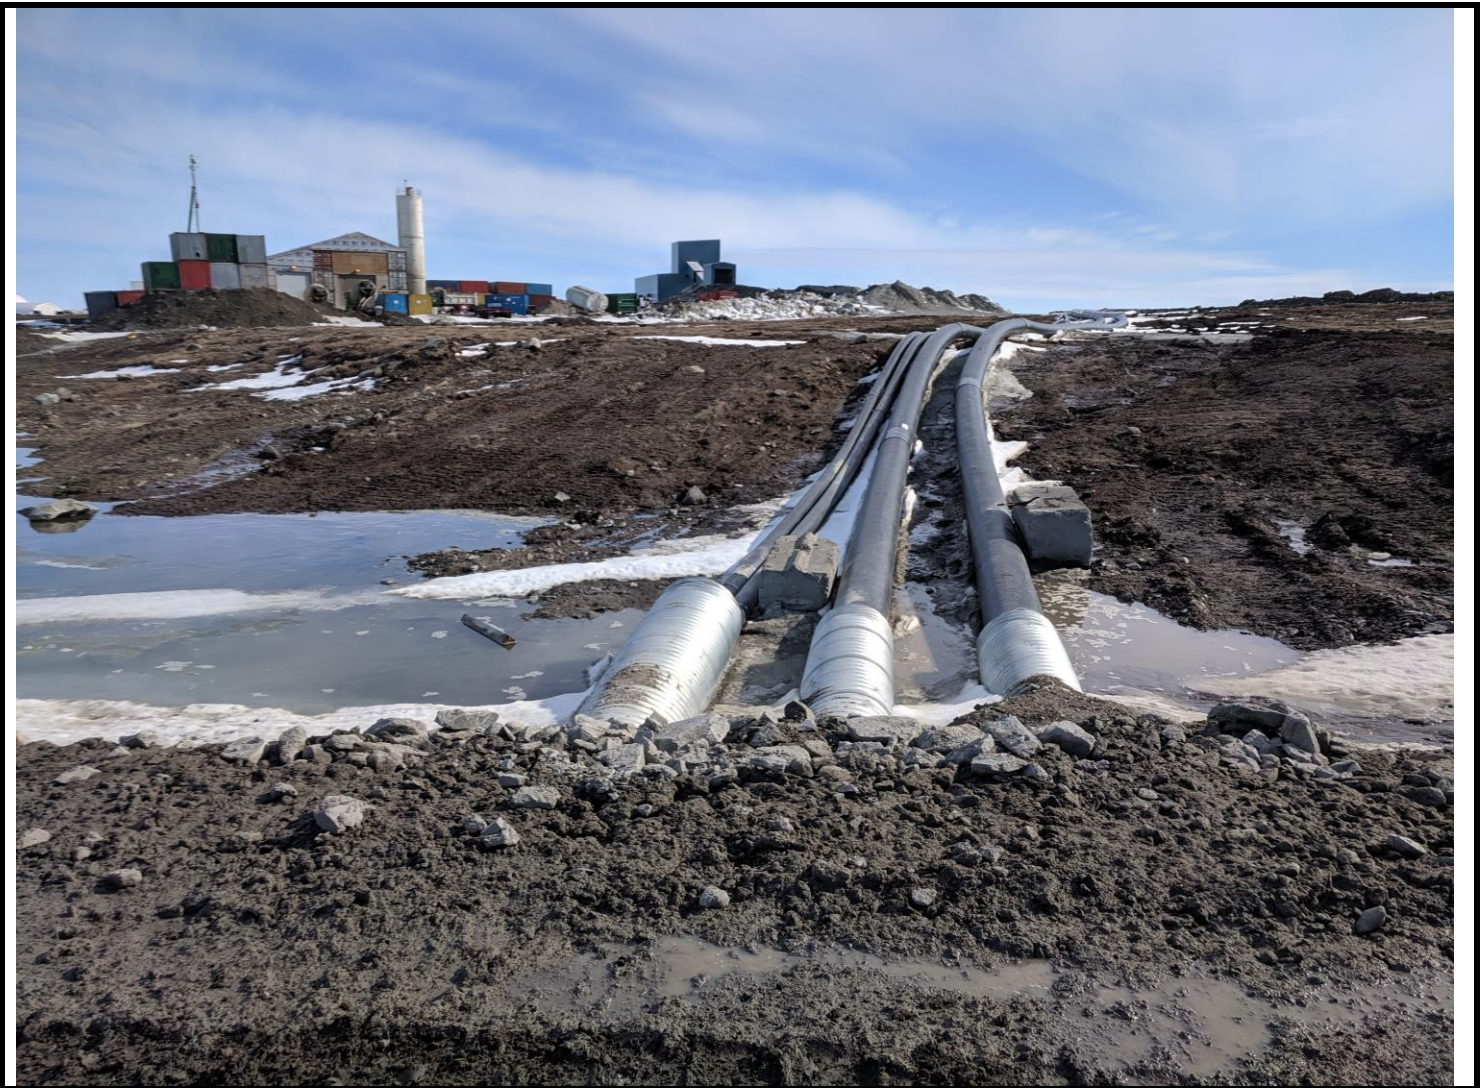
- Pooling along western side of road – unnamed culvert clear, water should proceed north through culvert before topping road banks.

Picture 7: Un-named culvert (wrongly labelled culvert 6) on west side of Haul Road

- Continue monitoring flow to ensure water passes through unnamed culvert (temp name culvert 6).
- Monitor area where channel 8 would flow for over-topping.

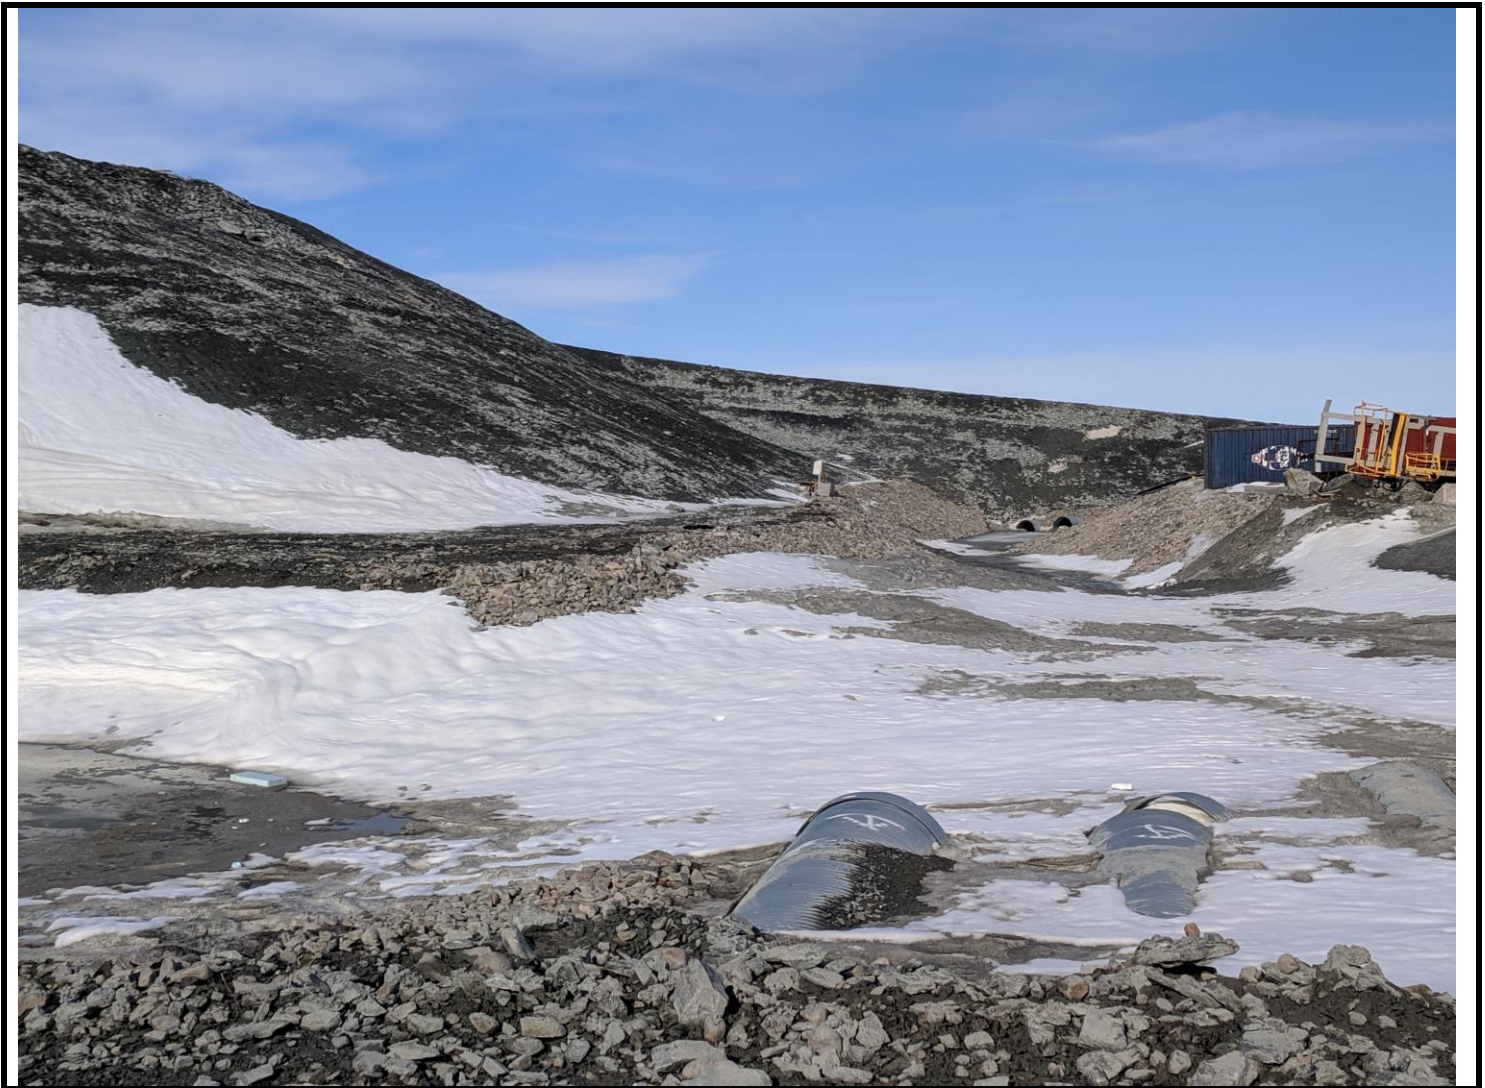
- Snow blocking flow through Culvert 2

Picture 8: Culvert 2 not flowing – blocked by snow.

- Attempt to clear culvert 2, otherwise monitor for over-topping upstream of channel.
