TSF WEEKLY INSPECTION FORM

Date: November 29, 2019	Time: 10:30
Weather: -14.3C; 39 km/h SW; drifting snow	Inspected by: Jennifer Pyluk
Present: Pierre-Luc Sevigny

TAILINGS PLACEMENT

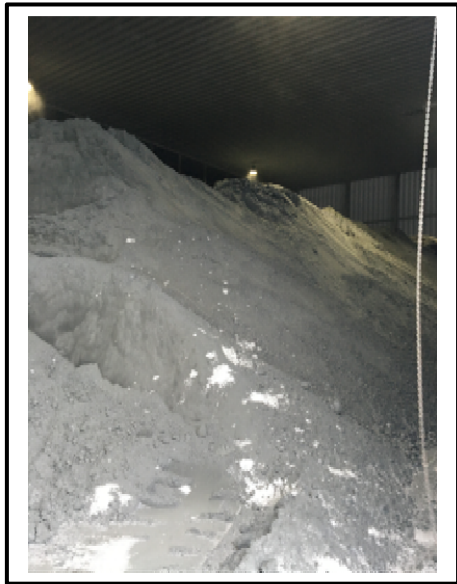
- The Church was observed to be approximately $\frac{3}{4}$ full. It is understood that tailings material to the east of the building have been in place "at least a week". It is noted that there has been no inclement weather during this time period. It is understood that both vehicle (haul truck) availability and driver availability have been issues. .

Photo 1: Tailings material backed up in the Church

- Winter placement conditions must be followed in order to achieve proper compaction and reduce settlement in the summer months:**
 - Tailings must be removed from the Church immediately** to avoid freezing of this material prior to placement. **Stockpiling in the Church should only occur in extreme conditions.**

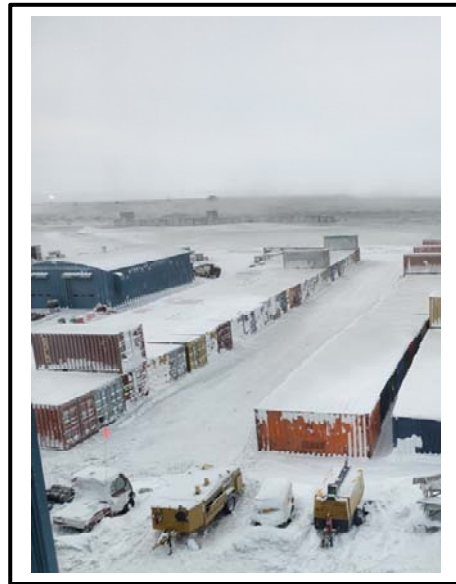
- Despite repeated warnings, all haul and light vehicle traffic was observed running across sub-cell 2 to reach the working area. This is exacerbating dust generation from the surface and is contrary to Section 5.0 of the Deposition Plan.

Photo 2: View from the MSB of dust from the TSF, haul truck running across sub-cell 2

4. **There must be no vehicle traffic on the finished tailings surface.** Flash freezing of the surface will occur and erosion/dust generation will be at its peak. Traffic over snow will grind/compress the snow into the tailings surface and will make snow removal in these areas more difficult. **AEM has regulatory requirements to make every effort to control the dust generated from the TSF.**
5. **Any unusual observations** (ie. "pot-holes") **can be signs of serious instabilities and should be reported immediately to the GE.** If the GE is not on site, photographs should be emailed for a visual evaluation.
6. **Snow should not be placed/stockpile anywhere but the designated snow dump location in Cell 2.** The location of the snow dump was chosen based on experiences during freshet 2019.

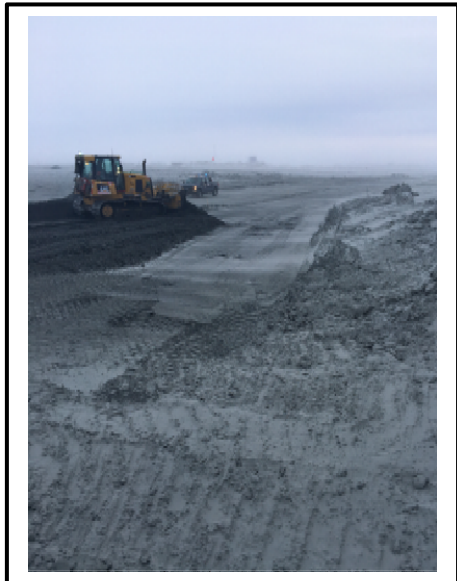
- No serious concerns were observed with the actual placement of tailings in the center cell at the time of the inspection and "fresh" (unfrozen) material was being placed. However, when asked how many passes with the compactor was occurring, the operator replied he was doing two (one forward and one backward). It is not clear as to why an operator was placed on a critical piece of equipment yet did not receive clear and correct directions as to what he was to be doing on that piece of equipment.

Photo 3: Pushing unfrozen tailings in the center cell; view facing southeast

- Compaction of tailings must occur immediately following placement.** If compacted while unfrozen, the same number of passes (**3 slow passes on high vibrate where "1 pass = 1 forward + 1 backward"**) applies. If frozen tailings material has to be placed, Engineering must be notified so that the least harmful placement location and compaction specifications can be chosen.

- It is unacceptable that the packer operator did not know how many passes he was required to complete and this raises serious questions about the amount of compaction that is being achieved.** If
