WATER LICENCE INSPECTION FORM

Licensee	Licensee Representative
Agnico-Eagle Mines Limited	Robin Allard
Licence No. / Expiry	Representative's Title
2AM-MEL1631 / March 31st 2031	General Supervisor Environment
Land / Other Authorizations	Land / Other Authorizations
--	--
Date of Inspection	Inspector
August 27 th 2020	Atuat SHOULDICE
Activities Inspected	
<input checked="" type="checkbox"/> Camp	<input type="checkbox"/> Drilling
<input type="checkbox"/> Roads/Hauling	<input checked="" type="checkbox"/> Mining
	<input type="checkbox"/> Construction
	<input type="checkbox"/> Reclamation
	<input type="checkbox"/> Fuel Storage
	<input type="checkbox"/> Other:

On Thursday August 27th, 2020 a “ No contact inspection” of license number 2AM-MEL1631 issued to Agnico Eagle Mines - Meliadine site was conducted by the Crown Indigenous Affairs and Northern Relations Canada Inspector Atuat Shouldice. Due to the Covid-19 restrictions that are put in place at the time of the inspection and to minimize close contacts each party, Dan Gorton licensee representative and I, the CIRNAC inspector, used own vehicles that followed each other around the site.

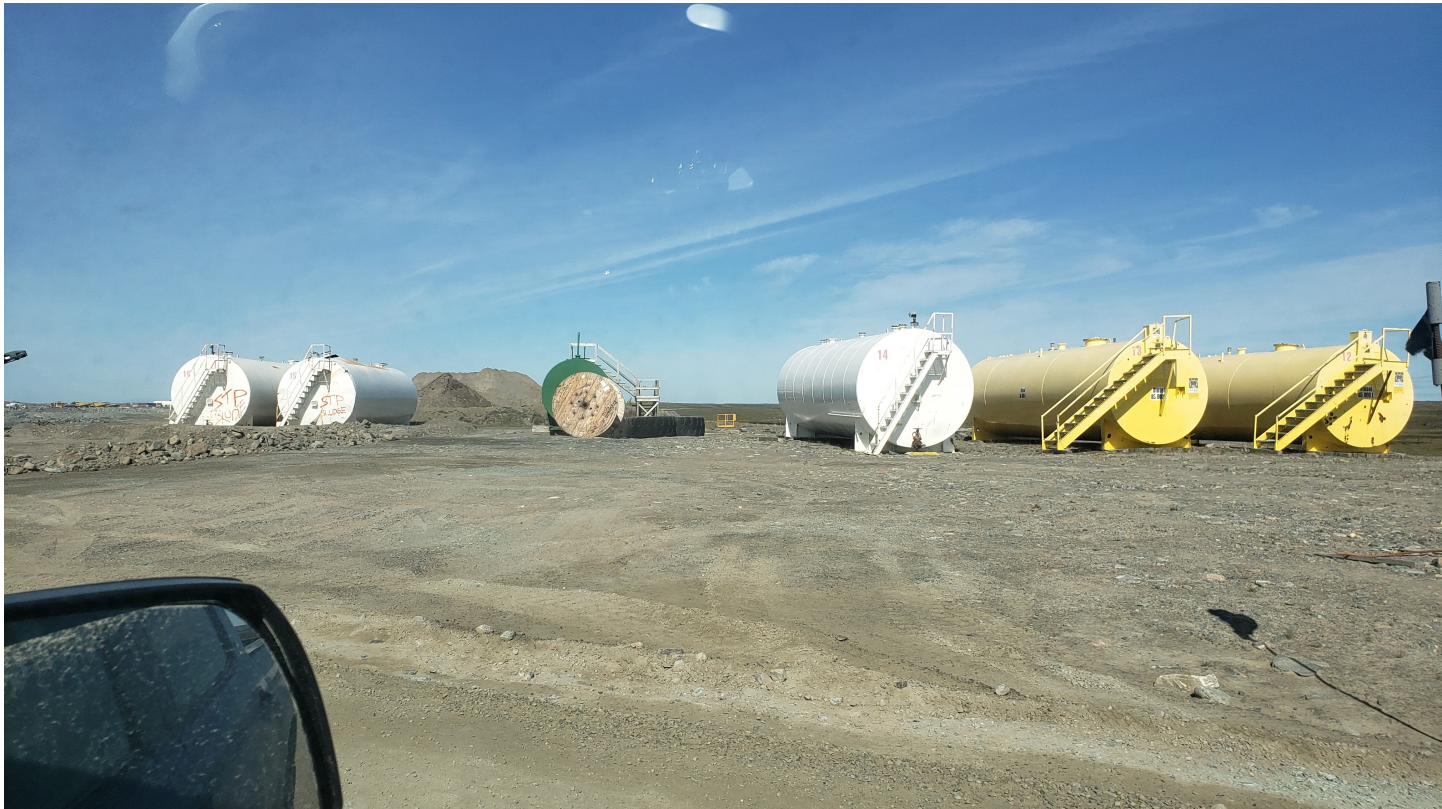
Date:	Authorization Number:	Camera/Model:	Inspector
August 13th, 2020	2AM-MEL1631	Samsung S9	RMO Shouldice
Photo No.	Lat/Long (DD.MM.SS.SS, NAD83)		
Photo 1

- Old tank farm:
 - No fuel being stored at old tank farm. As per the spill plan, contaminated soil from the past fuel spill is contained in lined berm, sorted and stored until room available in land farm. No concerns noted at this facility. See photo #1

Description: old fuel storage area

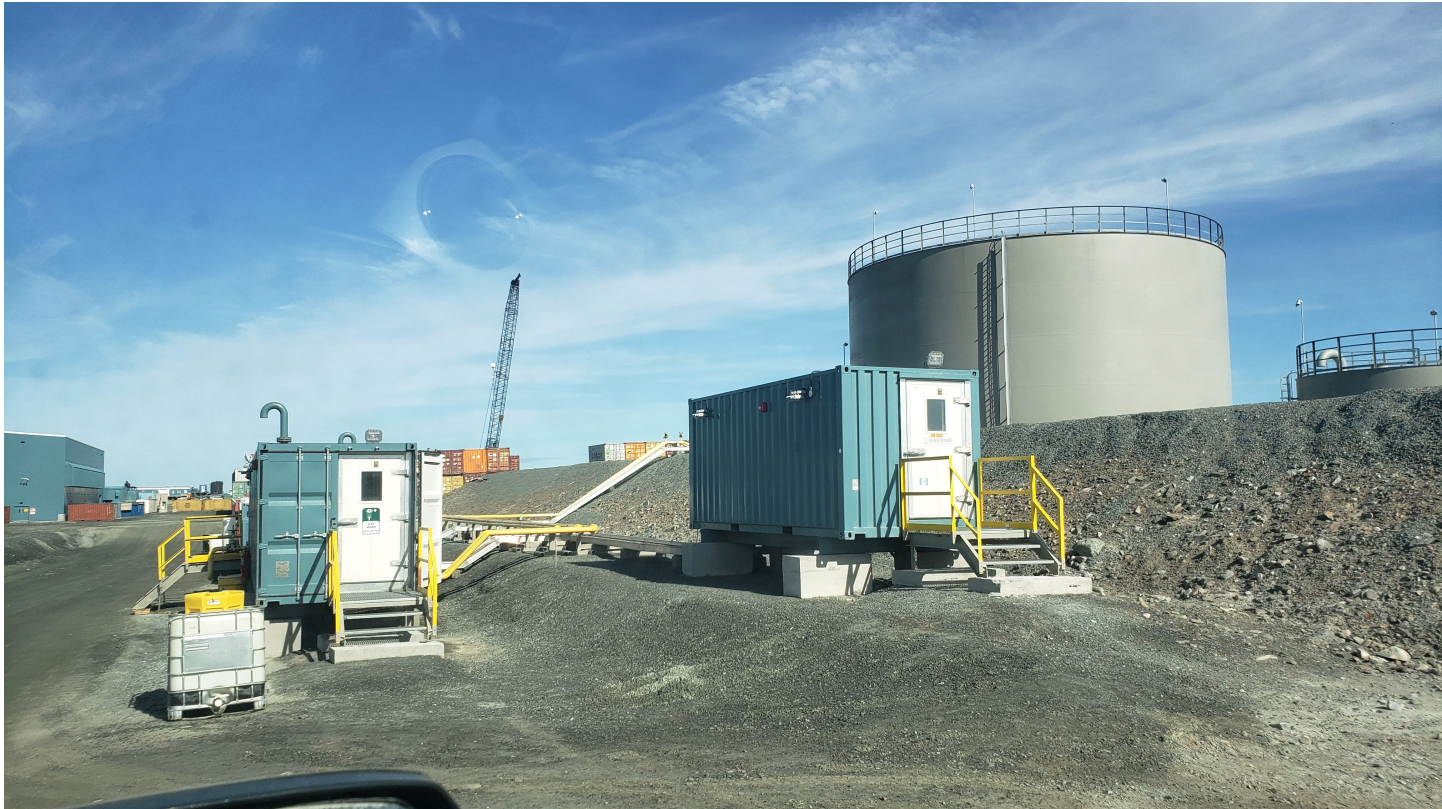
Photo #	Location (NAD 83 DD MM SS.SS)
2

- Tank farm:
 - This facility stores bulk , main fuel storage at Melvin Bay. Spill response gear available. No concerns were noted. Additionally, I was not able to inspect berm due to Covid-19 health restrictions for entering the site. See photo #2

Bulk fuel storage at MEL camp, resupplied from Malvin bay tank farm.

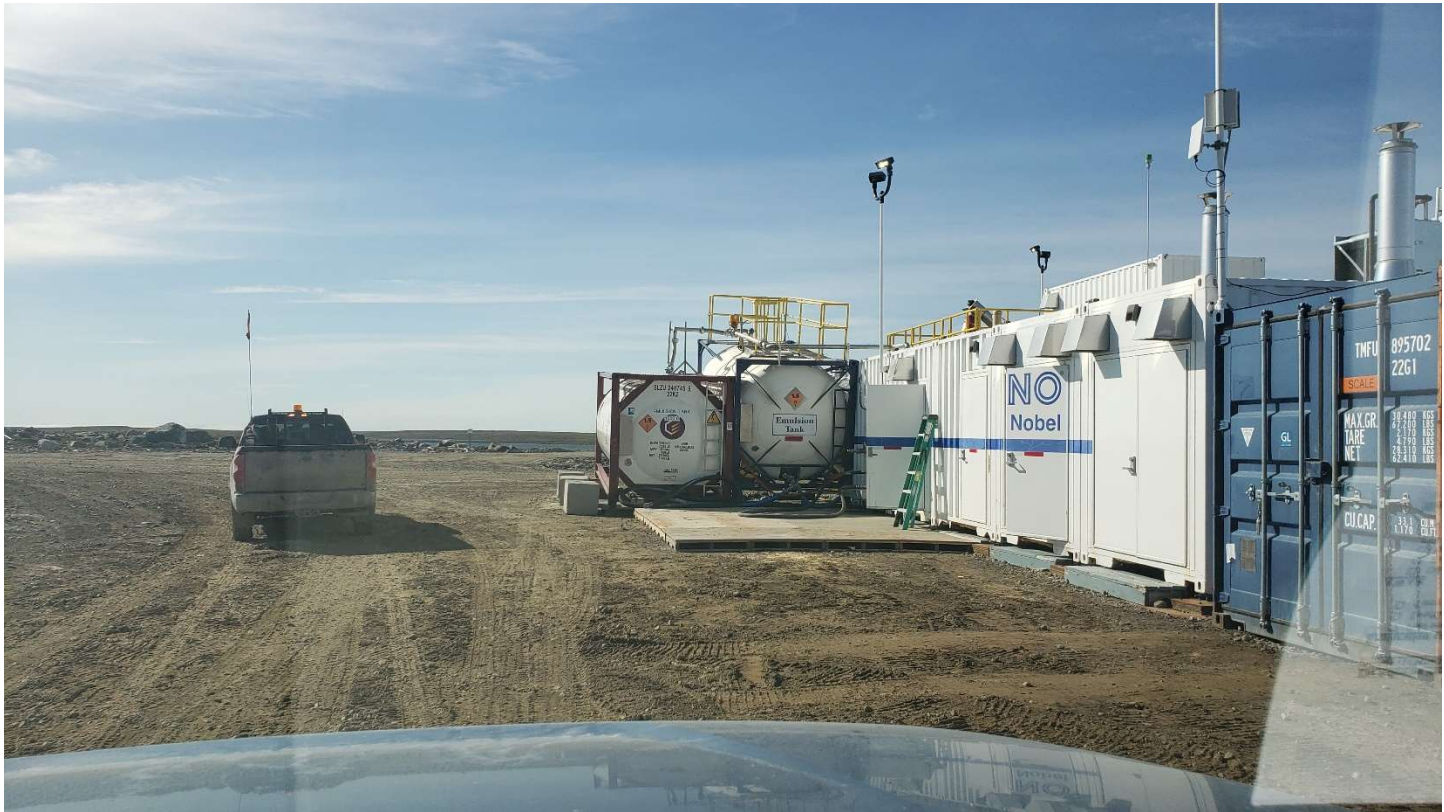
Photo #	Location (NAD 83 DD MM SS.SS)
3

- Spill kits available onsite. No concerns noted at filling stations. See photo #3
- Dry stack tailings:
 - It was observed that the tailings were packed and capped regularly. During the winter, contaminated snow on tailings site was used to keep the dust down and moisten tailings. No concerns noted at site. See photo #4

Description	
Emulsion transfer area
