WATER LICENCE INSPECTION FORM

Licensee	Licensee Representative
Agnico Eagle Mines Limited	Matt Gillman
Licence No. / Expiry	Representative's Title
2AM-MEL1631/ March 31 st , 2031	Environment Superintendent
Date of Inspection	Inspector
July 12 th , 13 th and 19 th	WRO Wilson
Activities Inspected	
<div><div><input type="checkbox"/> Camp</div><div><input type="checkbox"/> Drilling</div><div><input checked="" type="checkbox"/> Mining</div><div><input type="checkbox"/> Construction</div><div><input type="checkbox"/> Reclamation</div><div><input type="checkbox"/> Fuel Storage</div></div> <div><div><input type="checkbox"/> Roads/Hauling</div><div><input type="checkbox"/> Other: Spill</div><div><input type="checkbox"/> Other:</div></div>

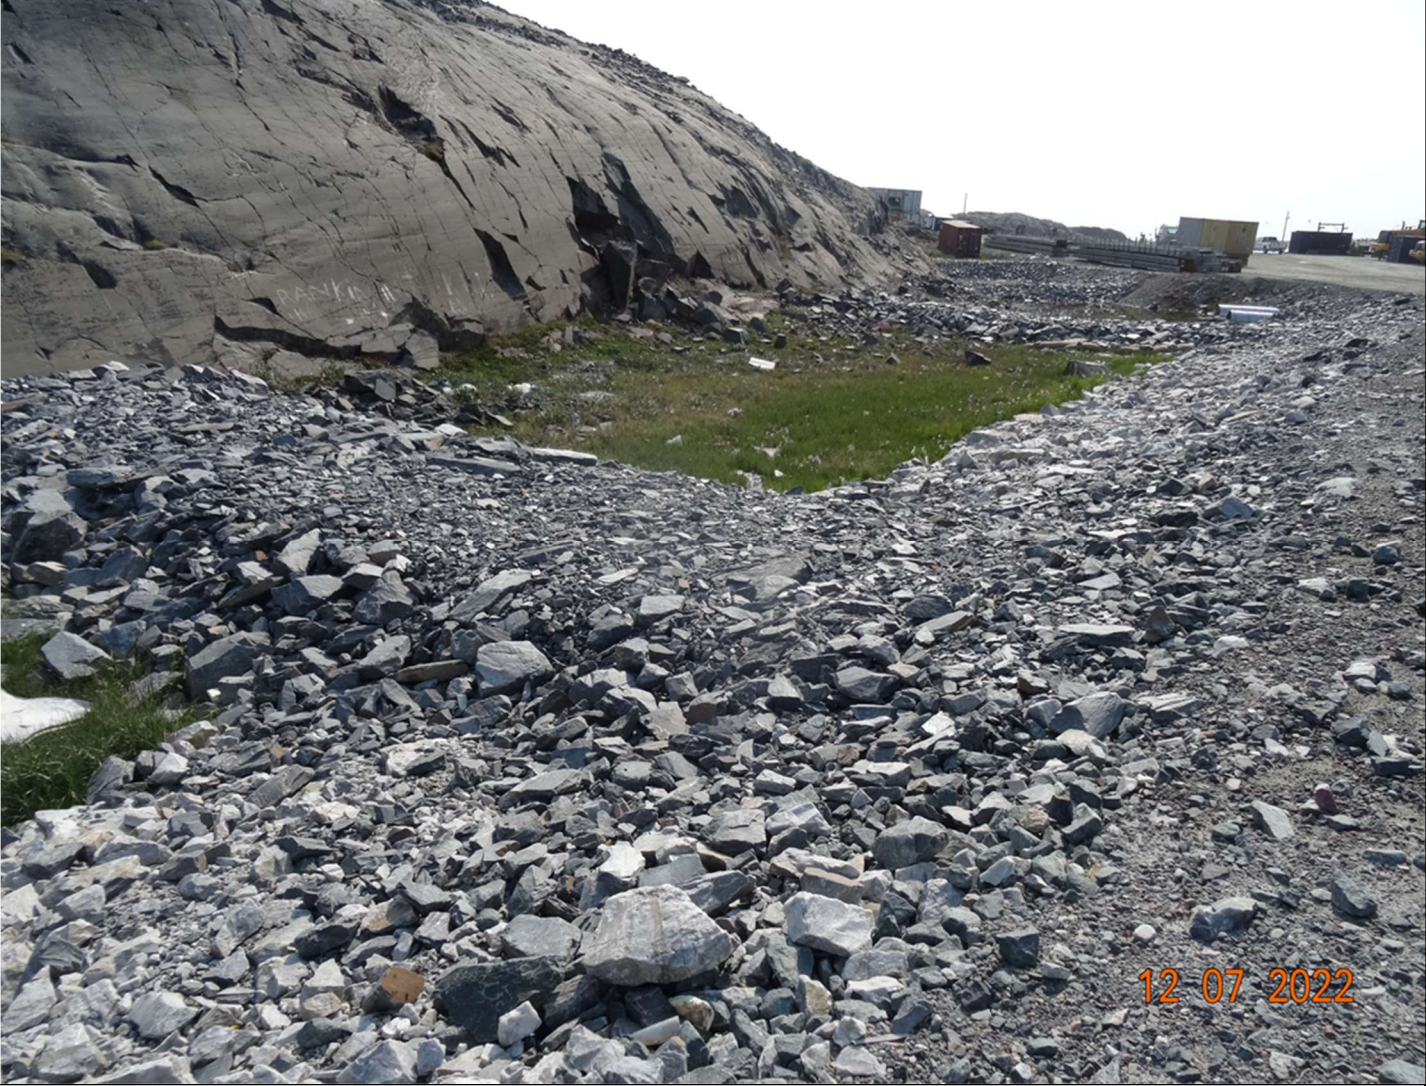
Date:	Authorization Number:	Camera/Model:	Inspector
July 12-13 and 19, 2022	2AM-MEL1631	Sony DSC-HX50V	C. Wilson
Photo No.	Lat/Long (DD.MM.SS.SS, NAD83)		
Photo 1	N62° 48' 2.26", W92° 5' 36.55"

Check dams to address sediment issues identified at sampling station MEL-SR1.

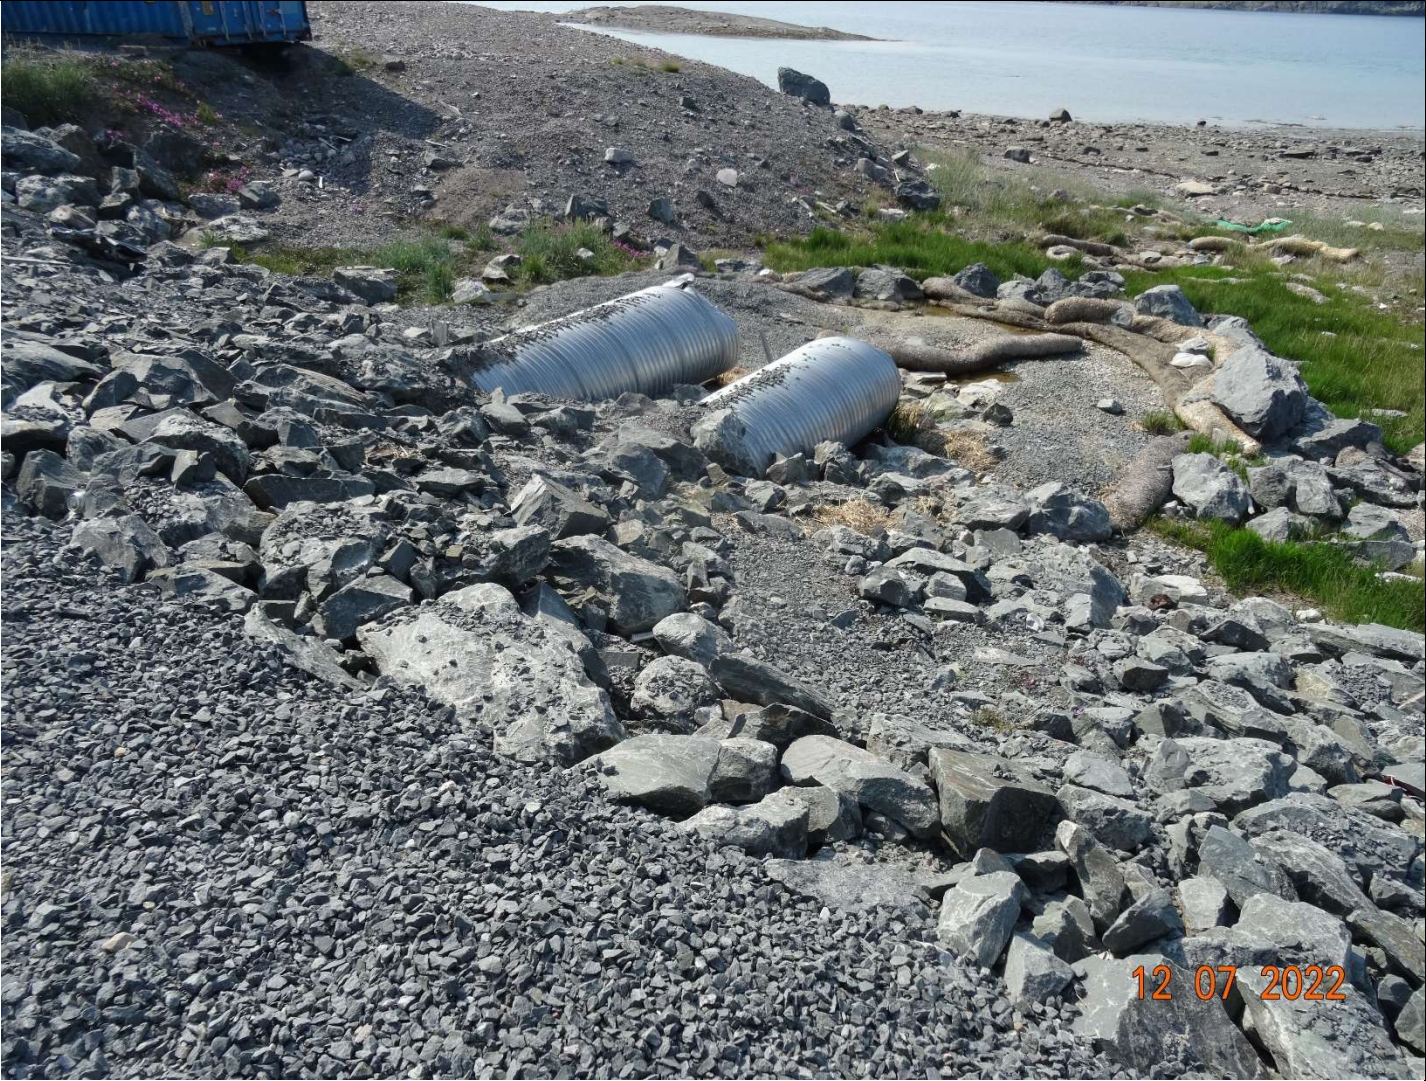
Photo No.	Lat/Long (DD.MM.SS.SS, NAD83)
Photo 2	N62° 48' 0.29", W92° 5' 35.23"

Description: MEL-SR1 Area

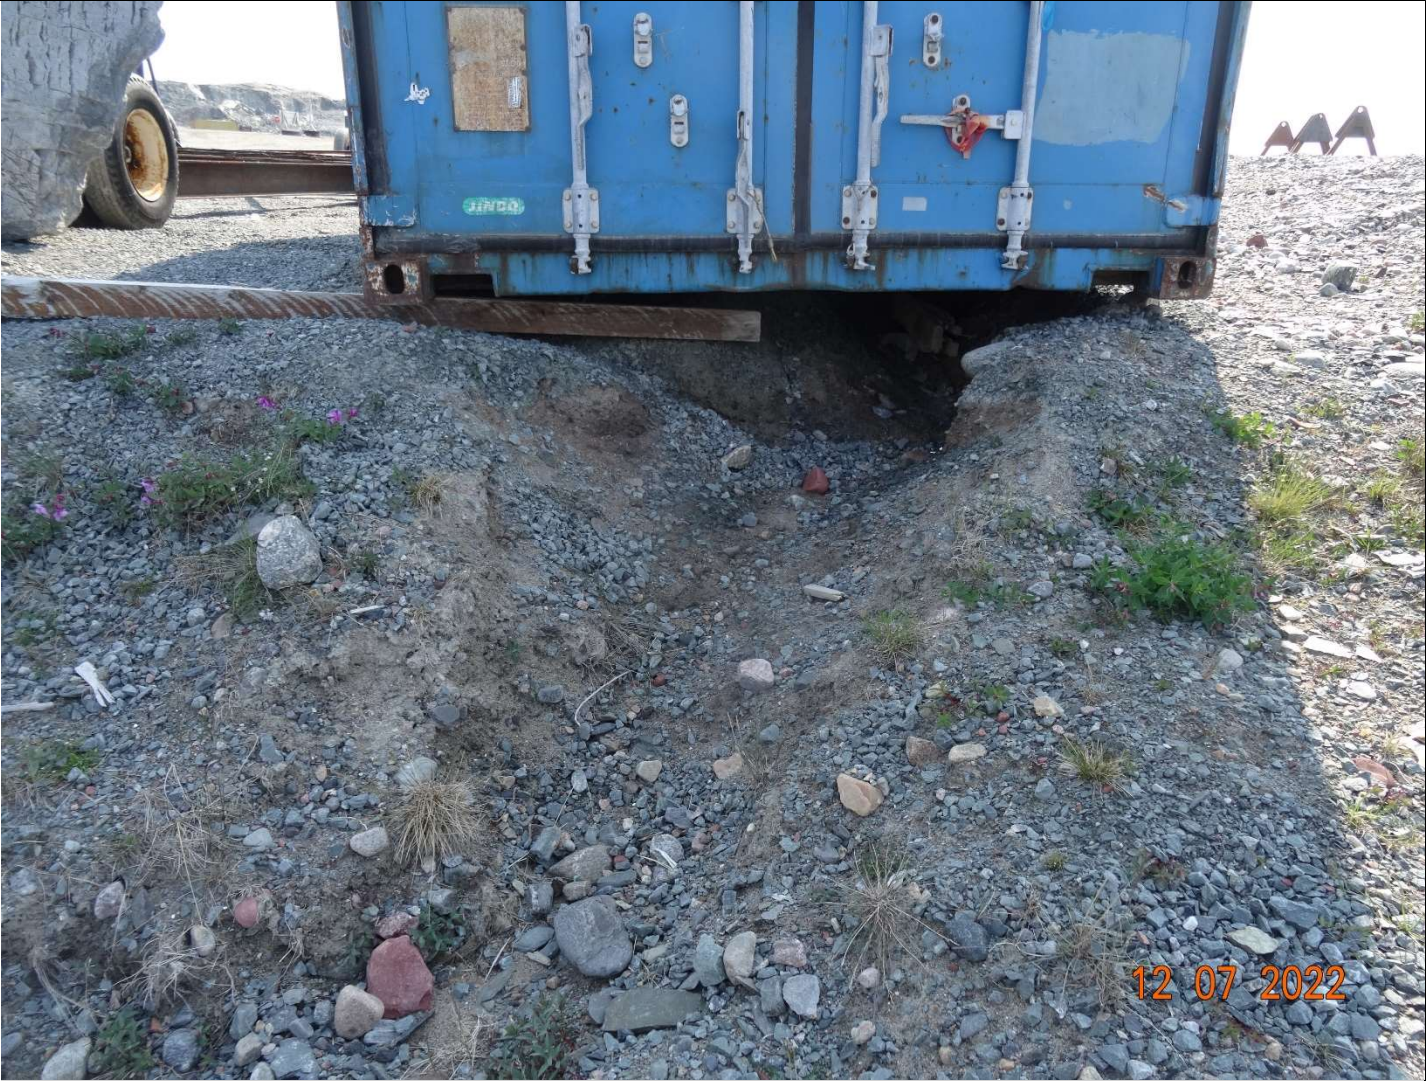
Photo No.	Lat/Long (DD.MM.SS.SS, NAD83)
Photo 3	N62° 47' 58.50", W92° 5' 33.31"

Description:
Erosion and sedimentation East of MEL-SR1

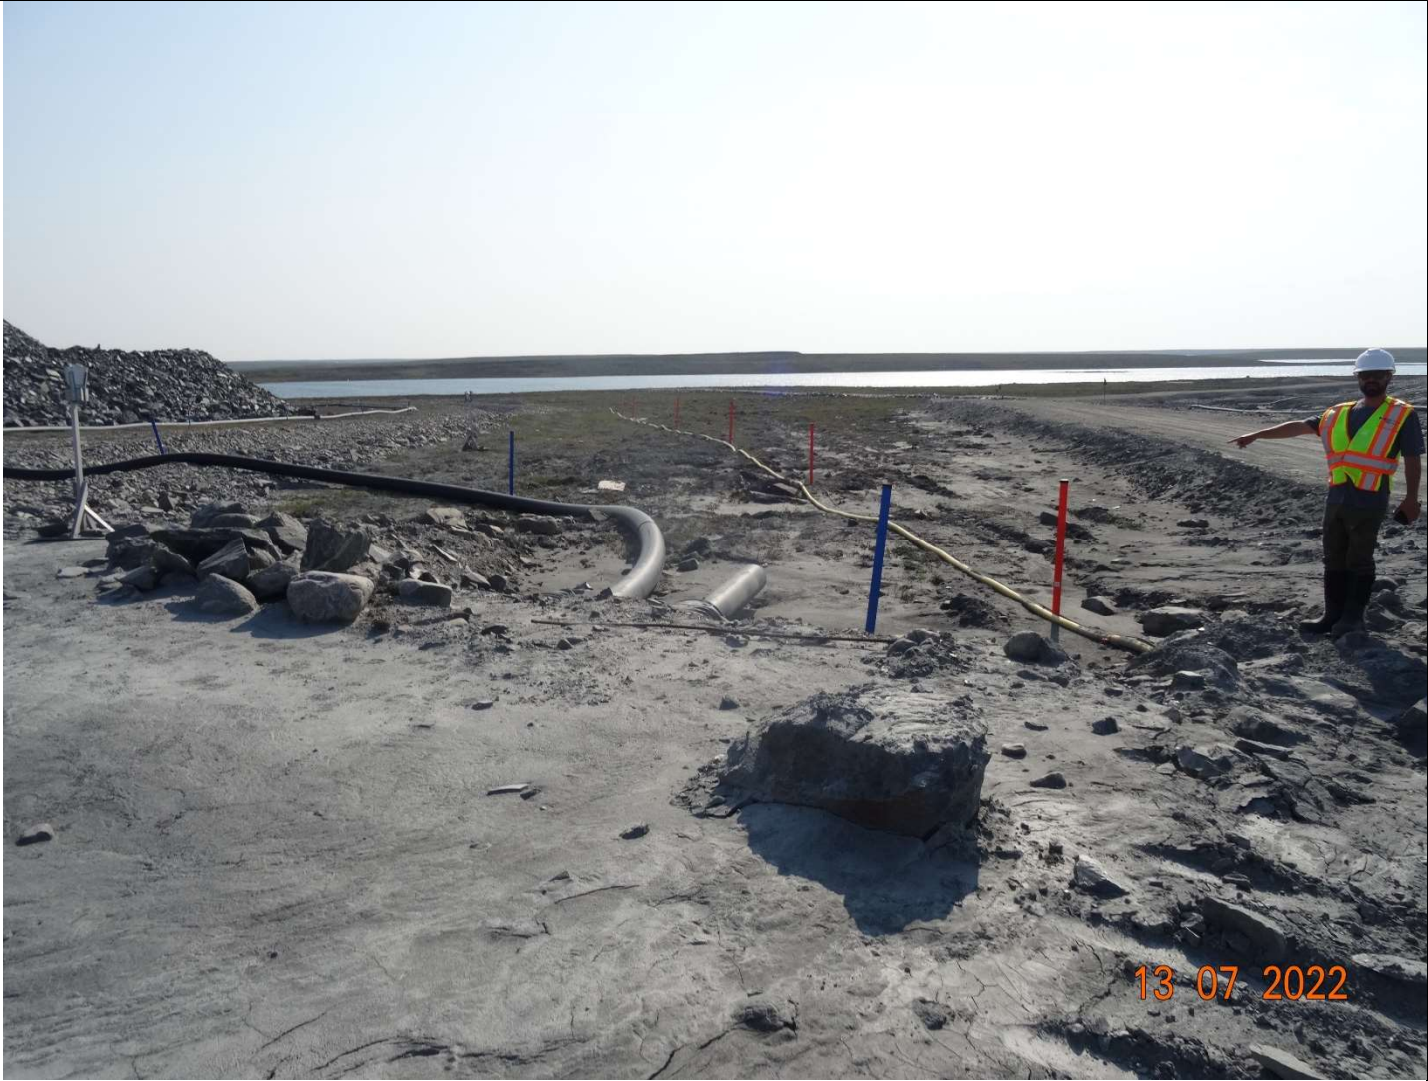
Photo No.	Lat/Long (DD.MM.SS.SS, NAD83)
Photo 4	N63° 2' 0.01", W92° 13' 48.03"

Description:
Unknow material outside the containment of the TSF along the Cp-3 Access Road.

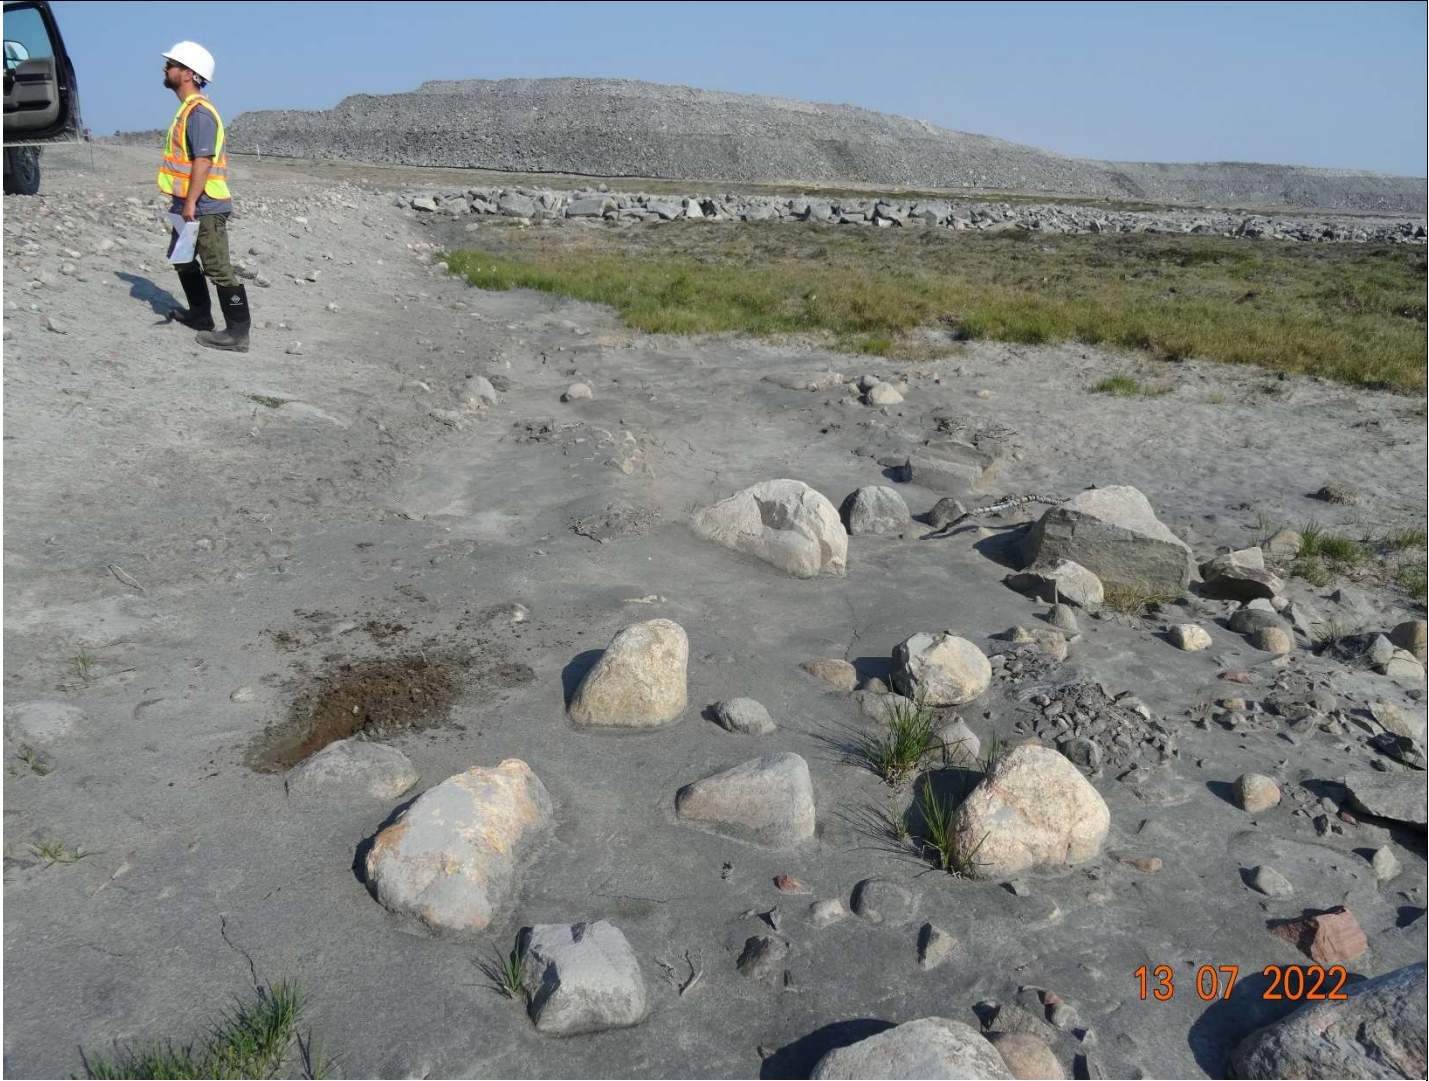
Photo No.	Lat/Long (DD.MM.SS.SS, NAD83)
Photo 5	N63° 1' 56.93", W92° 14' 6.34"

Description:
Unknown grey fine material outside outside of TSF containment along the CP-3 Access Road.

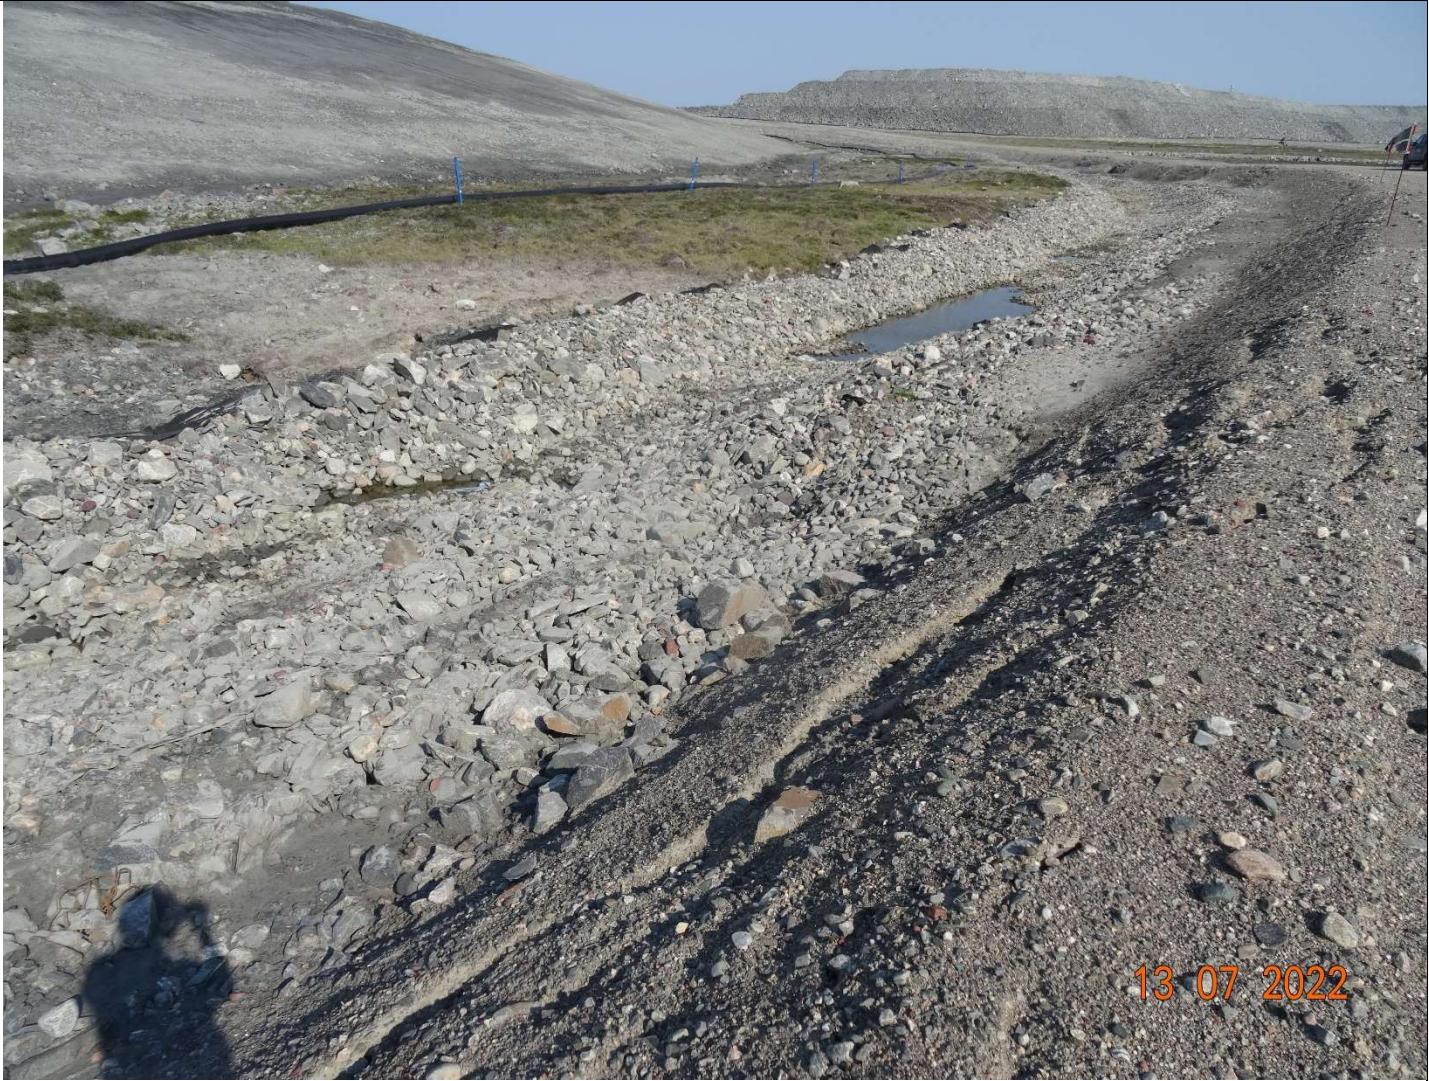
Photo No.	Lat/Long (DD.MM.SS.SS, NAD83)
Photo 6	N63° 1' 59.69", W92° 14' 17.24"

Description:
Channel 3, slouching, cracking and ponding water.

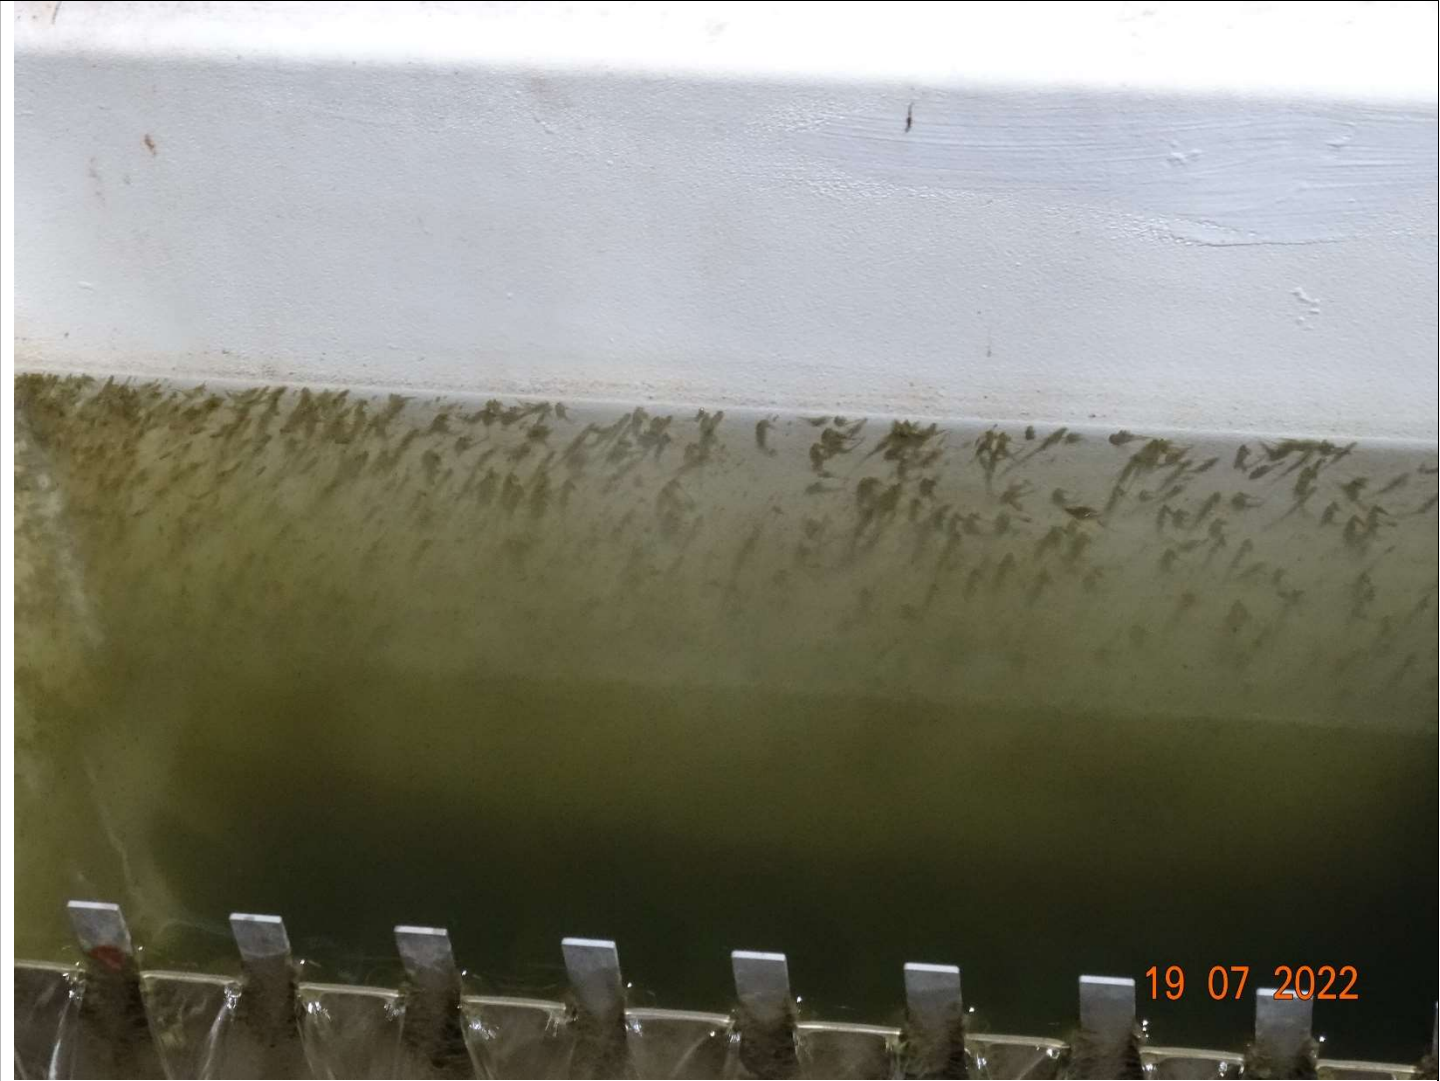
Photo No.	Lat/Long (DD.MM.SS.SS, NAD83)
Photo 8	Effluent Water Treatment Plant

Description:
Small aquatic life and green algae like material in EWTP.
