Water Licence Inspection Report

Authorization	Representative
Agnico Eagle Mines Ltd.	Kyle Conway
Authorization No. / Expiry	Representative's Title
2AM-MEL1631	Environment General Supervisor
Inspection Date	Inspector
May 31, 2023	RMO Kyle Amsel
Other Authorization/s	
KVCA07Q08, KVCA11Q01, KVPL11D01, Project Certificate No. 6	
Activities Inspected	
<div><input checked="" type="checkbox"/> Camp, Commercial <input type="checkbox"/> Drilling <input checked="" type="checkbox"/> Mining <input checked="" type="checkbox"/> Construction <input type="checkbox"/> Reclamation <input checked="" type="checkbox"/> Fuel Storage <input checked="" type="checkbox"/> Roads/Hauling <input type="checkbox"/> Winter Hauling</div> <div><input type="checkbox"/> Camp, Private <input type="checkbox"/> Other Click or tap here to enter text.</div>

The primary focus of this inspection was water management during freshet.

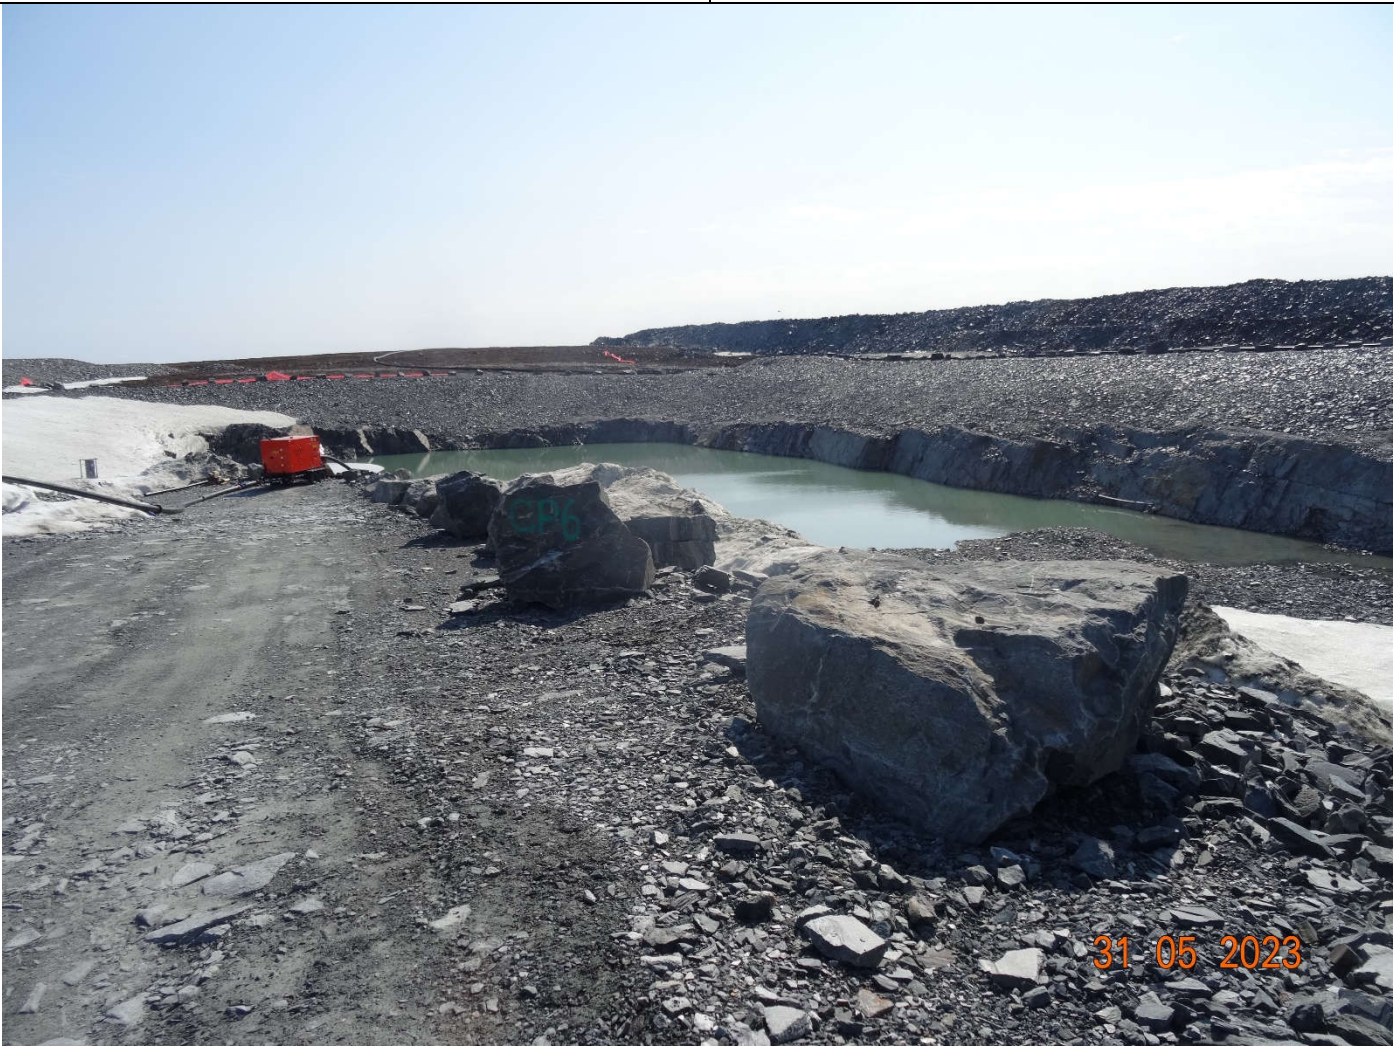
Photo 8

g. CP6, no pumping is occurring. Water from this area reports to CP1. (Photo 8)

Description:
Containment Pond 6/CP6

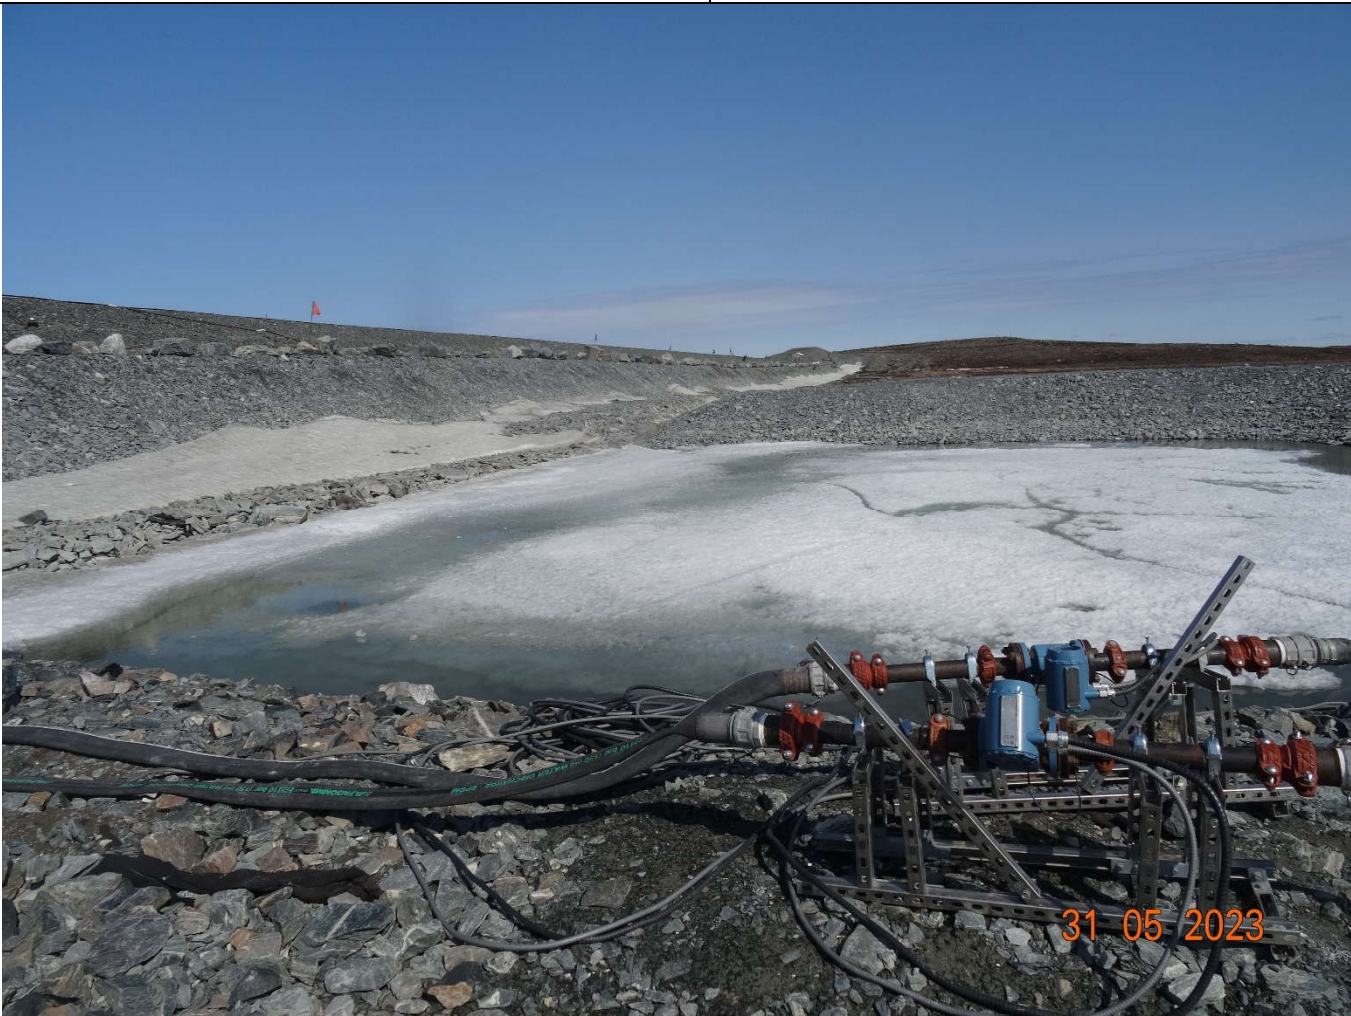
Photo No.
Photo 9

4. Dyke for CP1. (Photo 9)

a. The structure restrains water into CP1.

b. A trench and sump have been dug on the downstream toe of the structure. At the time of Inspection no pumping was occurring.

Description:
Dyke for Containment Pond 1. Photo from toe of structure with sump in foreground.

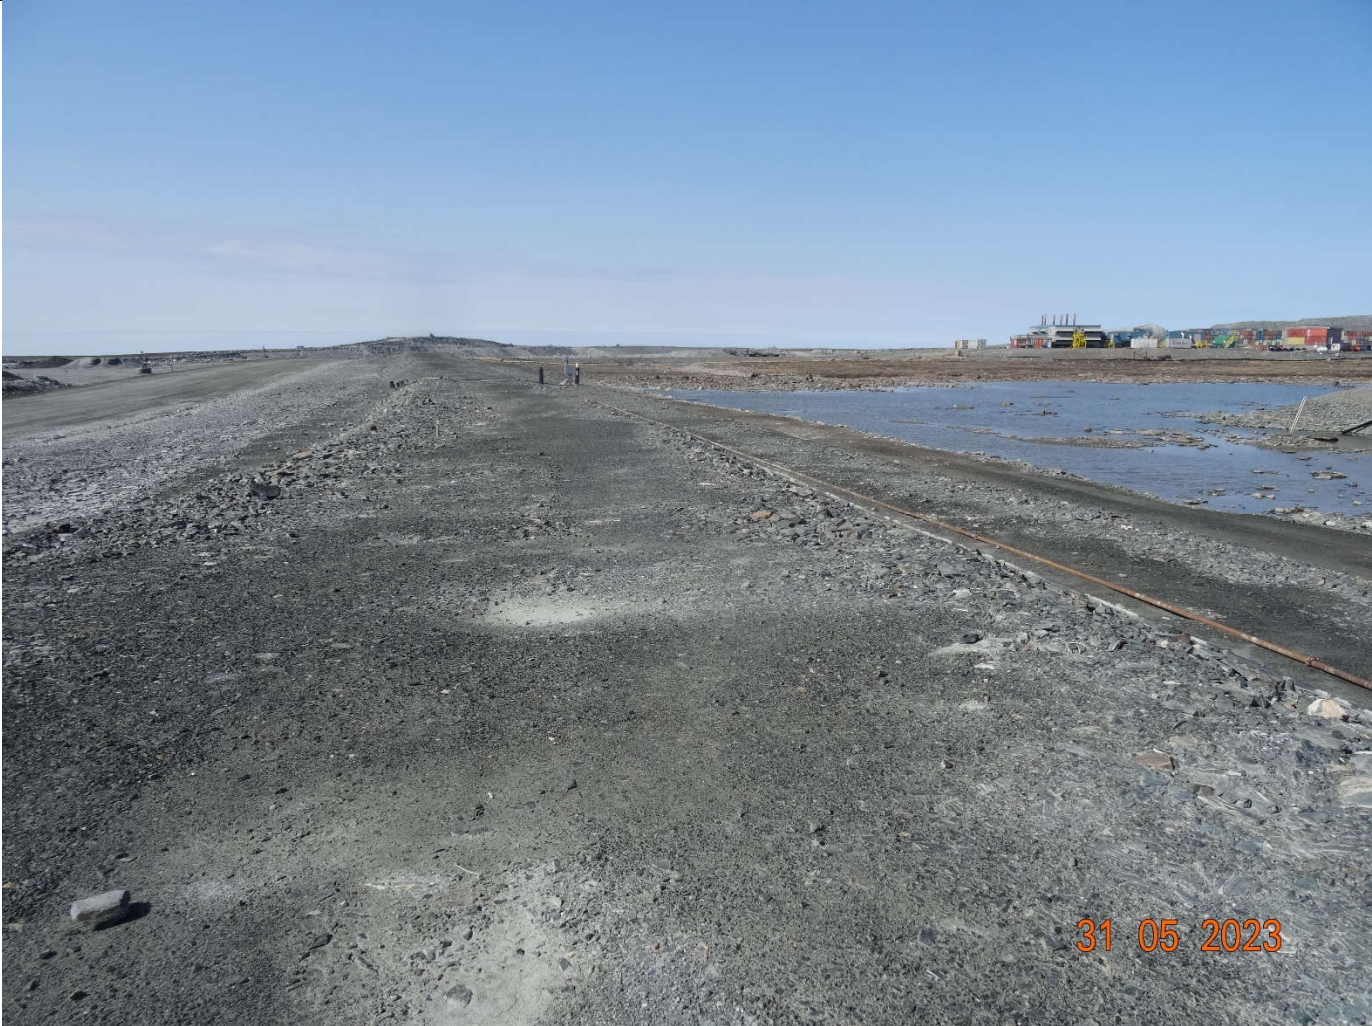
Photo No.
Photo 10

5. Dyke for CP5. (Photo 10)

a. This structure restrains water into CP5.

b. At the time of Inspection no water was near the dyke.

c. A collection sump or trench is not present on this structure as any potential seepage would report into the nearby open pit.

Description:
Dyke for Containment Pond 5. Photo taken from top of structure with pond on right.

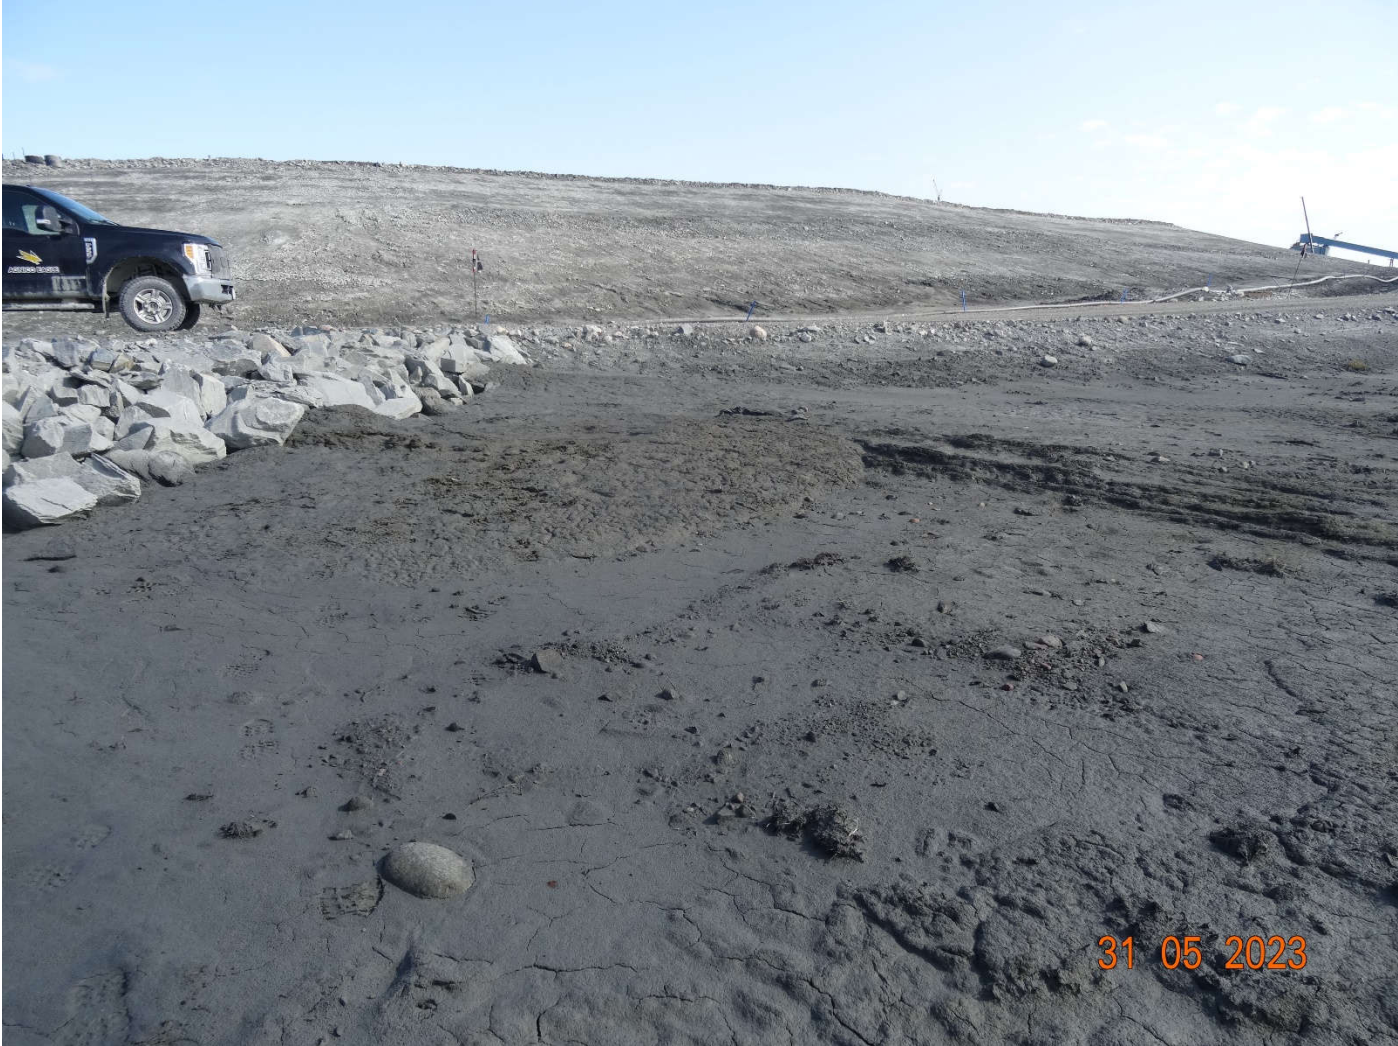
Photo No.	Lat/Long (DD.MM.SS.SS, NAD83)
Photo 11	N63 1' 56.6" W92 14' 3.1"

6. CP3 Channel and Fine Grain Material (Photo 11)

a. The area with fine grey material referenced in previous inspection report 2022-KIV05-CW was inspected. No new material was apparent.

Description:
Fine grain material located opposite road from CP3 Channel.

b. Representatives stated that AEM is committing to begin construction on the CP3 Channel and covering of fine grain material on June 12, 2023.

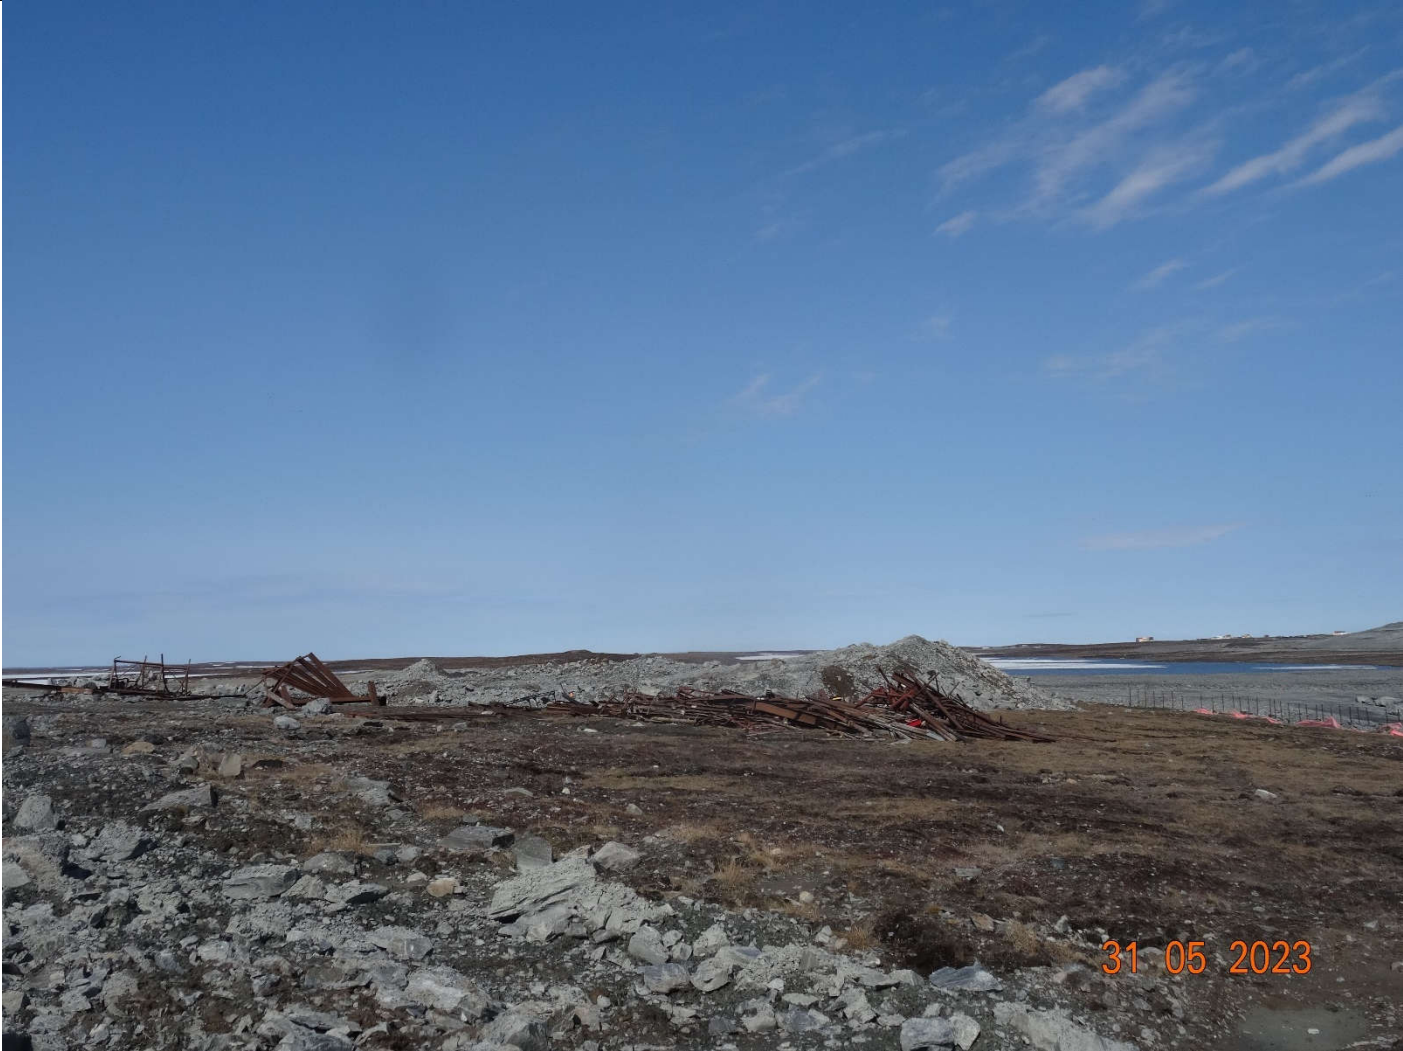
Photo No.	Lat/Long (DD.MM.SS.SS, NAD83)
Photo 12	N63 1' 27.6" W 92 13' 33.9"

a. A large pile of steel appears to have been deposited near CP4 which was not present on last Inspection.

Description:
Pile of scrap steel identified during Inspection.

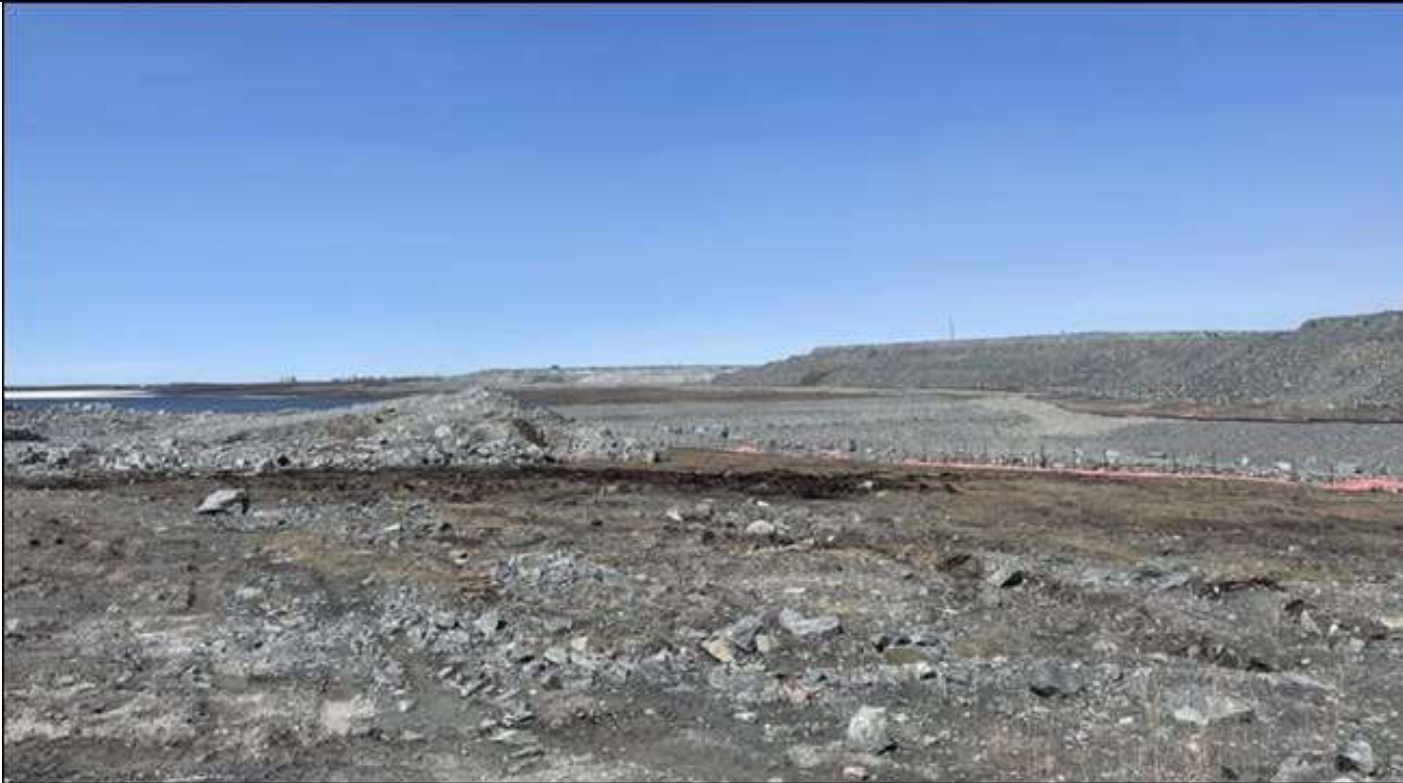
Photo No.	Lat/Long (DD.MM.SS.SS, NAD83)
Photo 13	NA

b. On June 5, 2023 Representative sent photos showing the steel has been removed from the area.
8. Representative presented a printed copy of the water licence to the Inspector satisfying Part B Item 3 of the Licence.
9. At the time of Inspection water usage as calculated at MEL-11 water totalizer from the proceeding midnight is 1,292,897m³
10. Reverse Osmosis Plant (RO) (Photo 14 & 15)

Description:
Area where scrap steel was cleaned up by Licensee.
