Water Licence Inspection Report

Authorization	Representative
Agnico Eagle Mines Ltd.	John Beachler
Authorization No. / Expiry	Representative's Title
2AM-MEL1631	Environment General Supervisor
Inspection Date	Inspector
May 22, 2024	RMO Kyle Amsel
Other Authorization/s	
KVCA07Q08, KVCA11Q01, KVPL11D01, Project Certificate No.:006	
Activities Inspected	
<input checked="" type="checkbox"/> Camp, Commercial <input type="checkbox"/> Drilling <input checked="" type="checkbox"/> Mining <input checked="" type="checkbox"/> Construction <input type="checkbox"/> Reclamation <input checked="" type="checkbox"/> Fuel Storage <input checked="" type="checkbox"/> Roads/Hauling <input type="checkbox"/> Winter Hauling <input type="checkbox"/> Camp, Private <input type="checkbox"/> Other <a href="#">Click or tap here to enter text.</a>

On May 22, 2024 Resource Management Officer Kyle Amsel (Inspector) for Crown-Indigenous Relations and Northern Affairs Canada conducted an Inspection of Water Licence 2AM-MEL1631 (Licence) issued to Agnico Eagle Mines Ltd. (Proponent) for use of water and deposit of waste in support of a mining undertaking (Undertaking).

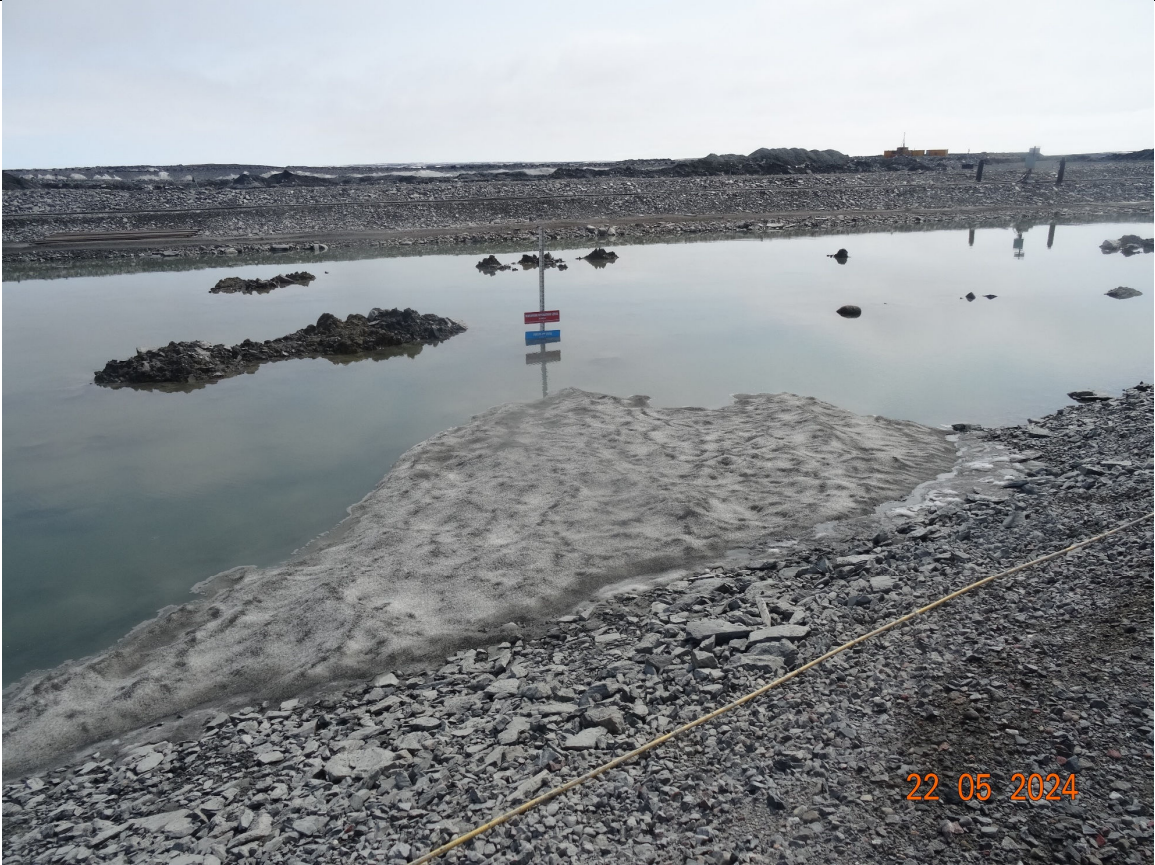
Photo No.	Lat/Long (DD.MM.SS.SS, NAD83)
Photo 4	N63° 1' 30.2" W92° 12' 14.3"

b) New signage is installed at Containment Pond 5 as a visual reference to de-watering crews (Photo 4)

**Description:**  
New signage in Containment Pond 5 to assist dewatering crews.

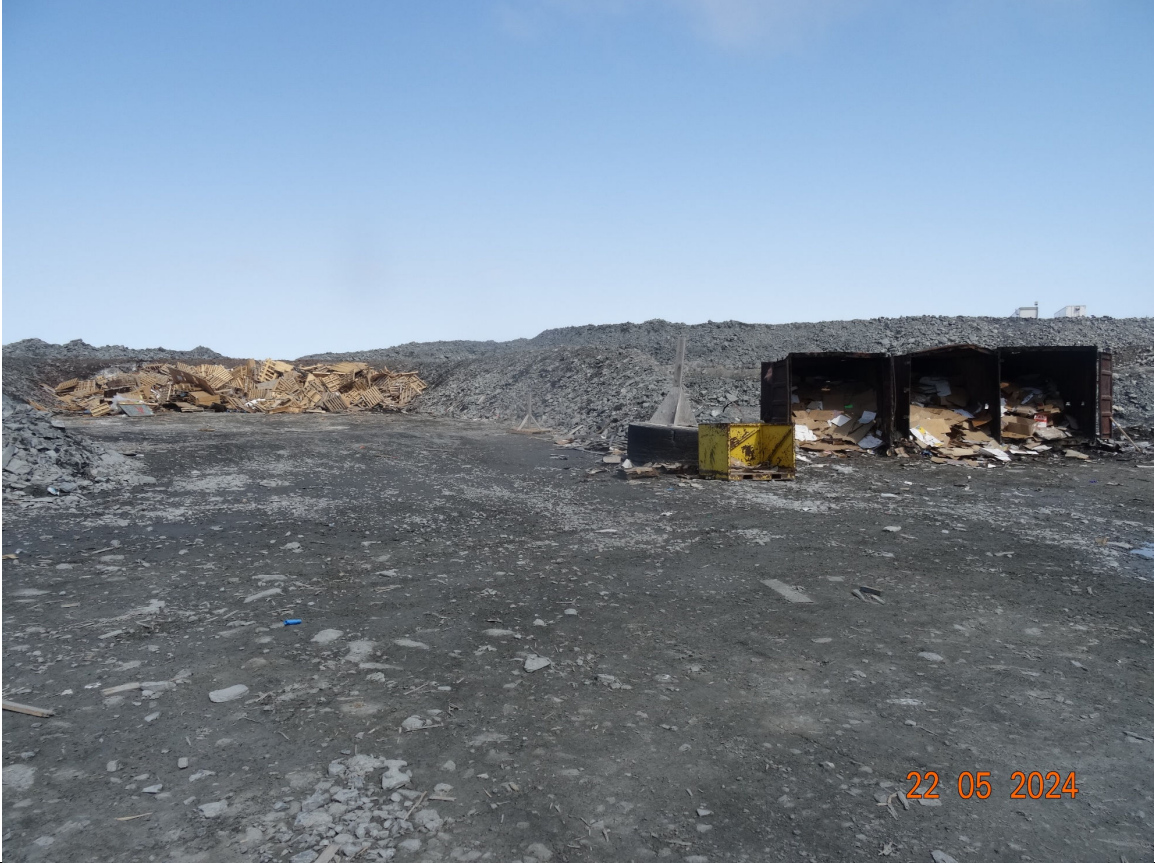
Photo No.	Lat/Long (DD.MM.SS.SS, NAD83)
Photo 5	N63° 1' 39.5" W92° 11' 50.0"

a) The Open burn pad is used for burning of clean wood and cardboard as well as Cyanide bags used in the milling process which is customary under the International Cyanide Code. During the inspection the Inspector noted pieces of plastic wrap from the pallets were in the burn pile. This is non-compliant with Part F Item 16 of the Licence which states “The Licensee shall not open burn plastics, wood treated with preservatives, electric wire, Styrofoam, asbestos or painted wood to prevent the deposition of waste materials of incomplete combustion and/or leachate from contaminated ash residual, from impacting any surrounding Waters, unless otherwise approved by the Board in writing.”

**Description:**  
Open burn area. Some plastic was identified in the area which is not permitted to be burned.

-Not open burn any plastics.
