Water Licence Inspection Report

Authorization	Representative
Agnico Eagle Mines Ltd.	John Beachler
Authorization No. / Expiry	Representative's Title
2AM-MEL1631	Environment General Supervisor
Inspection Date	Inspector
September 5, 2024	RMO Kyle Amsel
Other Authorization/s	
KVCA07Q08, KVCA11Q01, KVPL11D01, Project Certificate No.:006	
Activities Inspected	
<input checked="" type="checkbox"/> Camp, Commercial <input type="checkbox"/> Drilling <input checked="" type="checkbox"/> Mining <input checked="" type="checkbox"/> Construction <input type="checkbox"/> Reclamation <input checked="" type="checkbox"/> Fuel Storage <input checked="" type="checkbox"/> Roads/Hauling <input type="checkbox"/> Winter Hauling <input type="checkbox"/> Camp, Private <input type="checkbox"/> Other Click or tap here to enter text.

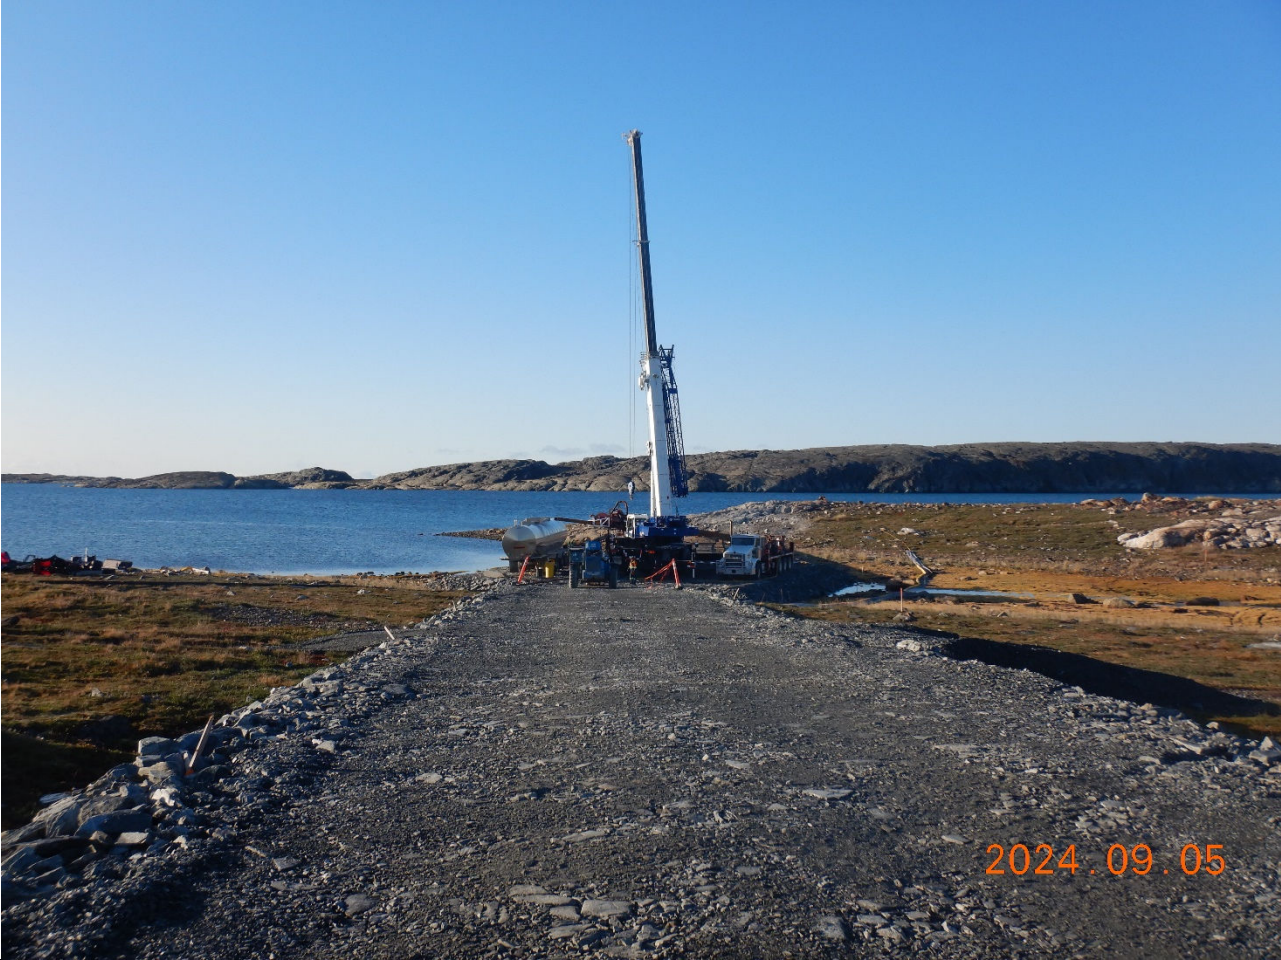
Photo No.	Lat/Long (DD.MM.SS.SS, NAD83)
Photo 2	NA

Description:
Laydown for horizontal drilling.
