Water Licence Inspection Report

Authorization	Representative
2AM-MEL1631	Kyle Conway
Authorization No. / Expiry	Representative's Title
March 31, 2031	Environment General Supervisor
Inspection Date	Inspector
March 13, 2025	RMO Kyle Amsel
Other Authorization/s	
KVCA07Q08, KVCA11Q01, KVPL11D01, Project Certificate No.:006	
Activities Inspected	
<input type="checkbox"/> Municipal <input checked="" type="checkbox"/> Camp, Commercial <input type="checkbox"/> Drilling <input checked="" type="checkbox"/> Mining <input checked="" type="checkbox"/> Construction <input type="checkbox"/> Reclamation <input checked="" type="checkbox"/> Fuel Storage <input checked="" type="checkbox"/> Roads/Hauling <input type="checkbox"/> Winter Hauling <input type="checkbox"/> Camp, Private <input type="checkbox"/> Other Click or tap here to enter text.

On March 13, 2025 Resource Management Officer Kyle Amsel (Inspector) for Crown-Indigenous Relations and Northern Affairs Canada conducted an Inspection of Water Licence 2AM-MEL1631 (Licence) issued to Agnico Eagle Mines Ltd. (Proponent) for use of water and deposit of waste in support of a mining undertaking (Undertaking).

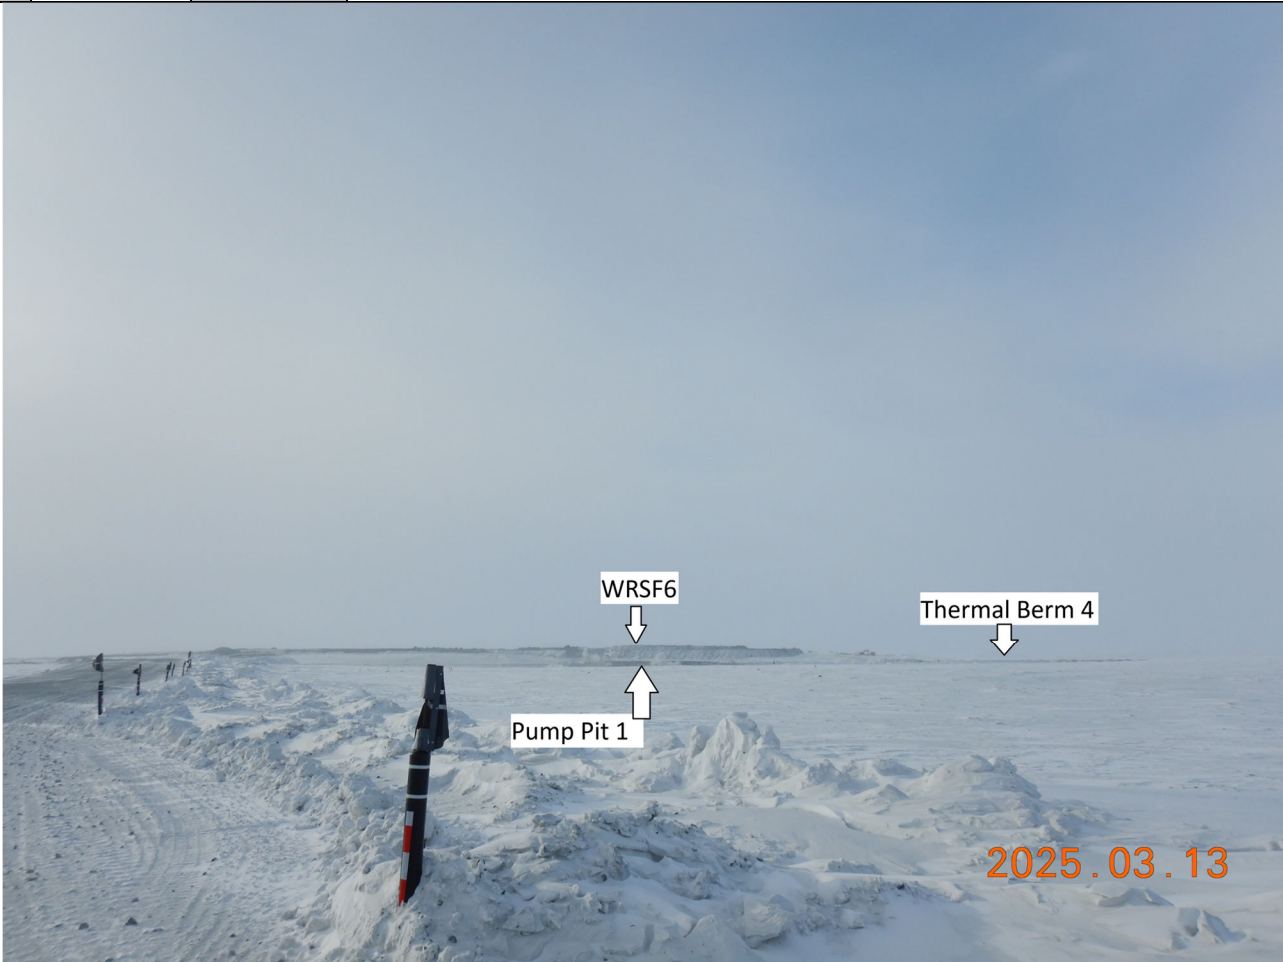
Photo #	Coordinates:
1	NA

1) Construction Activities. All noted structures in this part are under construction and will be inspected upon completion during freshet. (photo 1). Drawings were submitted as required under Part D of the Licence.

Description:
View of area under construction taken on Haul Road Southeast of main mine facing Southeast. See markup for details.

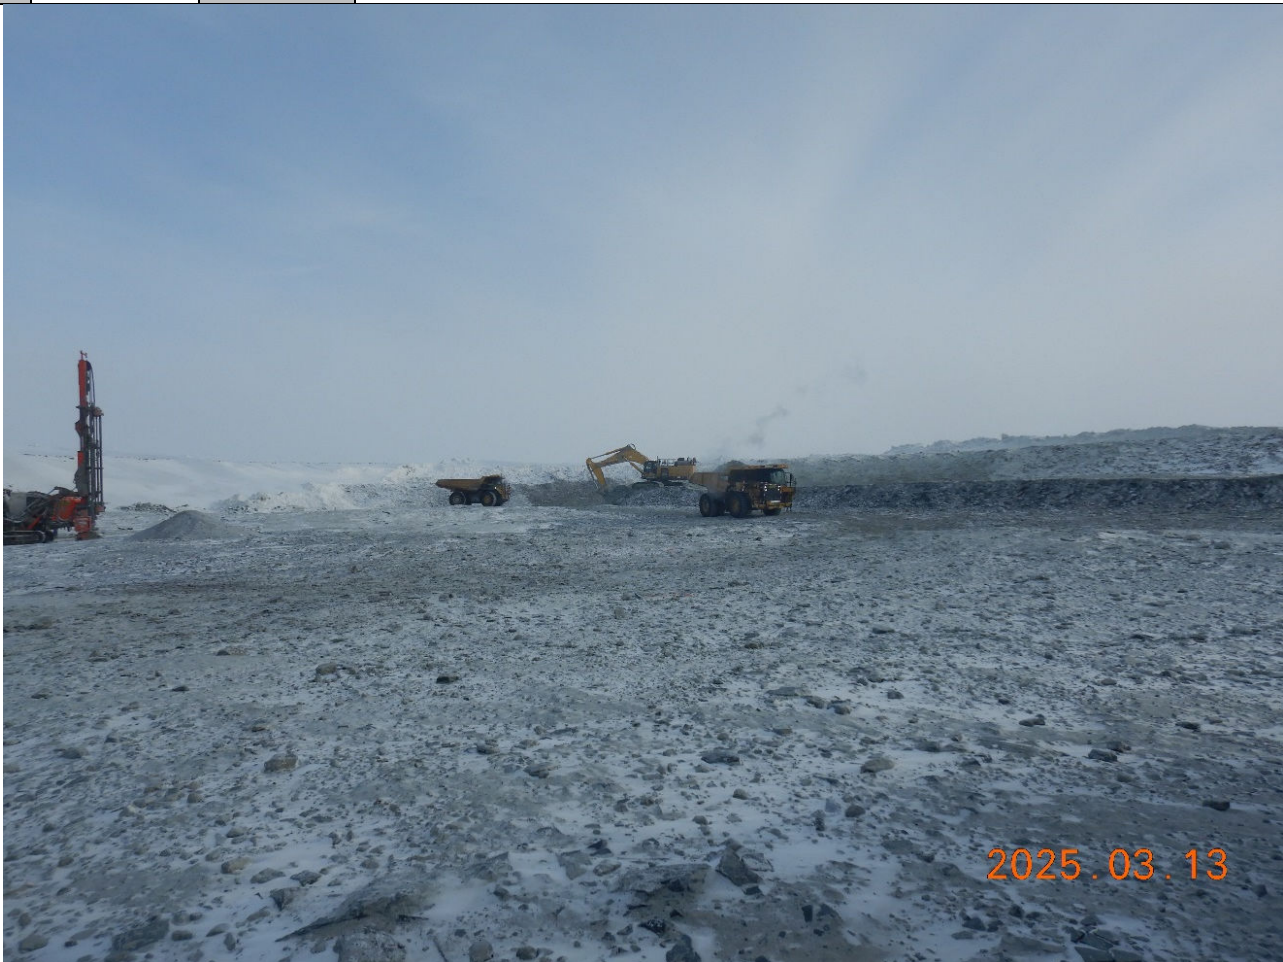
Photo #	Coordinates:
2	NA

i) The Proponents intention is to complete work at Pump 1 prior to freshet and mine out the pit. Upon completion of mining activities pump 1 will revert to Containment Pond (CP)9. The total depth of the pit will be 25m in 5m lifts. (photo 2)

Description:
Pump Pit 1. Note curent excavation.

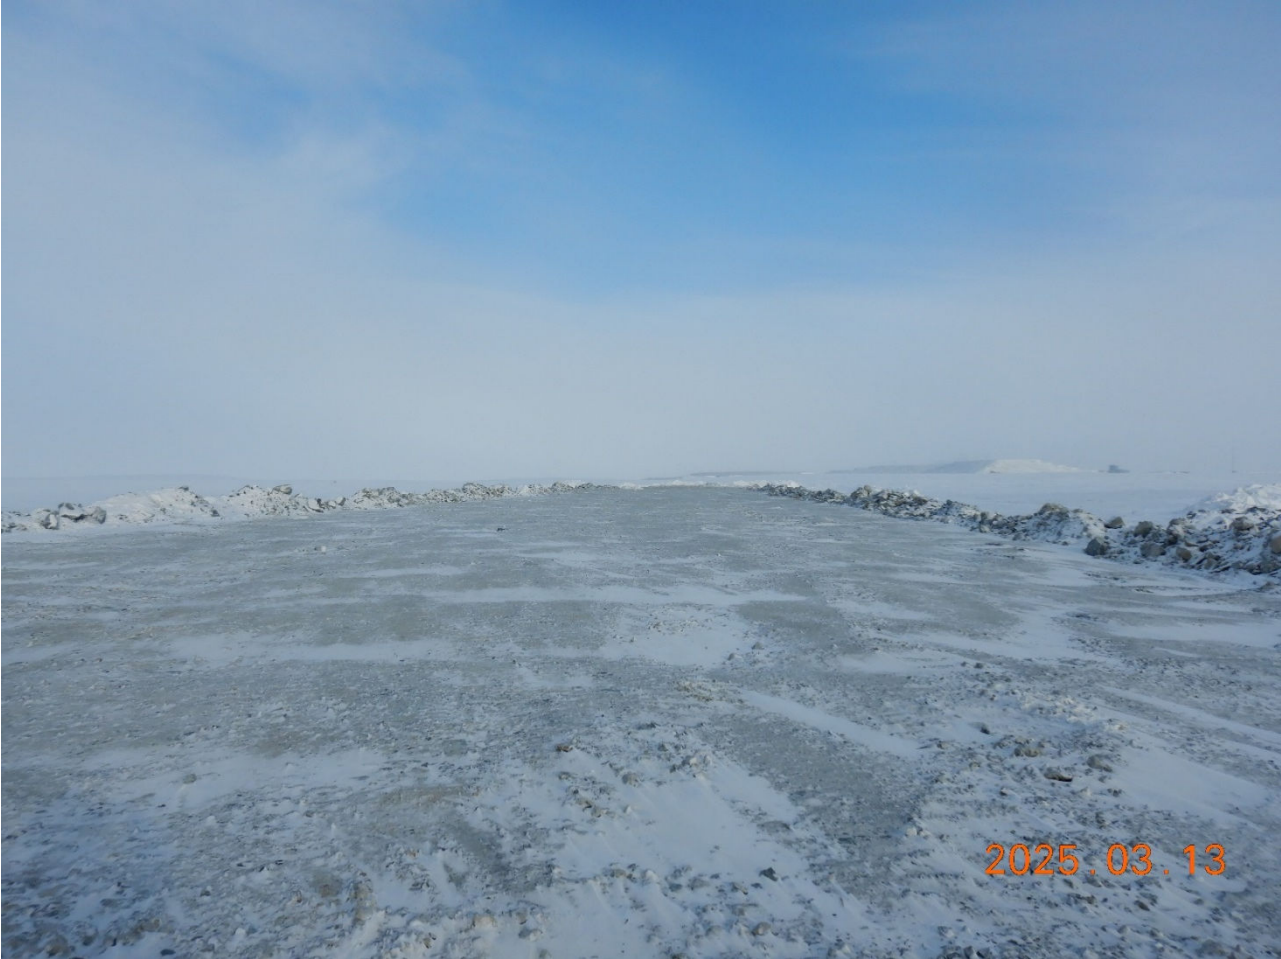
Photo #	4	Coordinates:	NA
---------	---	--------------	----

i) This berm is intended to prevent the active layer in the permafrost from degrading in summer months between CP9 and Lake B4. Should this infrastructure not be installed there is risk the contents of lake B4 could flow into CP9 with a reversed hydraulic gradient. (photo 4)

Thermal berm CP9. Note this is not final design form as additional lifts of material will be added along with capping.
