Water Licence Inspection Report

Authorization	Representative
2AM-MEL1631	Alexandre Langlais-Bourassa
Authorization No. / Expiry	Representative's Title
March 31, 2031	Supervisor, Environment
Inspection Date	Inspector
May 19, 2026	RMO Kyle Amsel
Other Authorization/s	
Activities Inspected	
<input type="checkbox"/> Municipal <input checked="" type="checkbox"/> Camp, Commercial <input type="checkbox"/> Drilling <input checked="" type="checkbox"/> Mining <input checked="" type="checkbox"/> Construction <input checked="" type="checkbox"/> Reclamation <input checked="" type="checkbox"/> Fuel Storage <input checked="" type="checkbox"/> Roads/Hauling <input type="checkbox"/> Winter Hauling <input type="checkbox"/> Camp, Private <input type="checkbox"/> Other Click or tap here to enter text.

PHOTO LOG

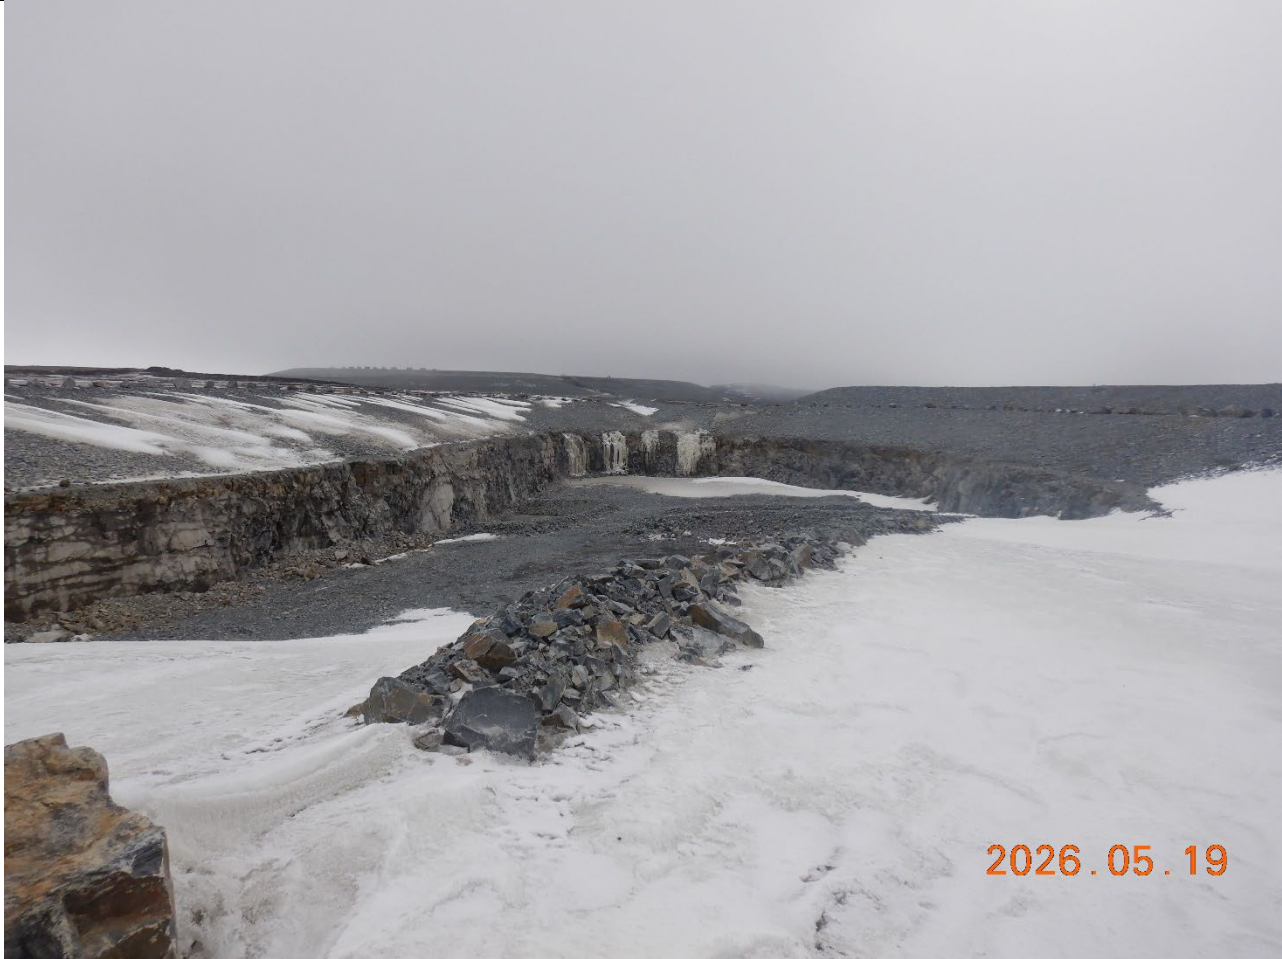
Date: May 19, 2026	Authorization Number: 2AM-MEL1631	Camera/Model: Nikon Coolpix	Inspector RMO AMSEL
Photo # 1	Coordinates: N63° 2' 22" W92° 15' 43"

Description:
CP8 completed

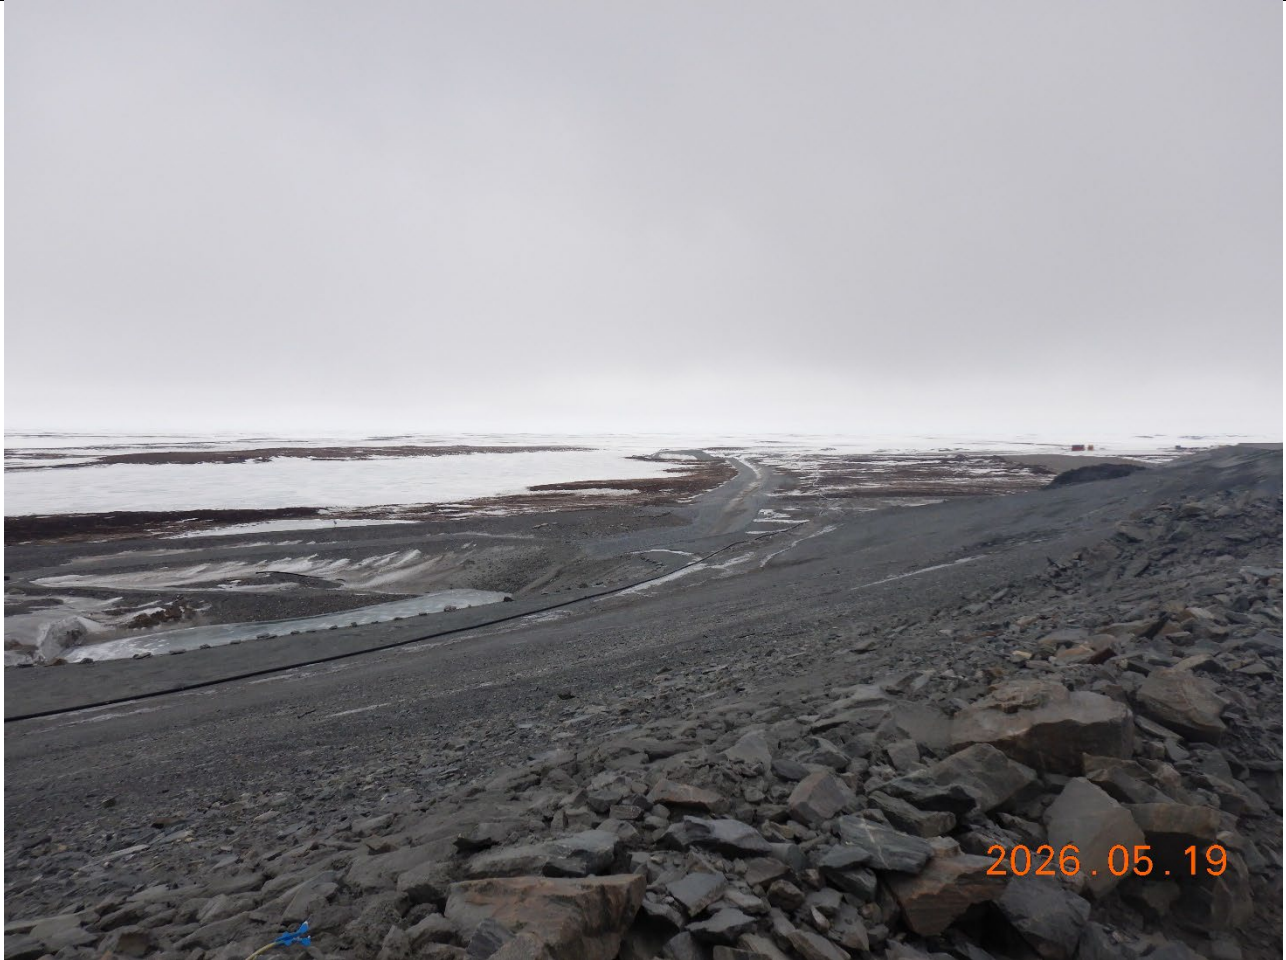
Photo #	2	Coordinates:	N63° 2' 7" W92° 14' 17"
----------------	---	---------------------	-------------------------

Description:
Channel 14 & 13. Channel 13 portion closest in photo, while 14 flows into distance.

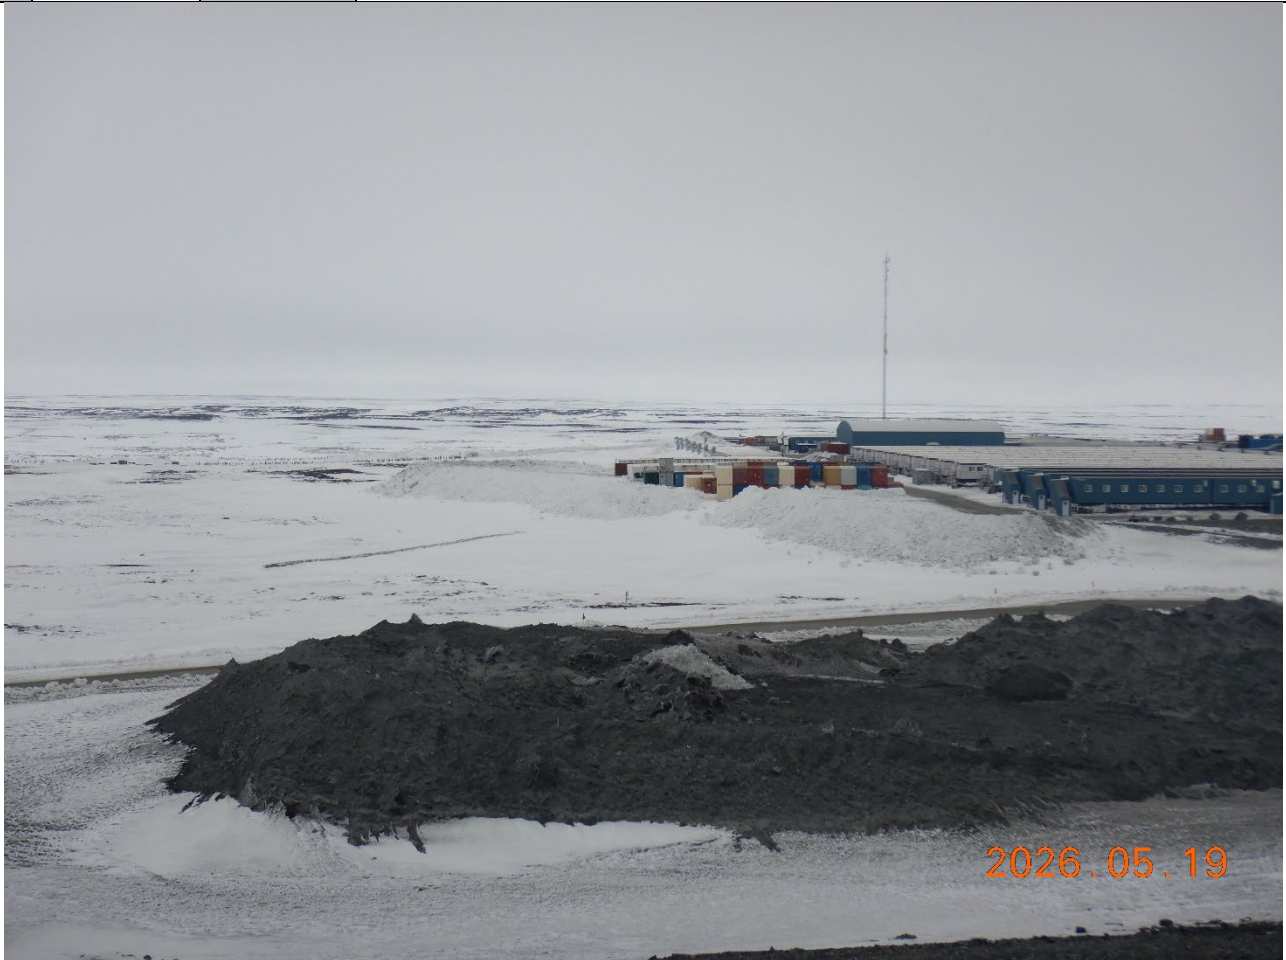
Photo #	3	Coordinates:	N63° 1' 13" W92° 13' 46"
----------------	---	---------------------	--------------------------

Description:
Brown piles in forefront of photo Tailings Facility Snow Dumps. Snow dumps in distance near buildings from accommodations. All report to CP1.

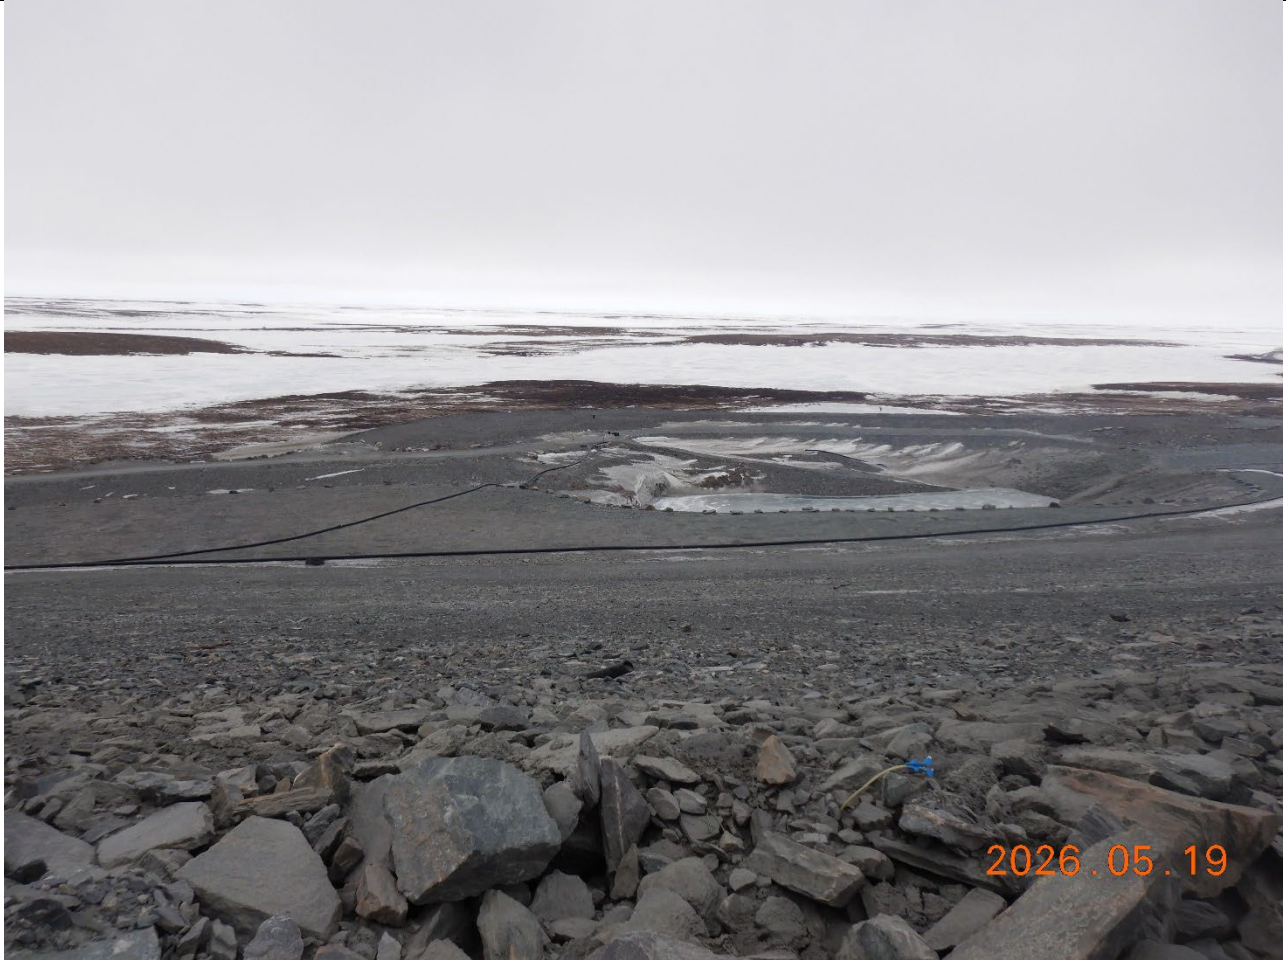
Photo # 4 Coordinates: N63° 2' 7" W92° 14' 17"

CP3.

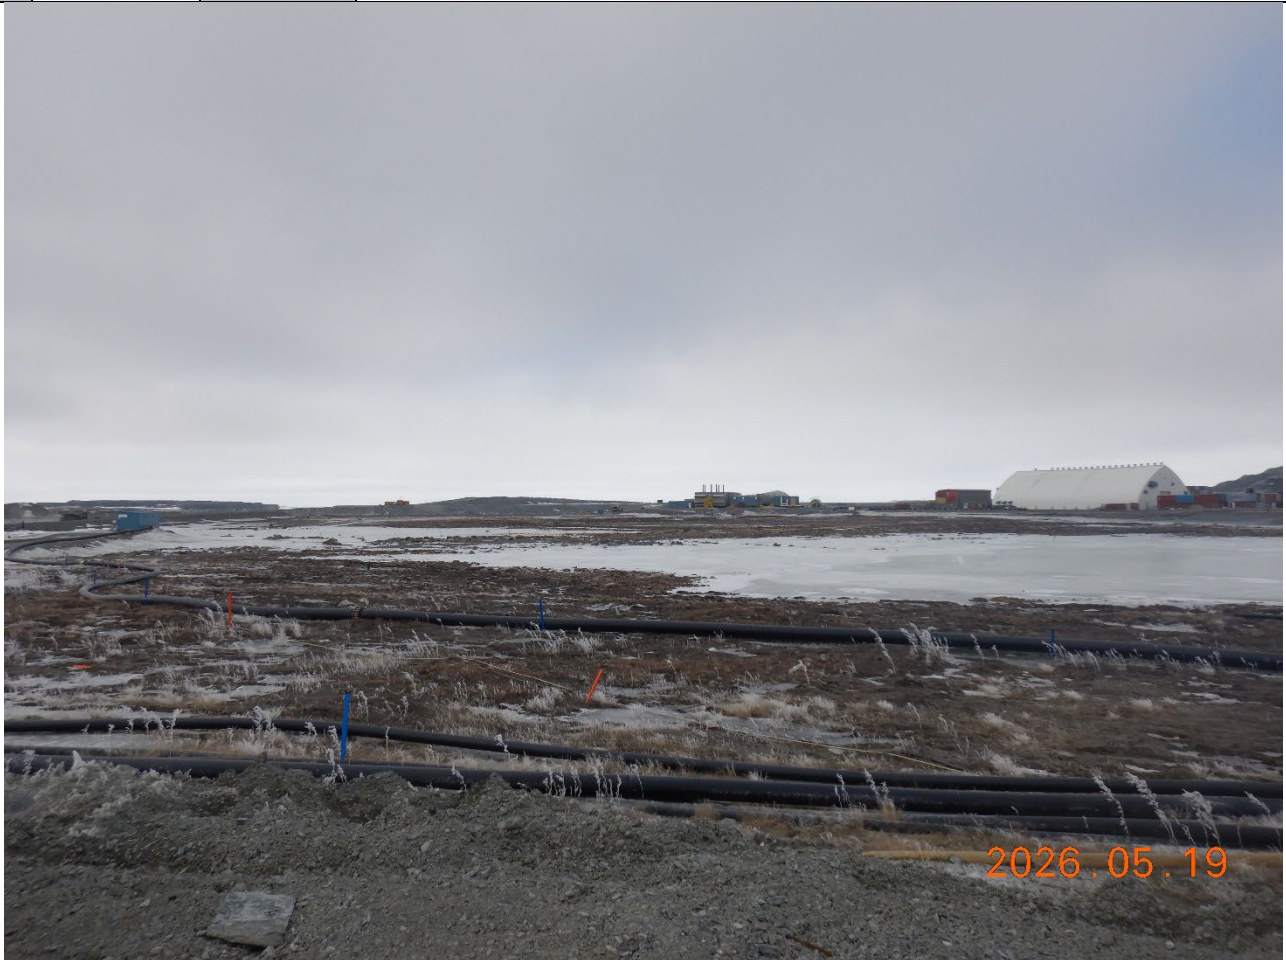
Photo # 5 Coordinates: N63° 1' 37" W92° 12' 9"

CP5.

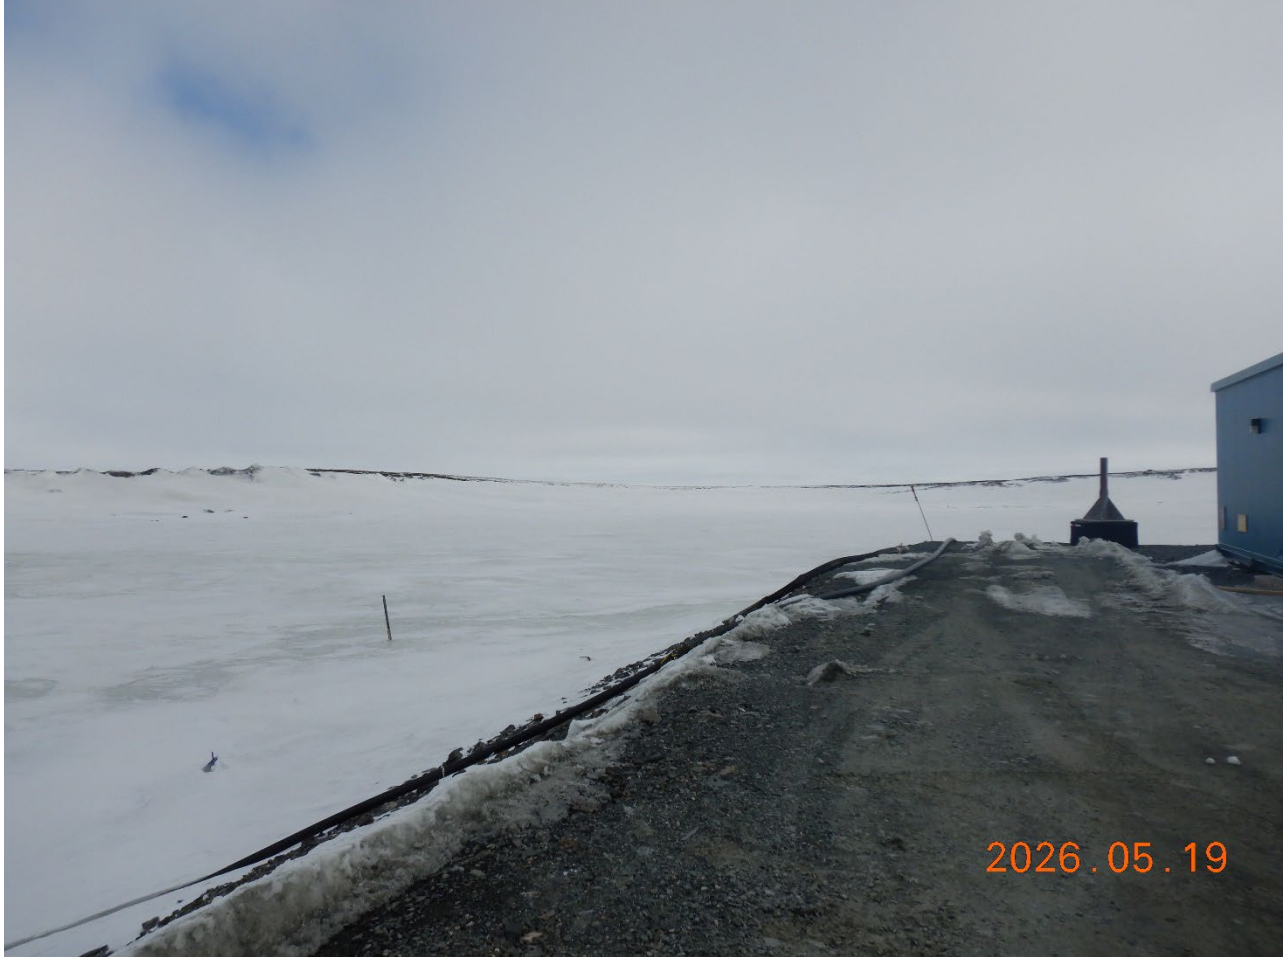
Photo #	6	Coordinates:	N63° 2' 13" W92° 12' 55"
----------------	---	---------------------	--------------------------

Description:	CP1
---------------------	-----

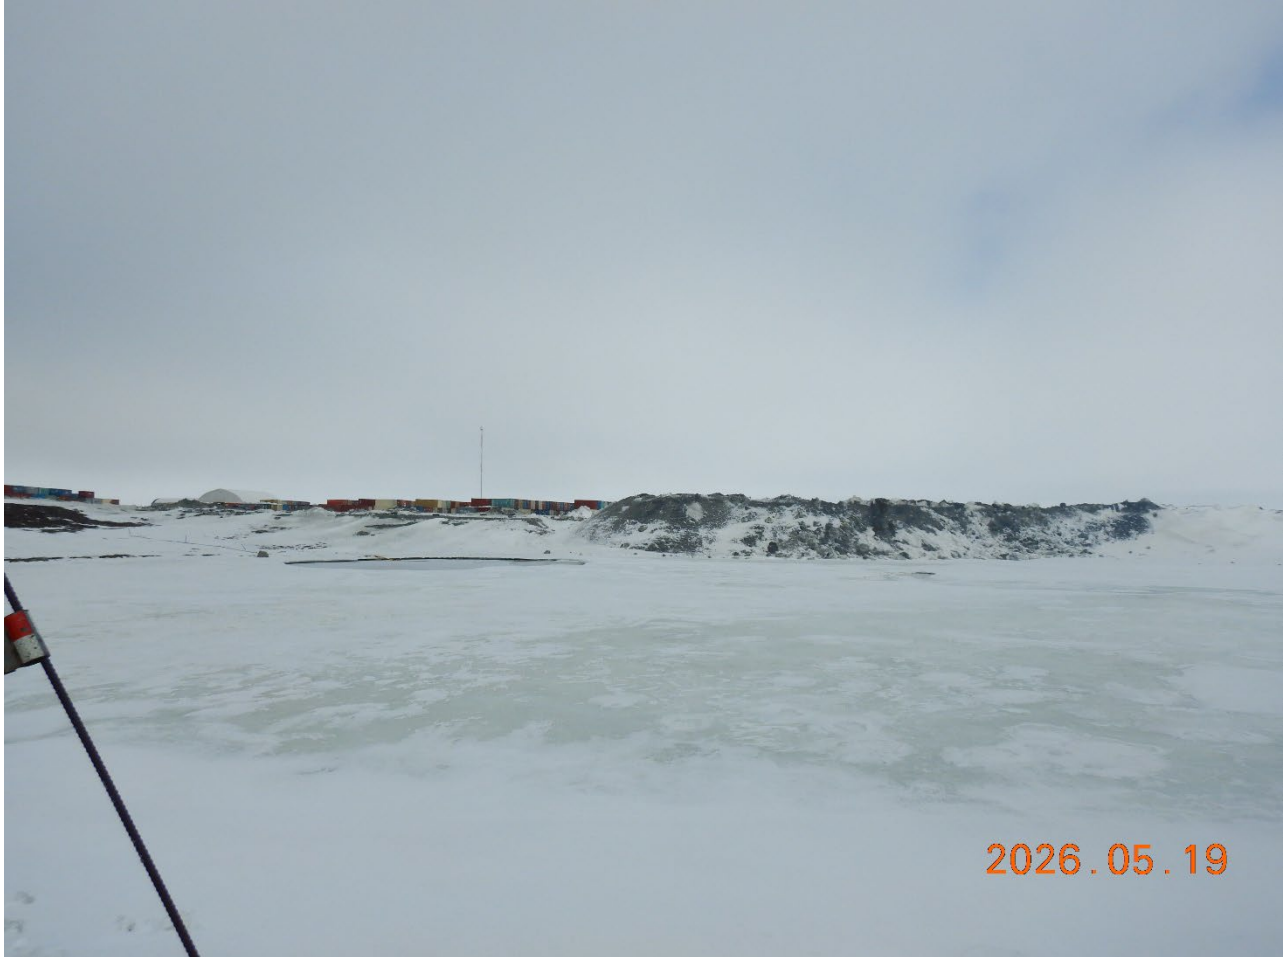
Photo #	7	Coordinates:	N63° 2' 14" W92° 12' 55"
----------------	---	---------------------	--------------------------

Description:	CP1 snow dump.
---------------------	----------------

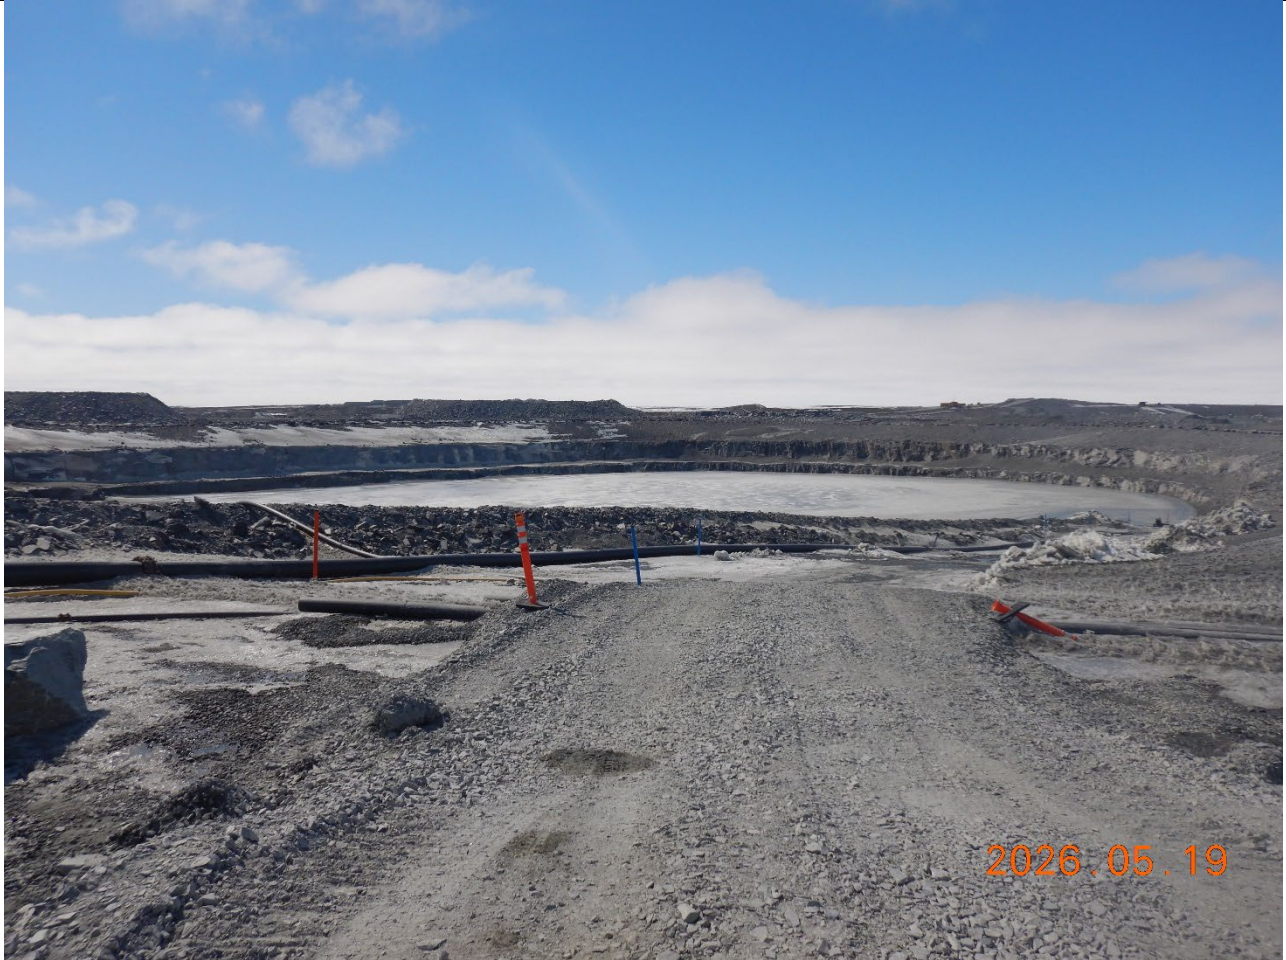
Photo #	8	Coordinates:	N63° 1' 36" W92° 10' 40"
----------------	---	---------------------	--------------------------

Description:	Tiri 2 pit.
---------------------	-------------

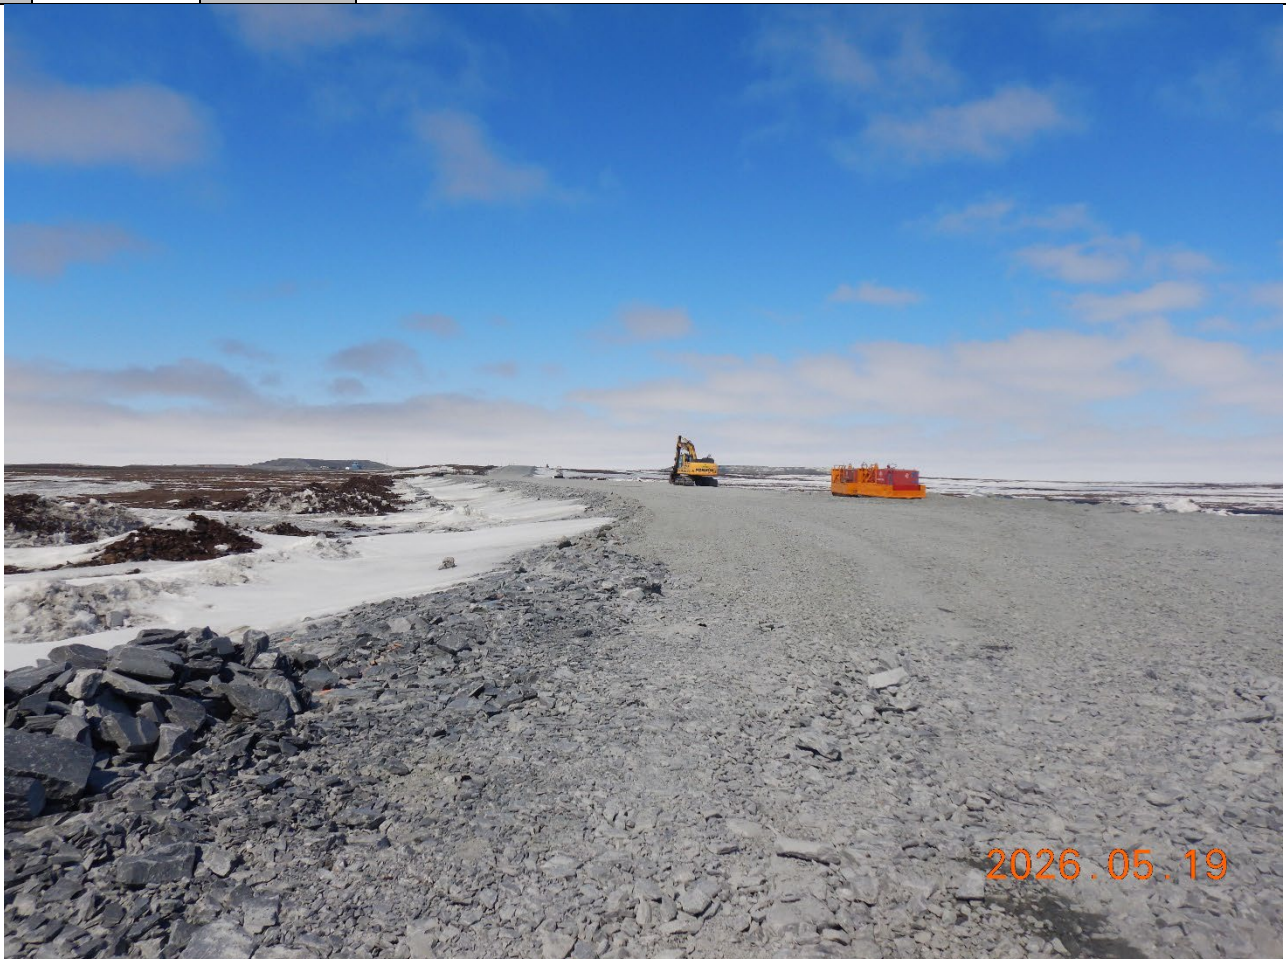
Photo #	9	Coordinates:	N63° 0' 20" W92° 10' 12"
----------------	---	---------------------	--------------------------

Description:	F Zone Haul Road
---------------------	------------------

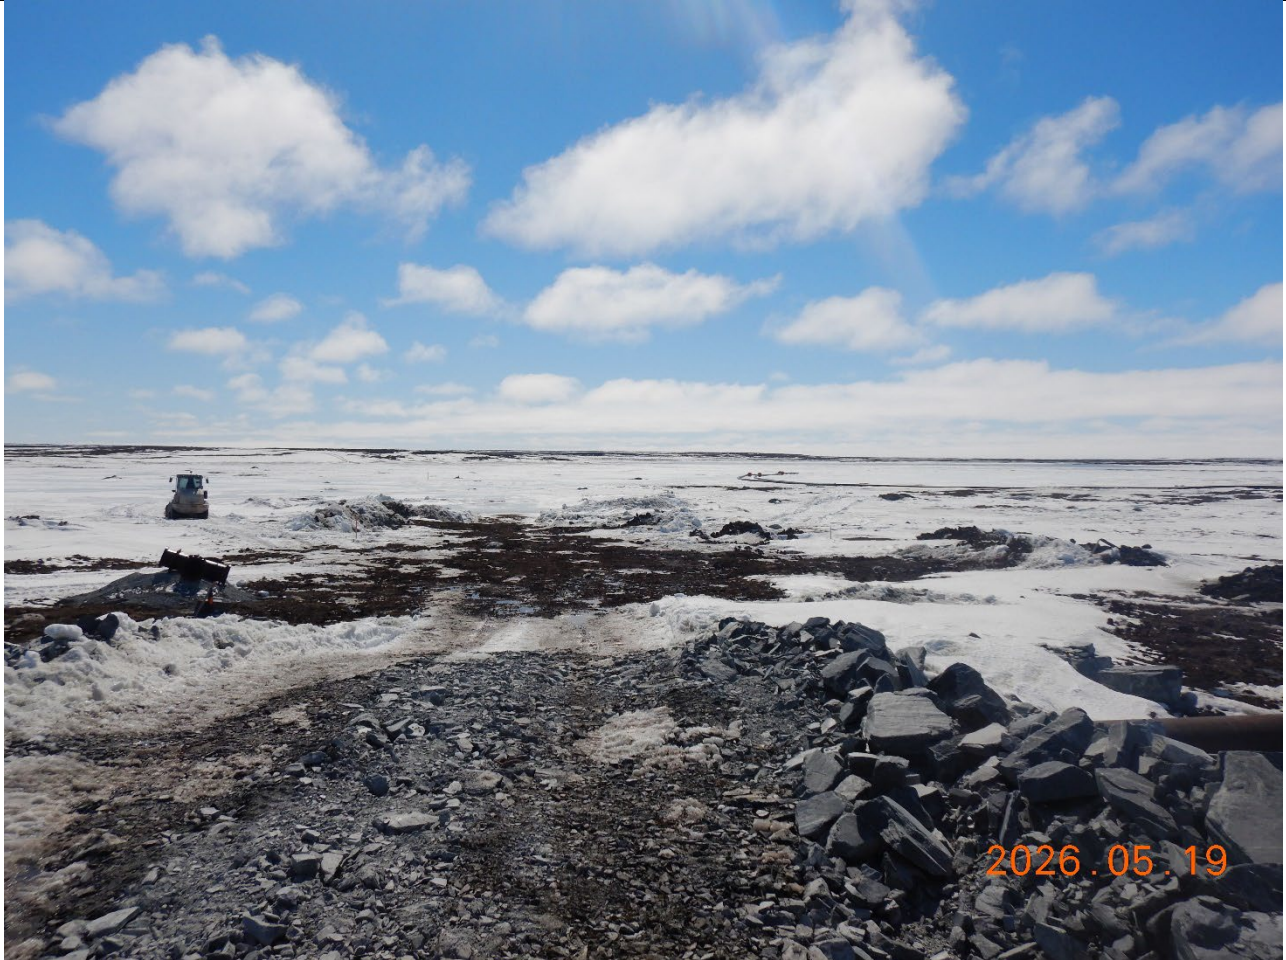
Photo #	10	Coordinates:	N63° 0' 18" W92° 10' 11"
----------------	----	---------------------	--------------------------

Description:
Lake A6. Note water lines laid on the ice surface of the ice.

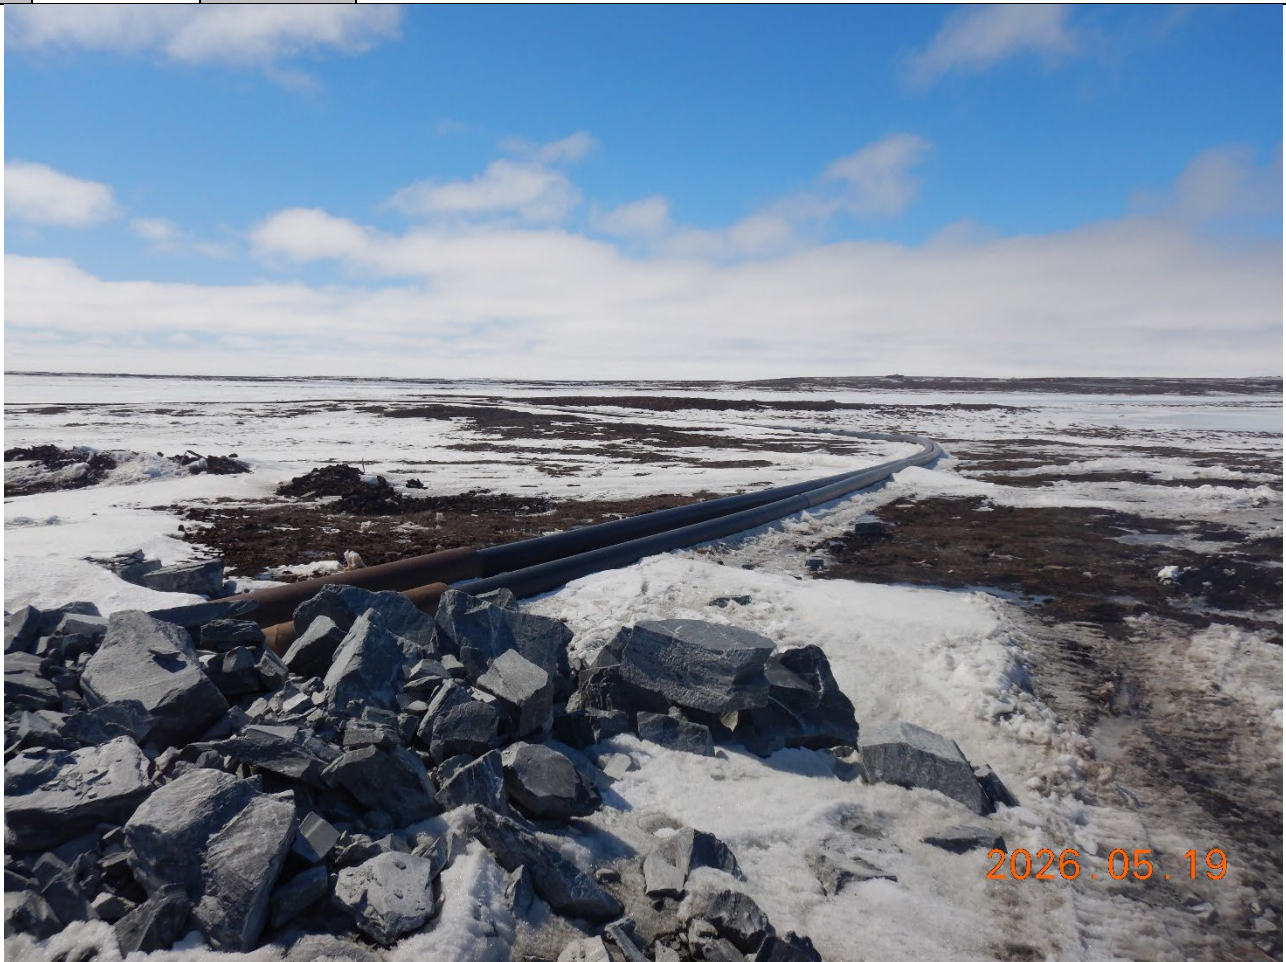
Photo #	11	Coordinates:	N63° 0' 18" W92° 10' 12"
----------------	----	---------------------	--------------------------

Description:
Water Lines from A6 to Meliadine lake for planned dewatering.

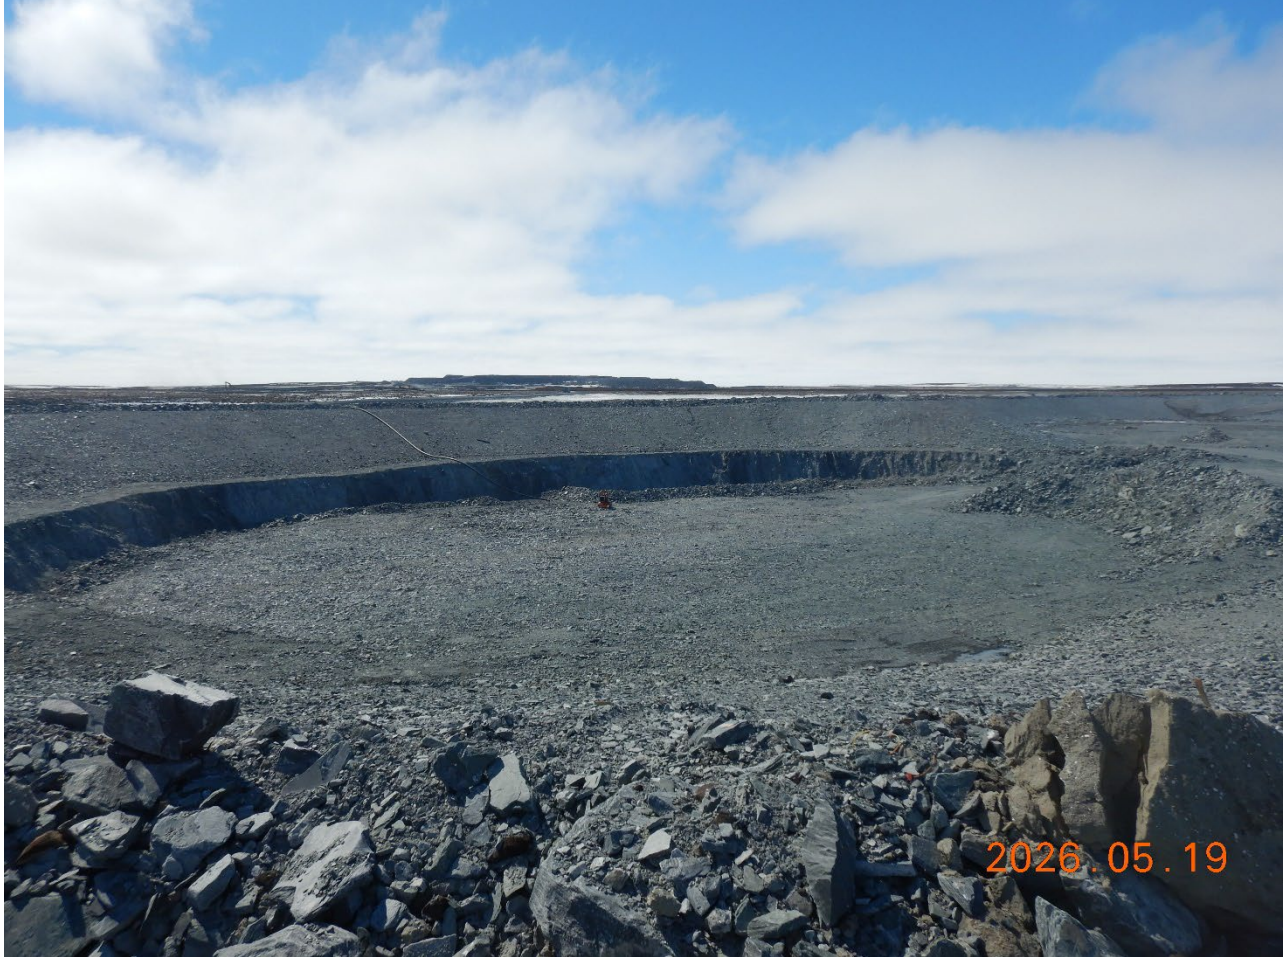
Photo #	12	Coordinates:	N63° 0' 19" W92° 10' 11"
----------------	----	---------------------	--------------------------

Description:	Wesmeg Pit 3.
---------------------	---------------

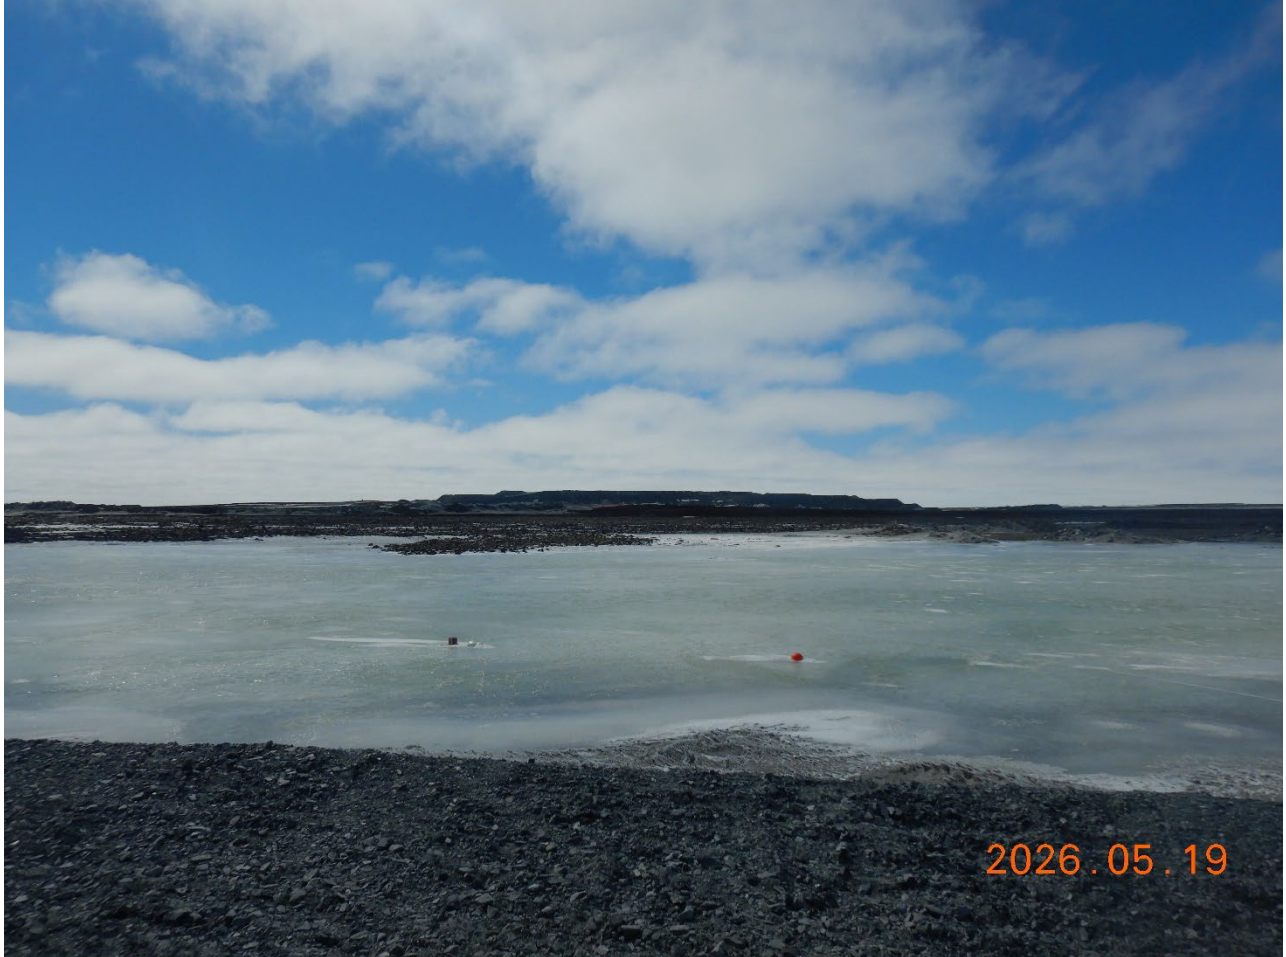
Photo #	13	Coordinates:	N63° 0' 47" W92° 12' 24"
----------------	----	---------------------	--------------------------

Description:	WRSF 6 in distance at Pump Development Area.
---------------------	--

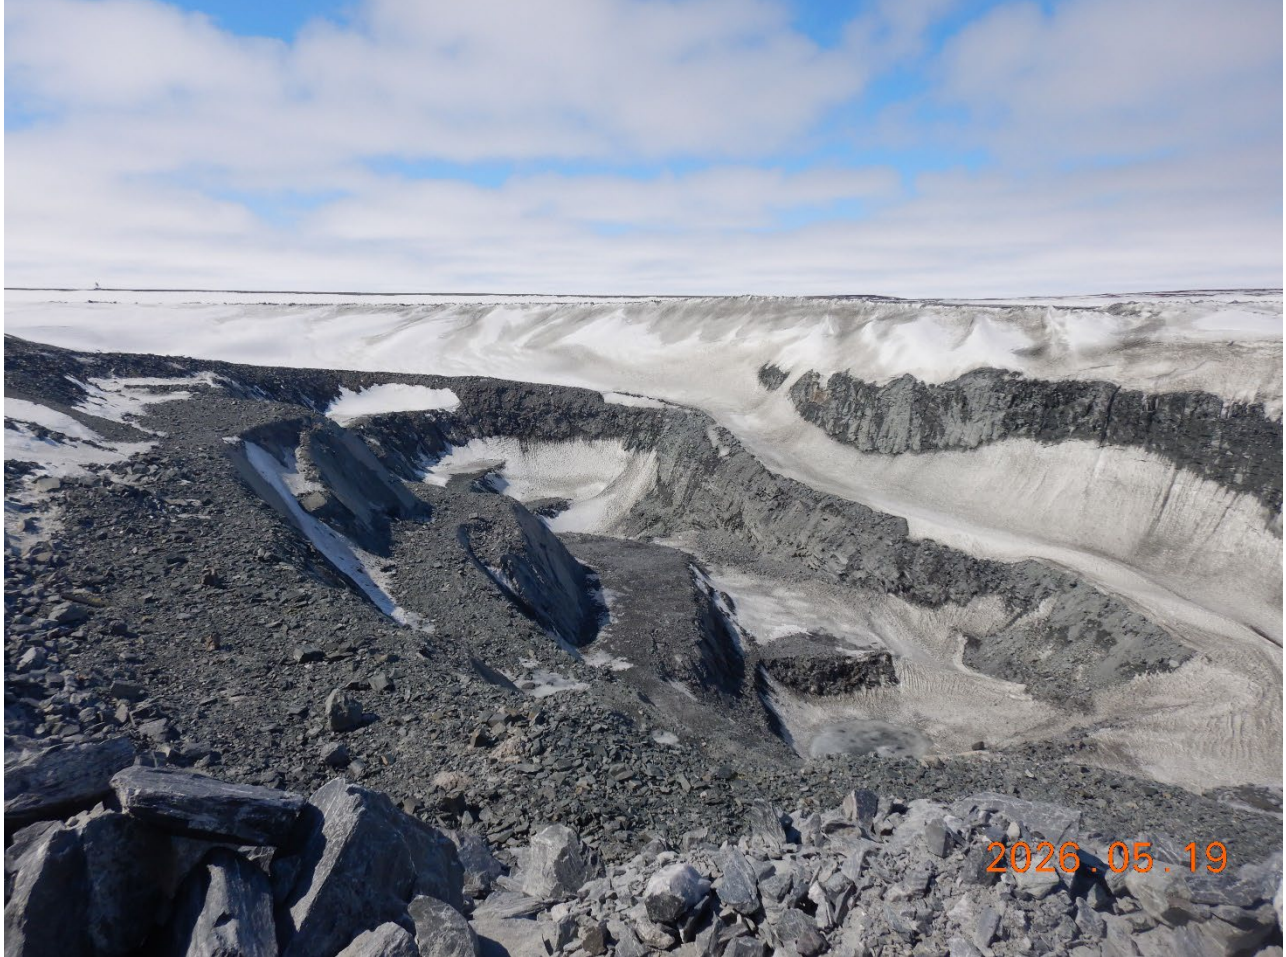
Photo #	14	Coordinates:	N63° 0' 33" W92° 13' 11"
----------------	----	---------------------	--------------------------

Description:	Pump Pit 2/CP9.
---------------------	-----------------

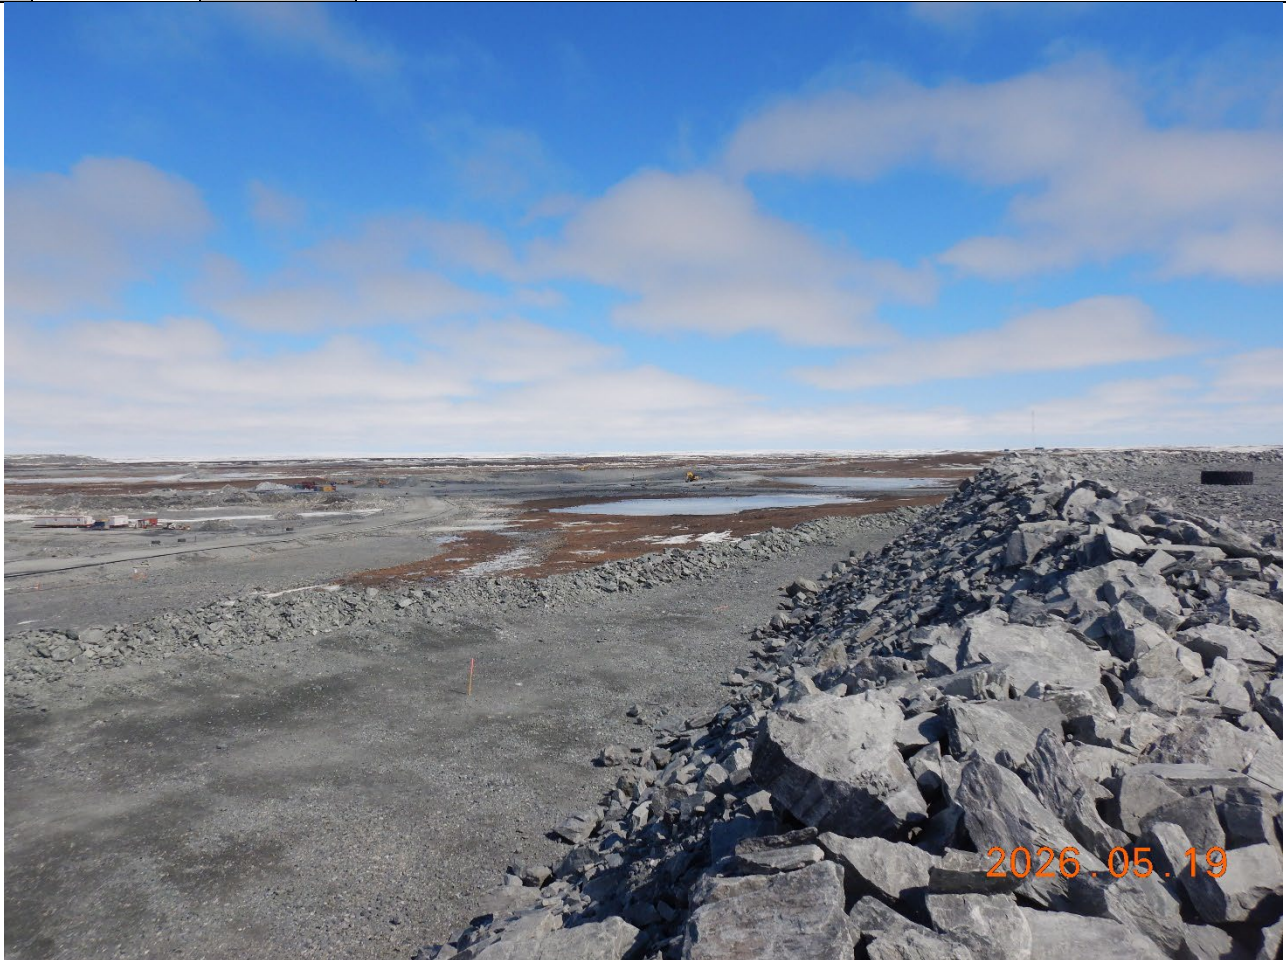
Photo #	15	Coordinates:	N63° 0' 26" W92° 13' 23"
----------------	----	---------------------	--------------------------

Description:	Pump Pit 1 in distance. Photo taken from top of WRSF 6 facing North.
---------------------	--

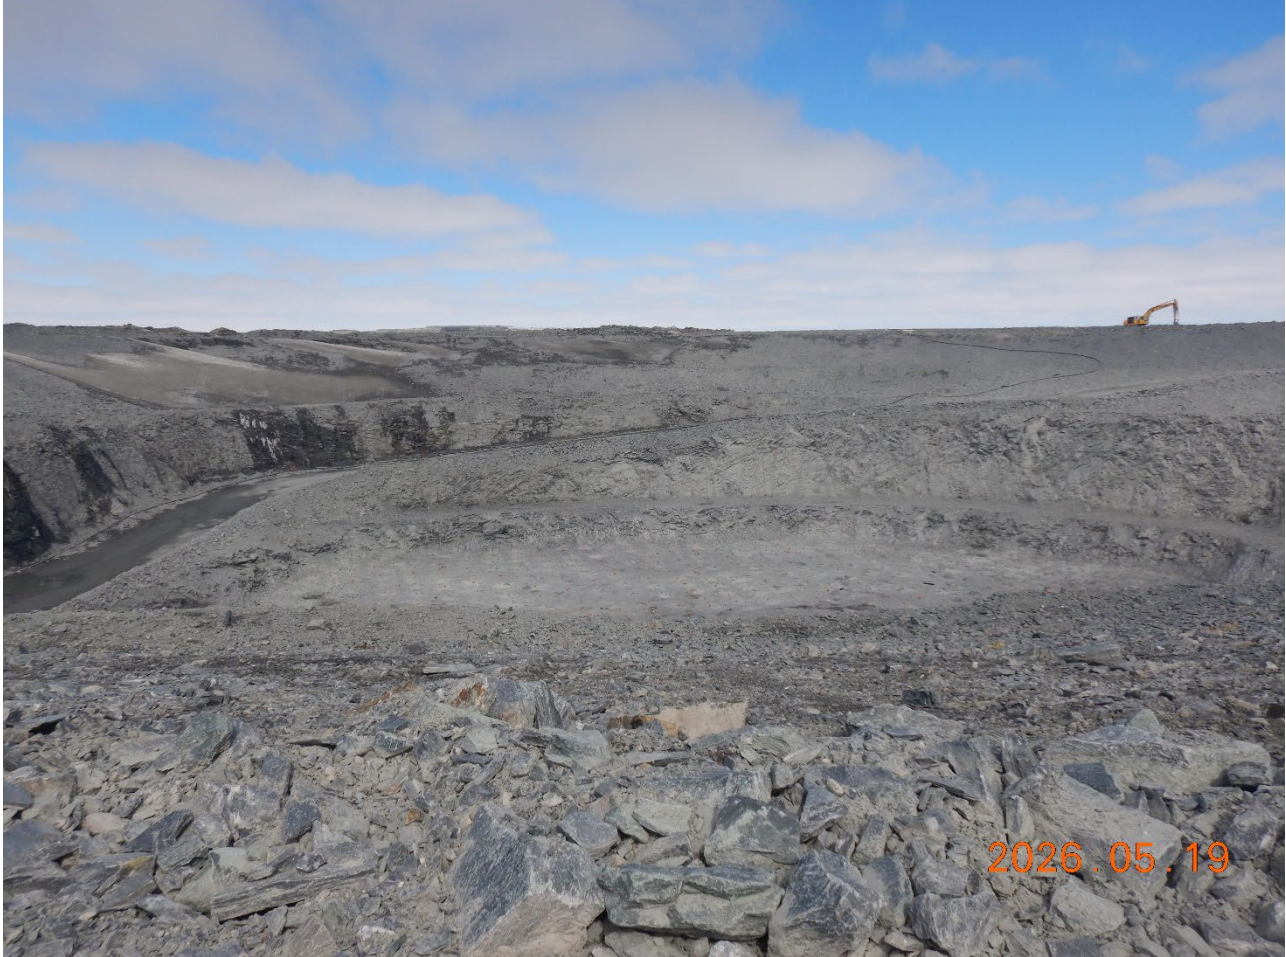
Photo #	16	Coordinates:	N63° 0' 19" W92° 13' 0"
----------------	----	---------------------	-------------------------

Description:	Pump Pit 1
---------------------	------------

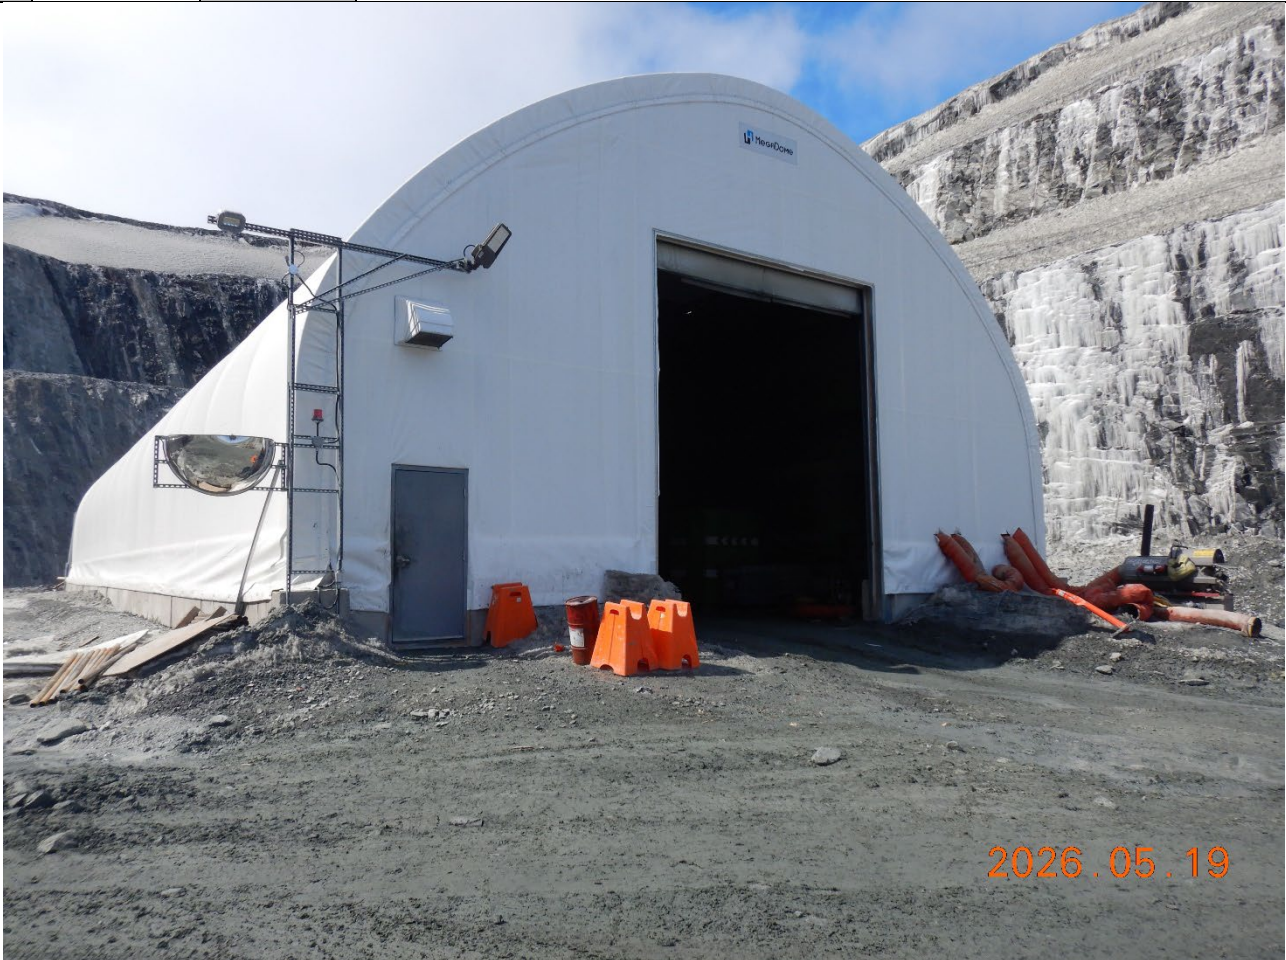
Photo #	17	Coordinates:	N63° 1' 21" W92° 13' 38"
----------------	----	---------------------	--------------------------

Description:	Dome constructed inside Tiri 1 Pit to support underground operations.
---------------------	---
