Water Licence Inspection Report

Authorization	Representative
2AM-MEL1631	Alexandre Langlais-Bourassa
Authorization No. / Expiry	Representative's Title
March 31, 2031	Supervisor, Environment
Inspection Date	Inspector
May 19, 2026	RMO Kyle Amsel
Other Authorization/s	
Activities Inspected	
<input type="checkbox"/> Municipal <input checked="" type="checkbox"/> Camp, Commercial <input type="checkbox"/> Drilling <input checked="" type="checkbox"/> Mining <input checked="" type="checkbox"/> Construction <input checked="" type="checkbox"/> Reclamation <input checked="" type="checkbox"/> Fuel Storage <input checked="" type="checkbox"/> Roads/Hauling <input type="checkbox"/> Winter Hauling <input type="checkbox"/> Camp, Private <input type="checkbox"/> Other Click or tap here to enter text.

PHOTO LOG

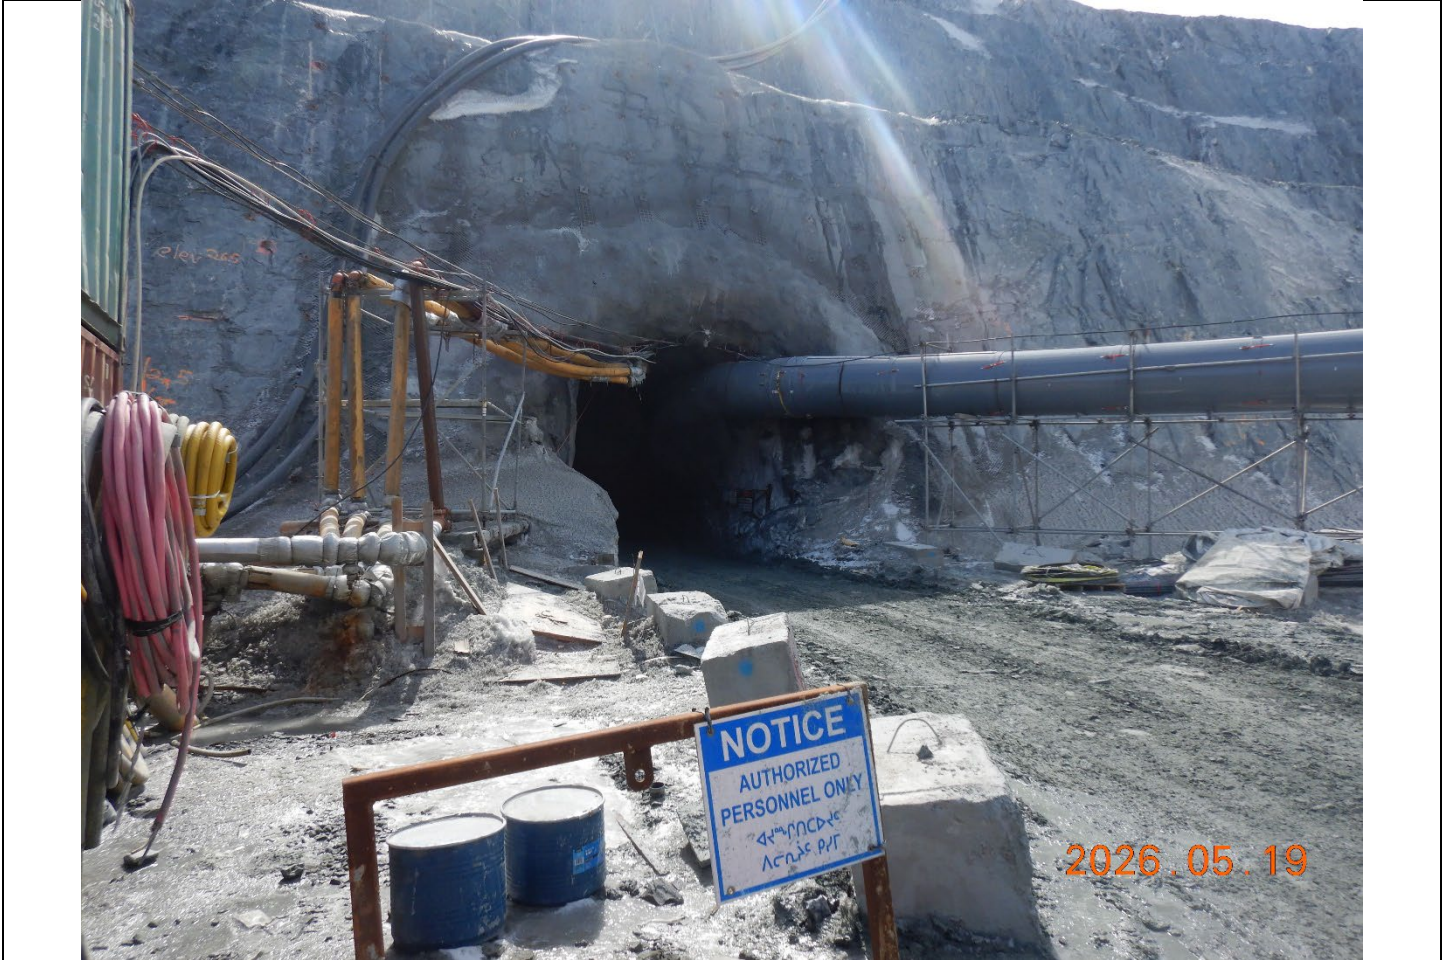
Photo #	18	Coordinates:	N63° 1' 21" W92° 13' 38"
---------	----	--------------	--------------------------

Description:	Portal in Tiri 1 Pit.
--------------	-----------------------

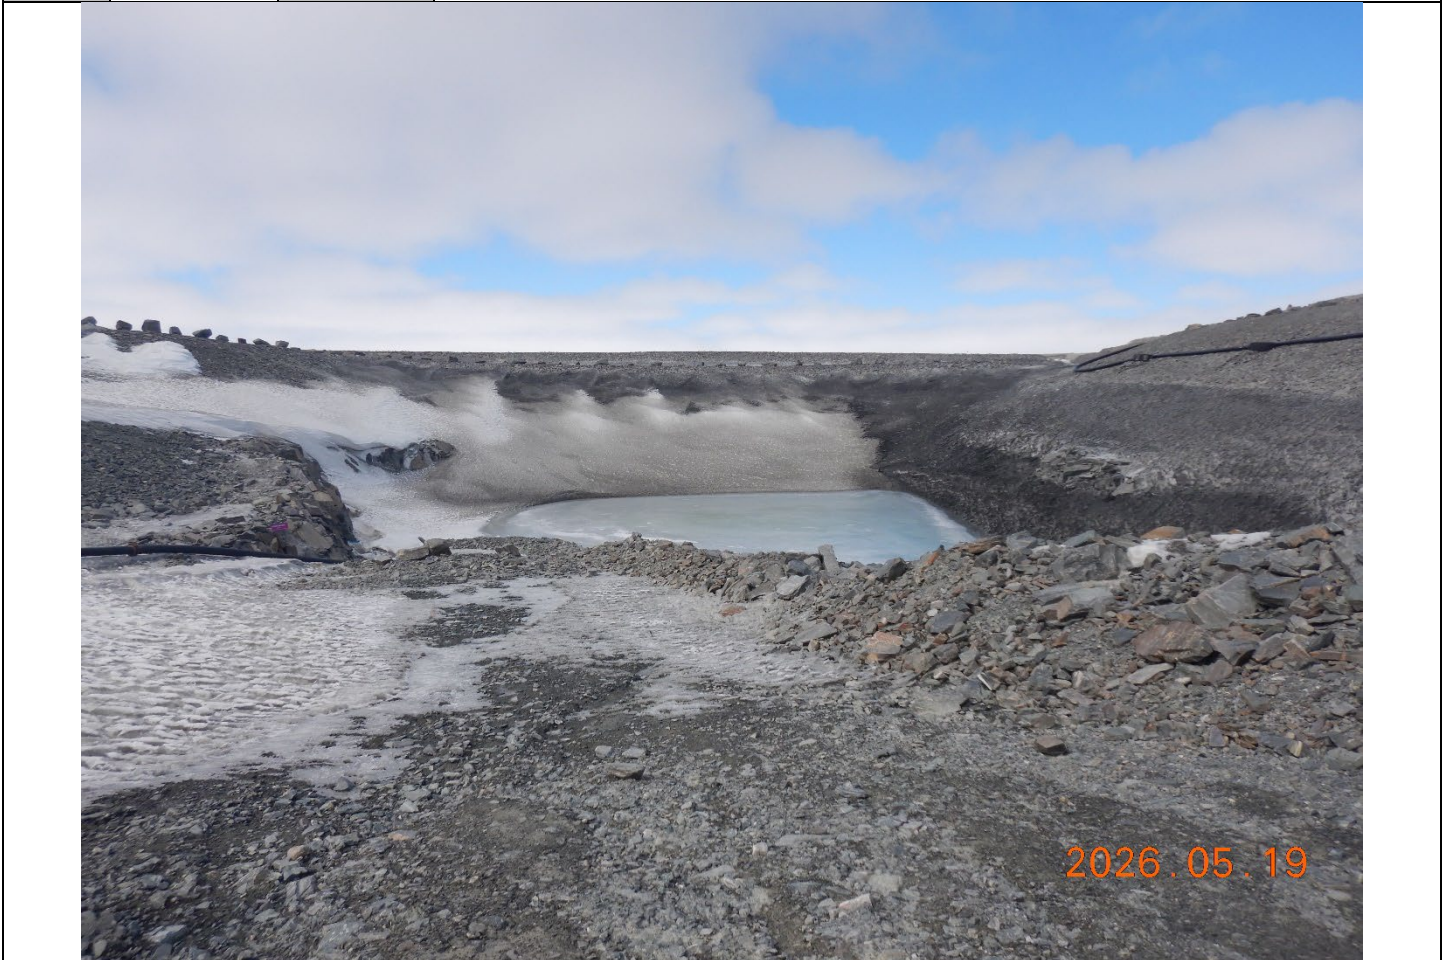
Photo #	19	Coordinates:	N63° 1' 21" W92° 13' 37"
---------	----	--------------	--------------------------

Description:	CP4.
--------------	------

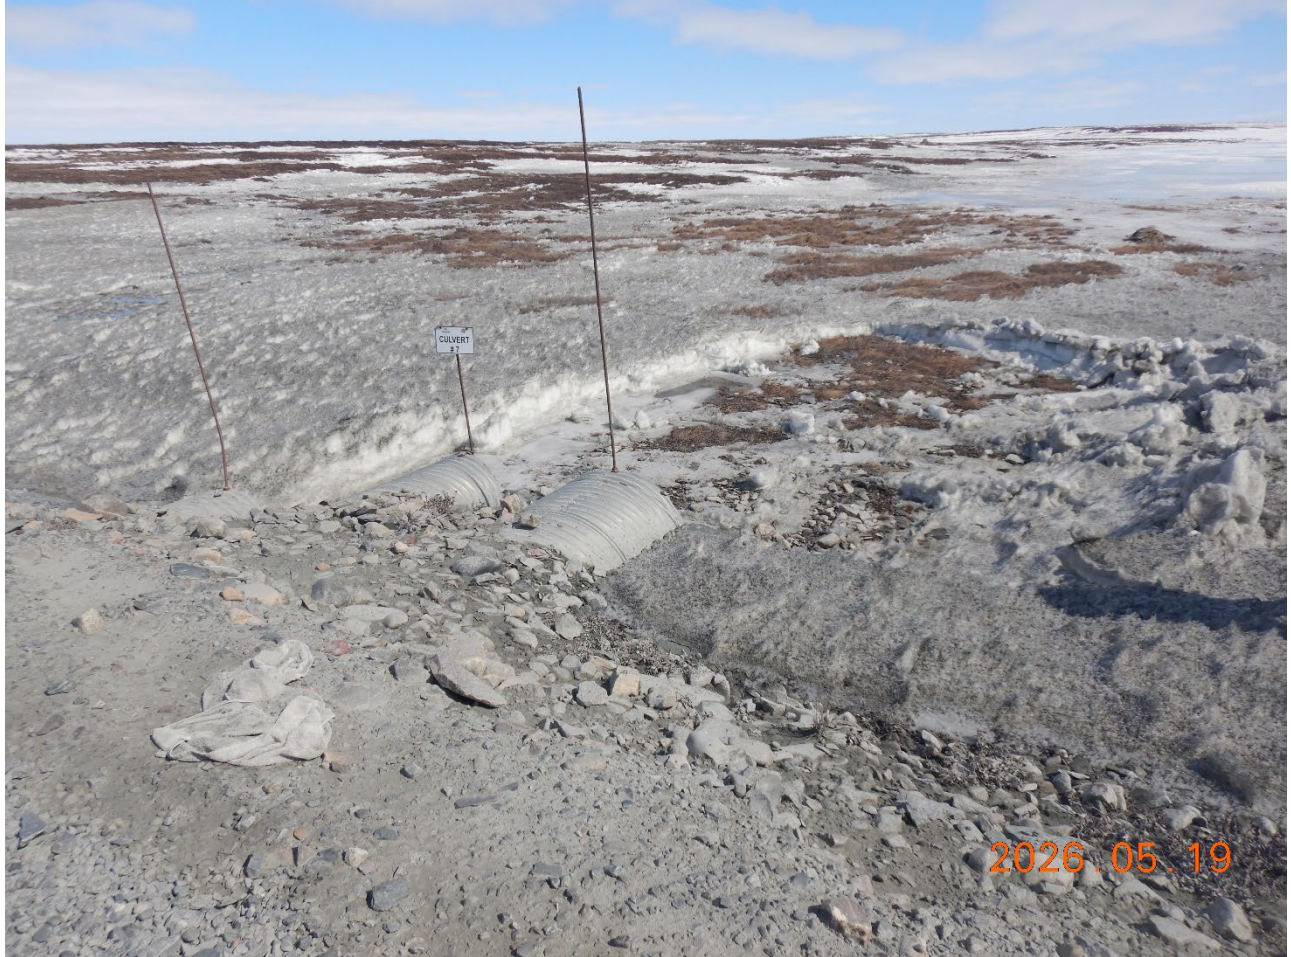
Photo # 20 Coordinates: N63° 0' 31" W92° 12' 39"

Description:
Culvert on All-Weather Access Road with snow removed for freshet.
