# Final Spill Report

## Tank Release April 8, 2017

**SPILL REMEDIATION AND RECLAMATION REPORT**  
**Meliadine Exploration Fuel Farm**  
**Tank 18, 30 m<sup>3</sup> Diesel Spill**

**Meliadine, Nunavut**  
**Release Date: April 8, 2017**

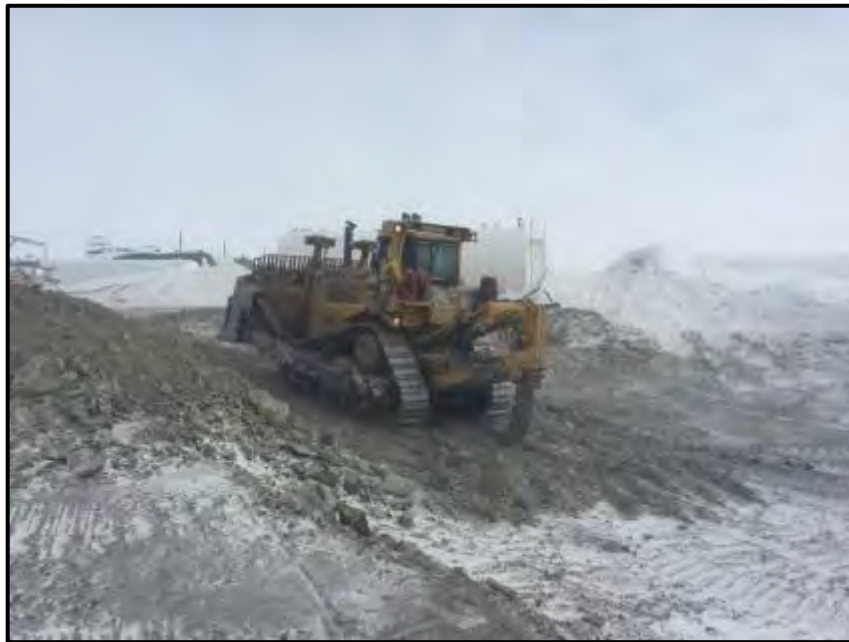
April 17: Removing impacted material from south corner of south excavation.

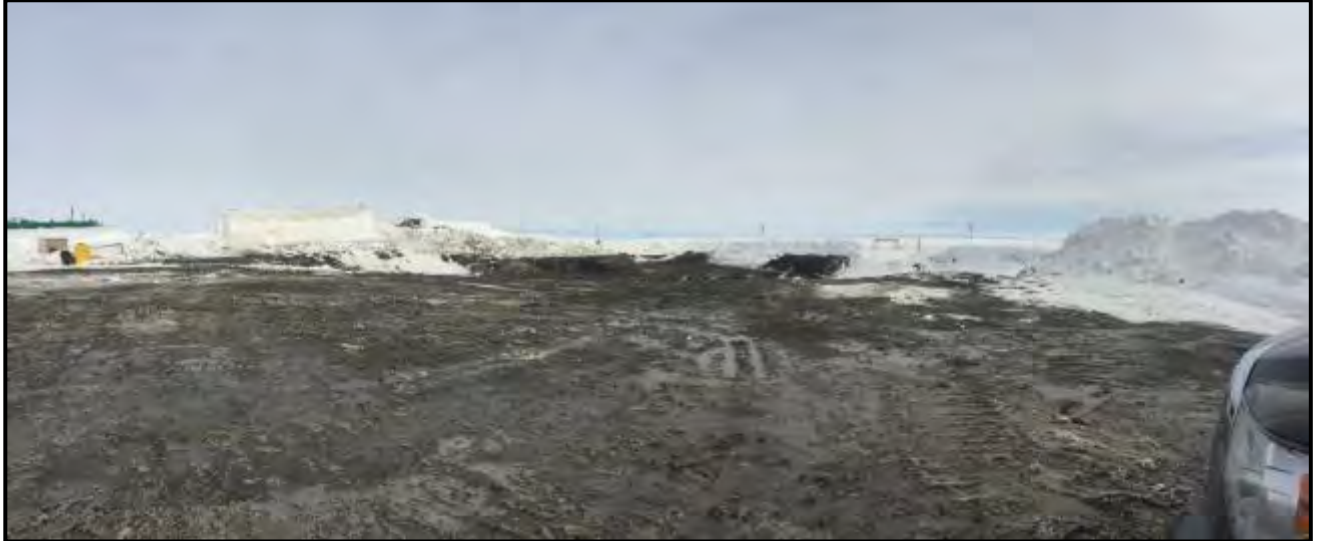
April 27: Excavation area at after removing exceedances.
