Meliadine Gold Project  
NWB Water Licence 2AM-MEL1631  
2017 Annual Report

Agnico Eagle Mines Limited – Meliadine Division

March 31, 2018

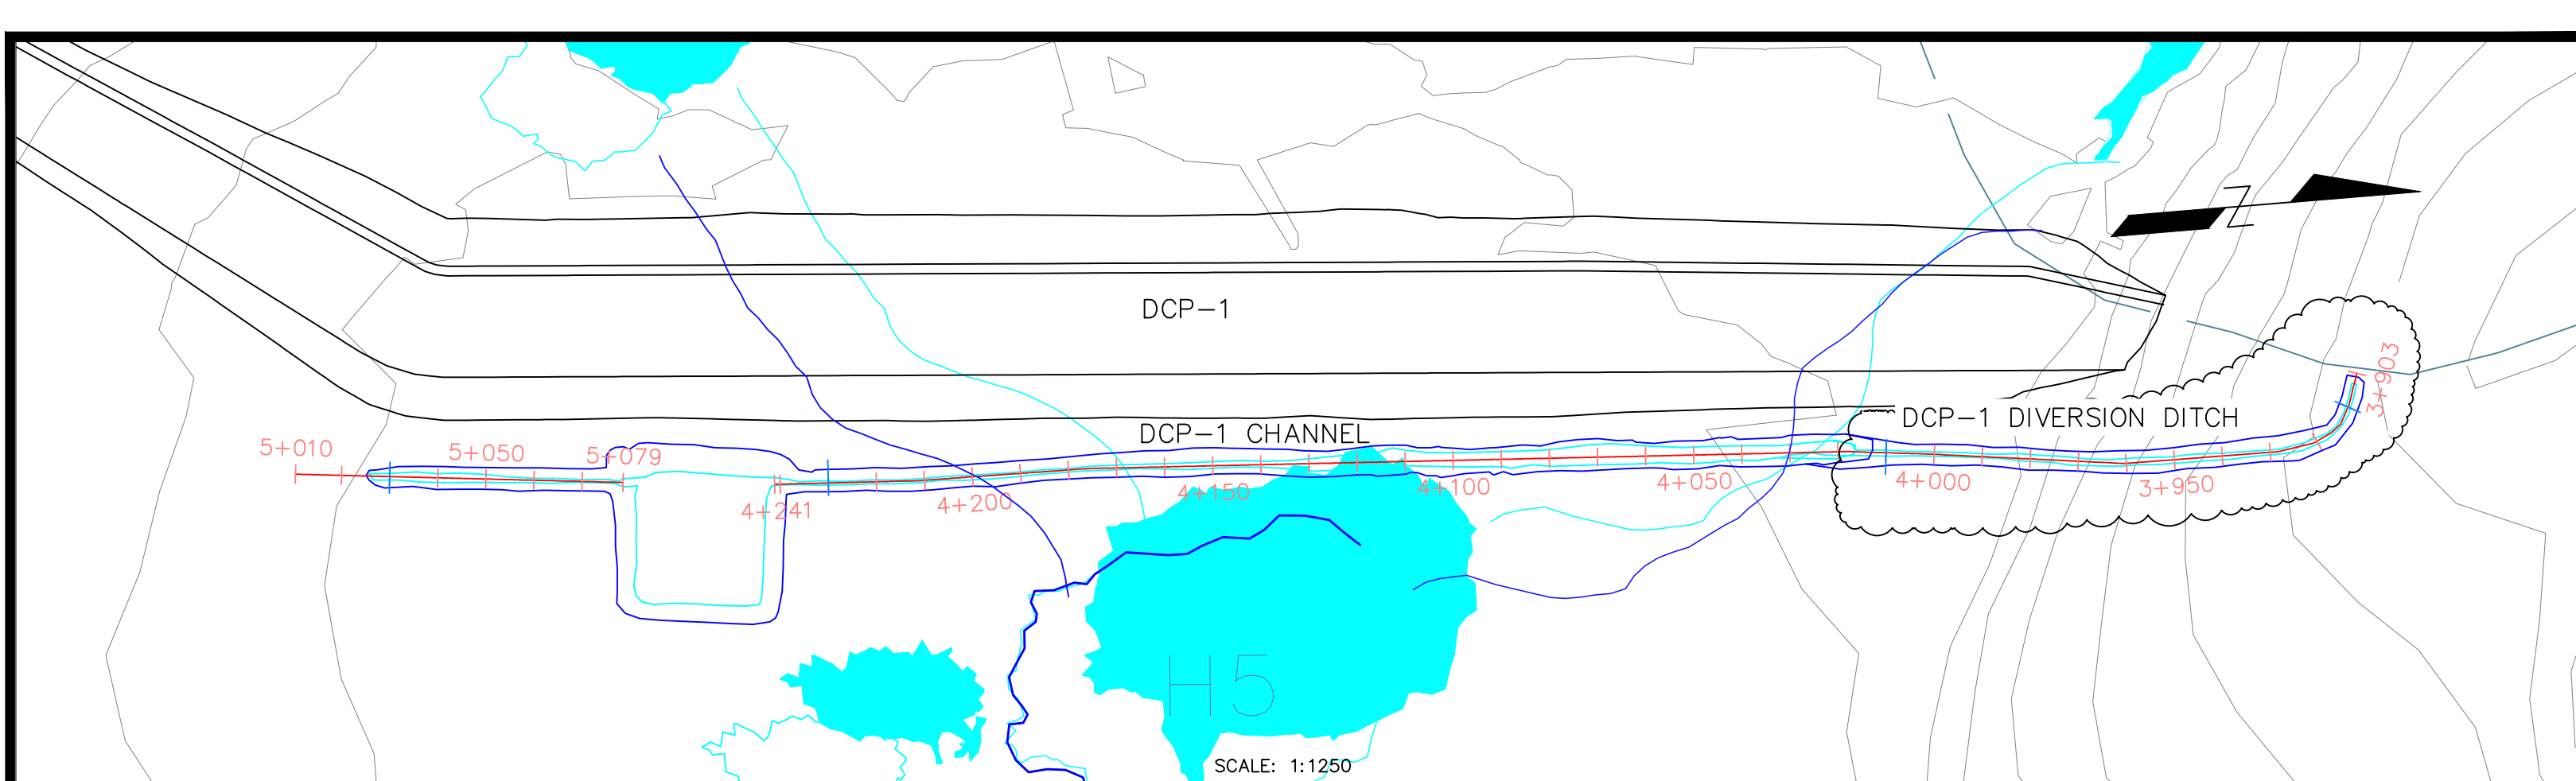
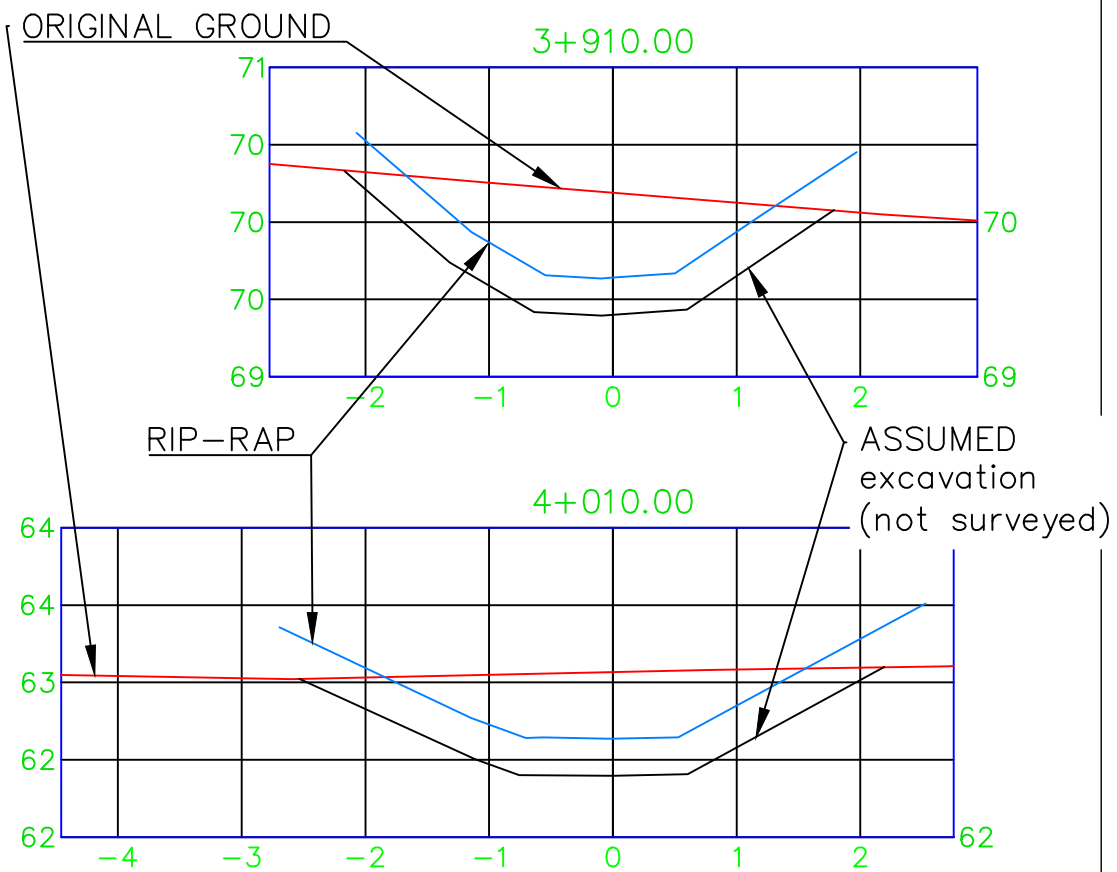
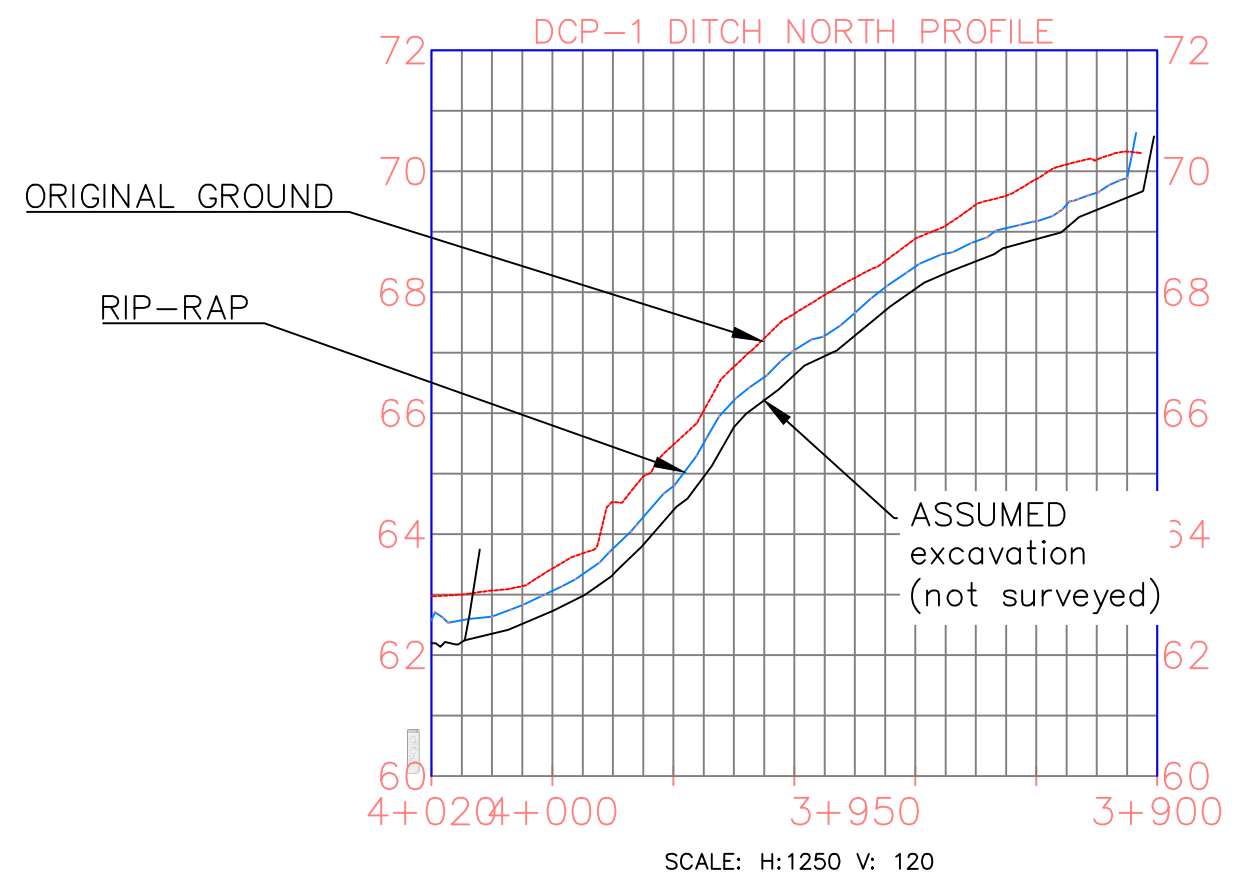
### ***As-built Report for DCP-1 Diversion Ditch***

The analysis of the HGTC-1 thermistor data, installed at D-CP1 dike, revealed the temperature anomaly, possibly caused by water infiltration. To intercept any surface water flowing down the north abutment towards the downstream key trench, and direct it away from the dike into the sump, the DCP-1 diversion ditch was excavated and connected to DCP-1 channel. The work on the ditch took place between October 6 and October 20; the as-built drawing of the ditch is provided in the Appendix A.

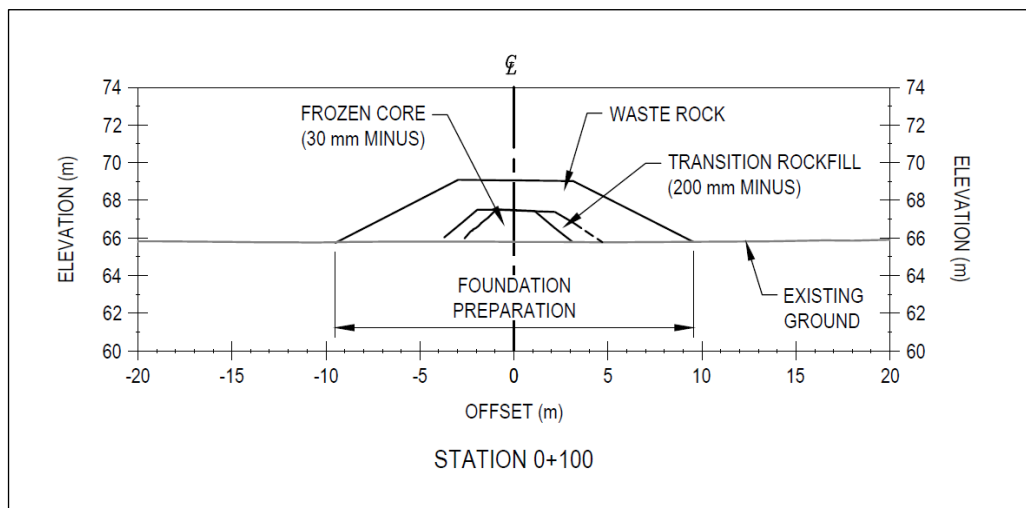
Figure 4: Typical Section through Temporary P-Area Dike DP3-A

Additional information regarding the thermal conditions and monitoring of the dikes is provided in Section 3.2. Figure 4 shows a typical section through one of the dikes (DP3-A).
