Meliadine AWAR Inspection – 2017

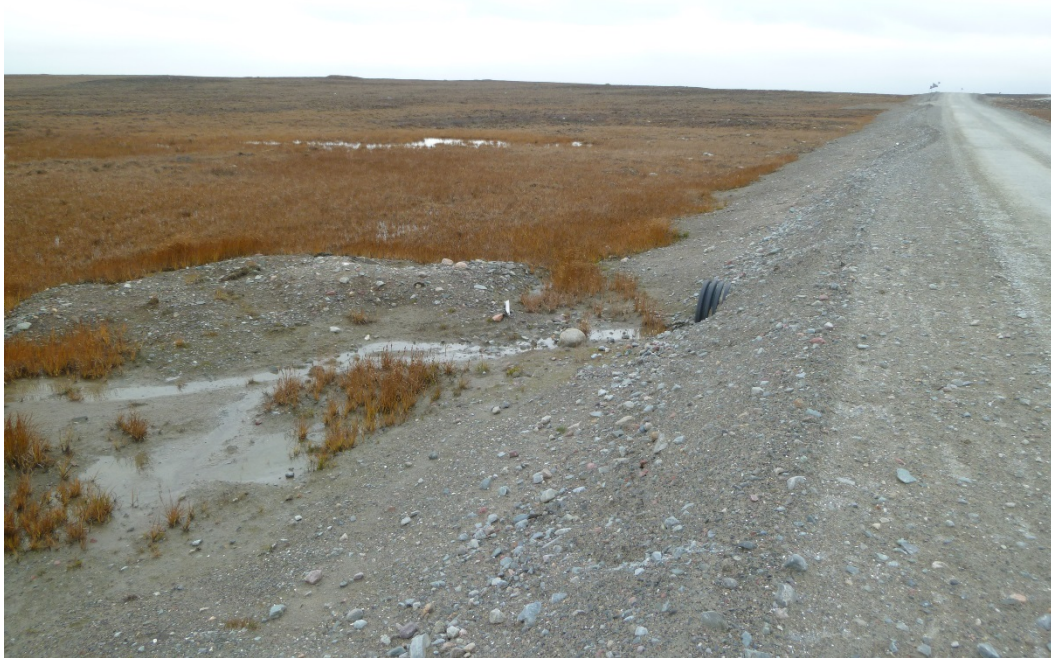
Photograph 31: Downstream end of 600 mm Ø HDPE Culvert at KM25.8. Some Sediment Erosion and Deposition Evident (22 September 2017)

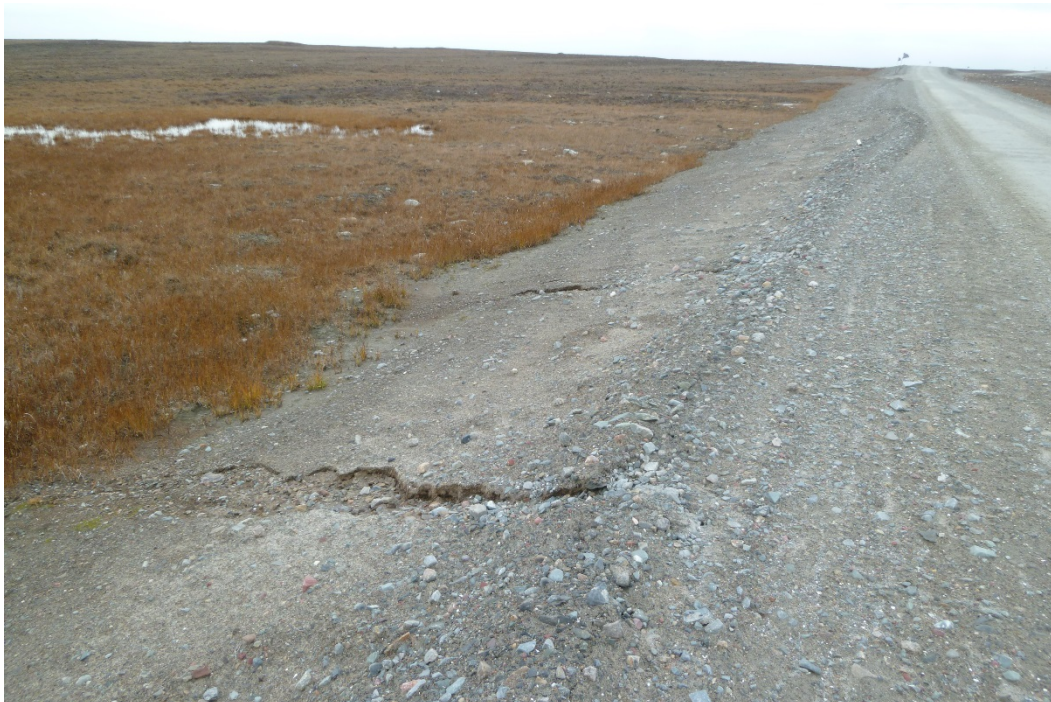
Photograph 32: Erosion of Road Embankment Near 600mm Ø HDPE culvert at KM25.8 (22 September 2017)

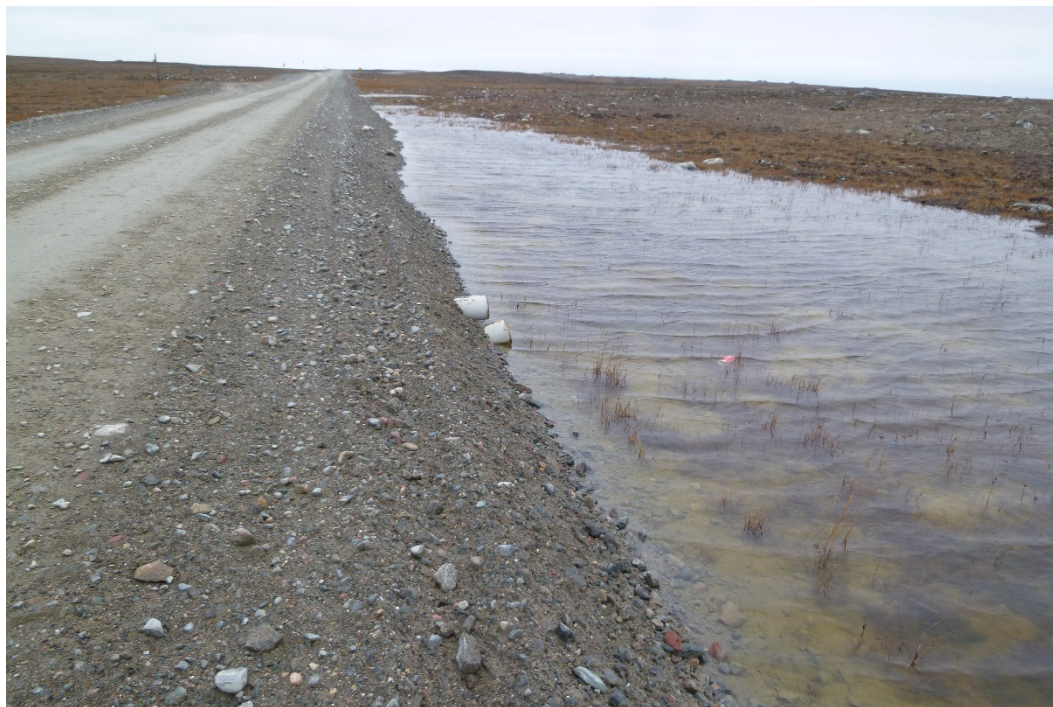
Photographs 33 through 35 were taken at KM26.2. 2 vertically offset, 160 mm Ø steel pipes. The lower pipe is bent upwards. Unable to see through the lower culvert.

Photograph 33: Upstream Ends of Two Vertically Offset, 160 Mm Ø Steel Pipes at KM26.2. The Lower Pipe is Bent Upwards and Should Be Replaced (20 September 2017)

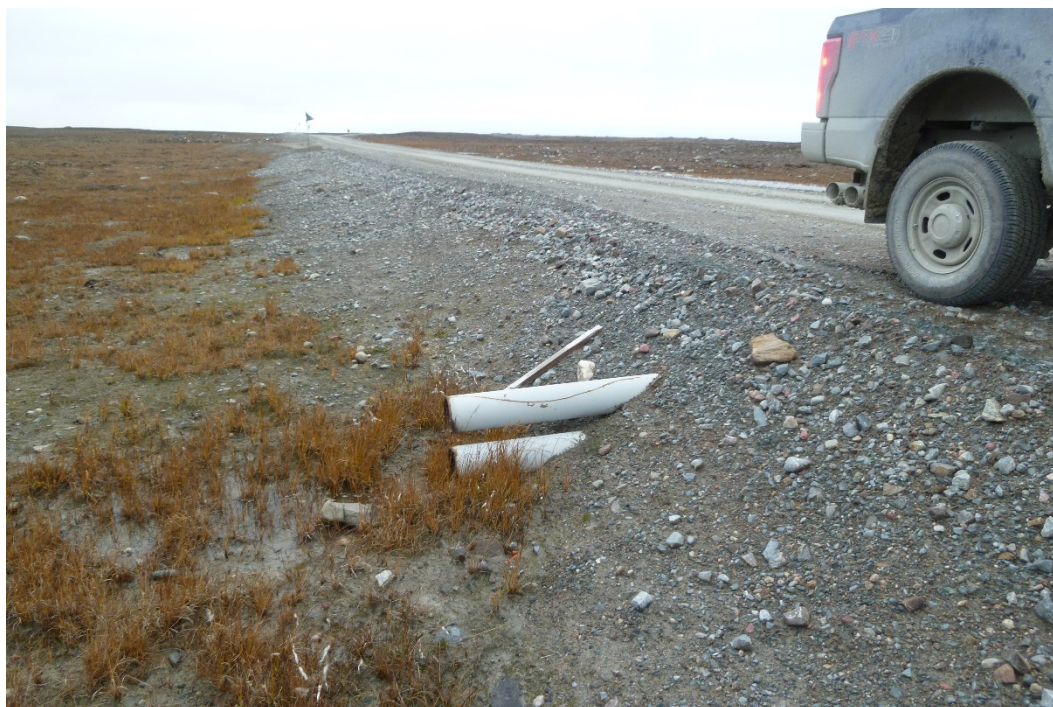
Photograph 34: Two Vertically Offset, 160 mm Ø steel pipes. Downstream Ends of the Pipes, at KM26.2 (20 September 2017)

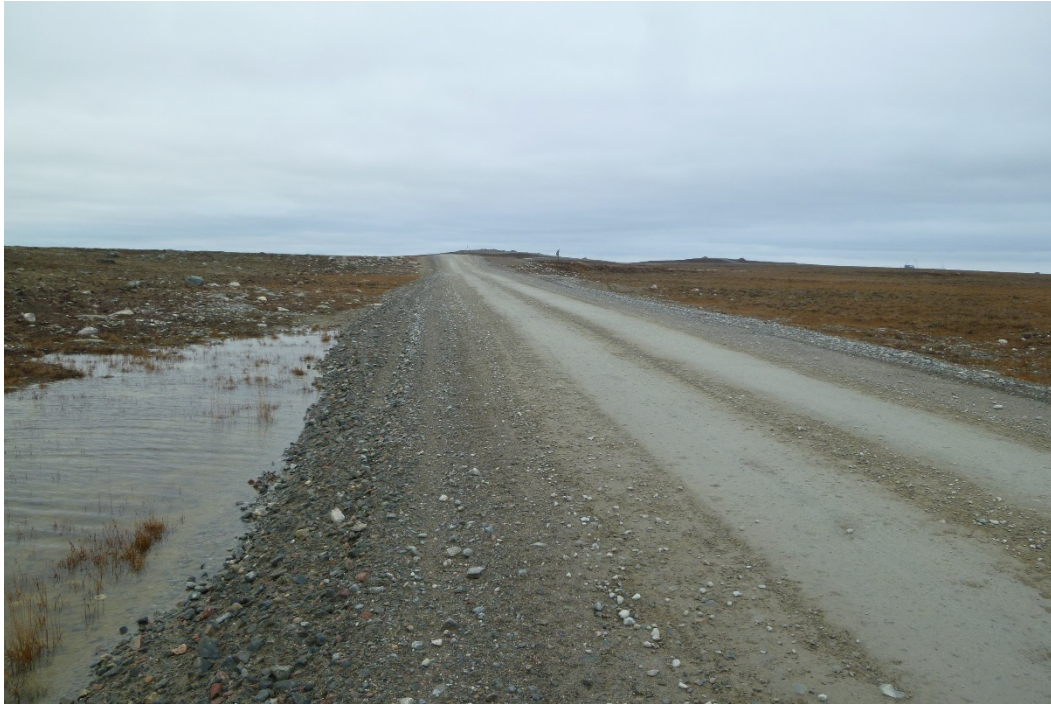
Photograph 35: Road North of Two Vertically Offset, 160 mm Ø Steel Pipes, at KM26.2 (20 September 2017)

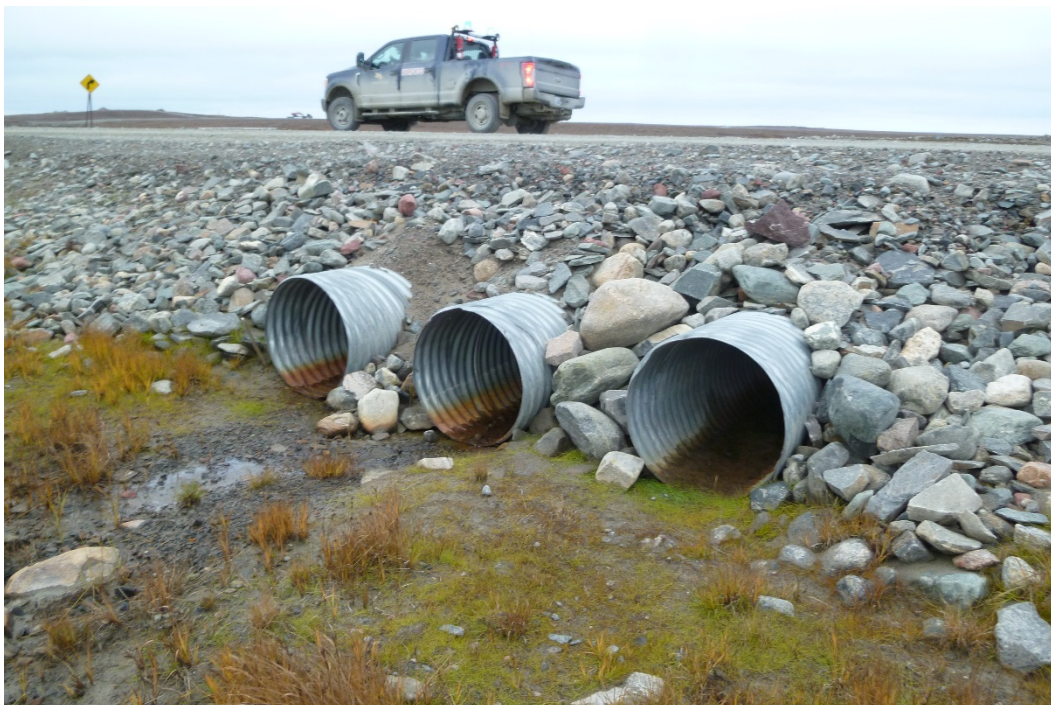
Photograph 36: 3x700mm Ø CSP at KM26.5. Inverts from Upstream Side (20 September 2017)

Photographs 36 through 39 are at KM26.5, 3x700mm Ø CSP, installed at equal elevation. Small dents in culverts, no blockages, no flow.

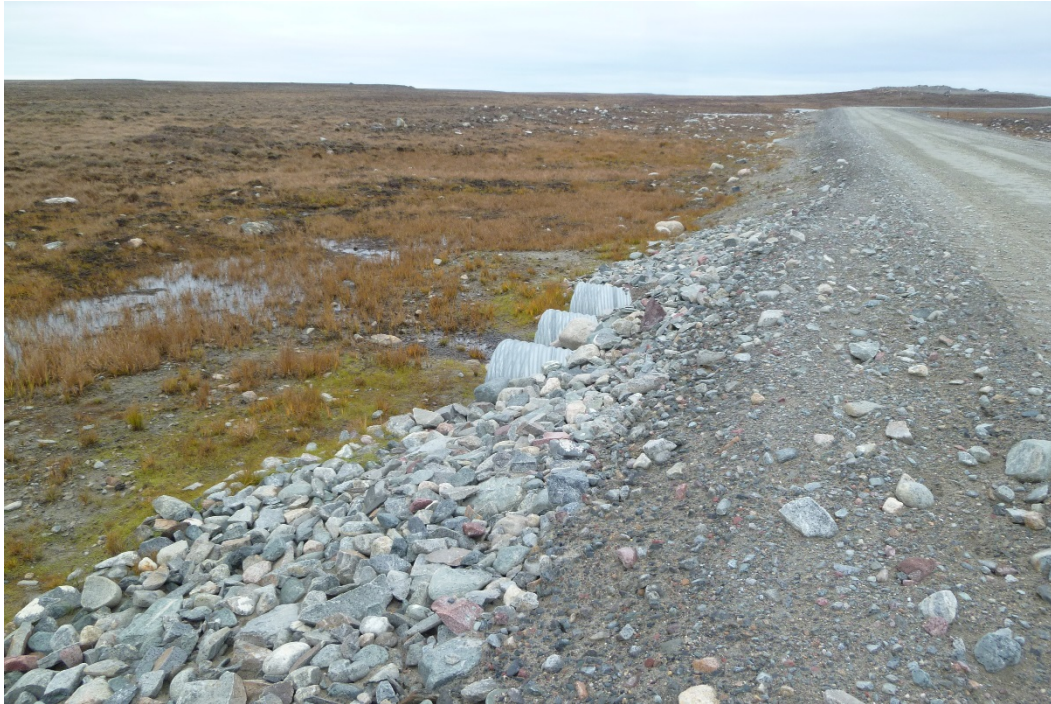
Photograph 37: 3x700mm Ø CSP at KM26.5. Upstream Ends of the Culverts (20 September 2017)

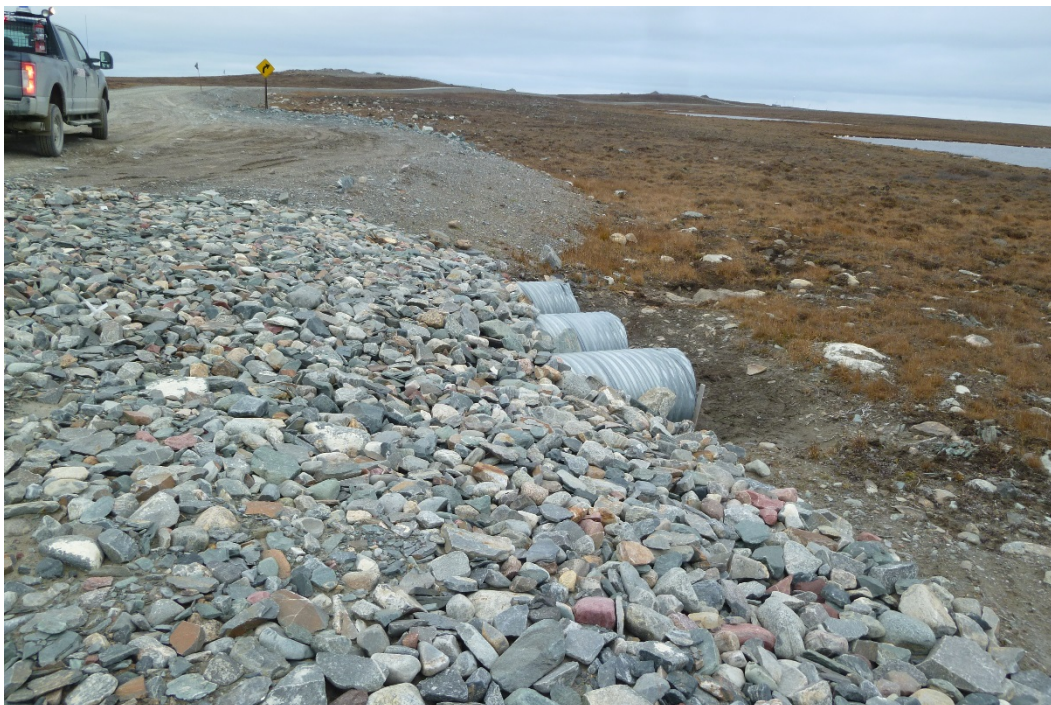
Photograph 38: 3x700mm Ø CSP at KM26.5. Downstream Ends of the Culverts (20 September 2017)

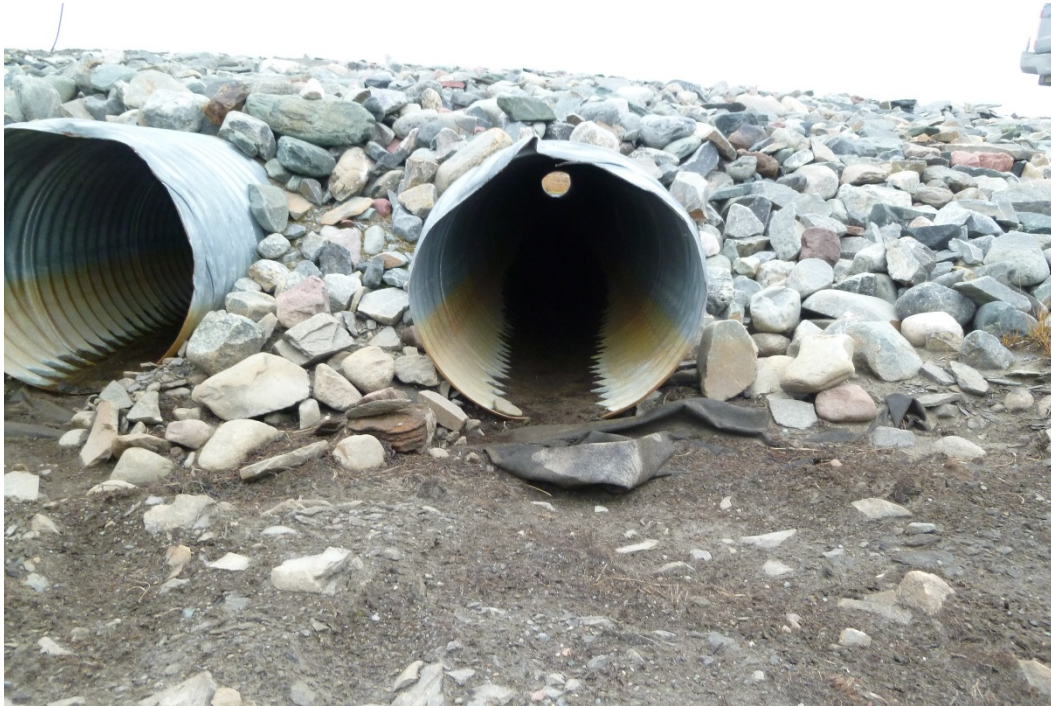
Photograph 39: 3x700mm Ø CSP at KM26.5. This Photo Showing the Inside of the North Culvert from Downstream Looking Upstream (20 September 2017)

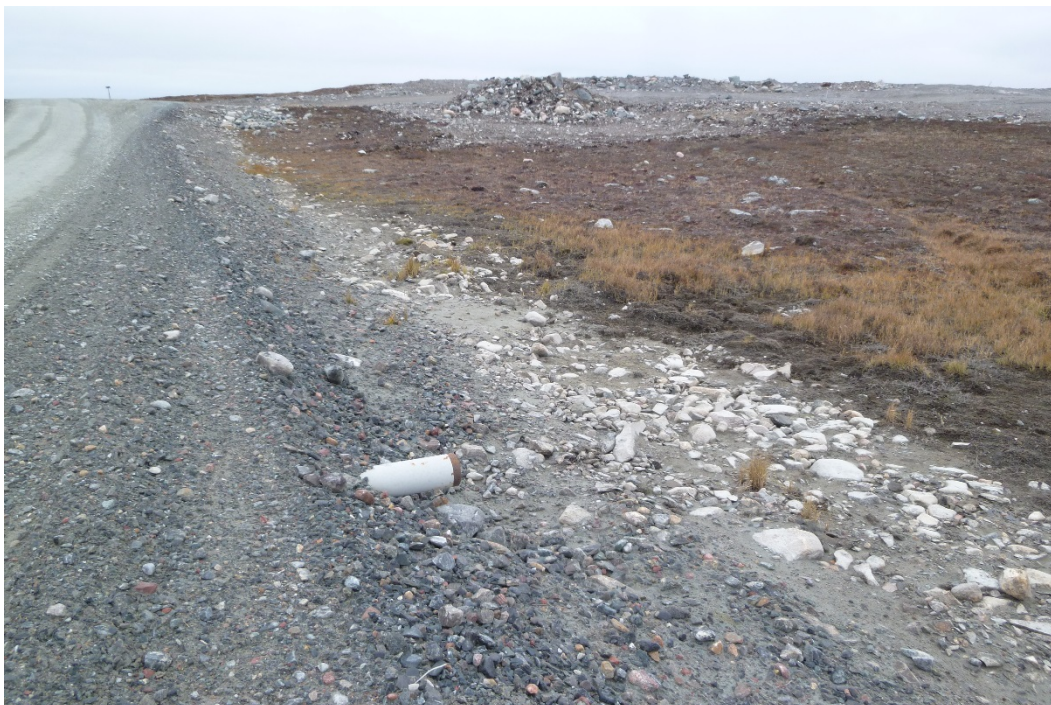
Photograph 40: 2 Vertically Offset 160mm Ø Steel Pipes, Clear, no Flow, Upstream View – at KM26.8 (20 September 2017)

Photographs 40 through 42 are at KM26.8, 2x160mm Ø steel pipes, installed vertically offset. No flow.

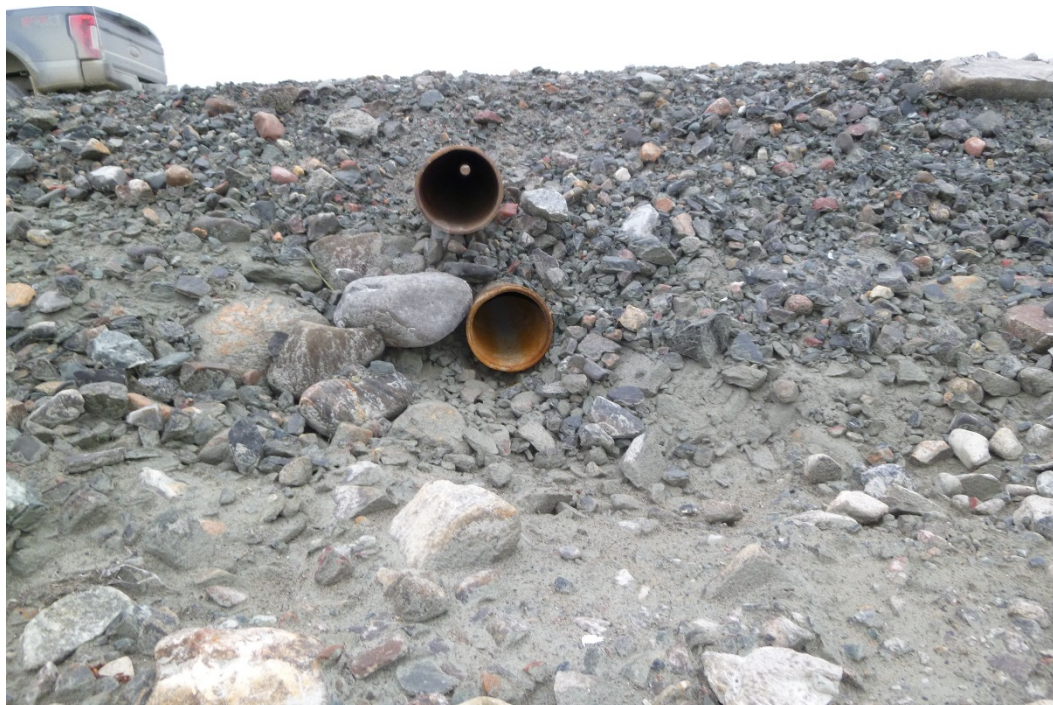
Photograph 41: 2 Vertically Offset 160 mm Ø Steel Pipes, Looking from Upstream to Downstream at Inlet of The Steel Pipes, At KM26.8. Pipes Showing More Oxidation Since 2016 Inspection (20 September 2017)

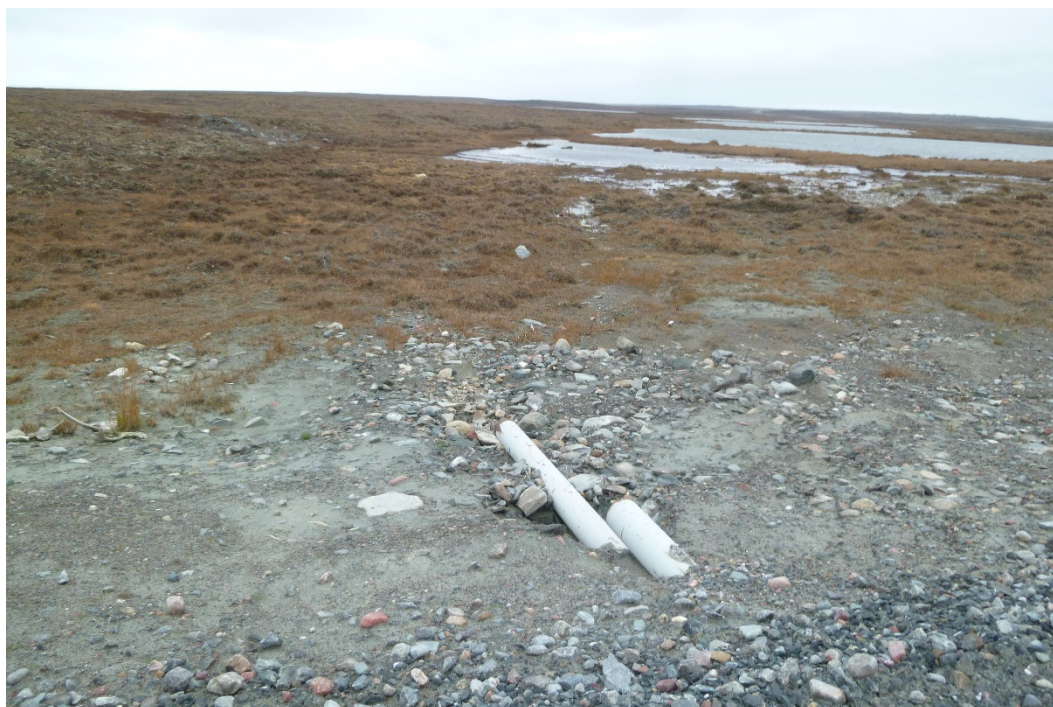
Photograph 42: 2 vertically Offset 160 mm Ø Steel Pipes, Looking Downstream at Outlet of the Steel Pipes, At KM26.8 (20 September 2017)

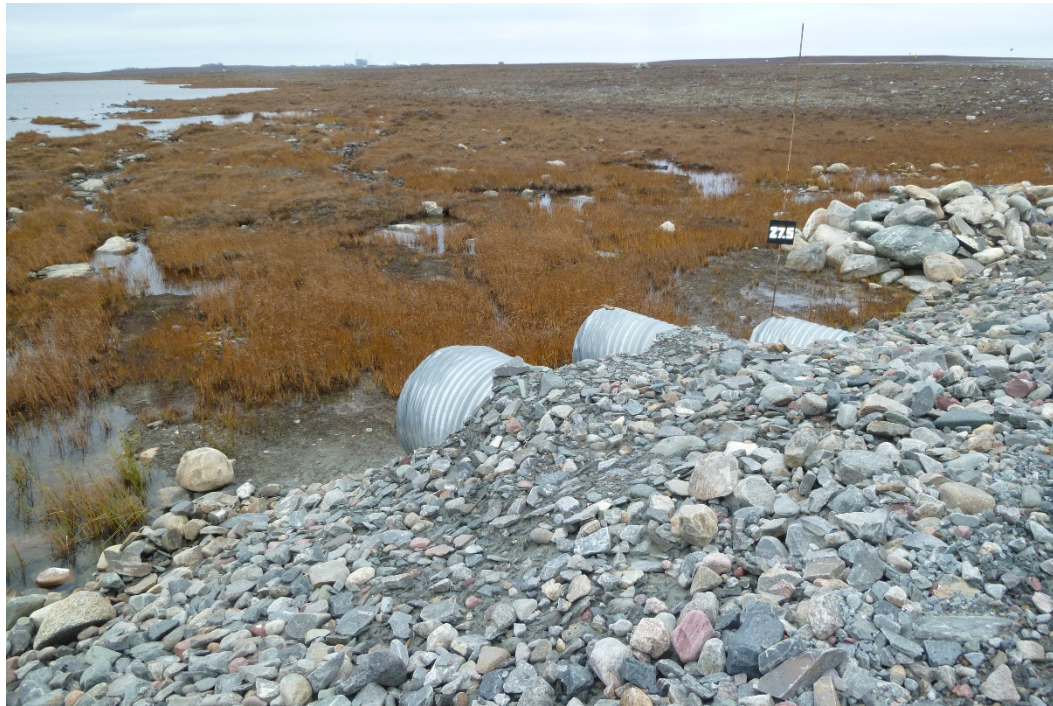
Photograph 43: View Upstream from Three Culverts at KM27.1 (20 September 2017)

Photographs 43 through 47 are at KM27.1, 3 CSP – 900 mm, 700 mm, and 1000 mm Ø CSP, installed vertically offset. Small flow in lowest CSP.

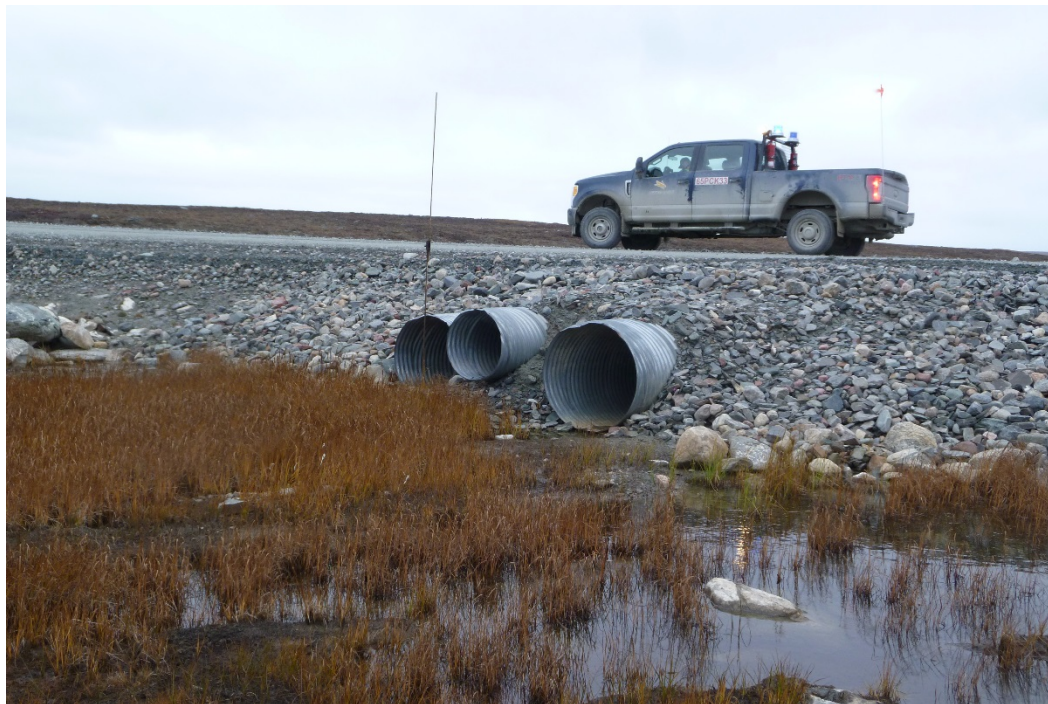
Photograph 44: Upstream Ends of Three Culverts at KM27.1. From left to right, 1000 mm, 700 mm, and 900 mm Ø CSP (20 September 2017)

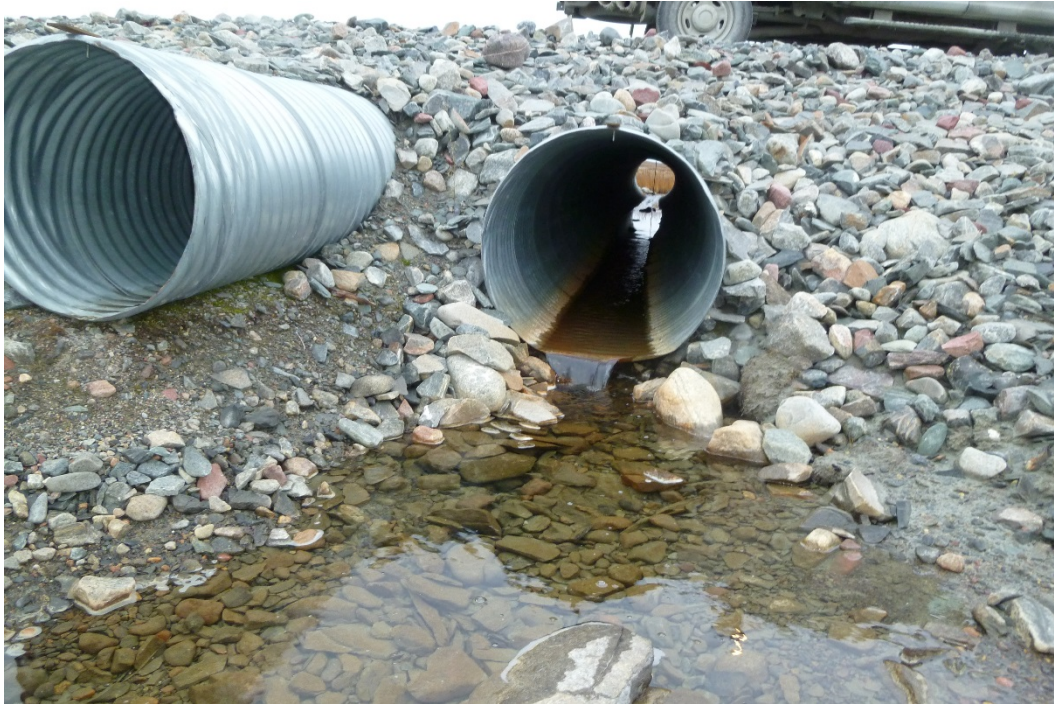
Photograph 45: Photo through the 900mm \varnothing culvert from Downstream to Upstream, Small Flow – KM27.1 (20 September 2017)

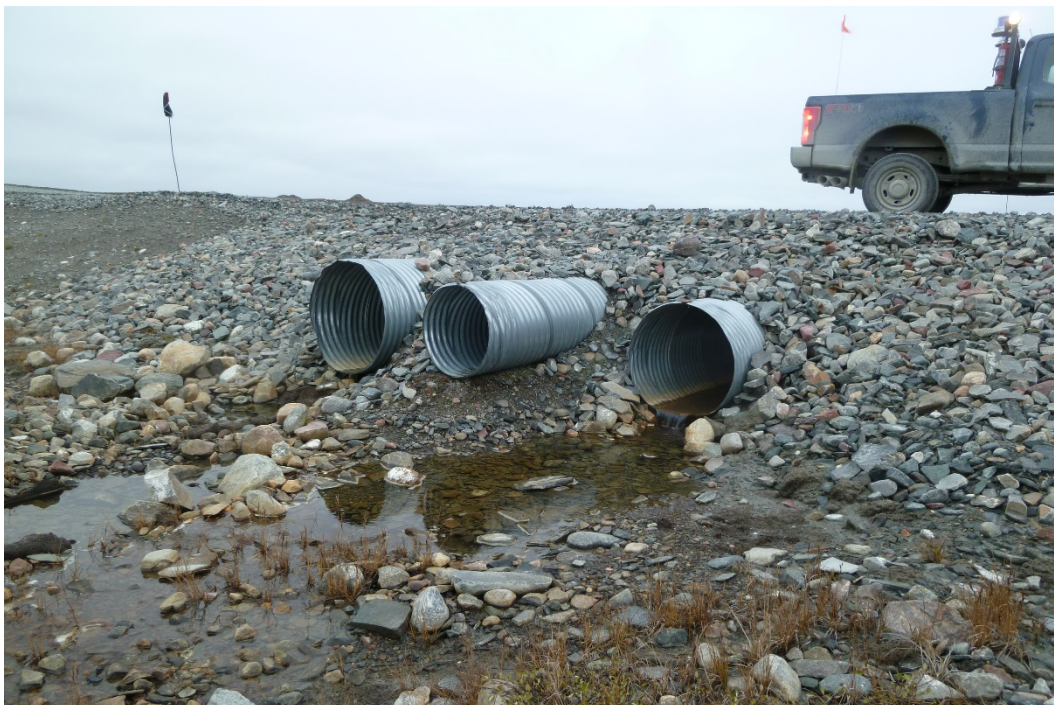
Photograph 46: Downstream Ends Of 3 CSP Culverts, Left to Right: 1000 mm, 700 mm, 900 mm \varnothing at KM27.1 (20 September 2017)

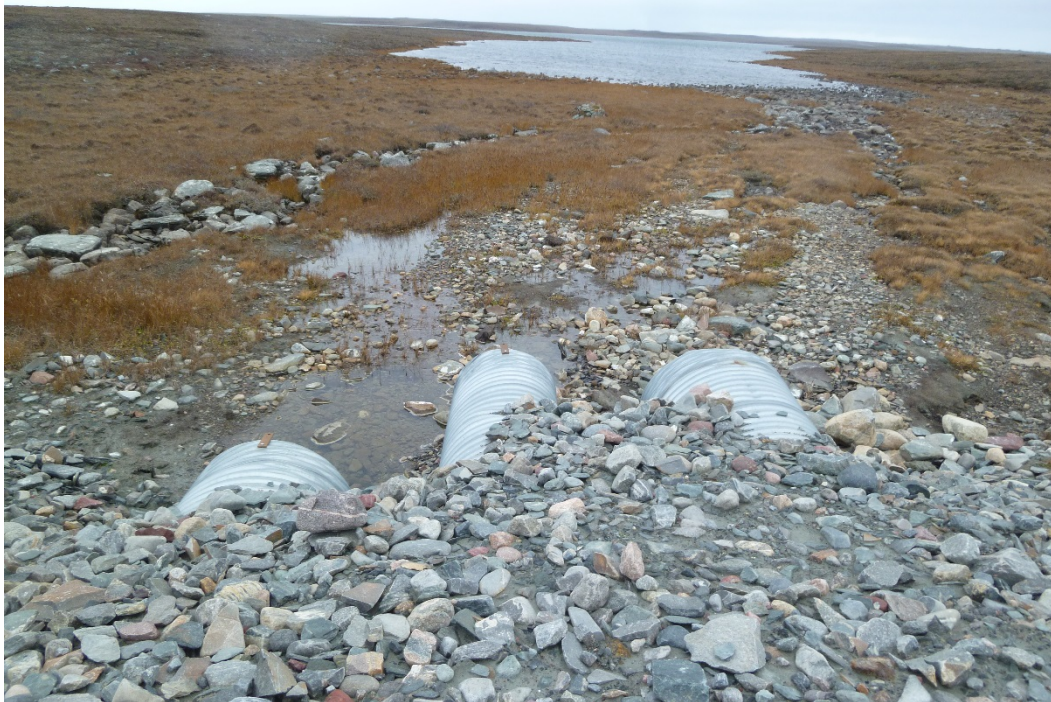
Photograph 47: Looking Downstream At 3 CSP, Left to Right: 900 mm, 700 mm, 1000 mm Ø at KM27.1 (20 September 2017)

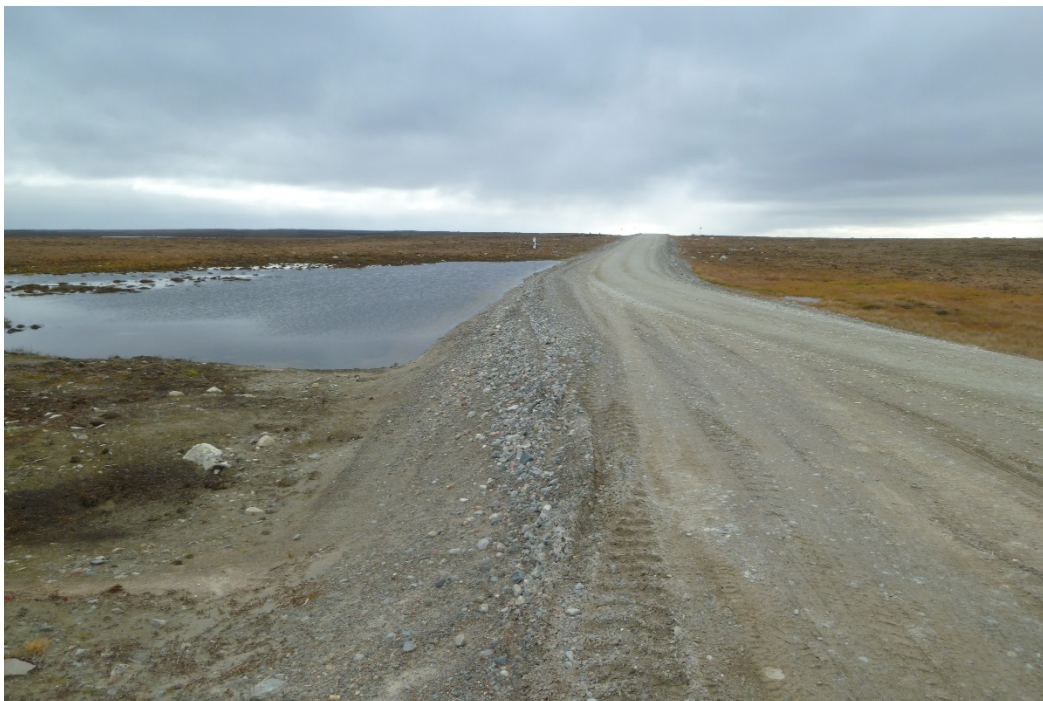
Photograph 48: KM28.7, Water Ponded on East Side of Road. AEM Reports that the Road is Wet for Most of the Open Water Season in this Area, Indicating Seepage through the Road. (22 September 2017)

Photographs 48 and 49 are at KM28.7, ponding water on east side of road. Consider installing culvert.

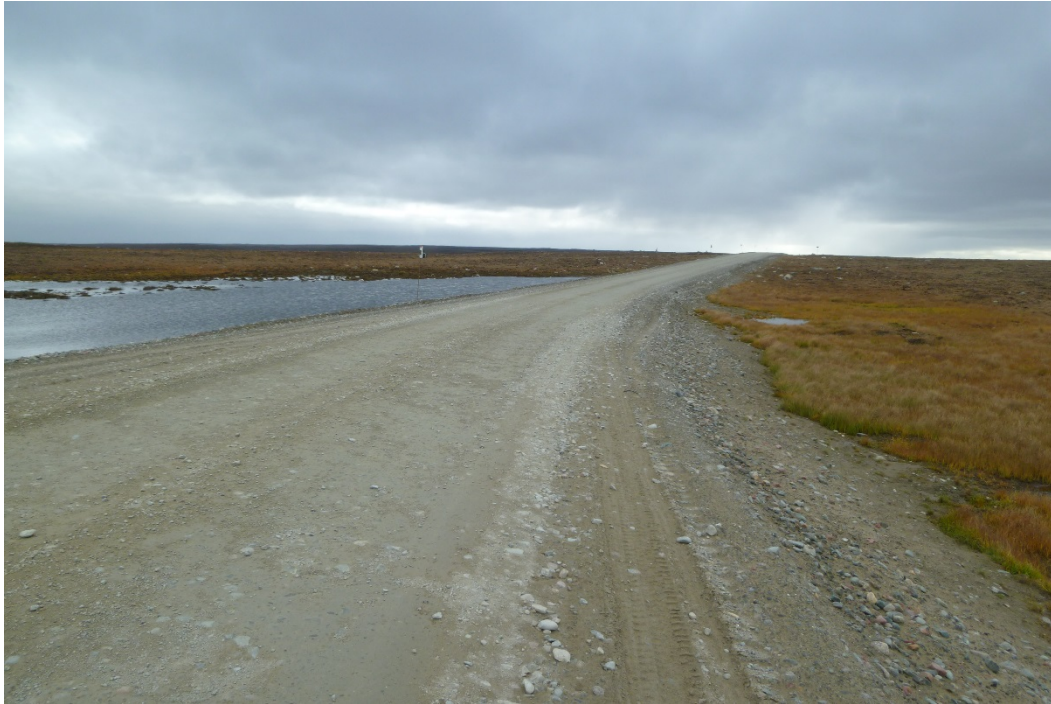
Photograph 49: KM28.7, Surface and West Side of Road Opposite Ponded Water on East (22 September 2017)

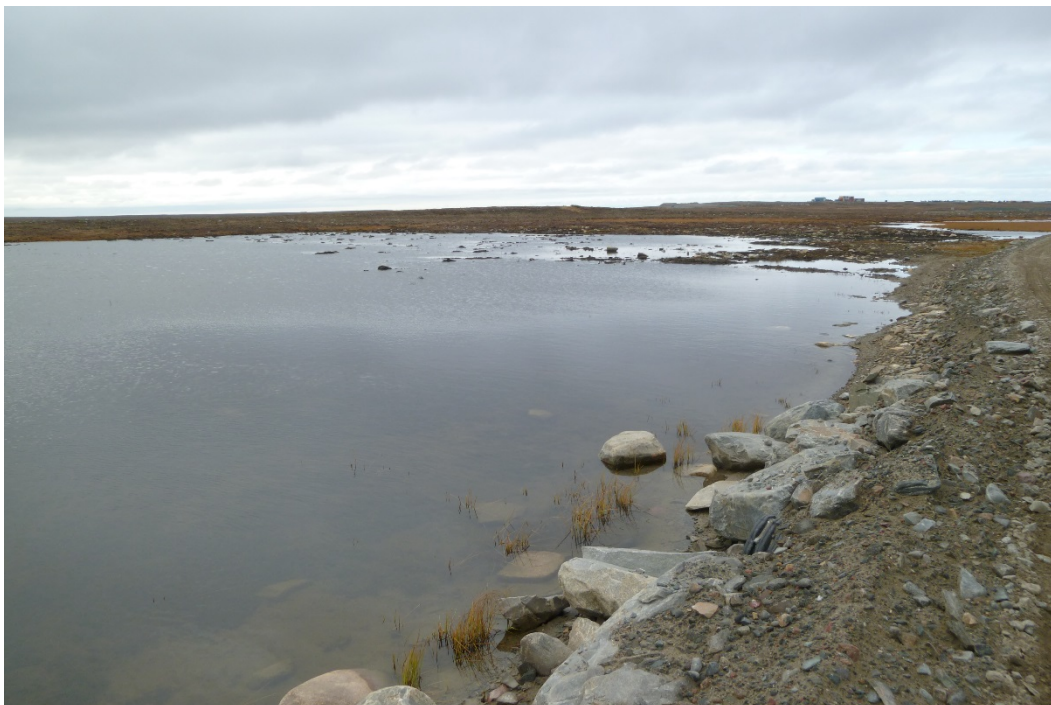
Photograph 50: Water Ponded on West Side of Road Upstream Of 500 mm Ø Corrugated HDPE Culvert at KM29.6, Looking North (22 September 2017)

Photographs 50 and 53 are at KM29.6, 1x500 mm Ø corrugated HDPE culvert, ponding water on west side of road. Consider lowering culvert invert.

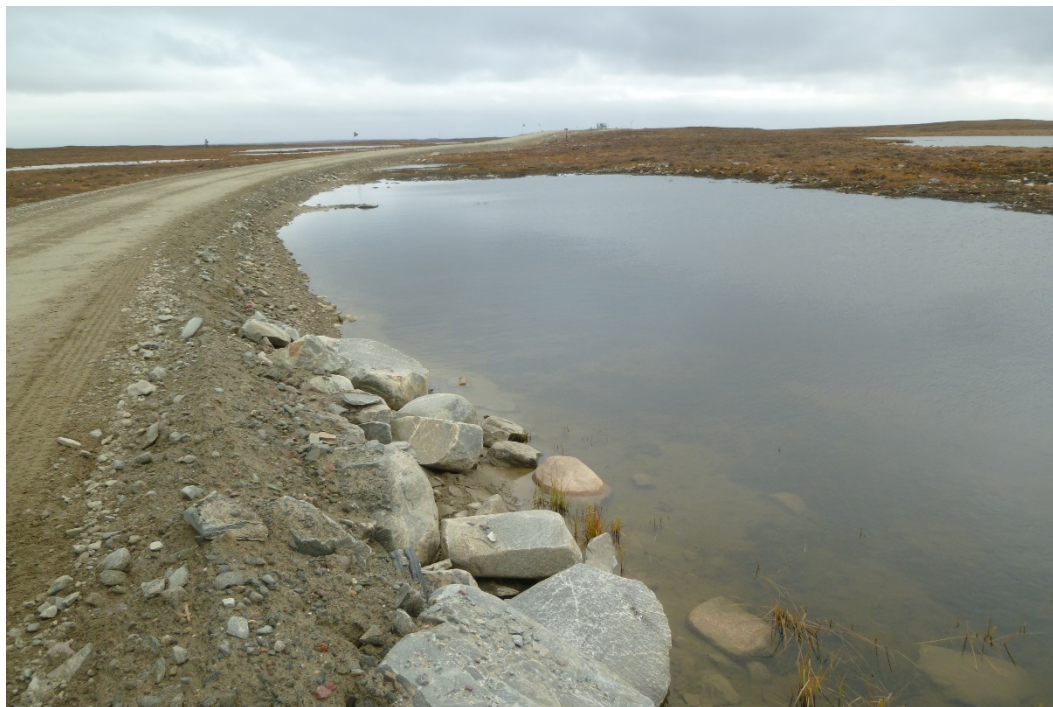
Photograph 51: 500mm Ø HDPE Corrugated Culvert Upstream Inlet (Between Rocks), At KM29.6, Looking South (22 September 2017)

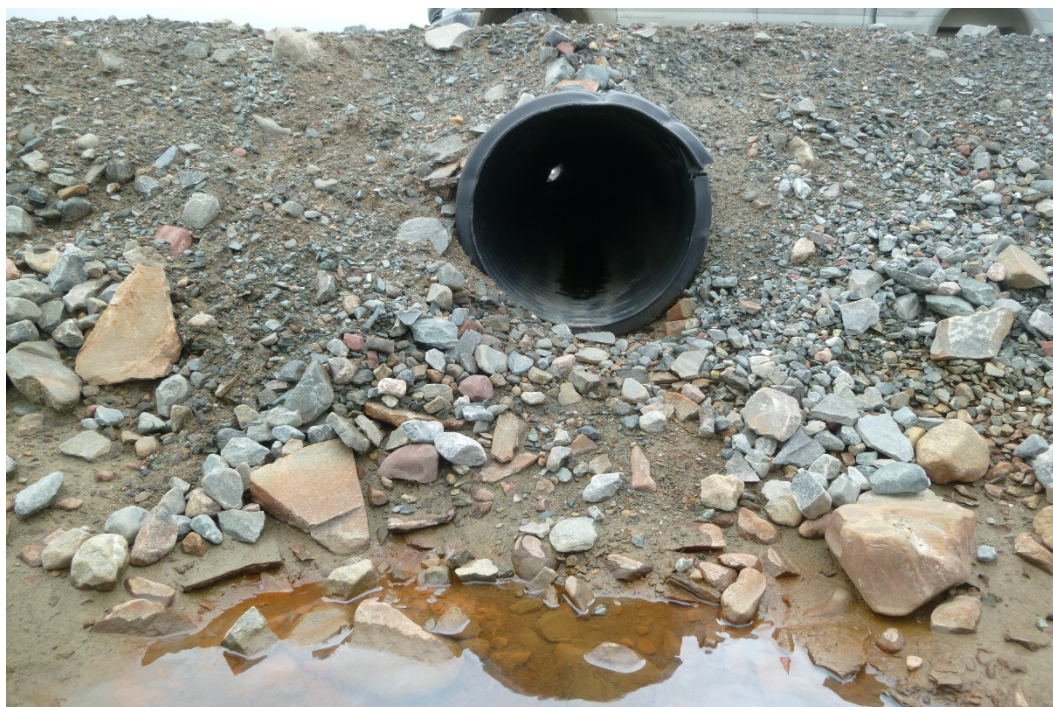
Photograph 52: 500 mm Ø HDPE Corrugated Culvert, View Through Culvert from Downstream to Upstream, Clear, No Flow, Some Dents of Side Wall at KM29.6 (22 September 2017)
