APPENDIX B

Meliadine AWAR Inspection – 2017

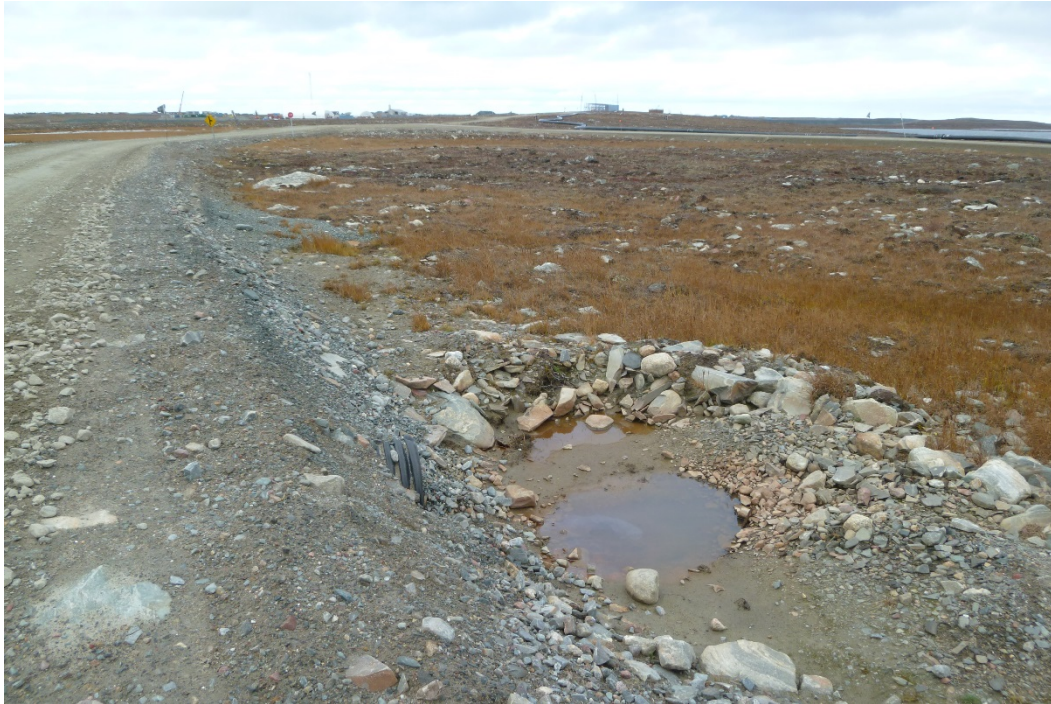
Photograph 53: 500 mm Ø HDPE Corrugated Culvert, Downstream Inlet of Culvert at KM29.6. Small Erosion Evident Upstream (22 September 2017)

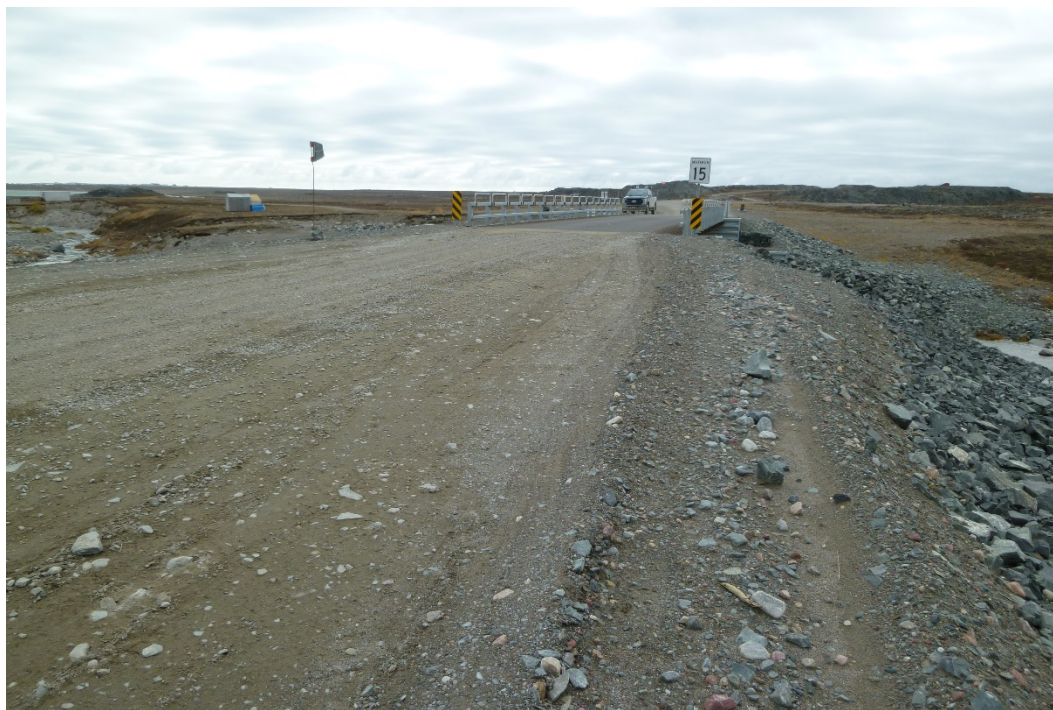
Photograph 54: Char River Bridge at KM6.0 Looking South (20 September 2017)

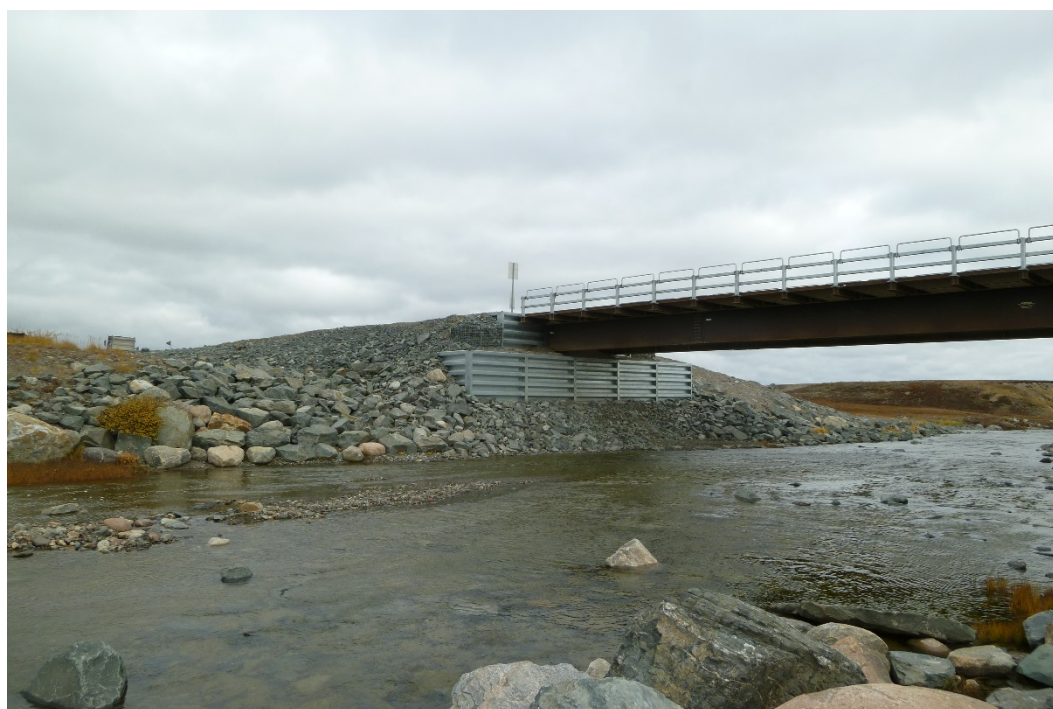
Photograph 55: Char River Bridge, Left (north) Abutment Armouring from the Upstream Side (20 September 2017)

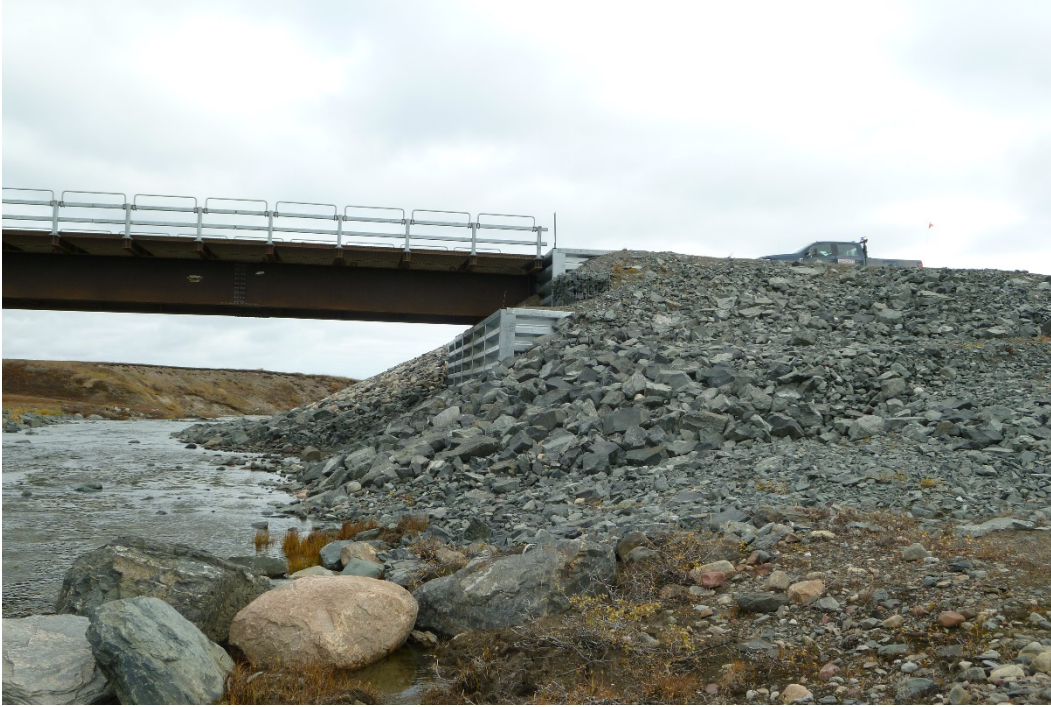
Photograph 56: Char River Bridge, Right (south) Abutment, Upstream (20 September 2017)

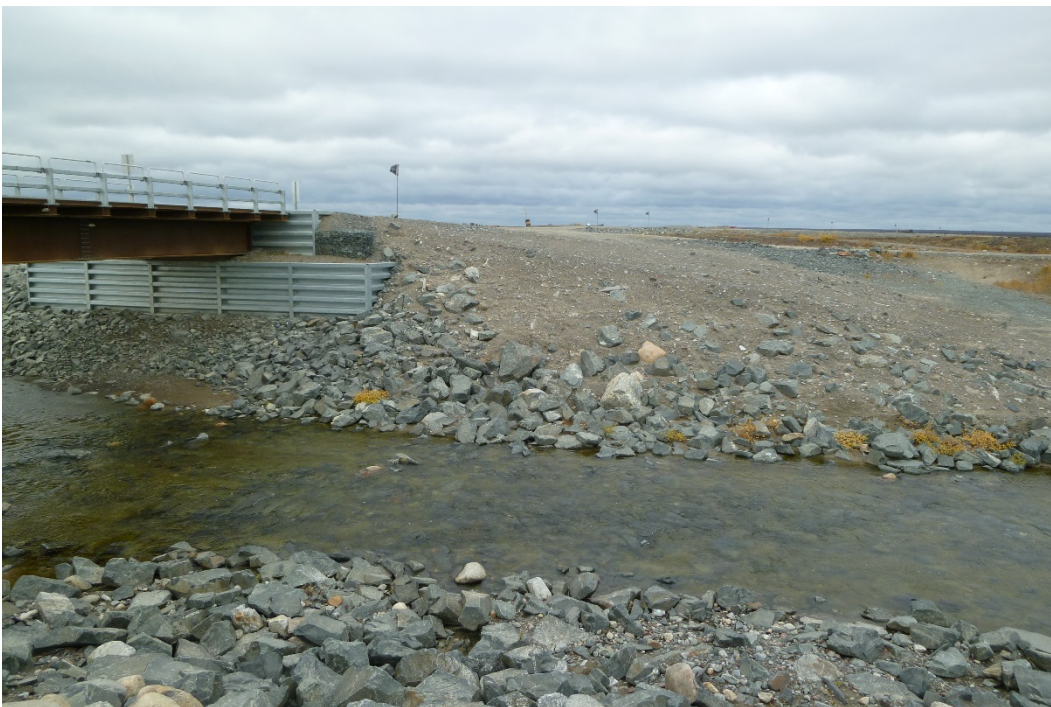
Photograph 57: Char River Bridge, left (north) Abutment, Downstream Side Taken from the Downstream Side of the Right (south) Abutment (20 September 2017)

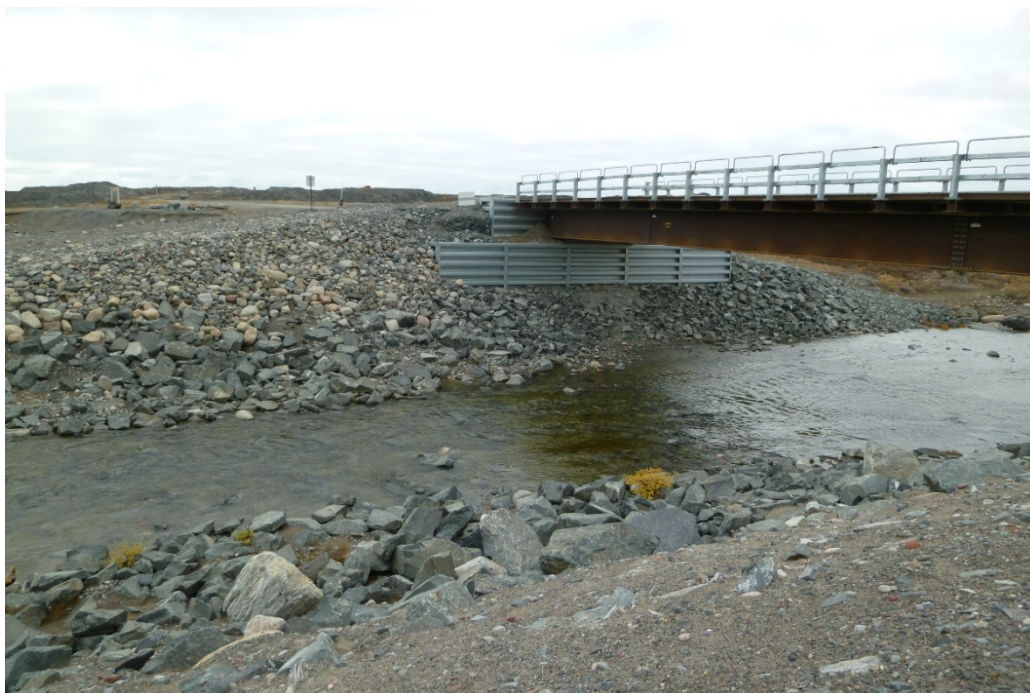
Photograph 58: Char River Bridge, Downstream Side of Right (South) Abutment, Taken from the Downstream Side of the Left (North) Abutment (20 September 2017)

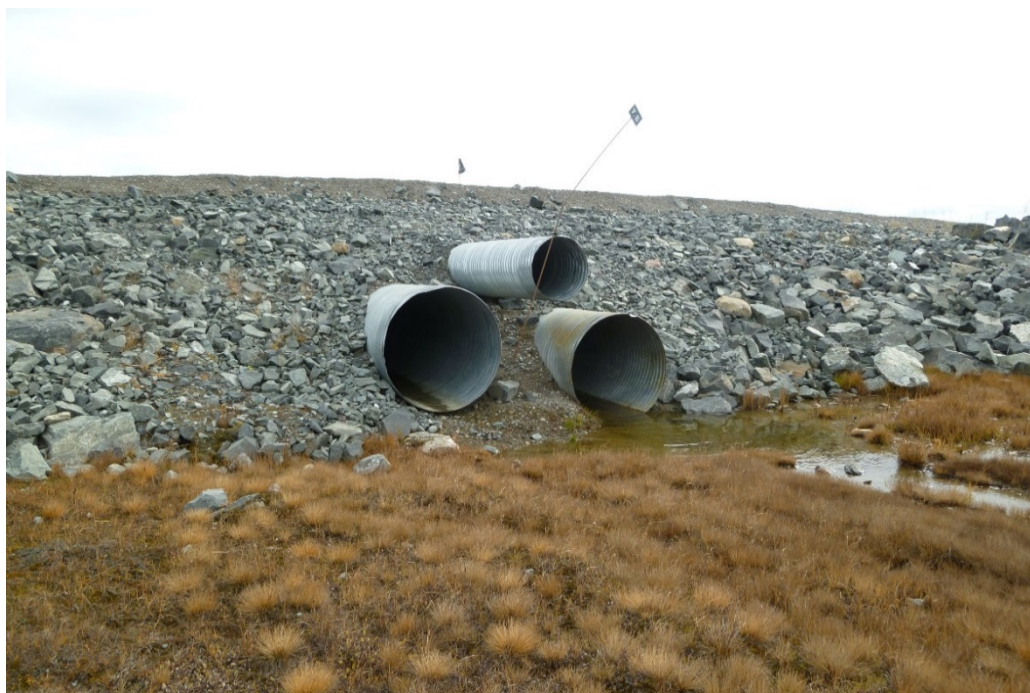
Photograph 59: At KM6.2, Upstream Ends Of 3 CSP Culverts. Lower Two Culverts Are 1300 mm in Diameter, Upper Culvert Is 700 mm in Diameter. All are in Good Condition (20 September 2017)

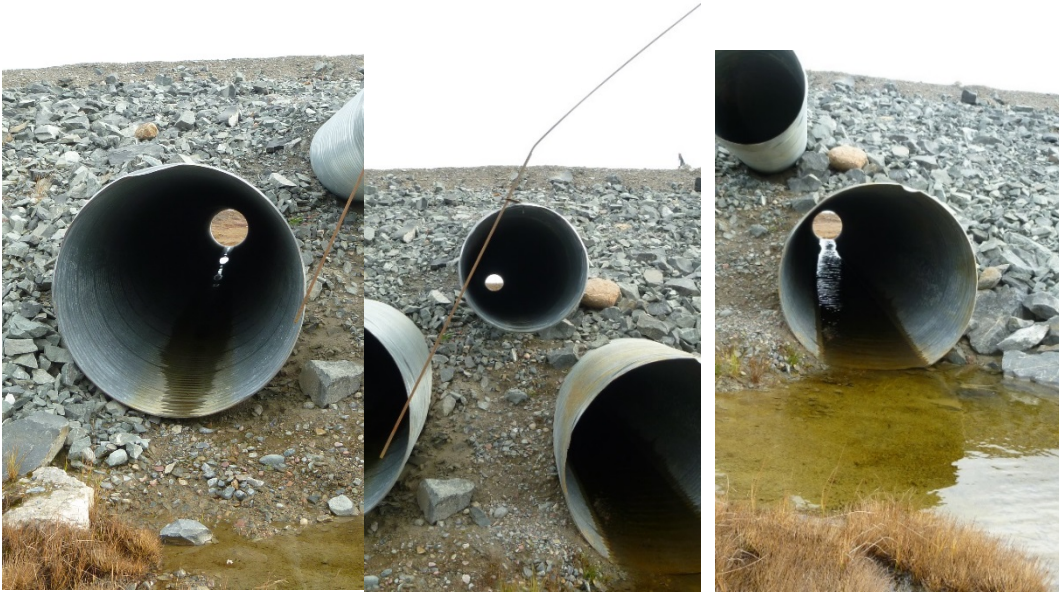
Photographs 60, 61 And 62: Upstream to Downstream View Through 3 CSP Culverts at KM6.2. Photographs are Ordered Left to Right Corresponding to the Order Shown in Photograph 56. Small Erosion Between Culverts, Consider Adding Armouring (20 September 2017)

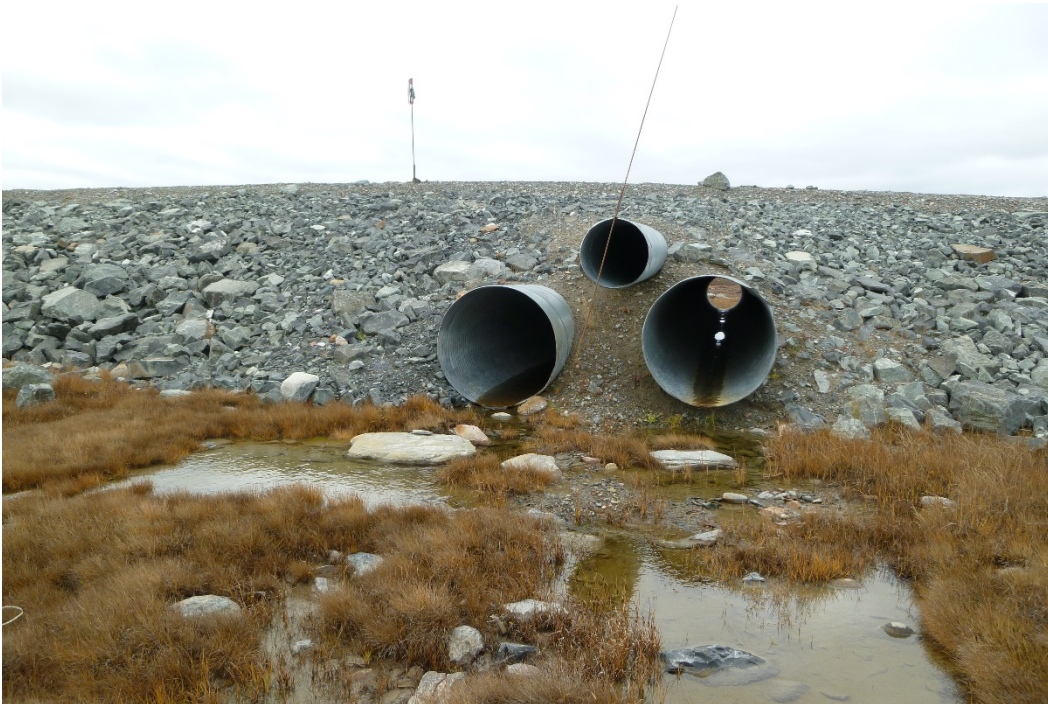
Photograph 63: Downstream Ends of 3 CSP Culverts at KM6.2 (20 September 2017)

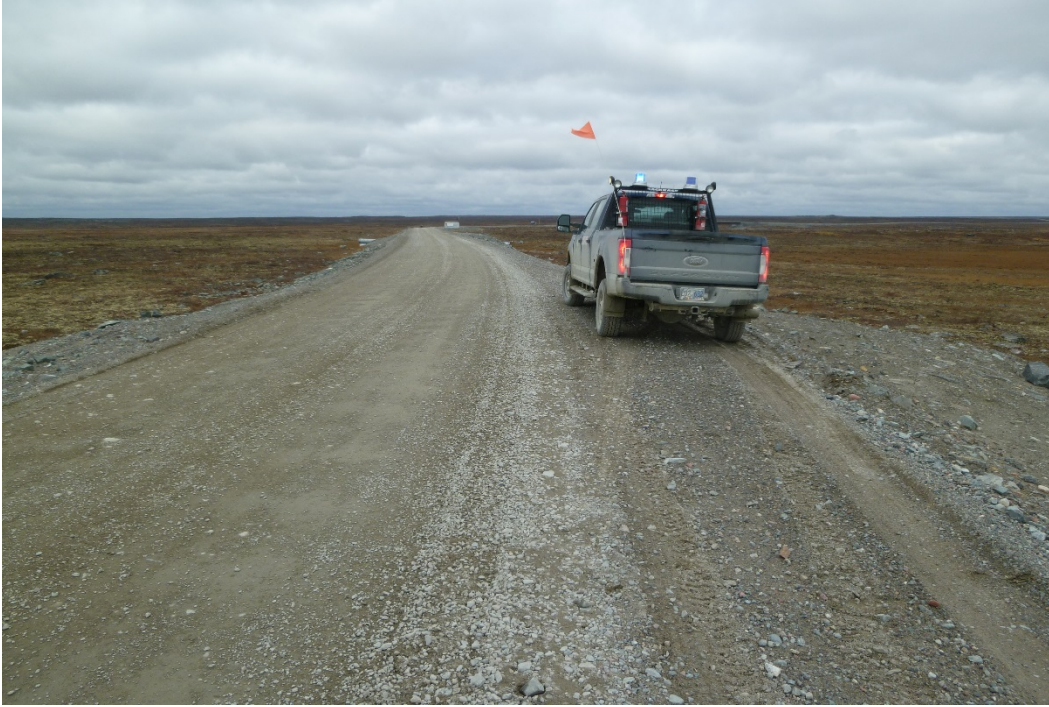
Photograph 64: Road Over 3 CSP Culverts at KM7.0 (20 September 2017)

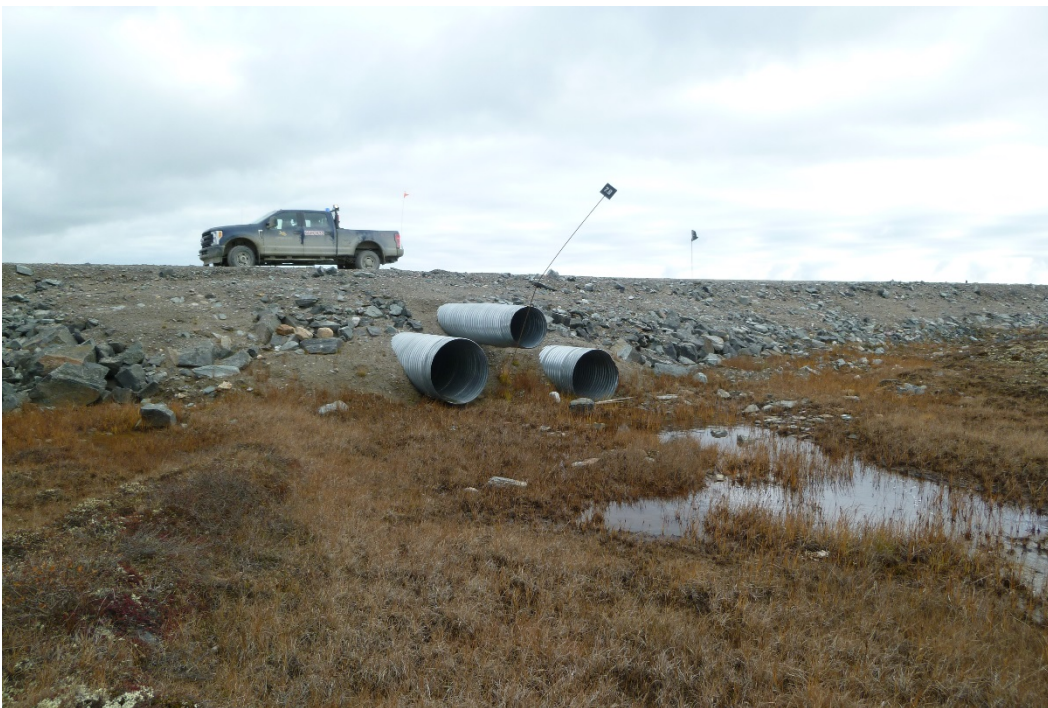
Photograph 65: At KM7.0, Upstream Ends of 3 CSP Culverts. Vertically Offset. Lower Two Culverts are 1000 mm in Diameter and Upper Culvert is 700 mm in Diameter. Some Exposed Esker Sand, Additional Armouring should be Considered (20 September 2017)

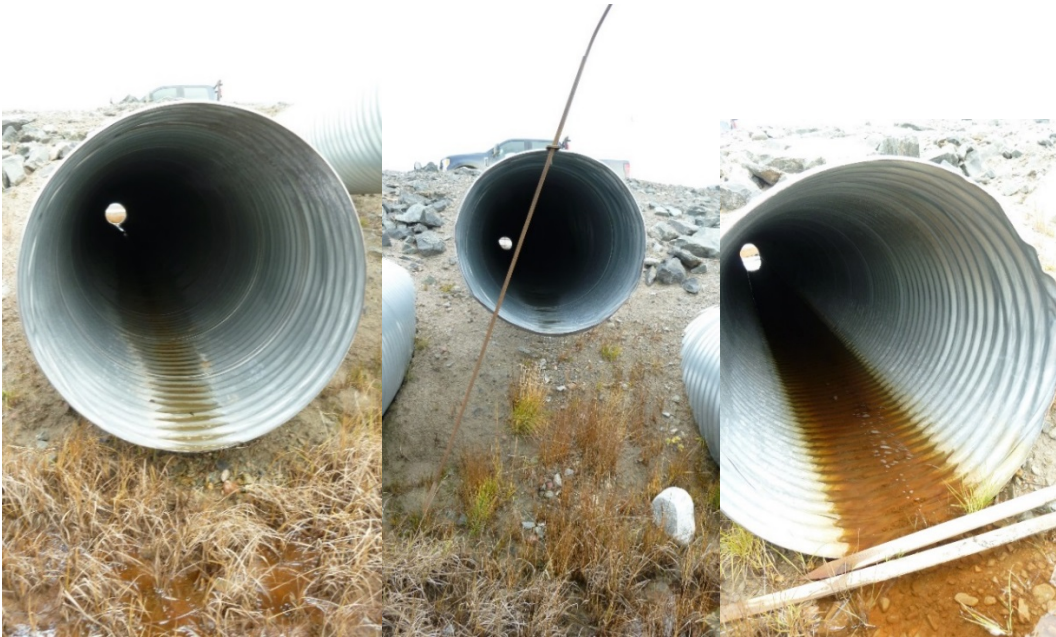
Photographs 66, 67, 68: Upstream to Downstream View Through 3 CSP Culverts at KM7.0. Photographs are Ordered Left to Right Corresponding to the Order Shown in Photograph 62 (20 September 2017)

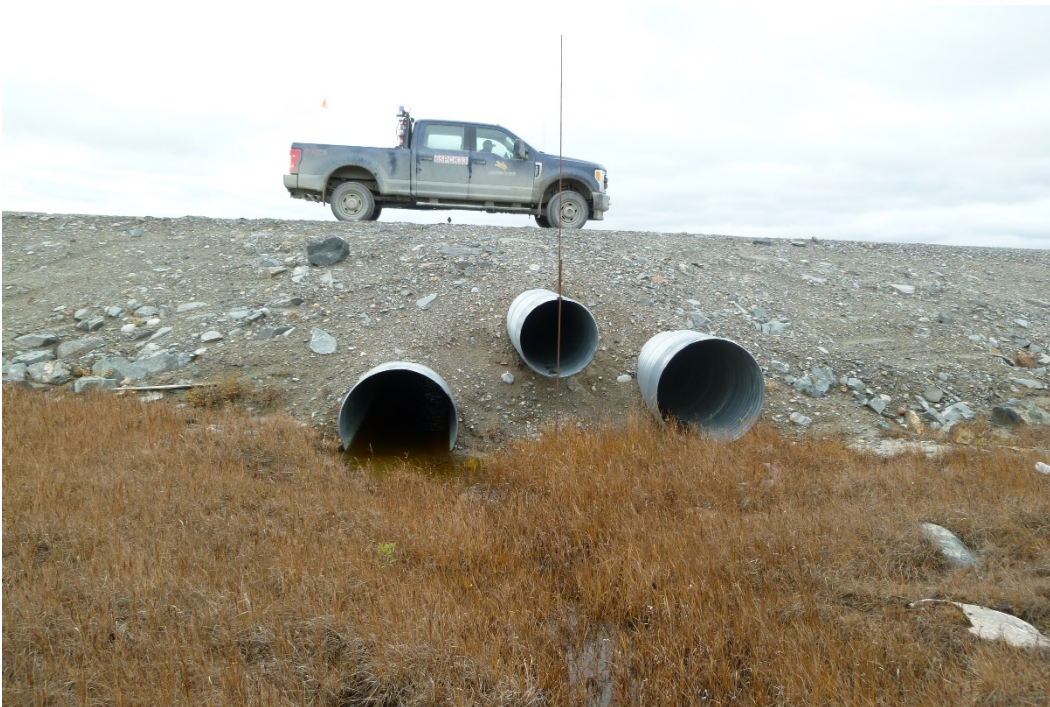
Photograph 69: Downstream Ends of 3 CSP Culverts at KM7.0 (20 September 2017)

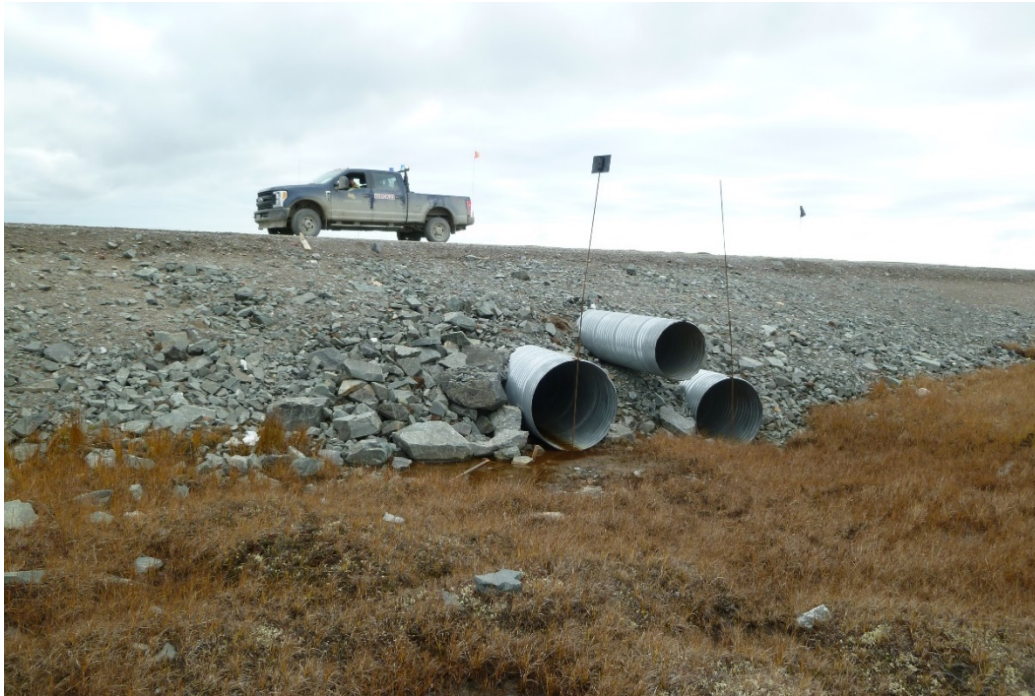
Photograph 70: At KM7.1, Upstream Ends of 3 CSP Culverts. Lower Two Culverts are 1000 mm in Diameter and Upper Culvert Is 700 mm in Diameter. Small Flow Through Culvert on the Right Hand Side, at Time of Inspection, Some Dents in 700 mm (20 September 2017)

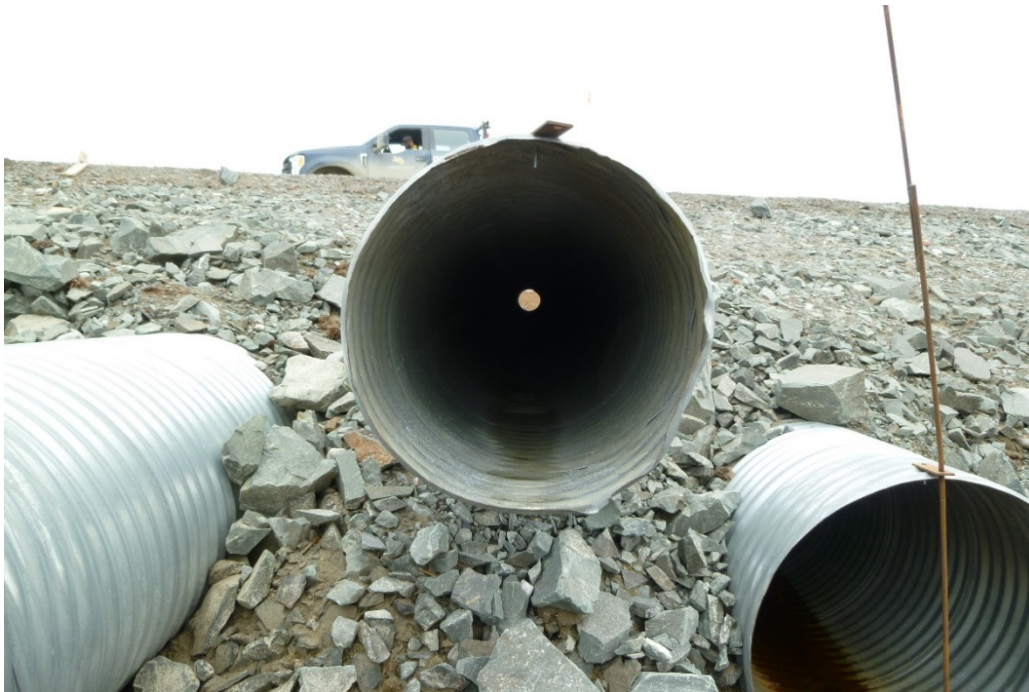
Photograph 71: Upstream to Downstream View Through 700 mm Diameter CSP Culvert at KM7.1 (20 September 2017)

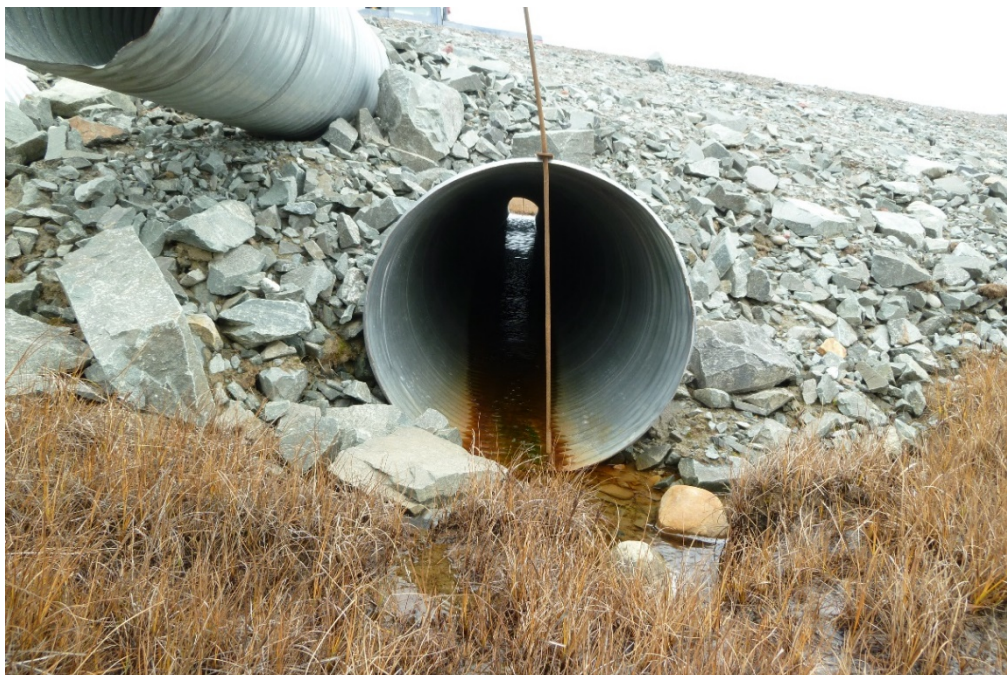
Photograph 72: Upstream to Downstream View Through Right 1000 mm Diameter CSP Culvert at KM7.1 (20 September 2017)

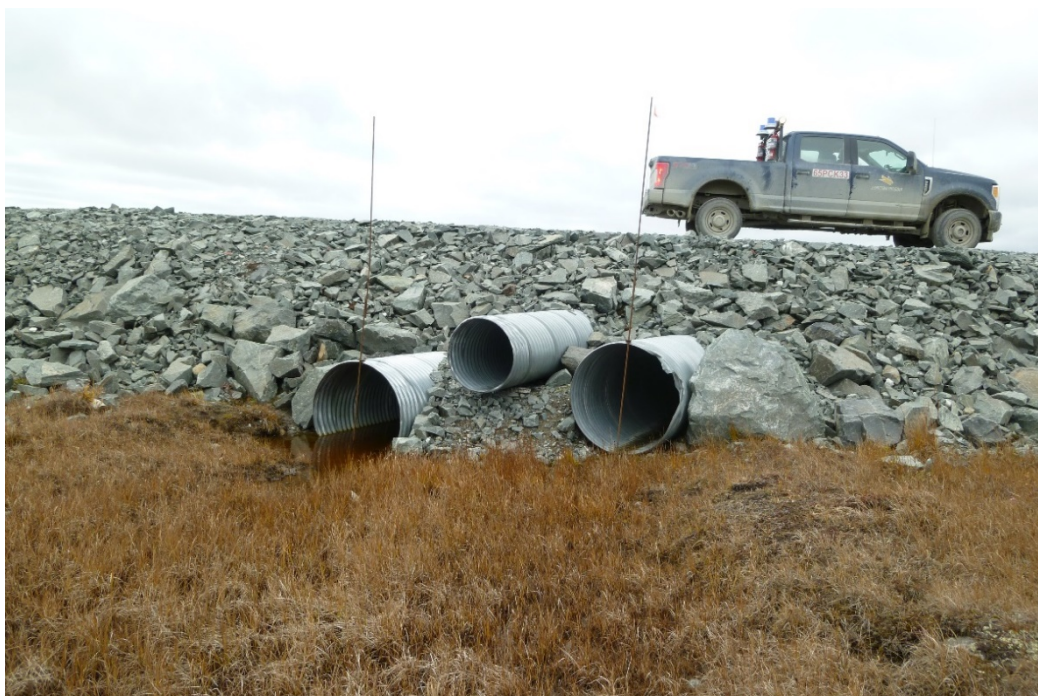
Photograph 73: Downstream Ends of 3 CSP Culverts at KM7.1 (20 September 2017)

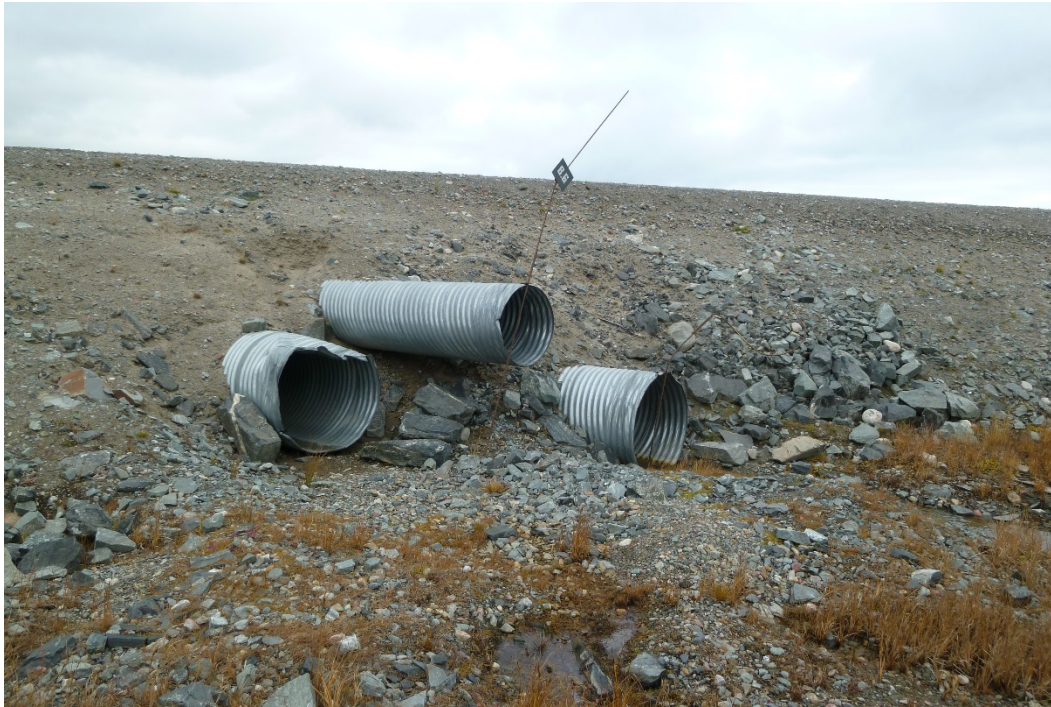
Photograph 74: At KM7.4, Upstream Ends of 3 CSP Culverts. Culvert Diameters are from Right to Left, 1000 mm, 700 mm, and 900 mm. Inlet of the 900 mm has been Partially Crushed (20 September 2017)

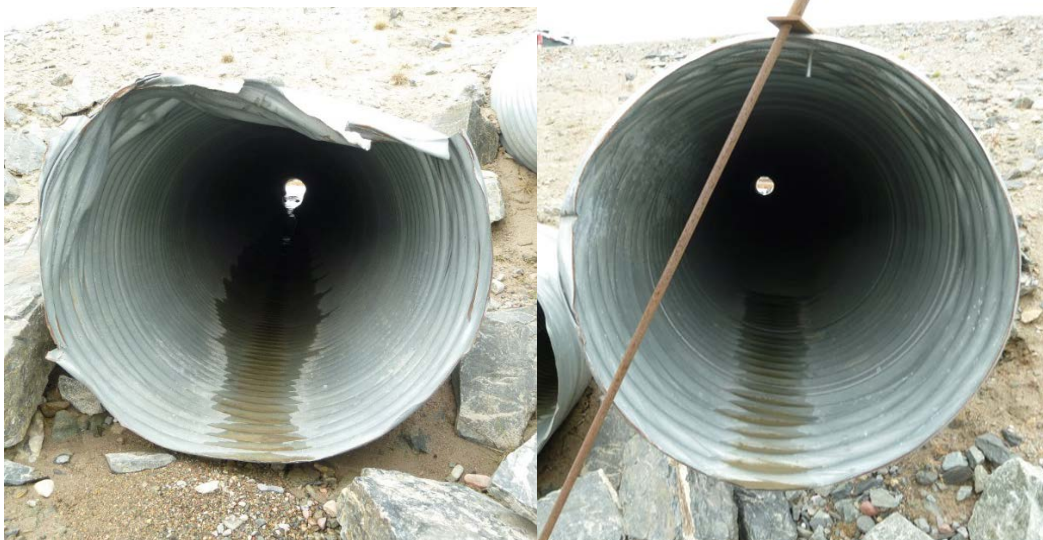
Photograph 75 And 76: At KM7.4, Upstream to Downstream View Through Damaged 900 mm Diameter Culvert Inlet, Likely Crushed by Rocks (On Left). Upstream to Downstream View Through 700 mm Diameter Culvert (on right) (20 September 2017)

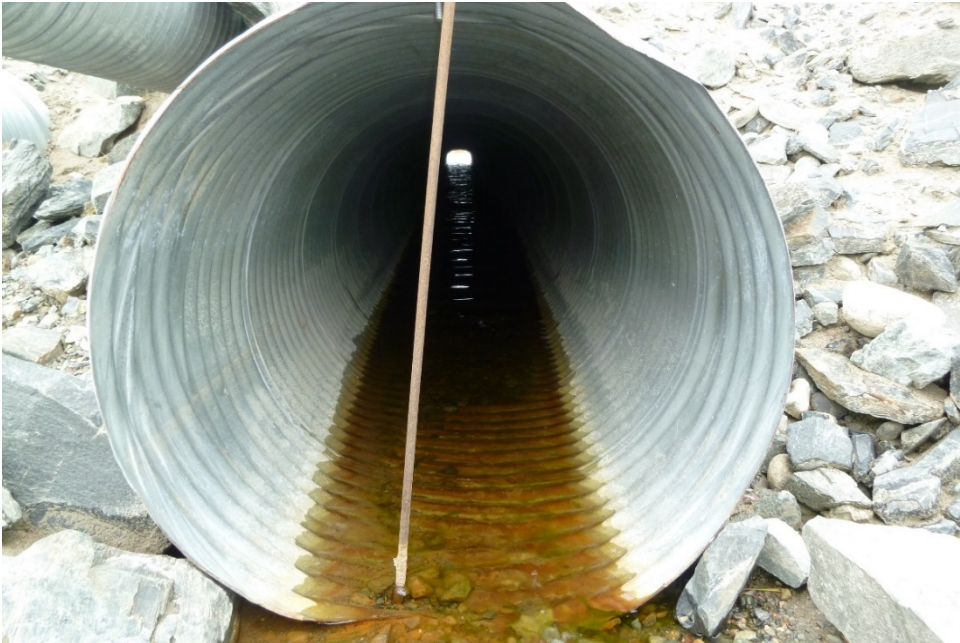
Photograph 77: At KM7.4, Upstream to Downstream View Through 1000 mm Diameter Culvert (20 September 2017)

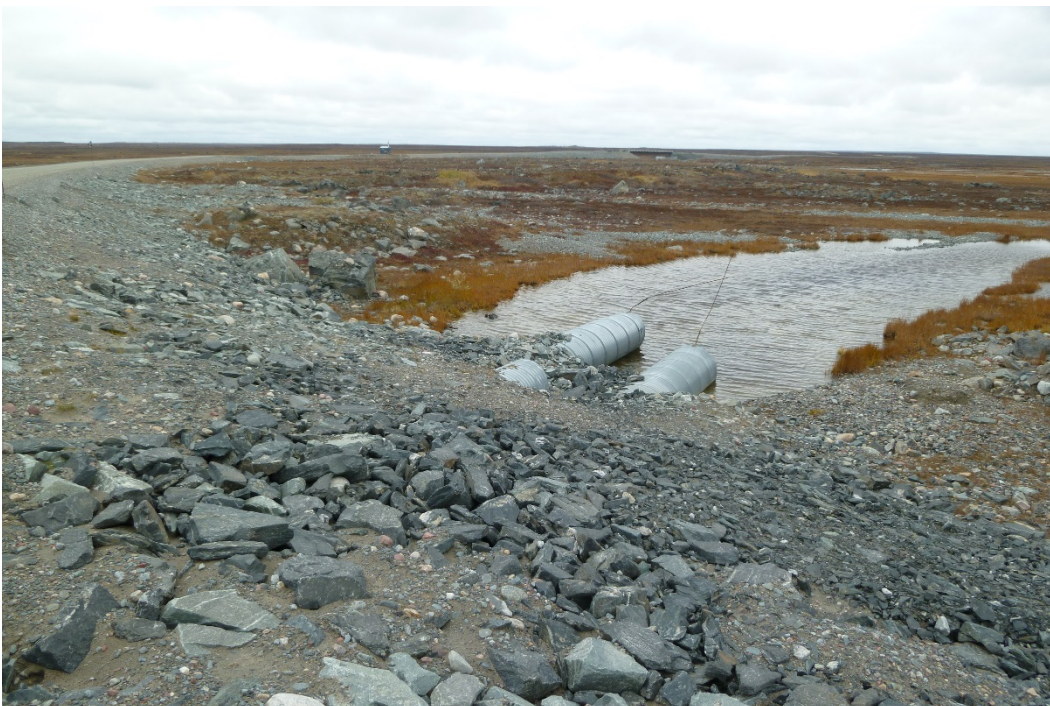
Photograph 78: At KM7.4, Looking at Downstream Ends of 3 CSP Culverts (20 September 2017)

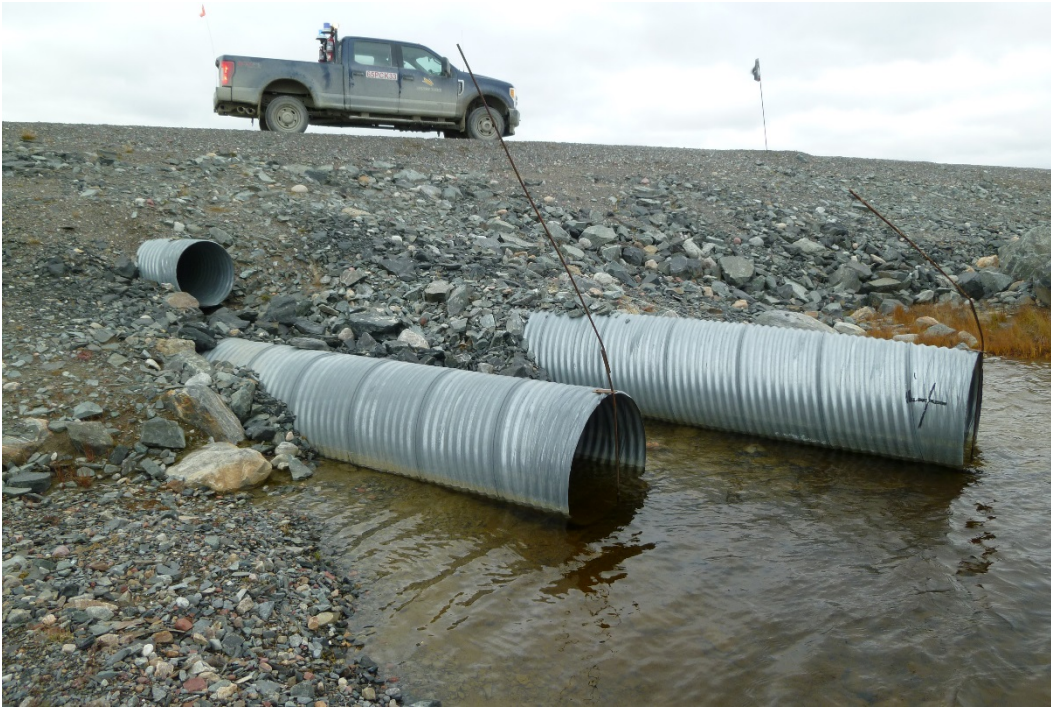
Photograph 79: Downstream Ends of 3 CSP Culverts at KM7.4. Middle, (700 mm Diameter) Culvert Should be Extended and Additional Armouring Added to Reduce Erosion Potential (20 September 2017)

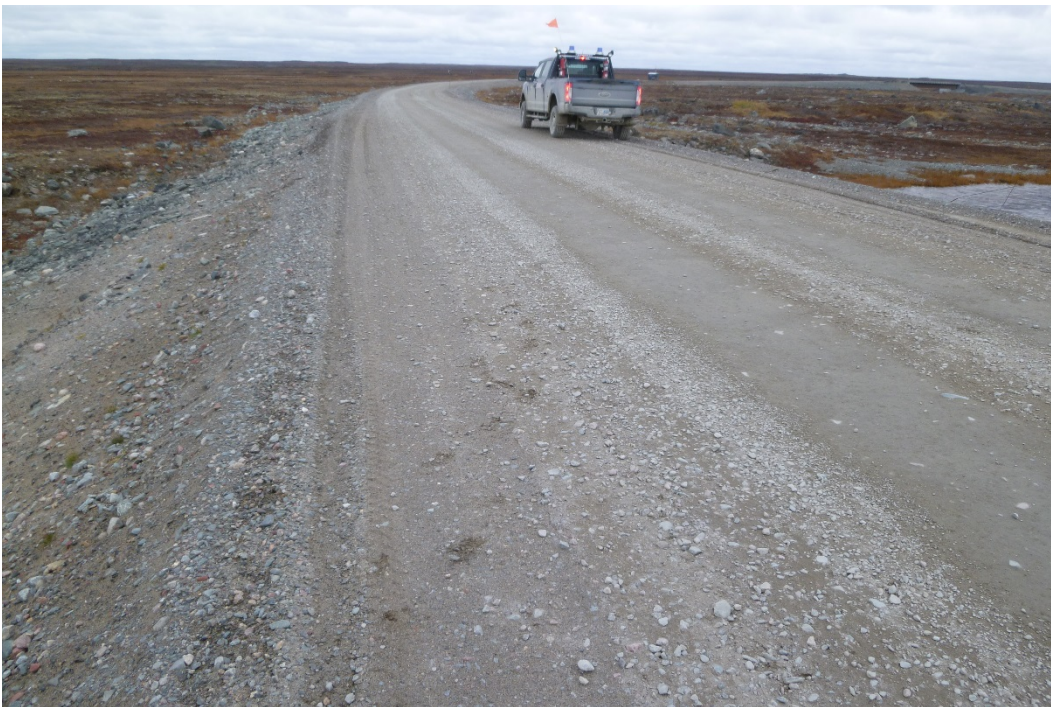
Photograph 80: Road Surface Over 3 CSP Culverts at KM 7.4 (20 September 2017)
