APPENDIX B

Meliadine AWAR Inspection – 2017

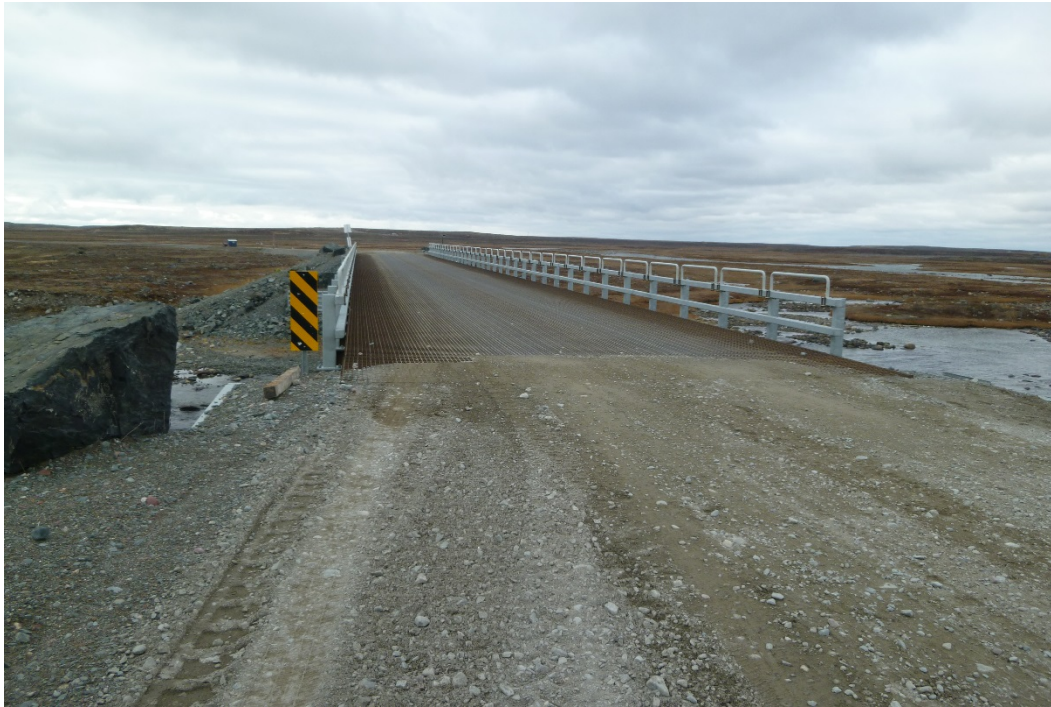
Photograph 81: Meliadine River Bridge at KM8.0, Looking South (20 September 2017)

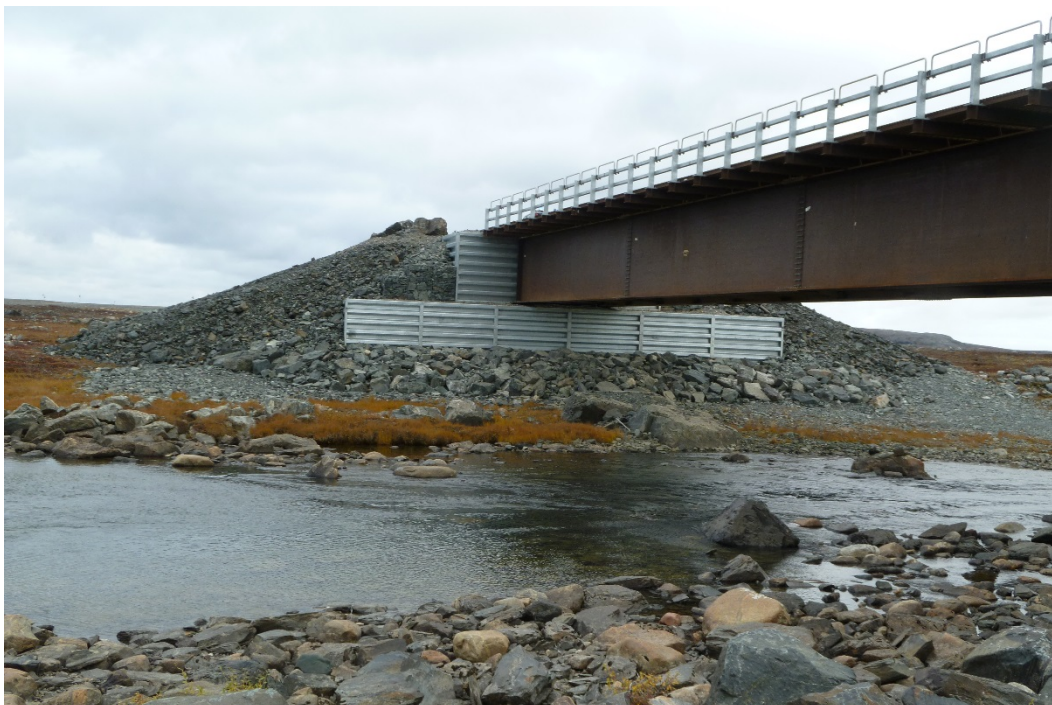
Photograph 82: Meliadine River Bridge at KM8.0. Left (North) Abutment Looking North. Upstream to the Left (20 September 2017)

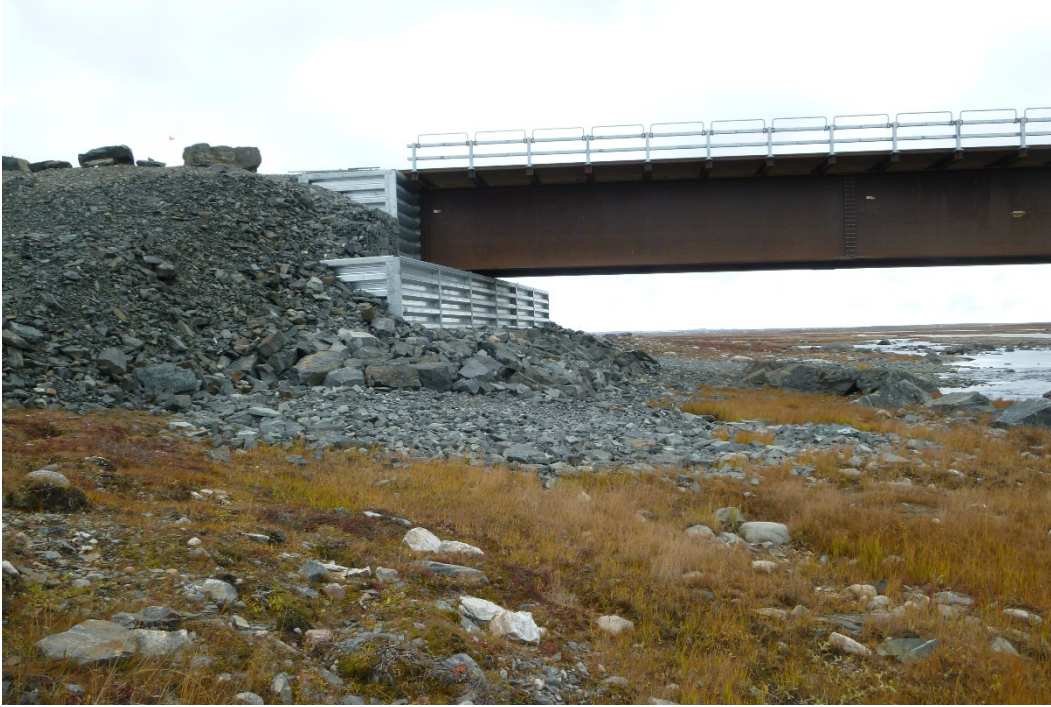
Photograph 83: Meliadine River Bridge at KM8.0. Left (North) Abutment Looking Downstream from Upstream (20 September 2017)

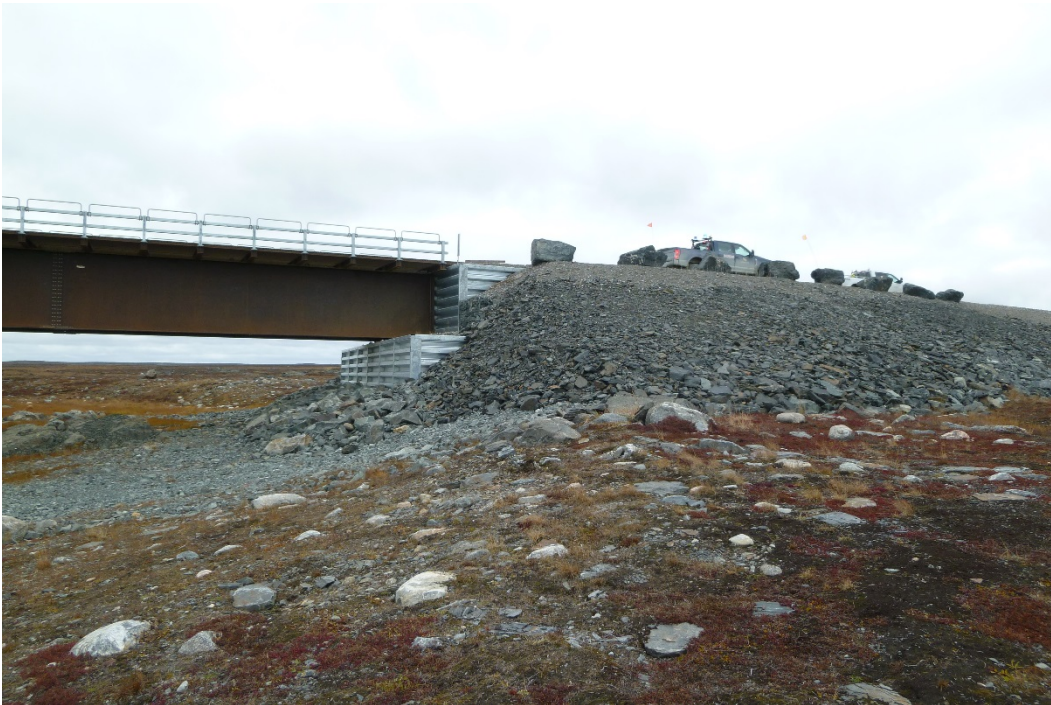
Photograph 84: Meliadine River Bridge at KM8.0. Left (North) Abutment Looking Upstream from Downstream (20 September 2017)

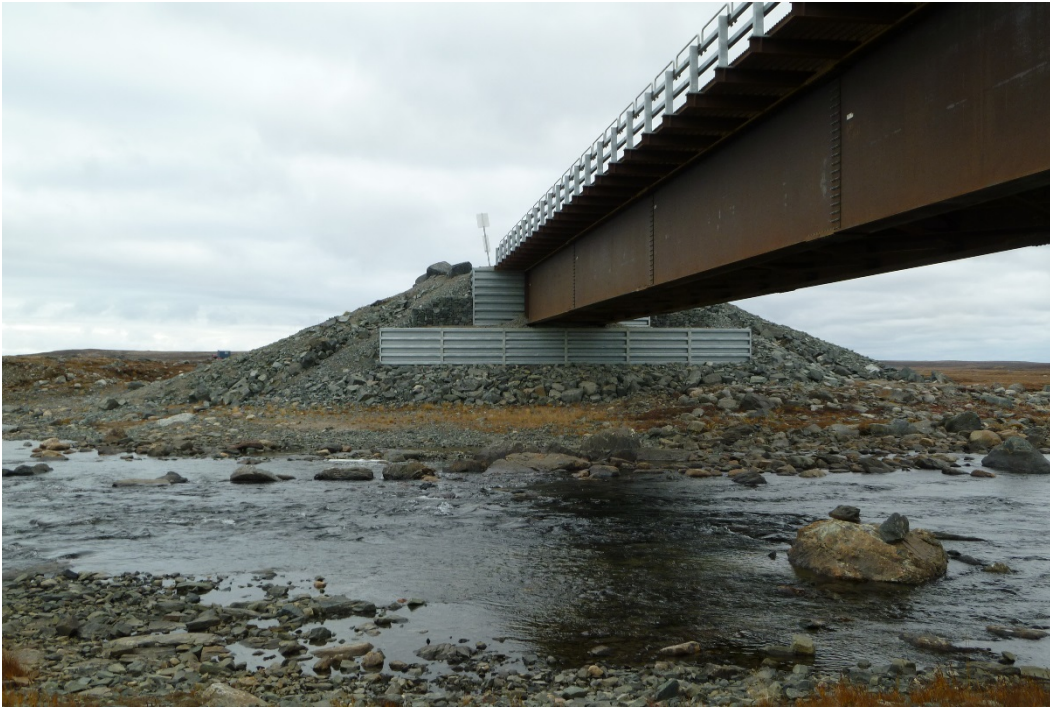
Photograph 85: Meliadine River Bridge at KM8.0. Right (South) Abutment, Looking South. Downstream to Left (20 September 2017)

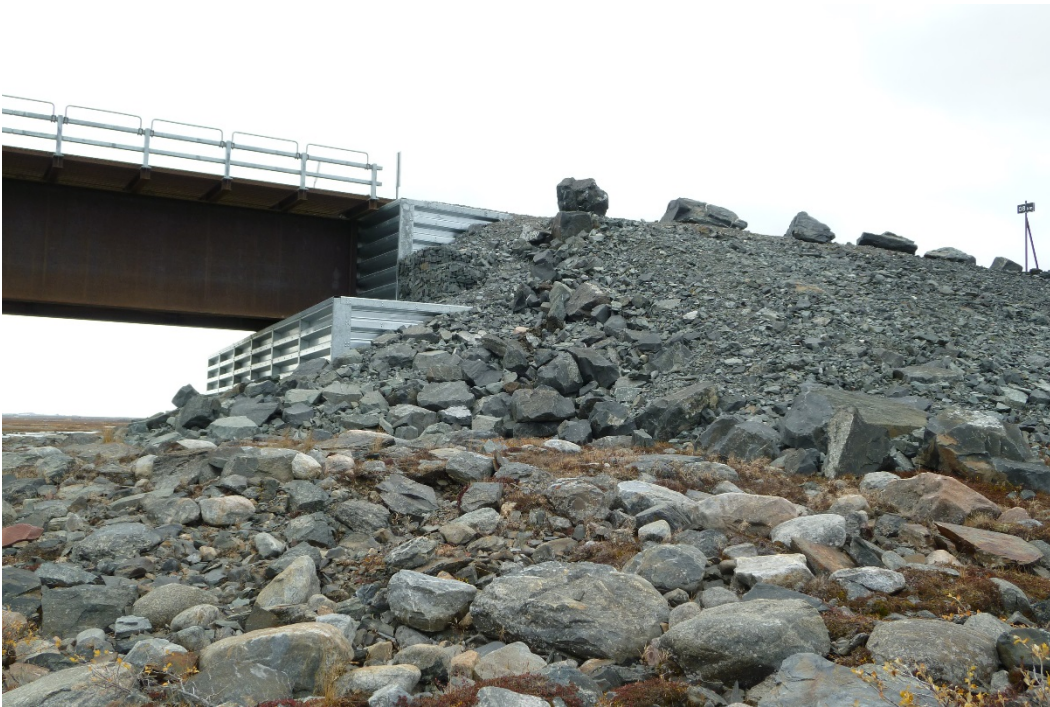
Photograph 86: Meliadine River Bridge at KM8.0. Right (South) Abutment Looking Downstream from Upstream (20 September 2017).

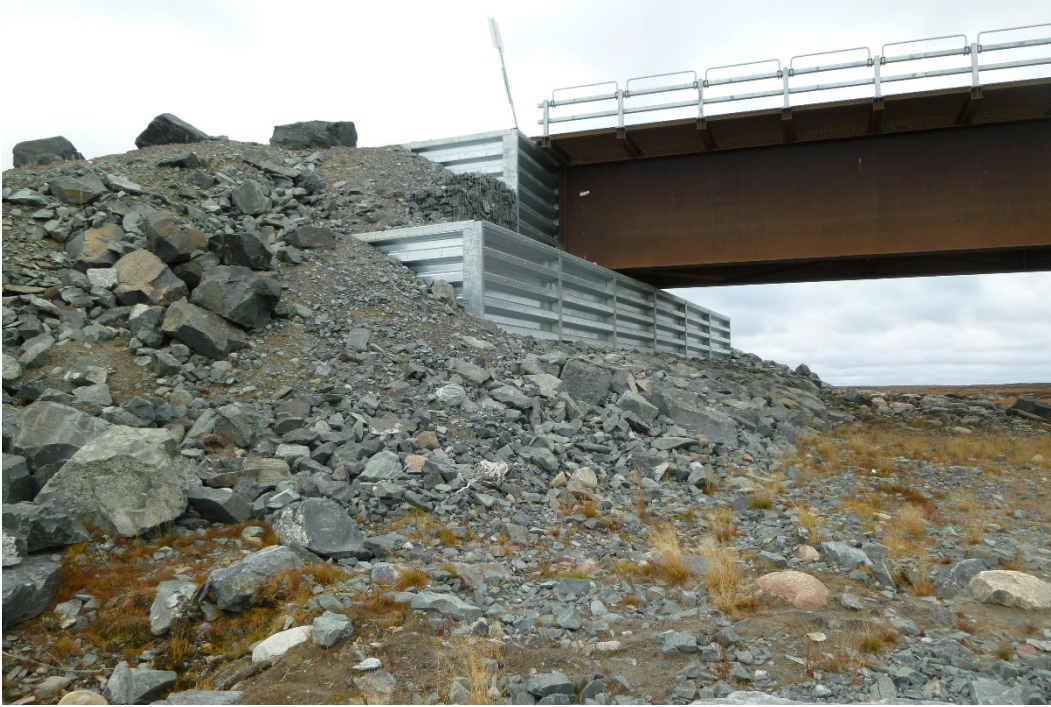
Photograph 87: Meliadine River Bridge at KM8.0. Right (South) Abutment Looking Upstream from Downstream (20 September 2017)

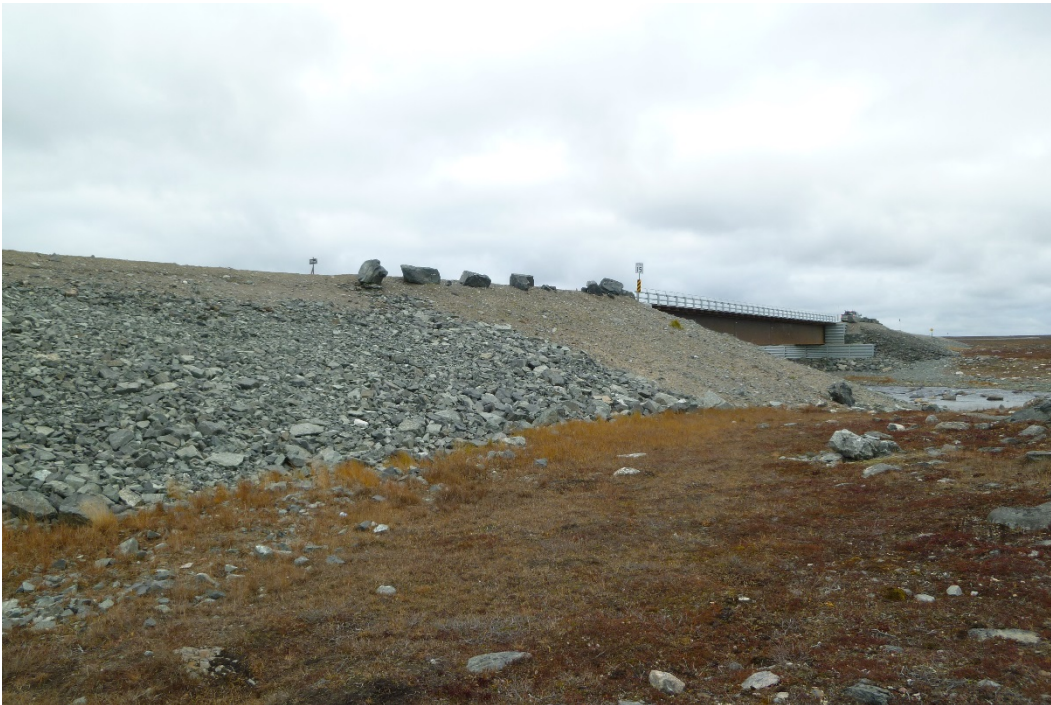
Photograph 88: Meliadine River Bridge at KM8.0. Slope of Right (South) Abutment, Esker Sand Exposed. Consider Adding Armouring with Coarser Grained Material to Reduce Erosion Potential (20 September 2017)

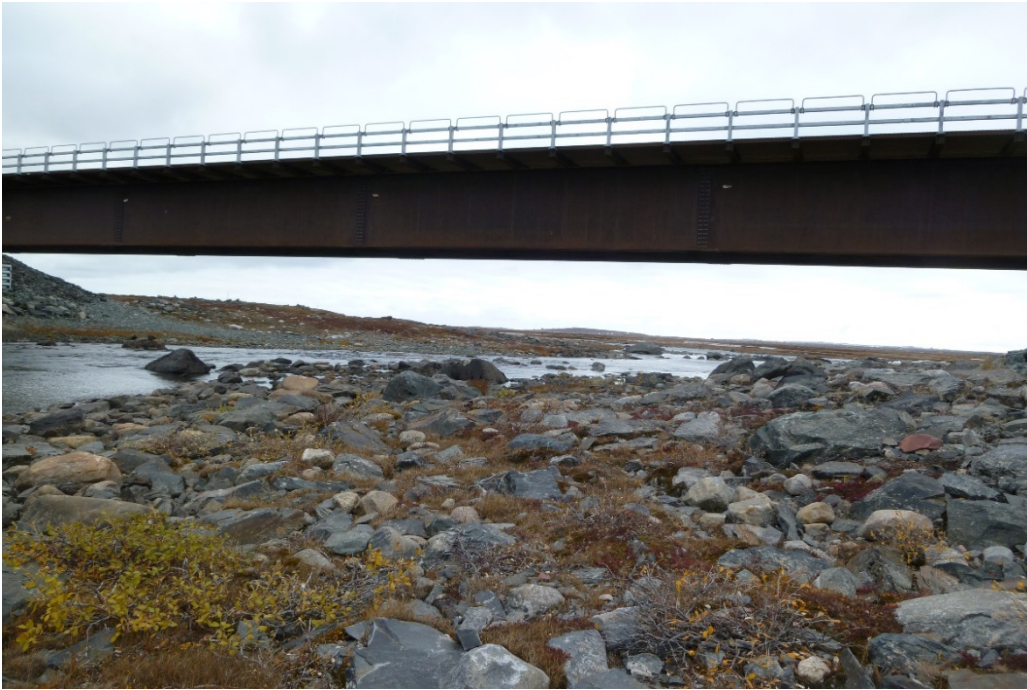
Photograph 89: Meliadine River Bridge View from Upstream to Downstream Beneath Bridge Deck. Low Flow at Time of Inspection Gravel and Cobble Bedding (20 September 2017)

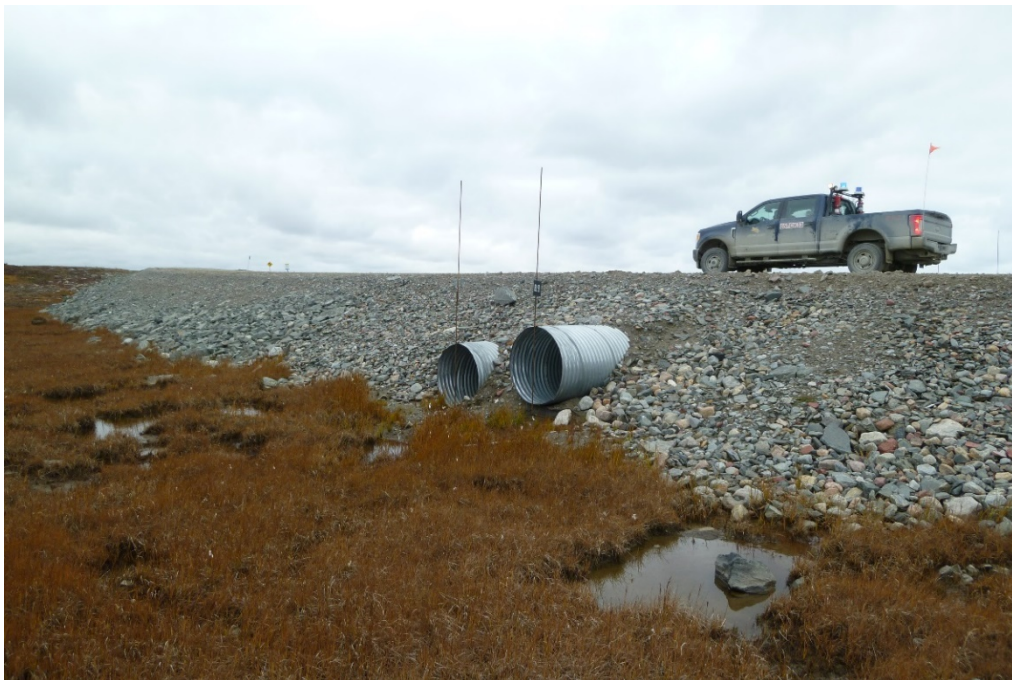
Photographs 90 to 94 were taken at KM9.1. There are 2 CSP culverts, each 1000 mm in diameter. There is some minor deformation in the culverts under the road, no flow, water ponded below inverts.

Photograph 90: Upstream Ends of Two 1000 mm Diameter CSP Culverts at KM9.1 Looking North (20 September 2017)

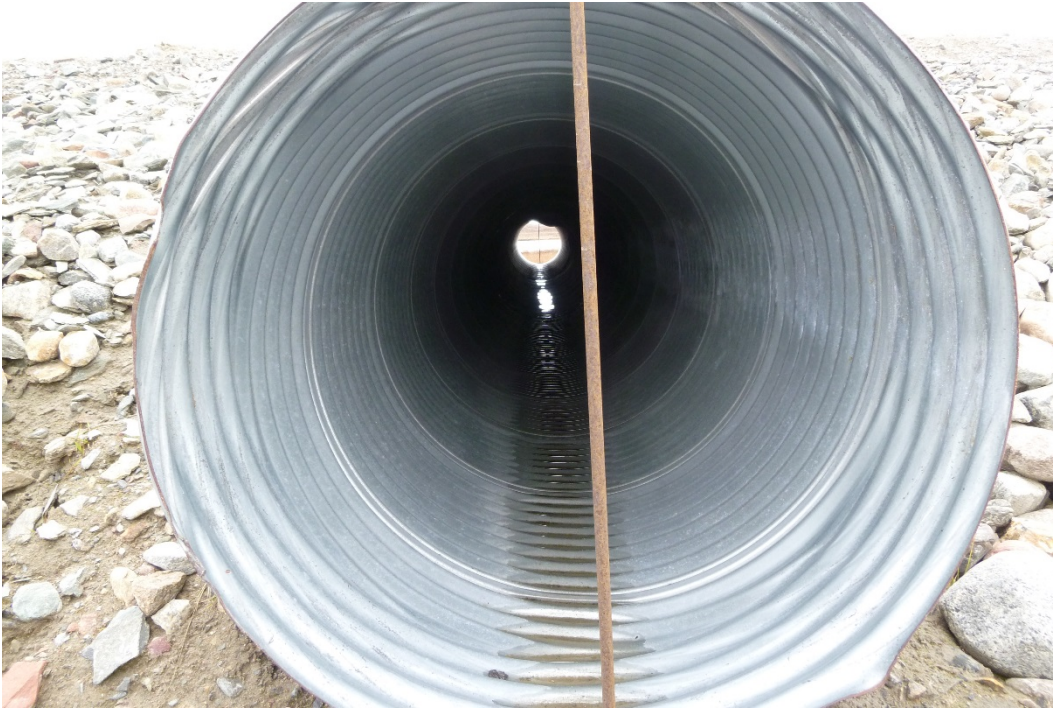
Photograph 91: View through North CSP Culvert at KM9.1 from Upstream to Downstream. Some Deformation of Culvert below Road (20 September 2017)

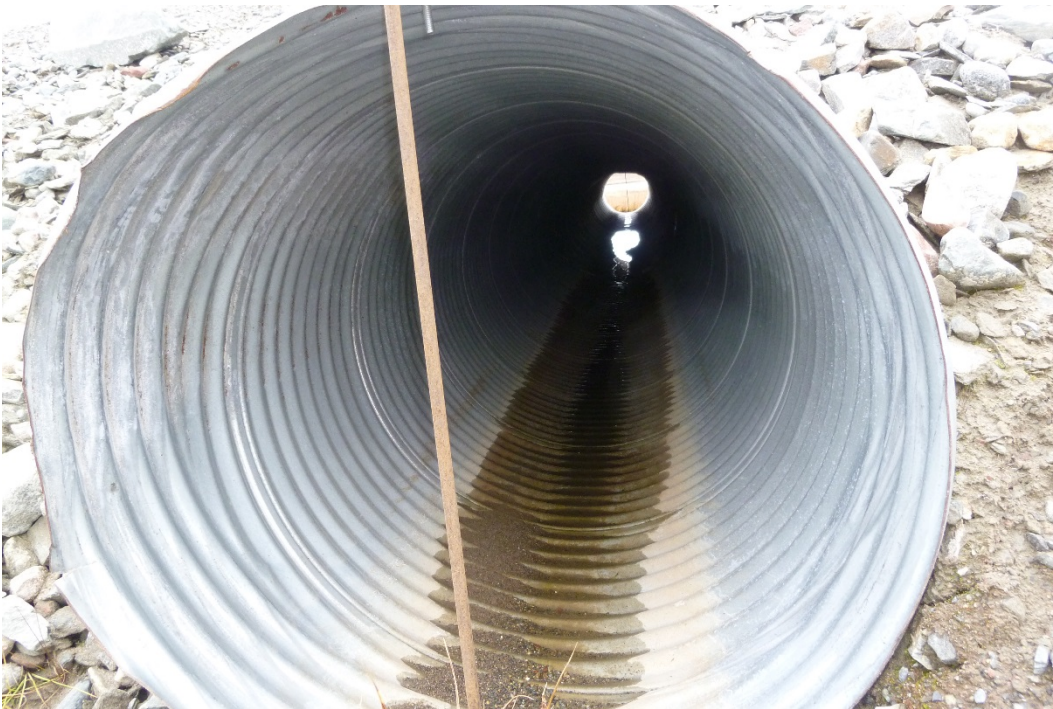
Photograph 921: View Through South CSP Culvert at KM9.1 from Upstream to Downstream (20 September 2017)

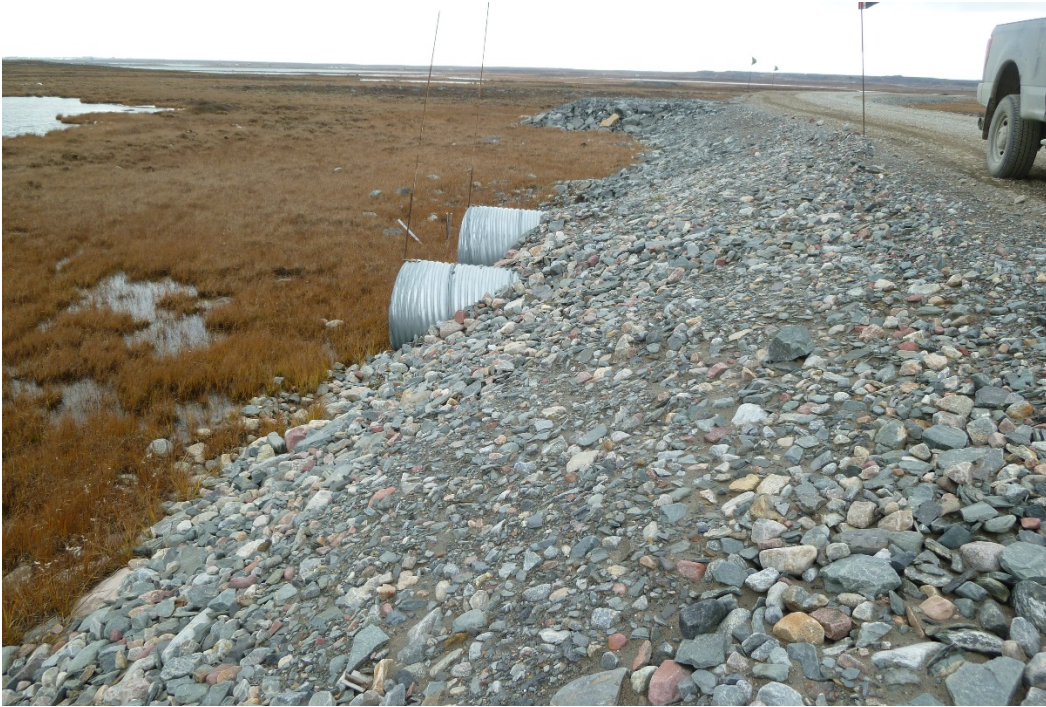
Photograph 93: Downstream Ends of Two CSP Culverts at KM9.1 (20 September 2017)

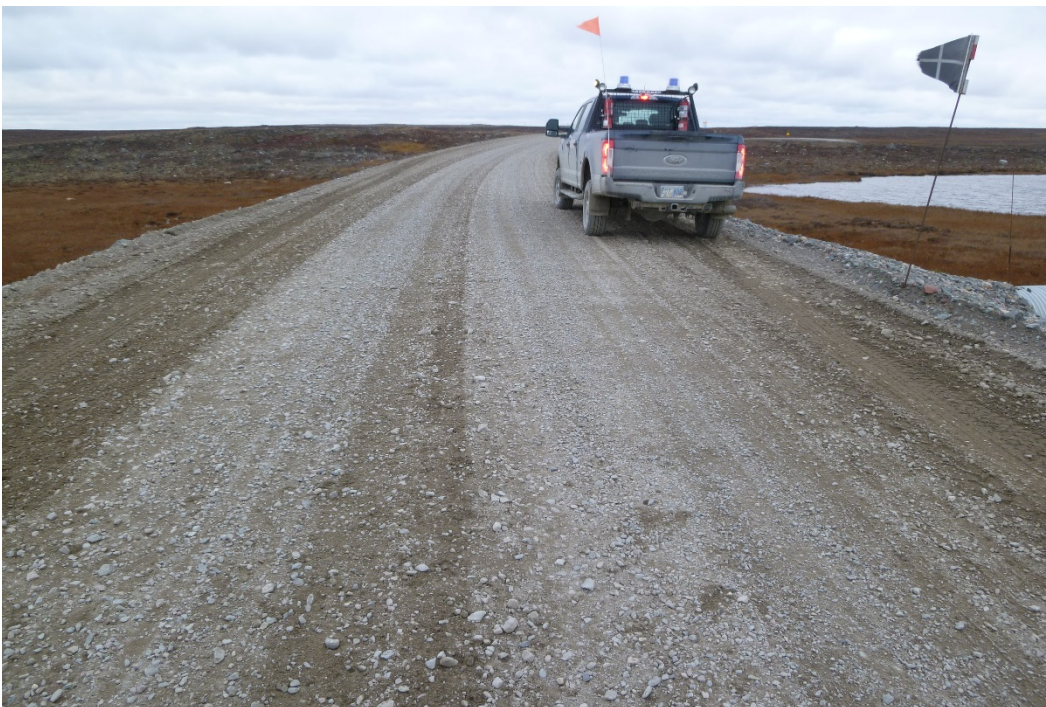
Photograph 94: Road Surface Over Two CSP Culverts at KM9.1 (20 September 2017)

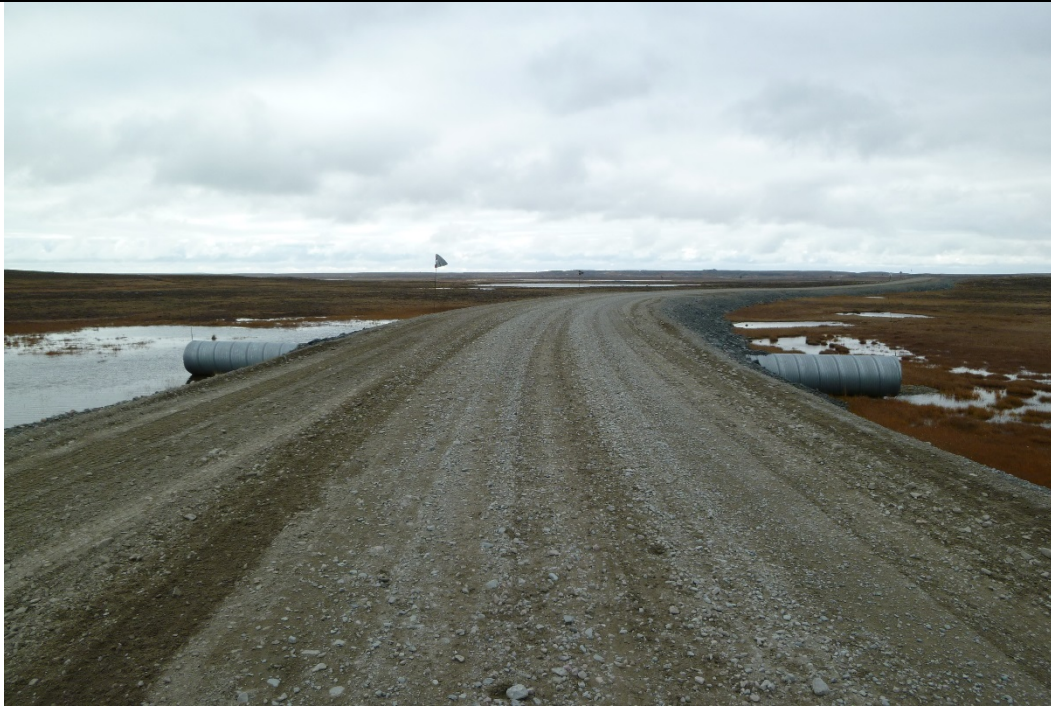
Photograph 95: Road Surface Over a Single 1300 mm Diameter CSP Culvert at KM9.5 (20 September 2017)

Photographs 95 to 98 were taken at KM9.5. There is a single CSP culvert, it is in good condition, clear and had virtually no flow, even though there is water ponded upstream, due to inlet elevation being elevated.

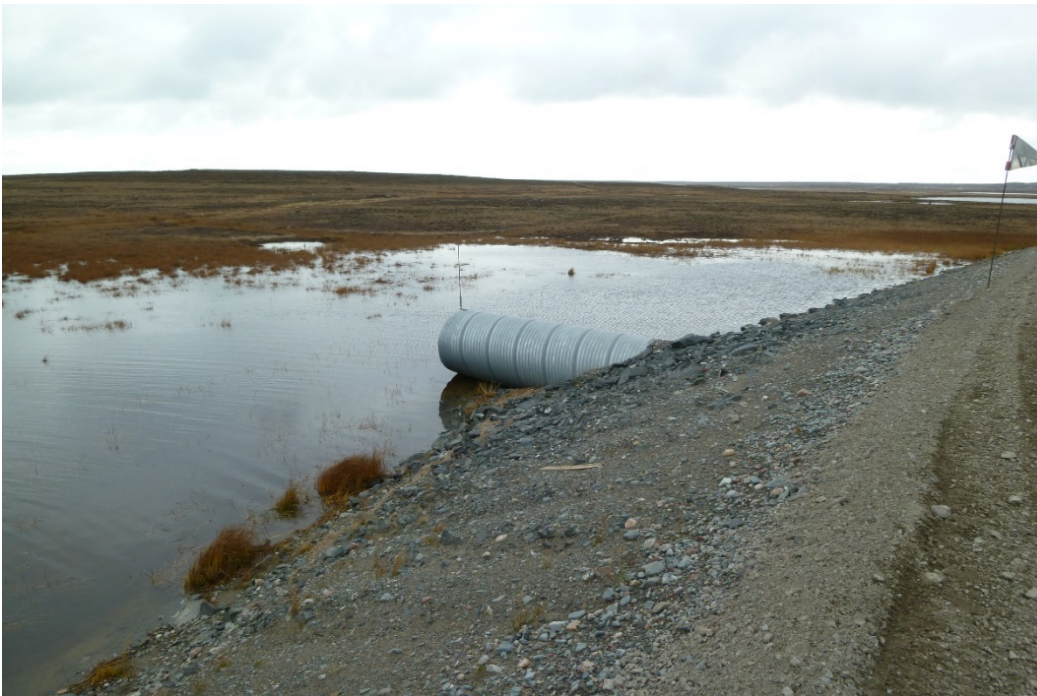
Photograph 96: Upstream End of a Single 1300 mm Diameter CSP Culvert at KM9.5. Good Condition, no Obstructions. Water Ponded on Upstream with very Low Flow Due to Elevated Inlet of CSP (20 September 2017)

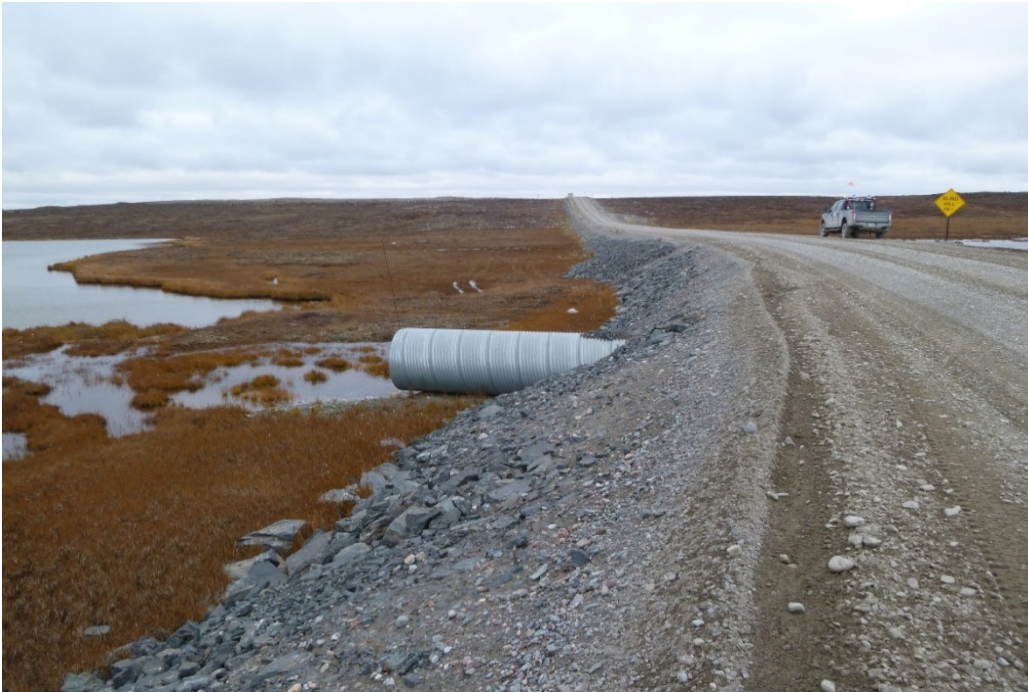
Photograph 97: Downstream End of a Single 1300 mm Diameter CSP Culvert at KM9.5 (20 September 2017)

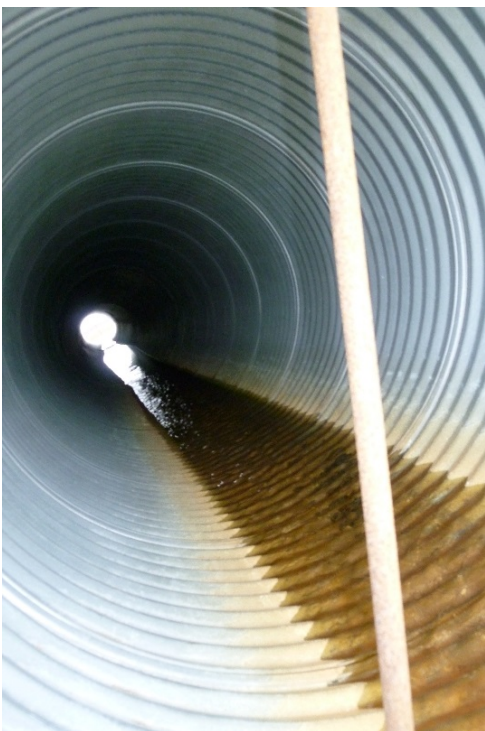
Photograph 98: KM9.5, Looking from Downstream to Upstream Through the 1300 mm Diameter Culvert (20 September 2017)

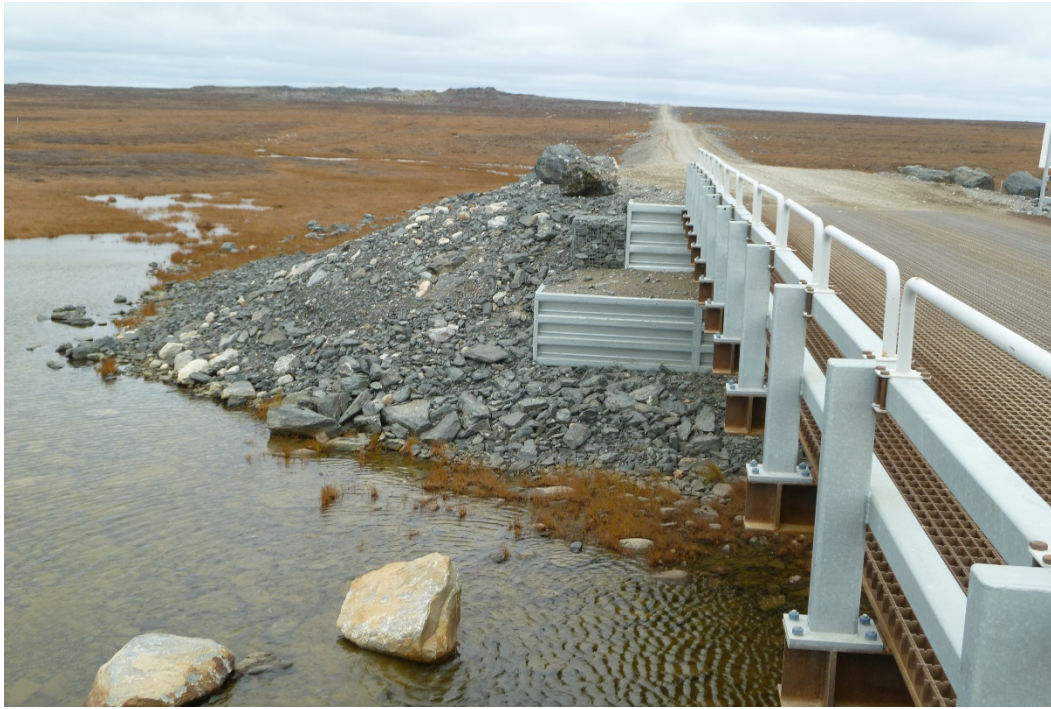
Photographs 99 to 106 taken of M-5 Bridge, at KM10.5. Abutments all look good.

Photograph 99: M-5 Bridge at KM10.5 Left (North) Abutment, Upstream Side (20 September 2017)

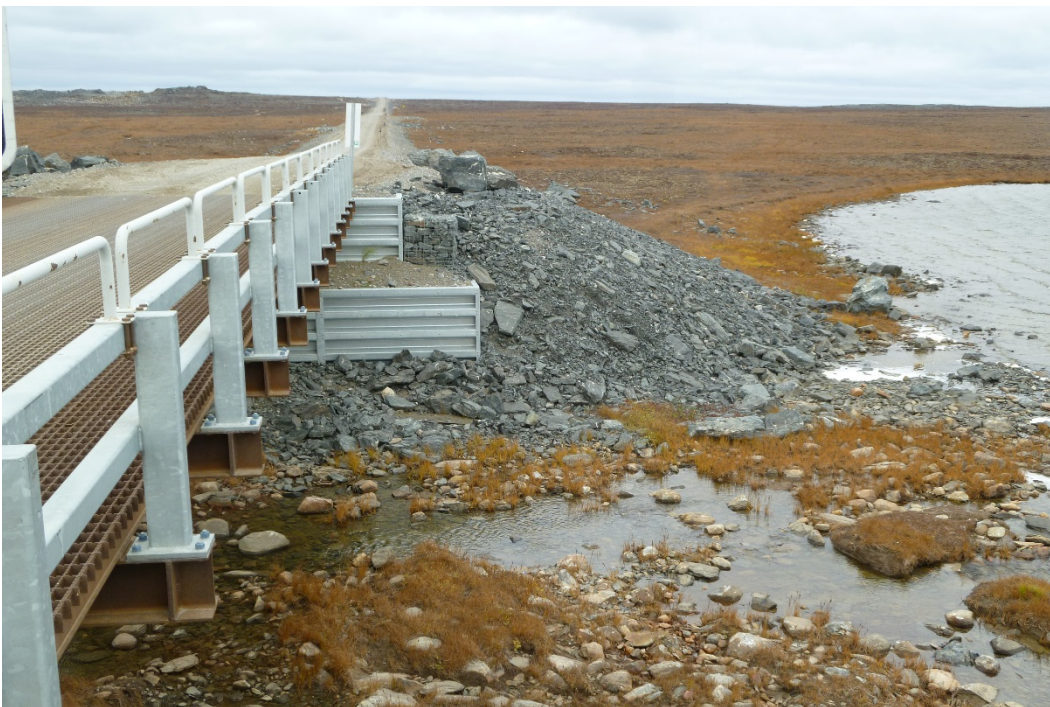
Photograph 100: M-5 Bridge at KM10.5 Left (North) Abutment, Downstream Side (20 September 2017)

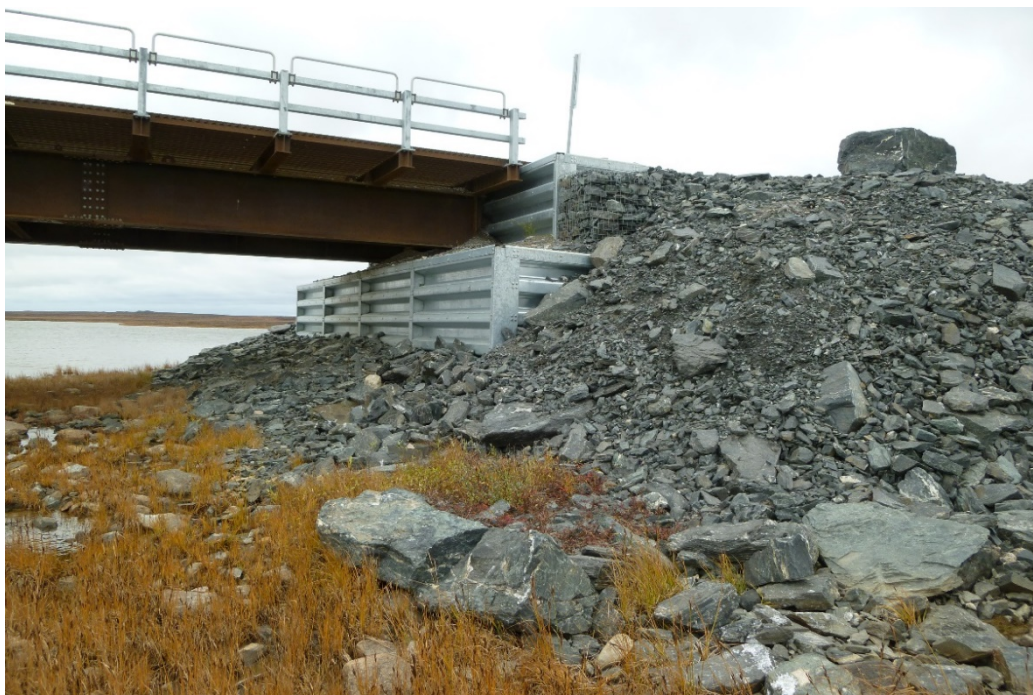
Photograph 101: M-5 Bridge at KM10.5 Left (North) Abutment Looking Upstream from the Downstream Side of the Bridge (20 September 2017)

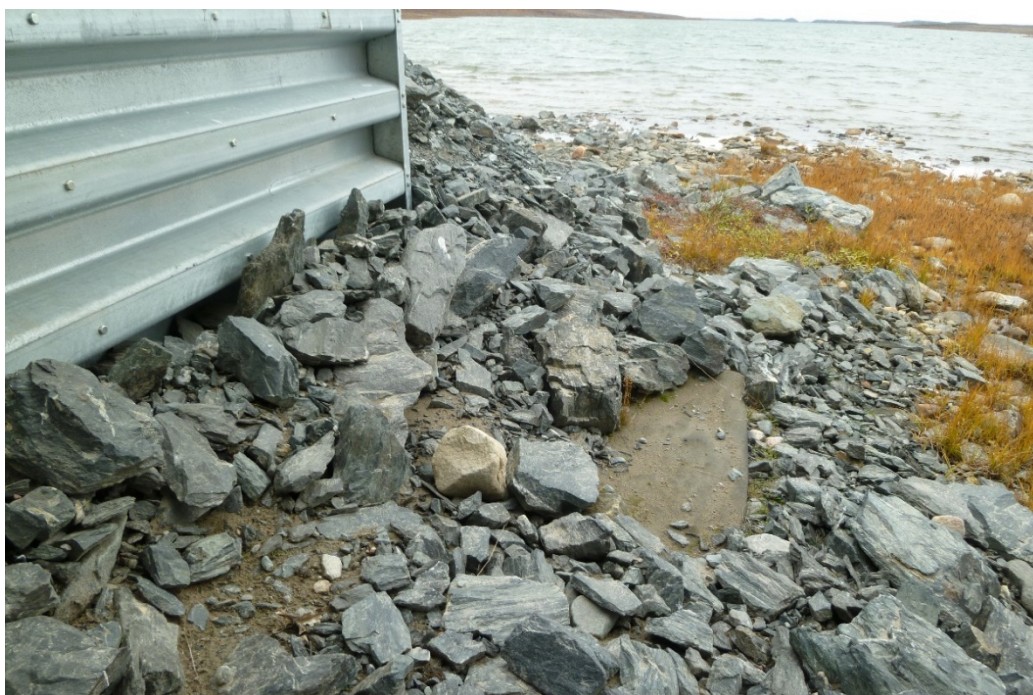
Photograph 1022: M-5 Bridge at KM10.5, Exposed Fabric on Downstream End of Left (North) Abutment Indicating Possible Erosion (20 September 2017)

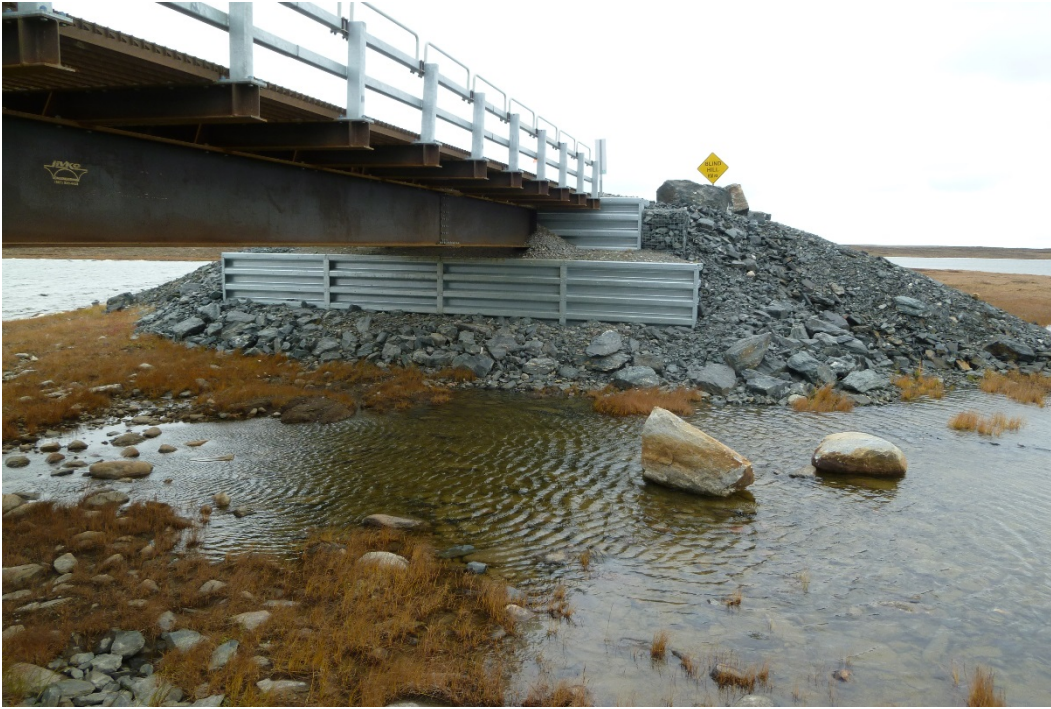
Photograph 103: M-5 Bridge at KM10.5 Right (South) Abutment, Upstream Side. Area of Possible Erosion or Settlement Identified During 2016 Inspection Shows no Signs of Change (20 September 2017)

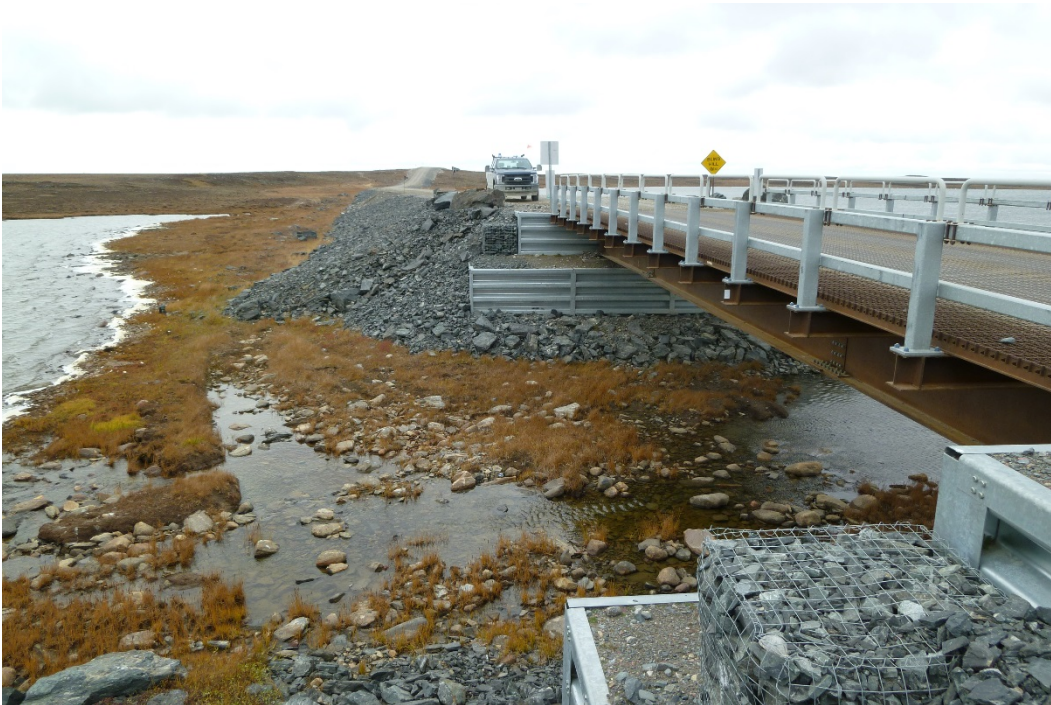
Photograph 104: M-5 Bridge at KM10.5 Right (South) Abutment, Downstream Side (20 September 2017)
