APPENDIX B

Meliadine AWAR Inspection – 2017

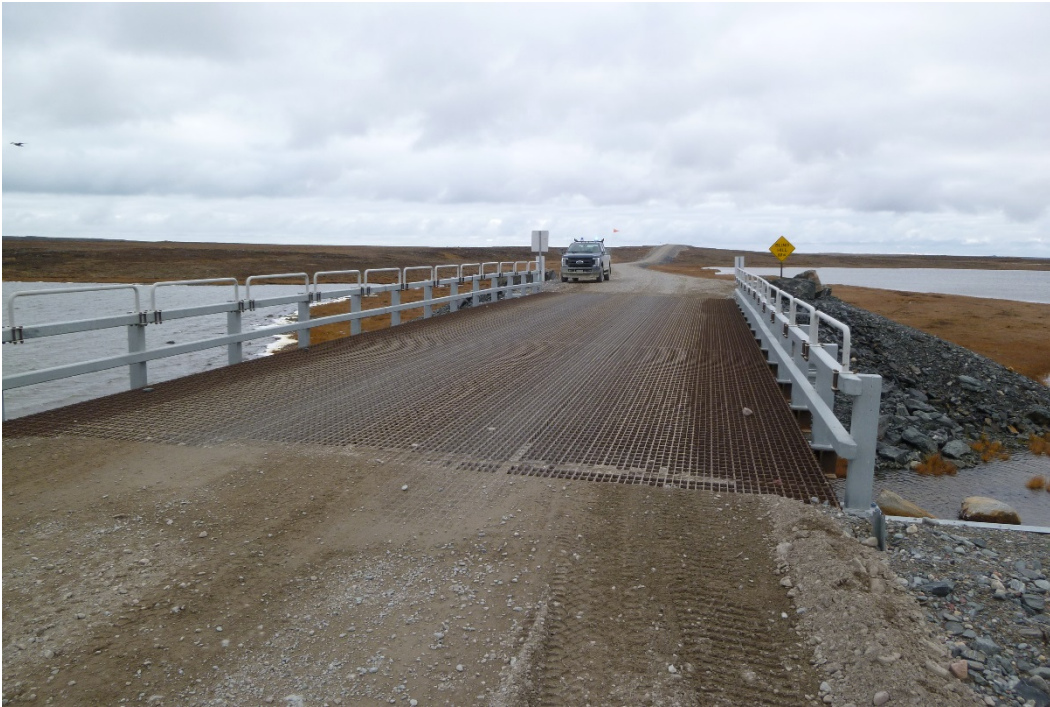
Photograph 105: M-5 Bridge Deck at KM10.5, Looking South (20 September 2017)

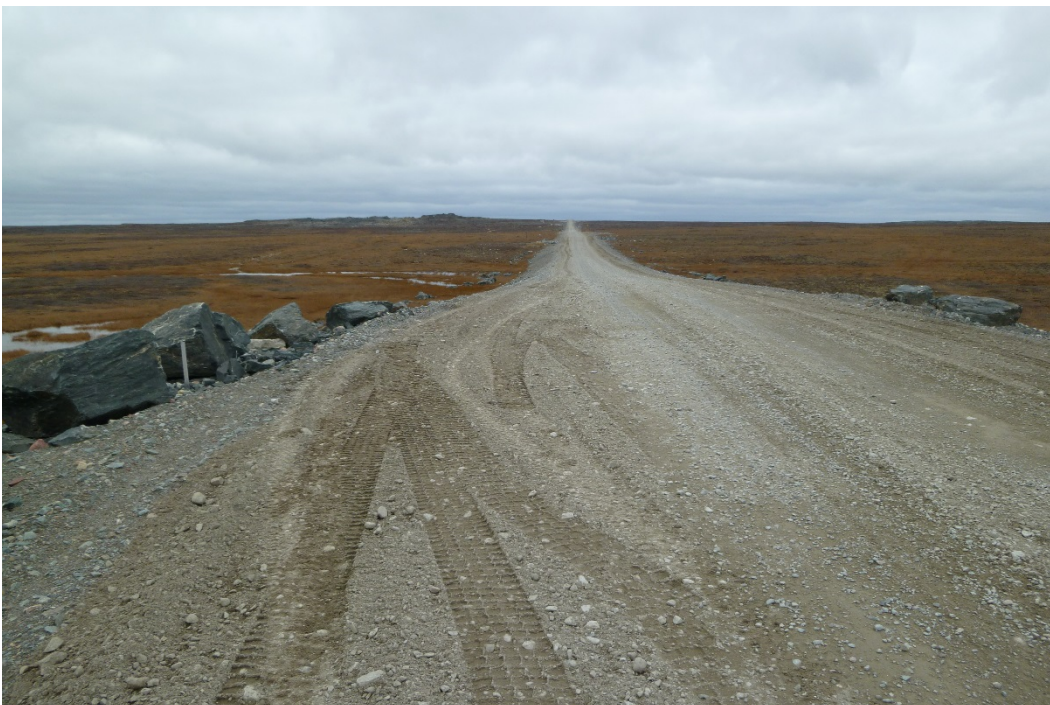
Photograph 106: Road Leading North From M-5 Bridge at KM10.5 (20 September 2017)

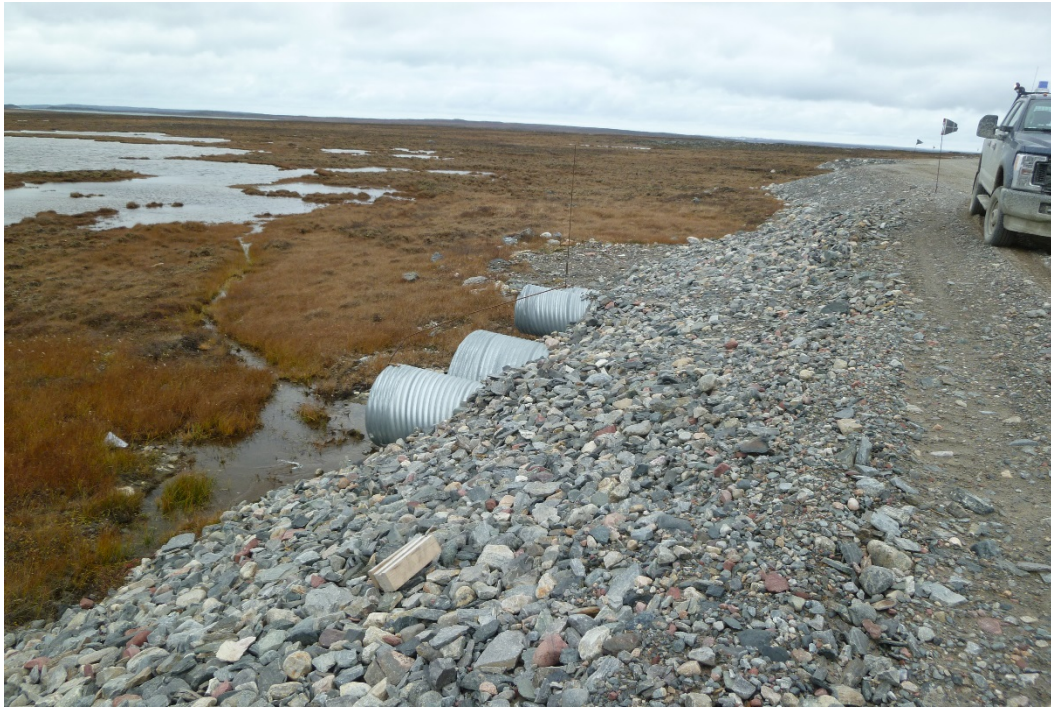
Photos 107 to 114 were taken along AWAR at KM12.1. Four CSP culverts installed at this location. These culverts appear bent in the middle under the road.

Photograph 107: Downstream Ends of Four CSP Culverts at KM12.1 (20 September 2017)

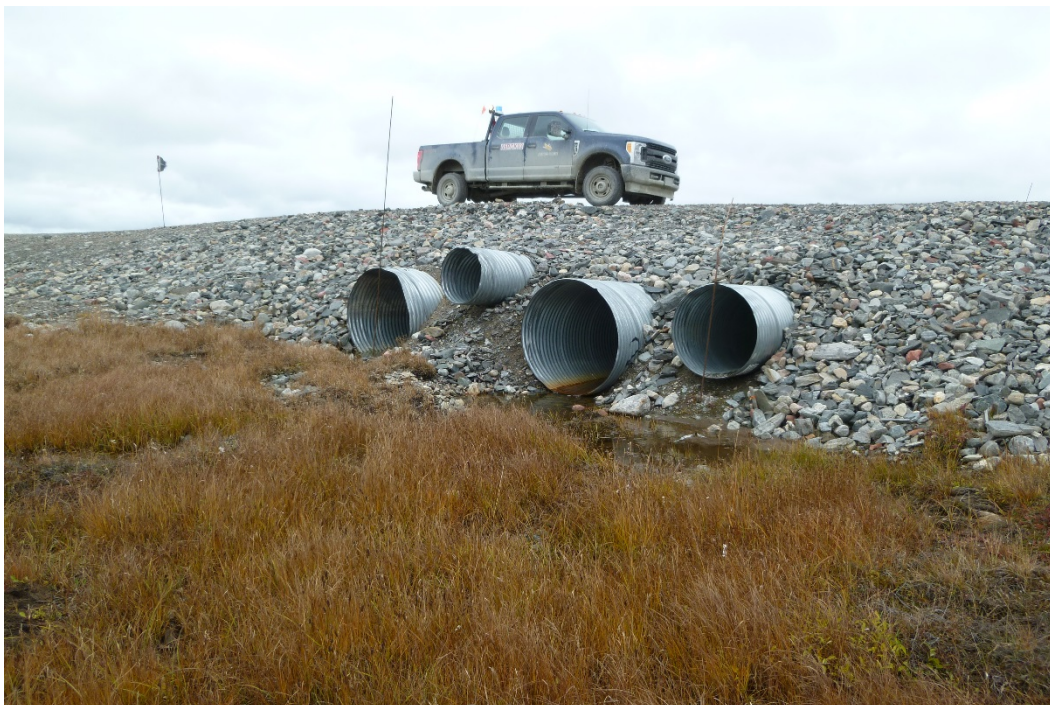
Photograph 108: Downstream Ends of Four CSP Culverts at KM12.1. From Left to Right Diameters are 1300 mm, 700 mm, 1300 mm, 900 mm (20 September 2017)

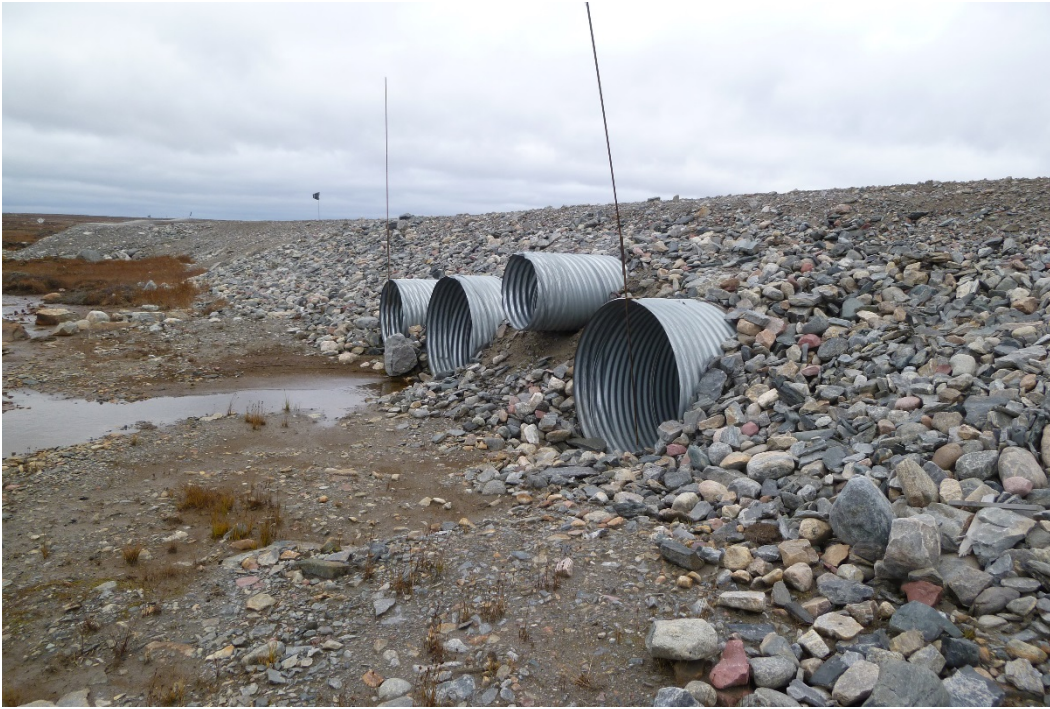
Photograph 109: Upstream Ends of Four CSP Culverts at KM12.1 (20 September 2017)

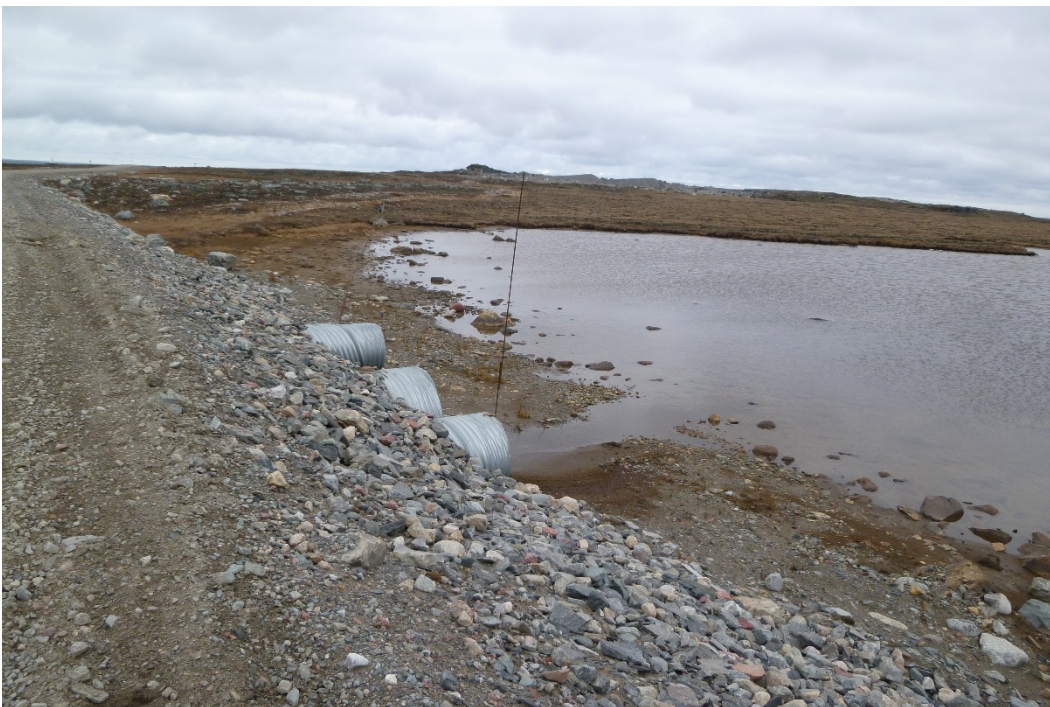
Photograph 110: Upstream Ends of Four CSP Culverts at KM12.1 (20 September 2017)

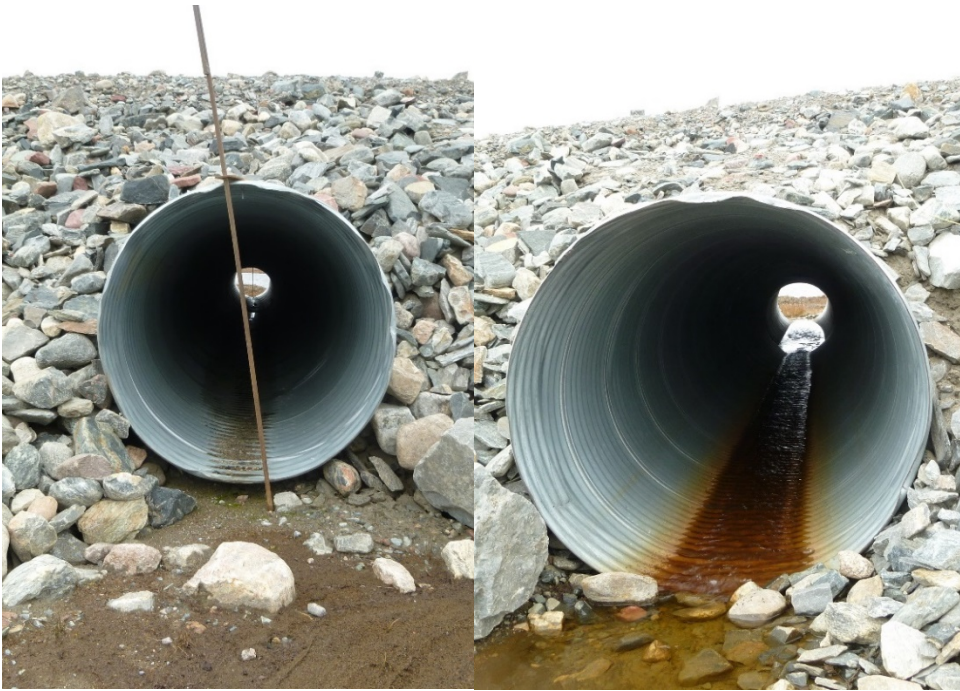
Photographs 111 and 112: Upstream to Downstream View Through Two Northern CSP Culverts at Km12.1. 900 mm Ø on Left and 1300 mm Ø On Right (20 September 2017)

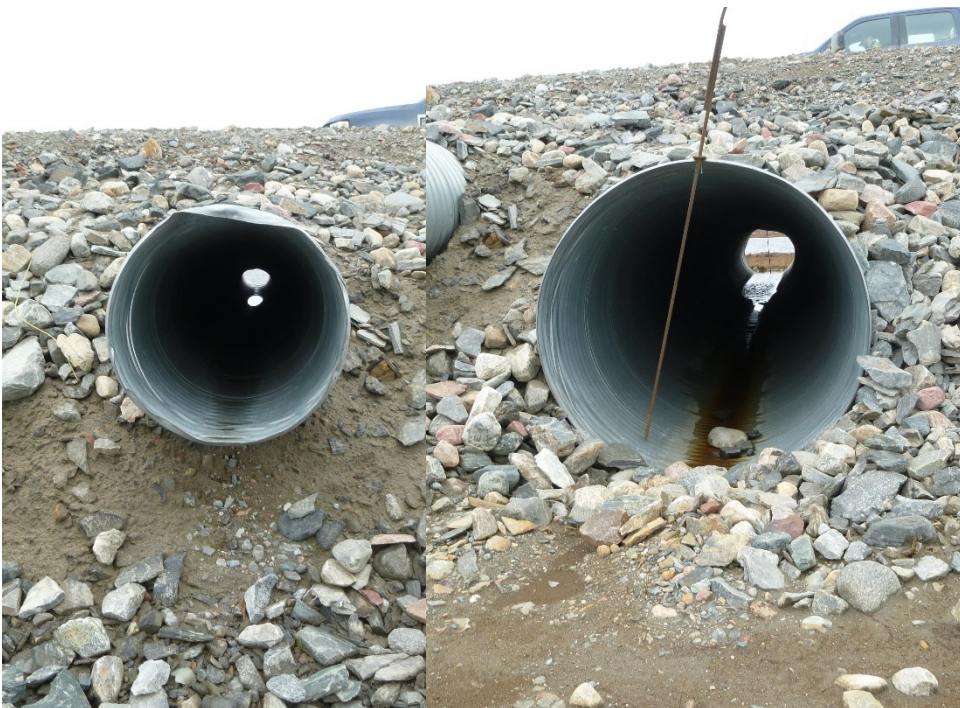
Photographs 113 and 114: Upstream to Downstream View Through Two Southern CSP Culverts at Km12.1. 700 mm Ø On Left and 1300 mm Ø On Right (20 September 2017)

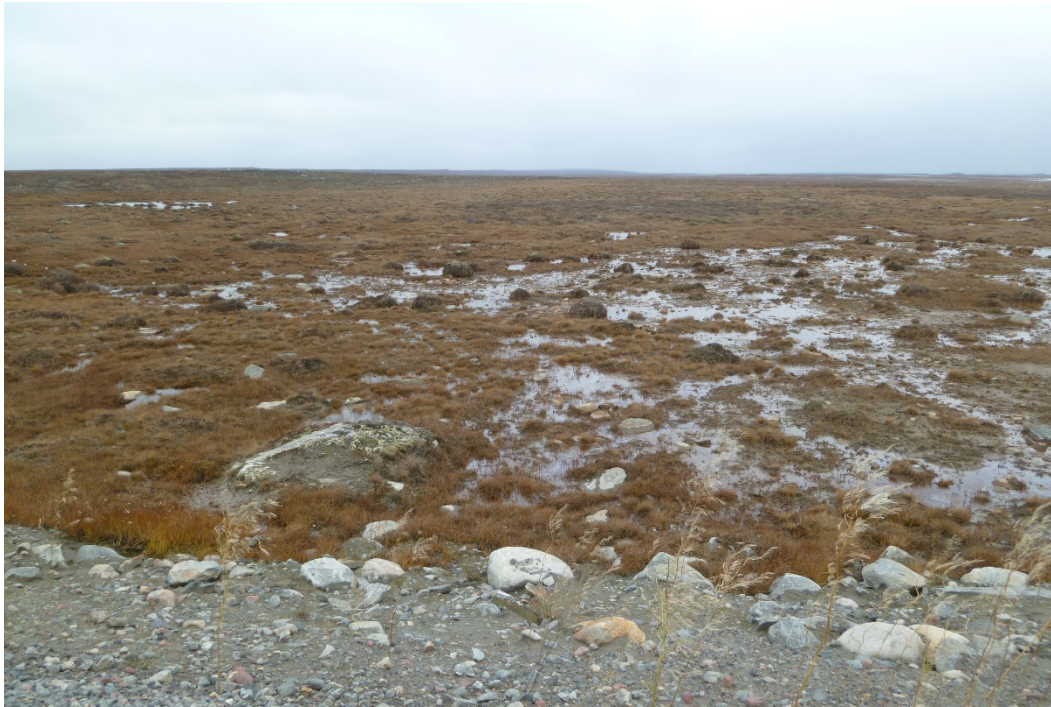
Photos 115 to 117 were taken along AWAR at KM12.6. Flow visible along the road, the road embankment shows signs of erosion/slumping.

Photograph 115: AWAR KM12.6, Some Water, No Defined Channel. Low Lying Area, Poor Drainage (22 September 2017)

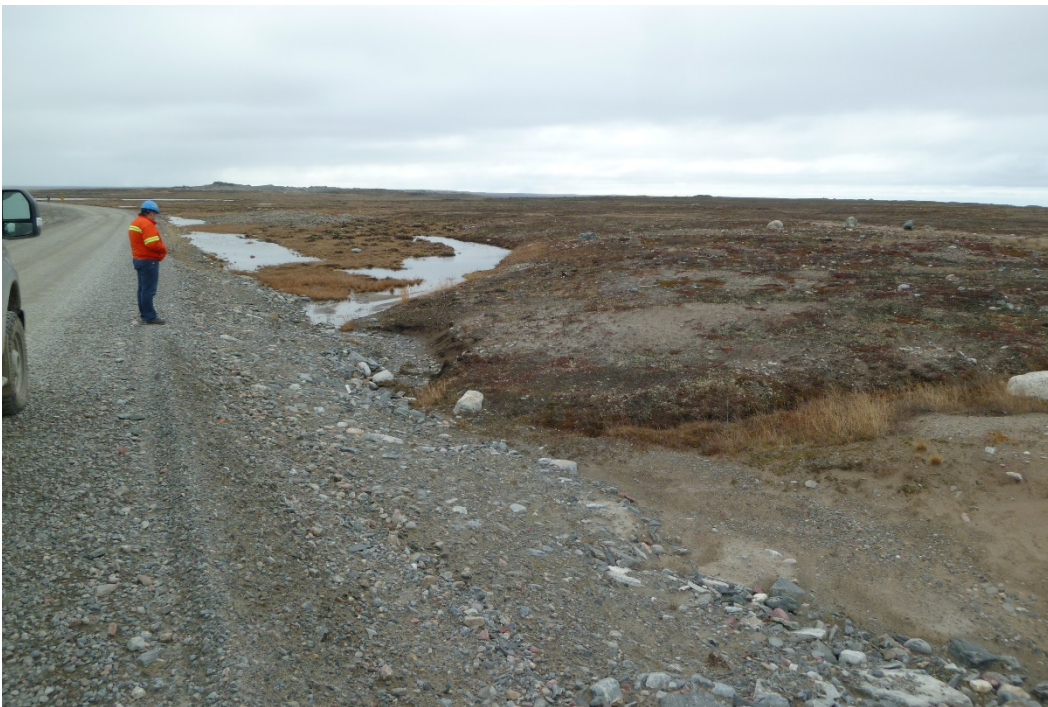
Photograph 116: KM 12.6, Ponded Water and Erosion of Toe Road Embankment Evident (22 September 2017)

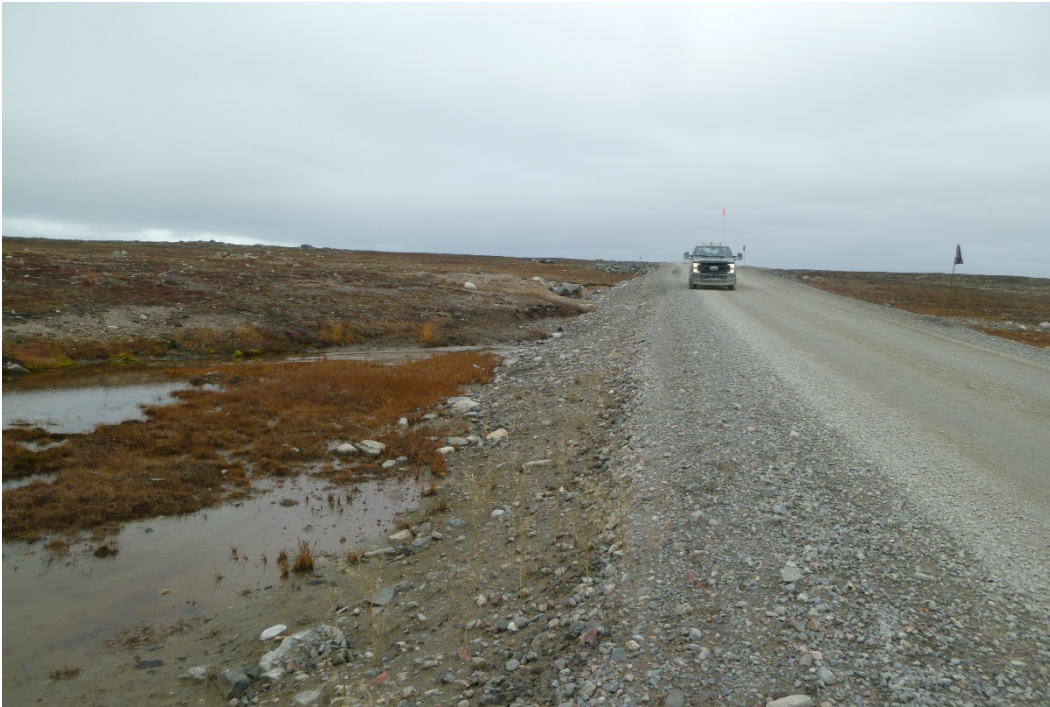
Photograph 117: KM 12.6, Ponded Water and Erosion of Road Embankment Evident (22 September 2017)

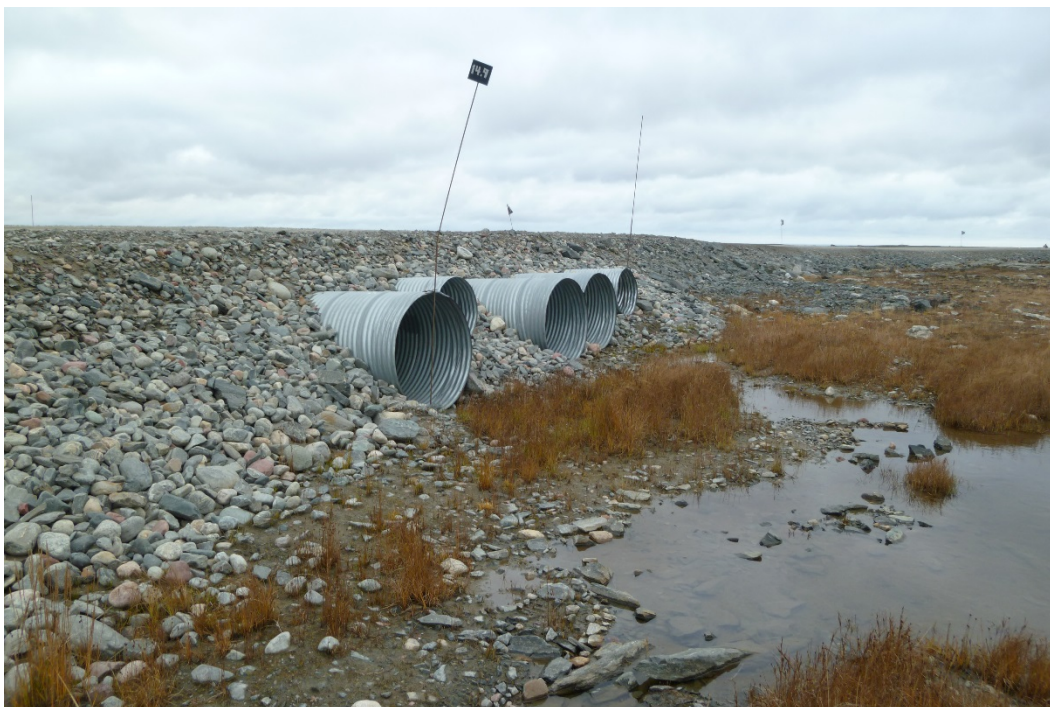
Photograph 118: At KM13.5, There are 5 CSP Culverts (3×1300 mm Ø; 2×900mm Ø). View of Upstream Ends of the Culverts. 900 mm Culverts are Vertically Elevated (20 September 2017)

Photos 118 to 125 were taken along AWAR at KM13.5. Five CSP culverts are installed at this location, three of 1300 mm Ø and two of 900 mm Ø. The inverts of the 900 mm culverts are elevated higher than the inverts of the 1300 mm culverts.

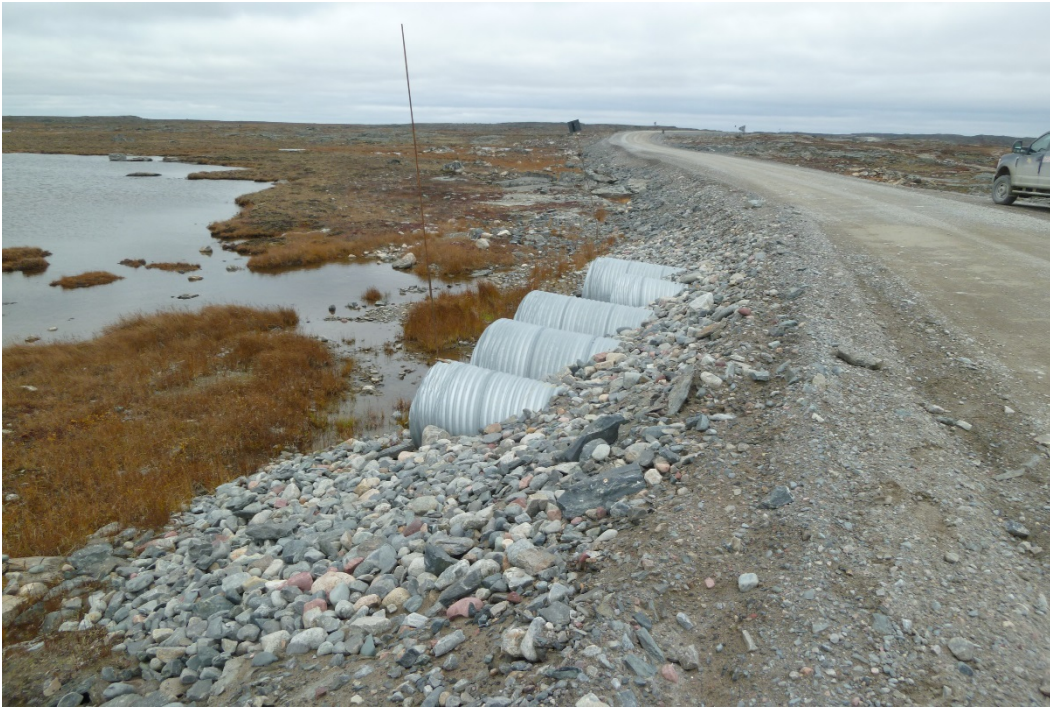
Photograph 119: Downstream View of 5 CSP Culverts at KM13.5 (20 September 2017)

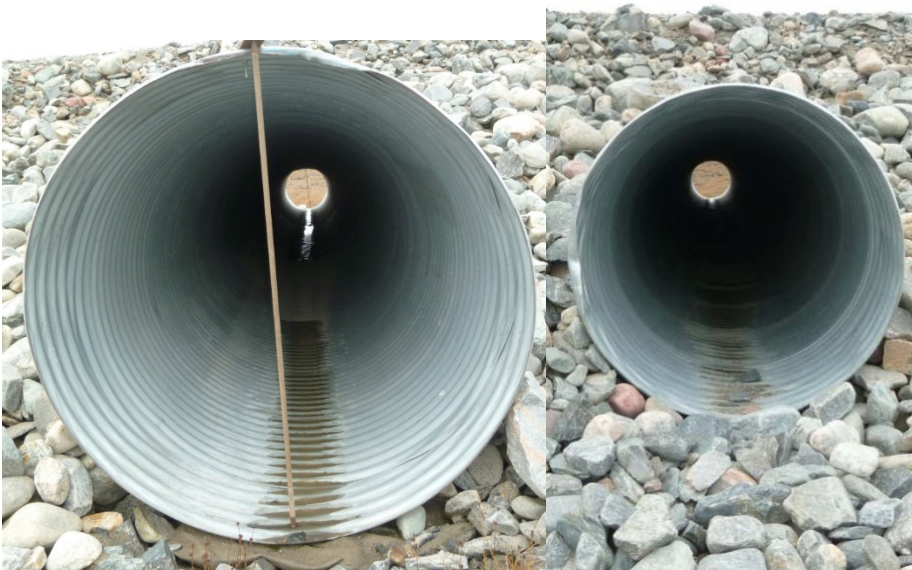
Photographs 120 and 121: Upstream to Downstream Views Through Northern-Most 1300 mm Ø CSP Culvert (Left Photograph) and North 900 mm Ø CSP Culvert (Right Photograph) Located at KM13.5 (20 September 2017)

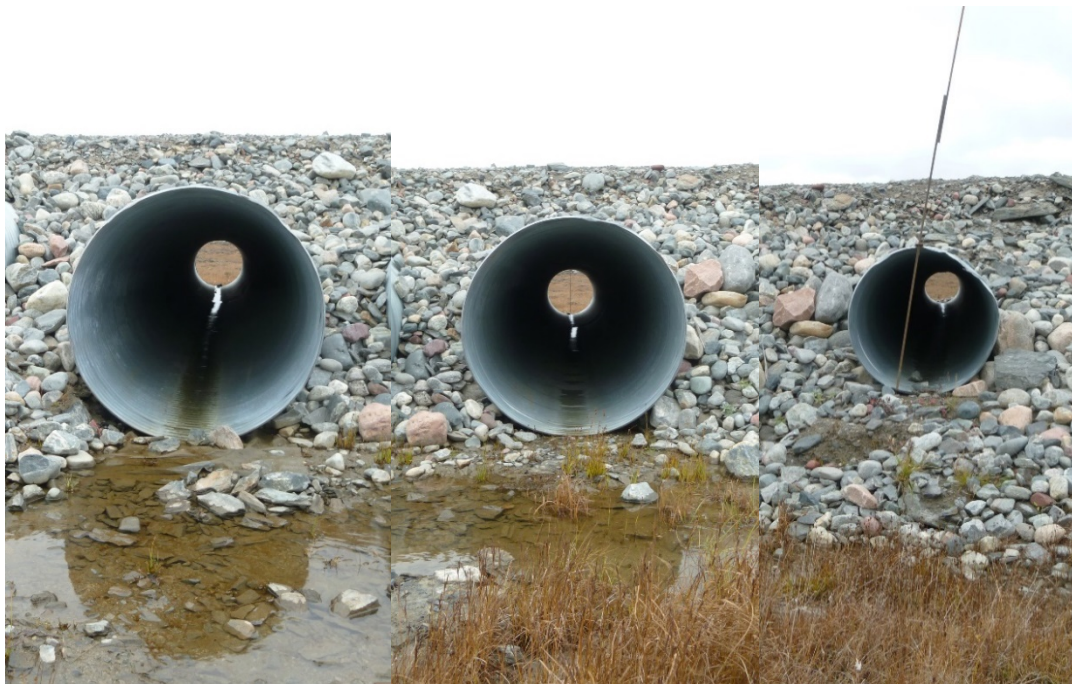
Photographs 122, 123 And 124: Upstream to Downstream Views Through Middle and South 1300 mm Ø CSP Culverts (Left and Middle Photographs Respectively) and South 900 mm Ø CSP Culvert (Right Photograph) Located at KM13.5 (20 September 2017)

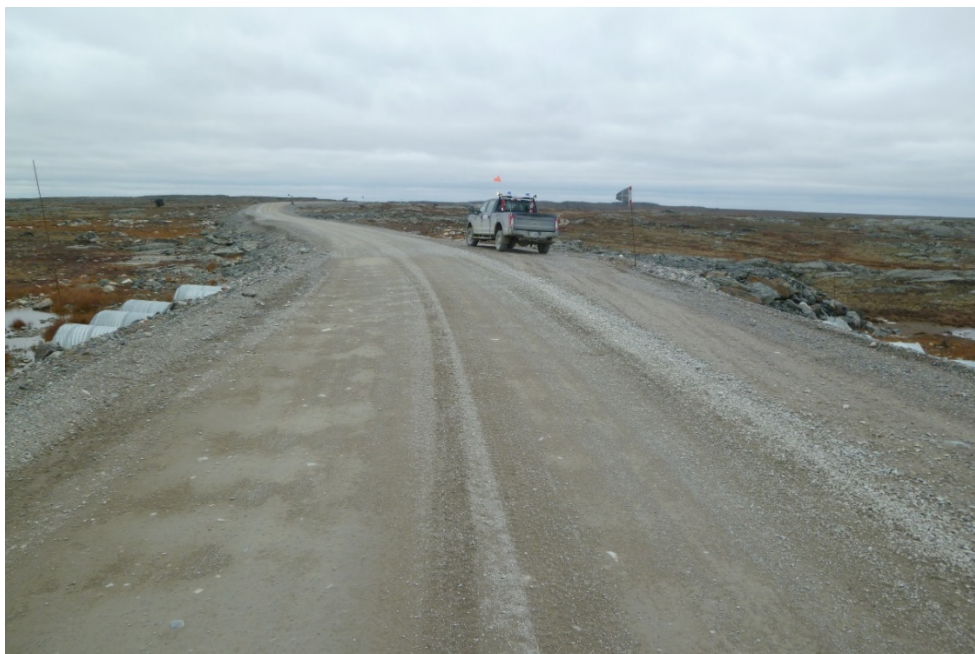
Photograph 125: Road Surface Over Five CSP Culverts Located at KM13.5, Looking North (20 September 2017)
