This report was prepared to summarize the findings of the 2017 geotechnical inspection conducted between 19 and 22 September, 2017, to comply with the requirements of AEM's Type A Water Licence No. 2AM-MEL1631, Part I, Item 14 (page 21) and Schedule I, Item 1 (page 39).

2017 ANNUAL GEOTECHNICAL INSPECTION MELIADINE GOLD PROJECT, NUNAVUT

Meliadine Site Photographs

P-Area: DP1-A, DP1-B, DP2-A, DP3-A

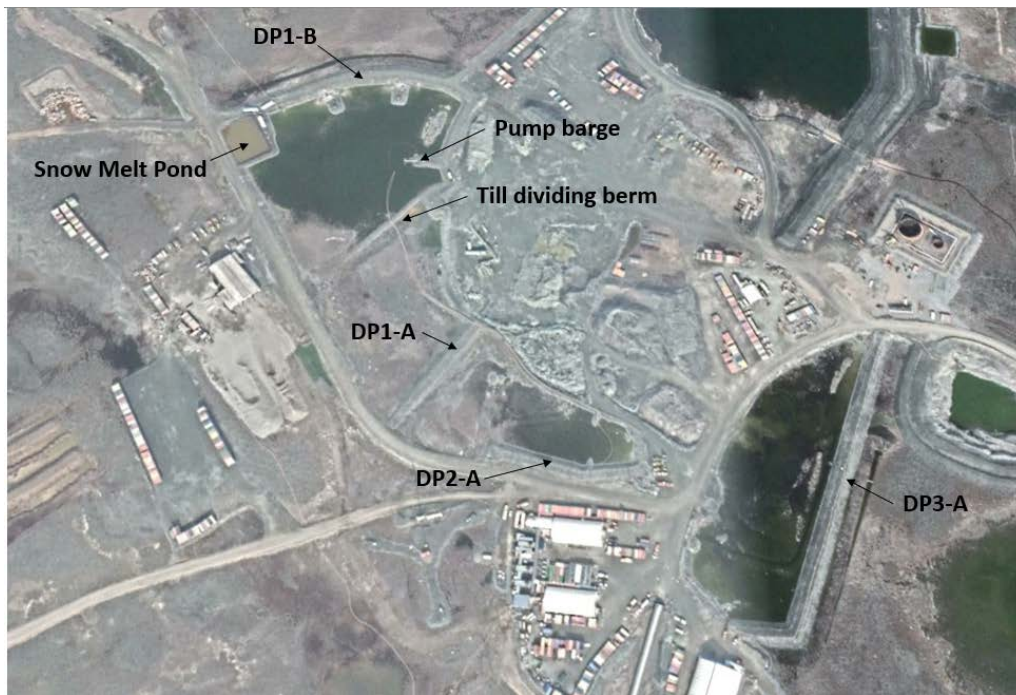
Photograph 1: Overview of P-Area, Google Earth Image, 20 August 2017

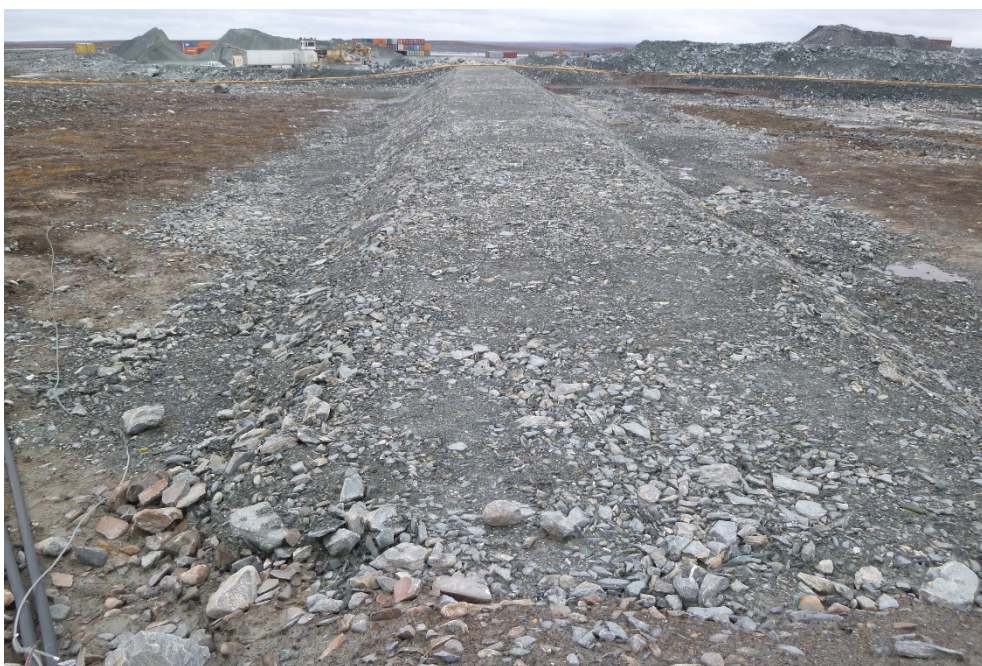
Photograph 2: DP1-A, Looking East from the Road (20 September 2017)

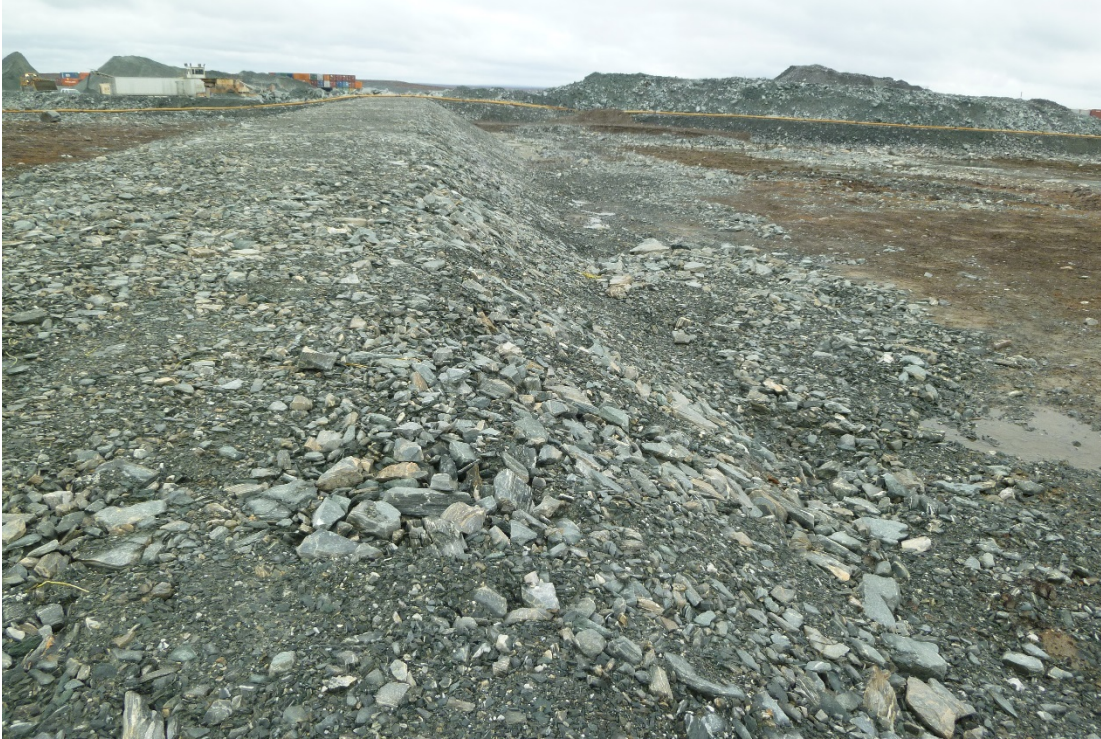
Photograph 3: DP1-A, South Slope Looking East (20 September 2017)

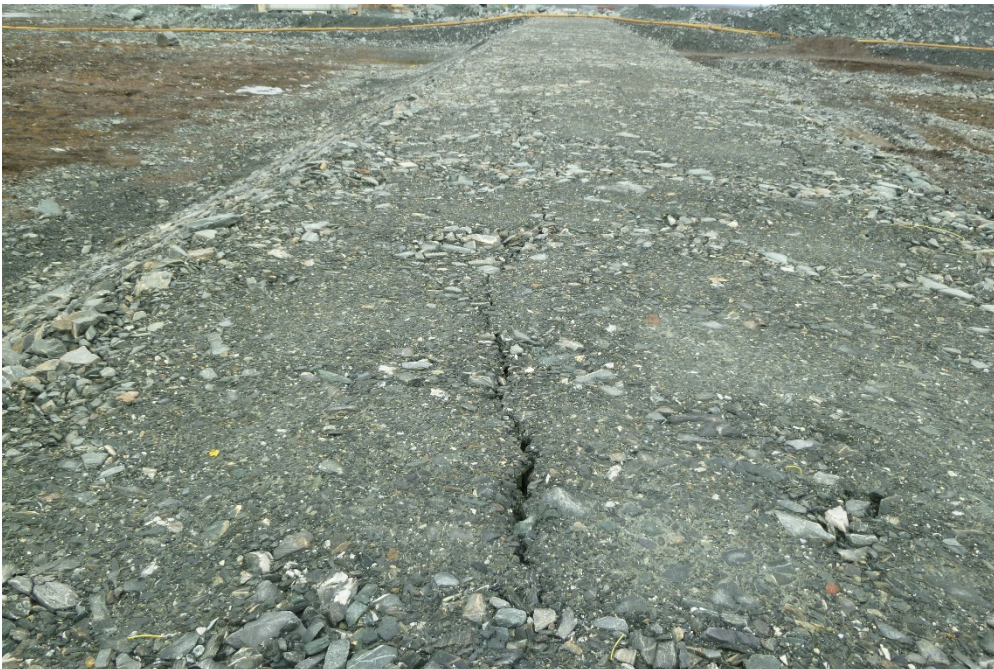
Photograph 4: DP1-A, Cracking Observed On Crest (20 September 2017)

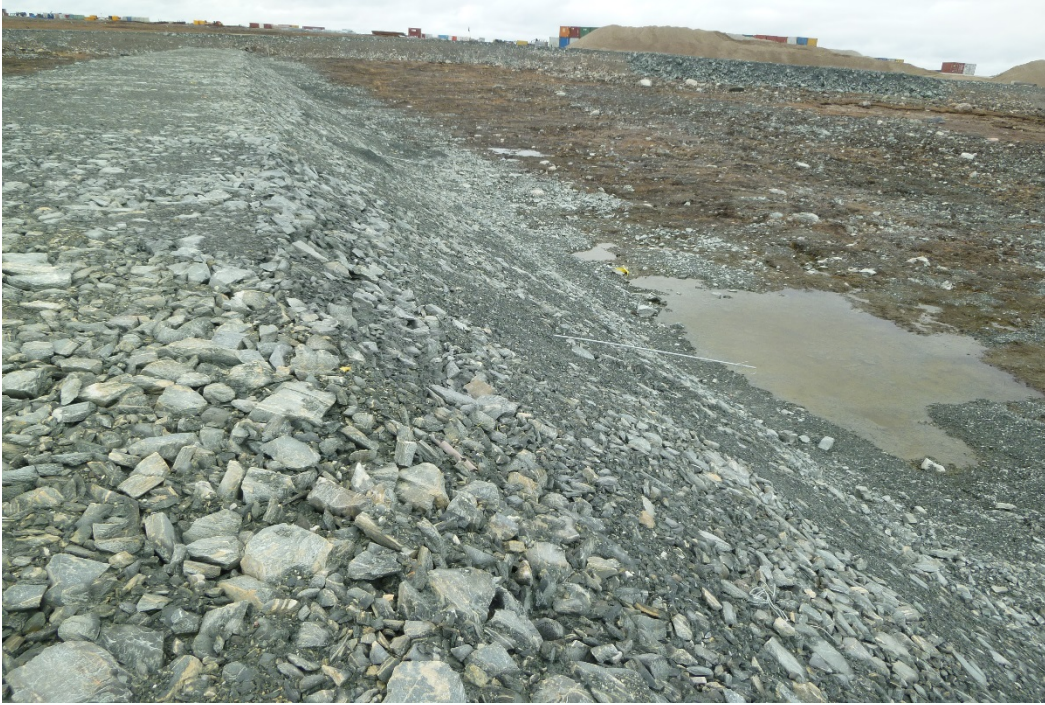
Photograph 5: DP1-A, North Slope, Looking West (20 September 2017)

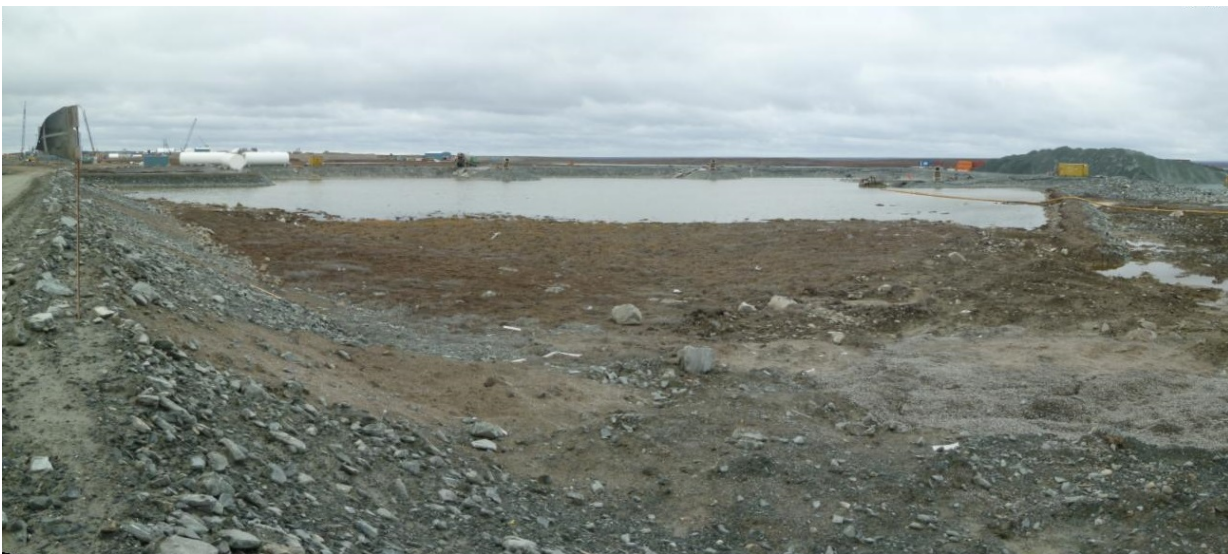
Photograph 6: DP1-B, Looking Northeast (20 September 2017)

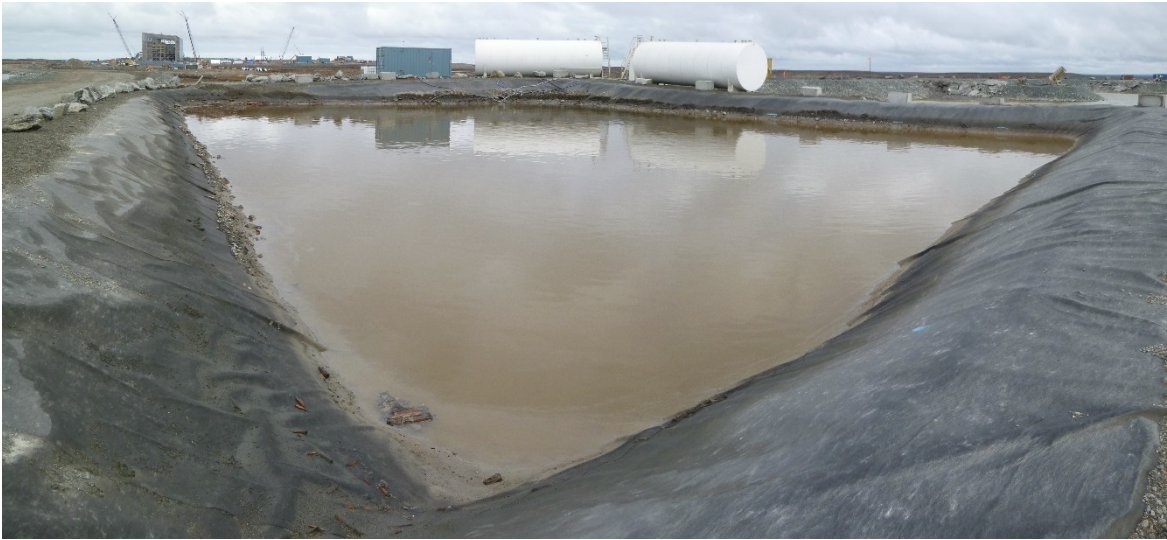
Photograph 7: Snow Melt Management Pond, Looking North (20 September 2017)

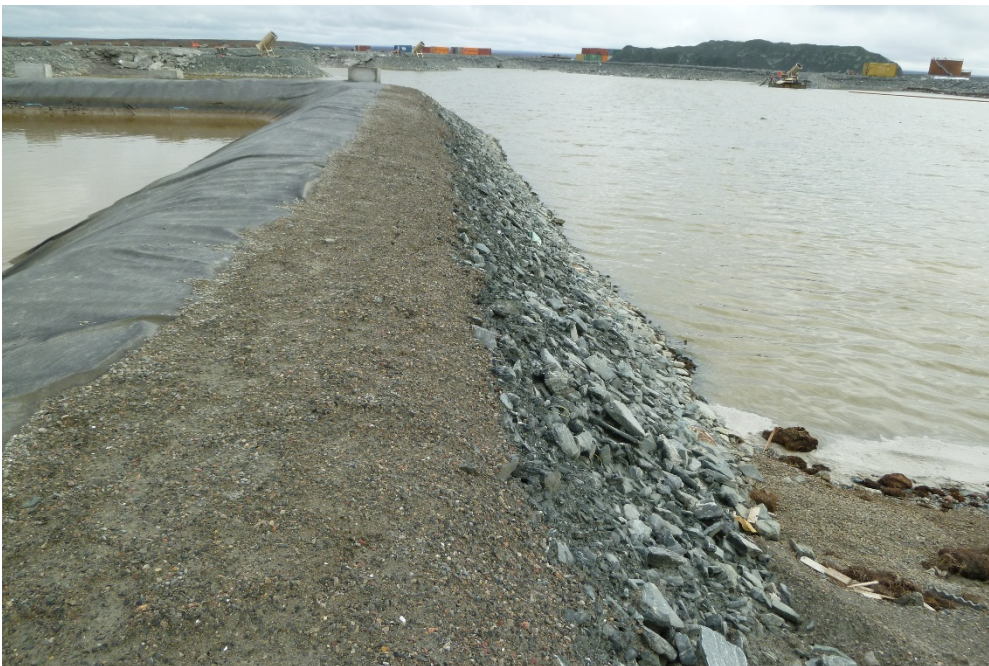
Photograph 8: Snow Melt Management Pond, South Berm Downstream Slope, Looking East (20 September 2017)

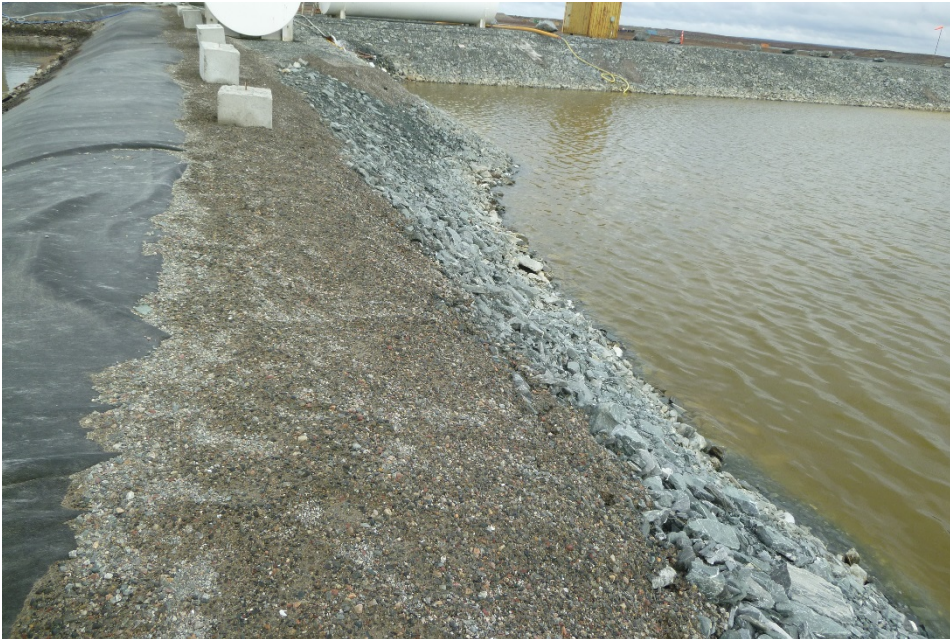
Photograph 9: Snow Melt Management Pond, East Berm Downstream Slope, Looking North (20 September 2017)

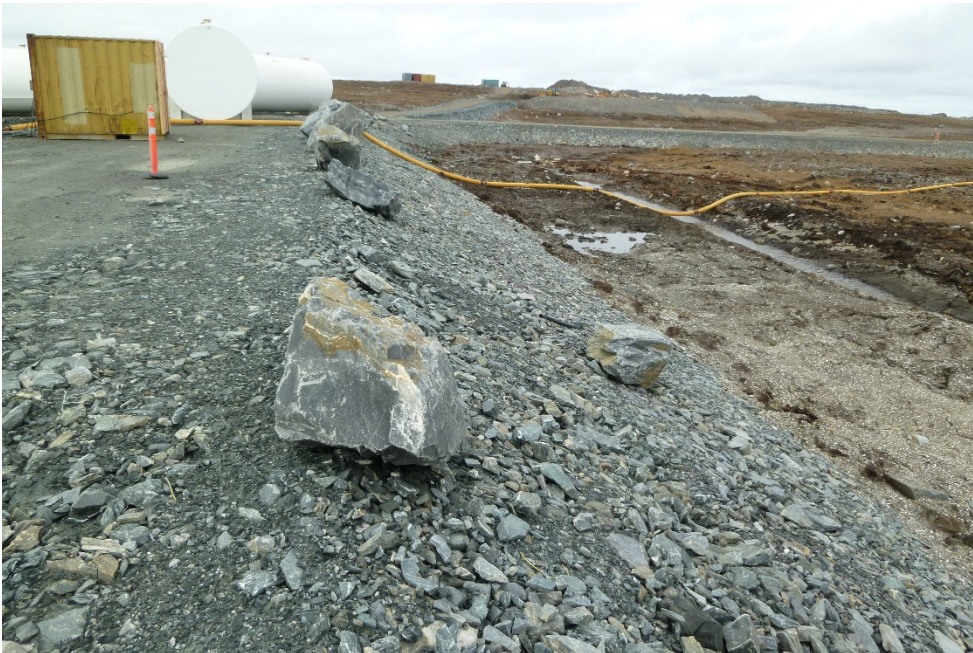
Photograph 10: DP1-B, Downstream Slope near Station 0+150, Looking East. Orange Delineator on Crest Marks Thermistor Location (20 September 2017)

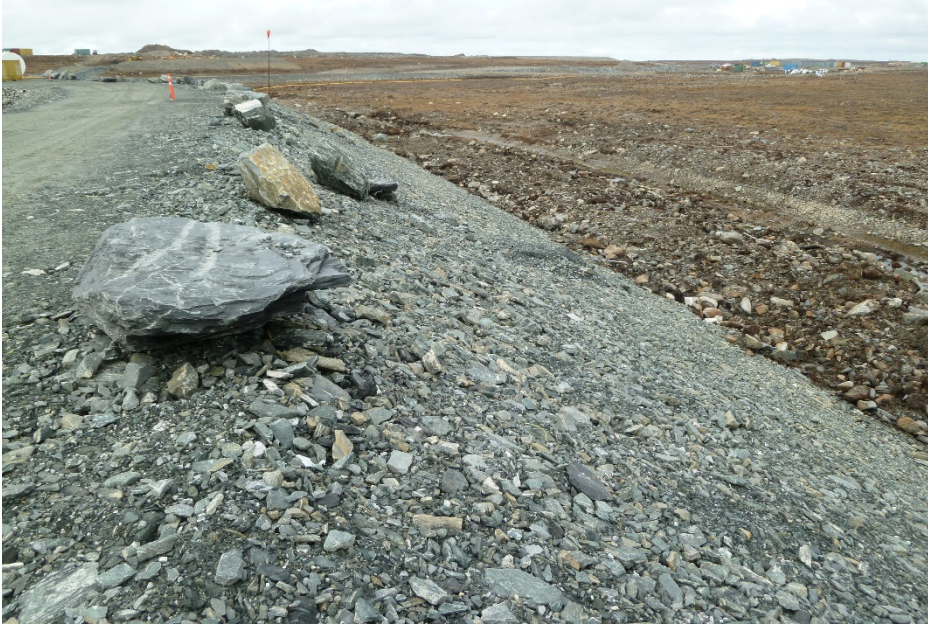
Photograph 11: DP1-B, Downstream Slope near Station 0+240, Looking West. Orange Delineator on Crest Marks Thermistor Location (20 September 2017)

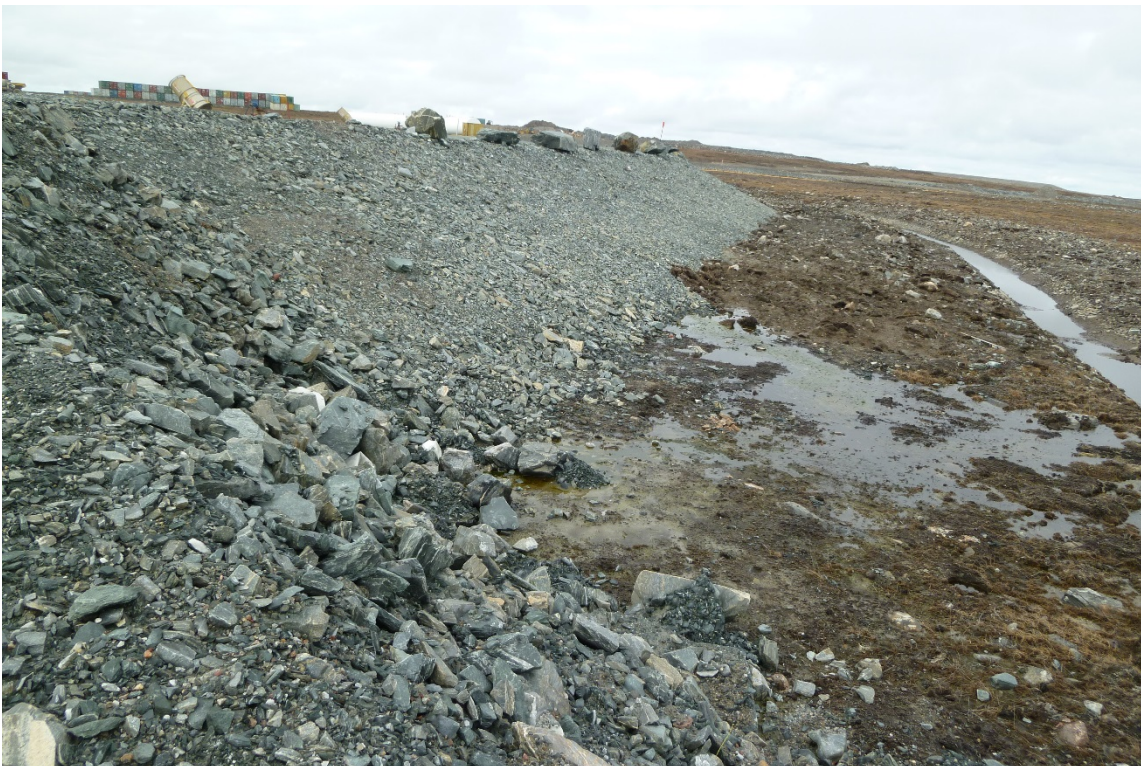
Photograph 12: DP1-B, Downstream Slope near Station 0+300, Looking West from Access Ramp. Some Seepage from Downstream Toe. Run-off and Seepage Collection Channel to Right of Photograph (20 September 2017)

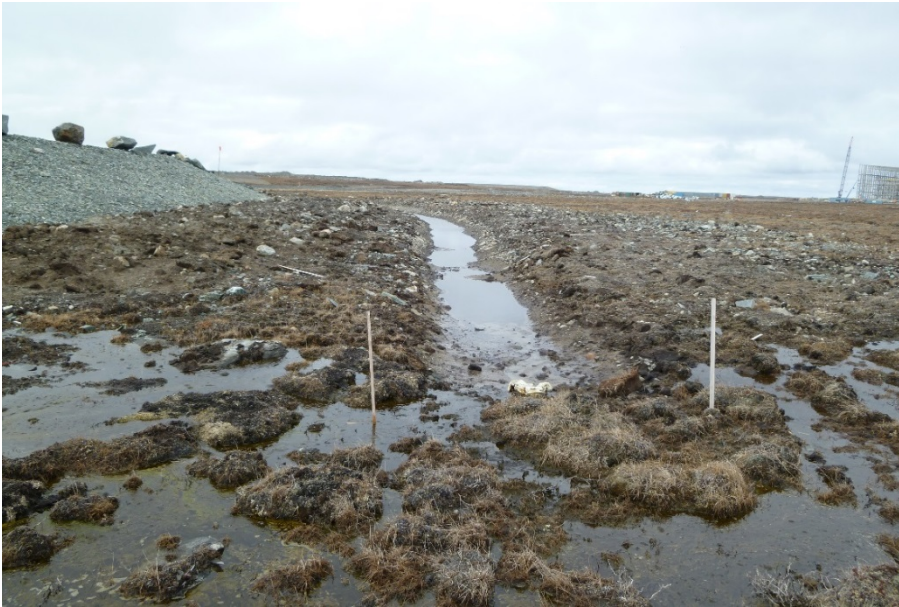
Photograph 13: DP1-B, Run-off and Seepage Collection Channel Downstream of Dike near Station 0+300, Looking West (20 September 2017)

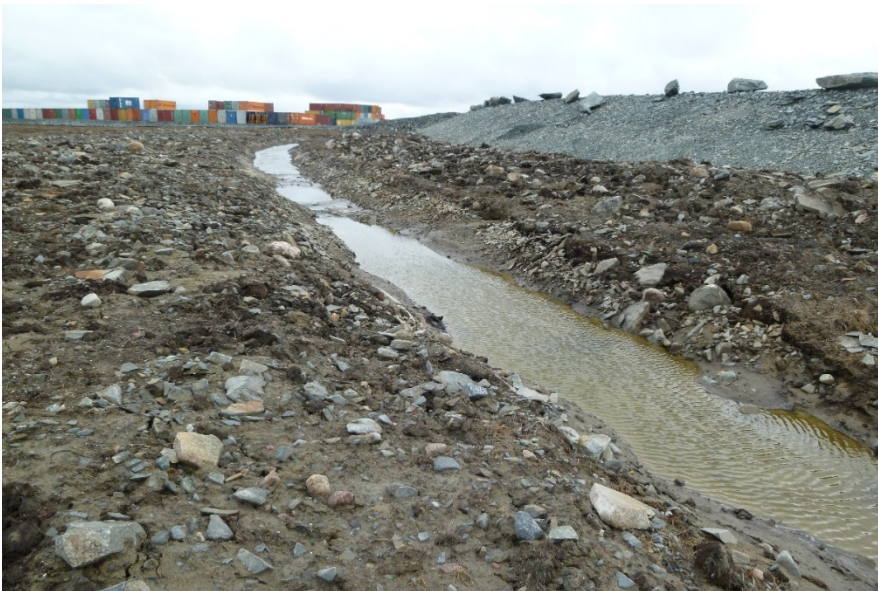
Photograph 14: DP1-B, Run-off and Seepage Collection Channel Downstream of Dike near Station 0+200, Looking East. Visible Flow towards Sump (20 September 2017)

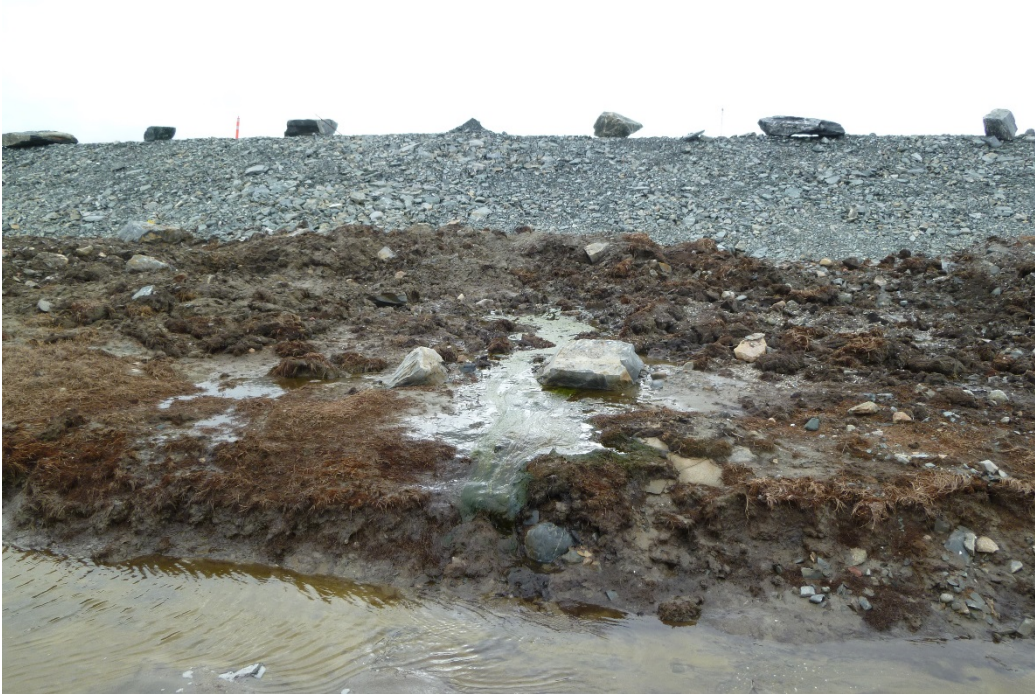
Photograph 15: DP1-B, Seepage Visible from Dike Toe near Station 0+190 (20 September 2017)

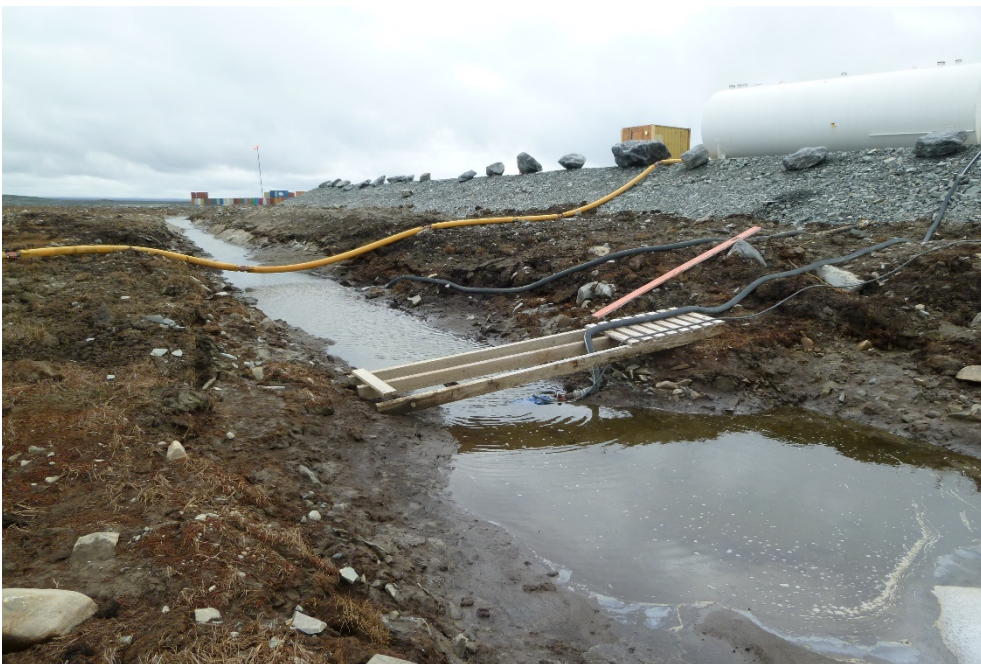
Photograph 16: DP1-B, Downstream Channel and Sump near Station 0+120, Looking East. Active Pumping at Time of Site Visit (20 September 2017)

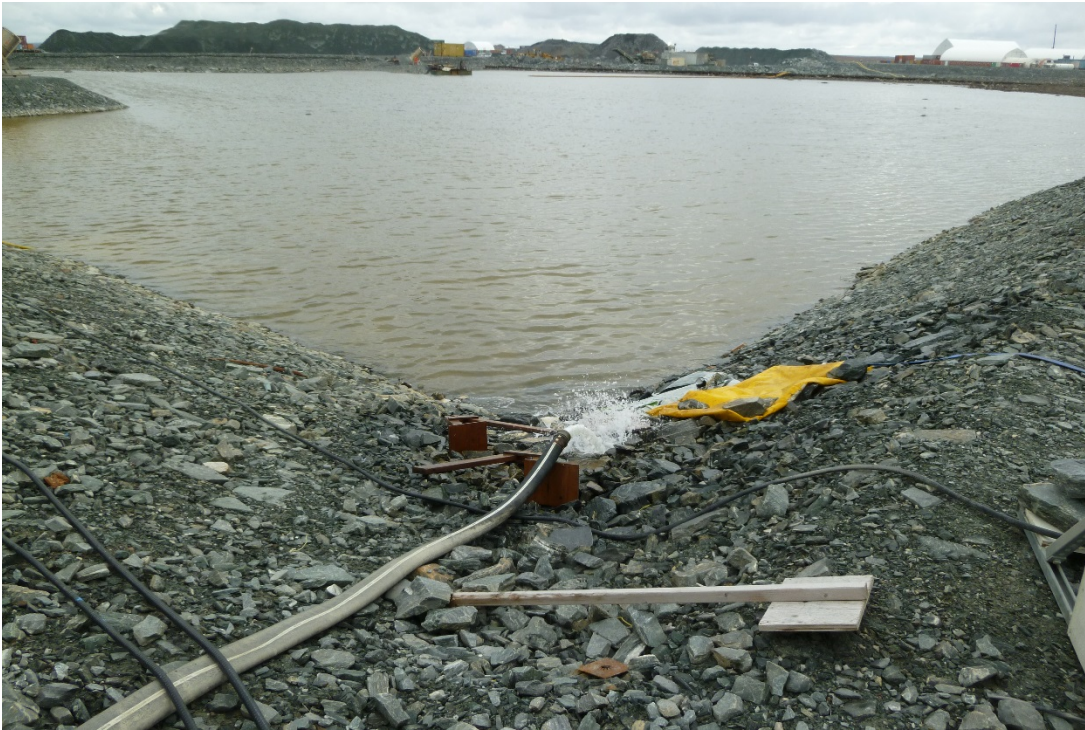
Photograph 17: DP1-B, Seepage Water being Pumped back into P1 from Downstream Sump, East of Snow Melt Pond (20 September 2017)

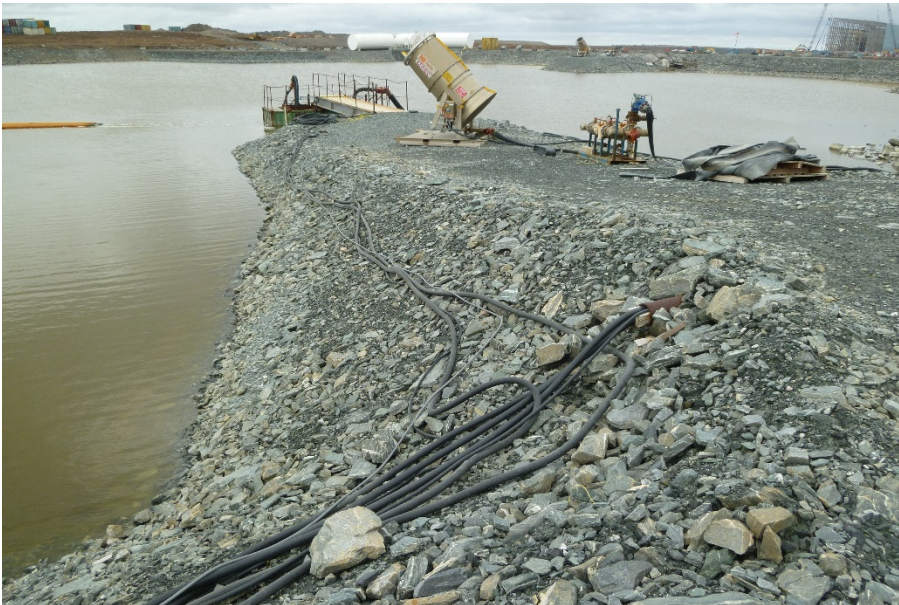
Photograph 18: DP1-B Causeway for Pump Barge and Evaporator #3 near Station 0+410, Looking Northwest (20 September 2017)

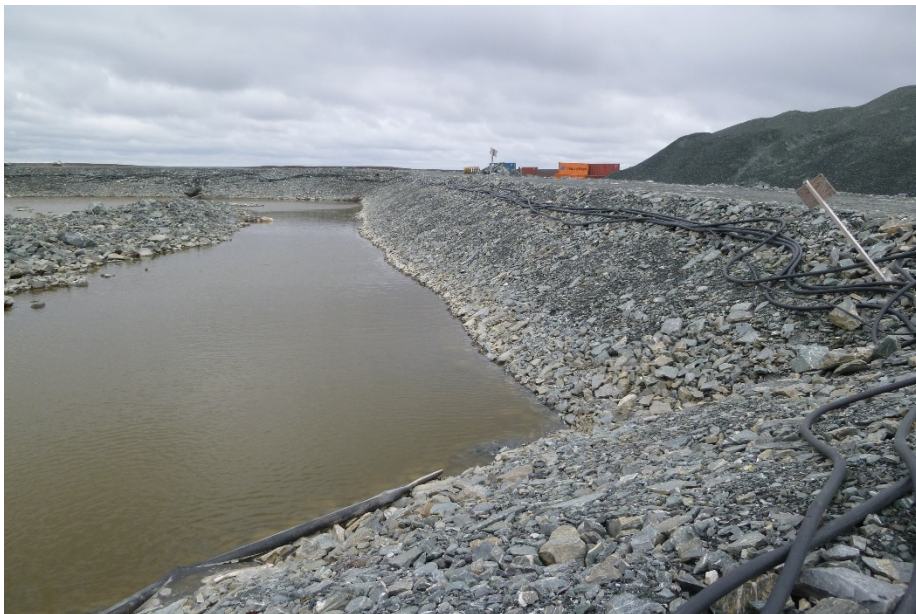
Photograph 19: DP1-B, Upstream Slope near Station 0+390, Looking Northeast from Pump Barge Causeway (20 September 2017)

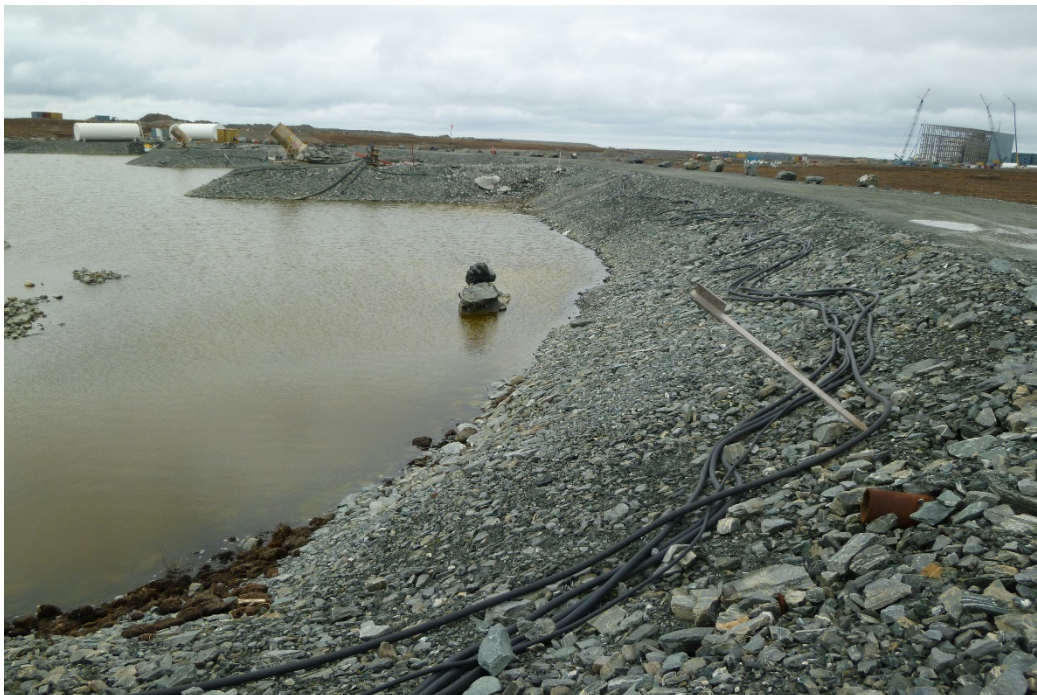
Photograph 20: DP1-B, Upstream Slope near Station 0+320, Looking North towards Jetty for Evaporator #2 (20 September 2017)

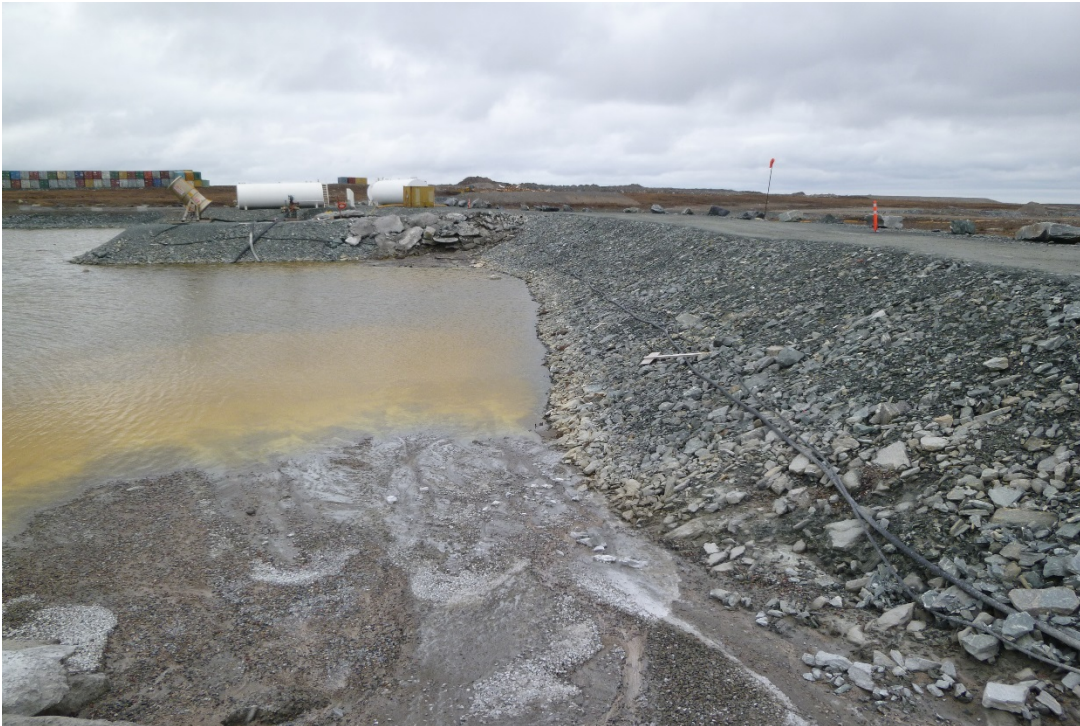
Photograph 21: DP1-B, Upstream Slope near Station 0+250, Looking West towards Jetty for Evaporator #1 (20 September 2017)

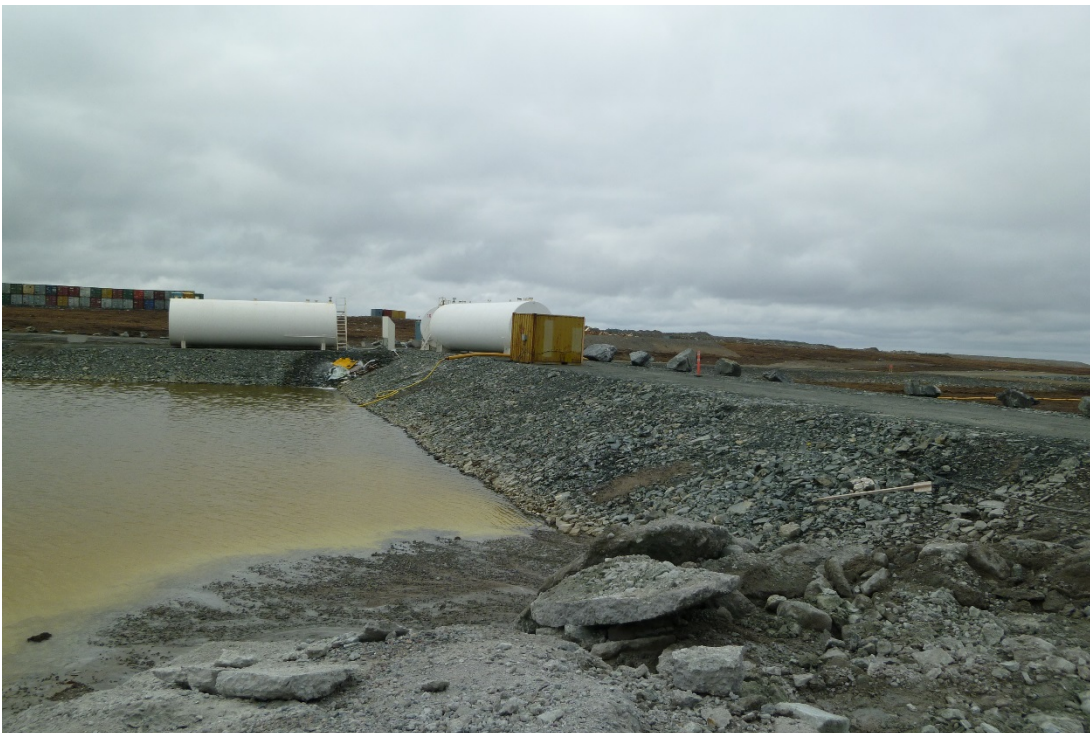
Photograph 22: DP1-B, Upstream Slope near Station 0+180, Looking West towards Snow Melt Pond (20 September 2017)
