## APPENDIX A1

P-Area DP1-A, DP1-B, DP2-A and DP3-A

# **APPENDIX A 2**

**Permanent Water Management Facilities: D-CP1, D-CP5, Channel 5, Berm 3, Saline Pond, and Channel 2**

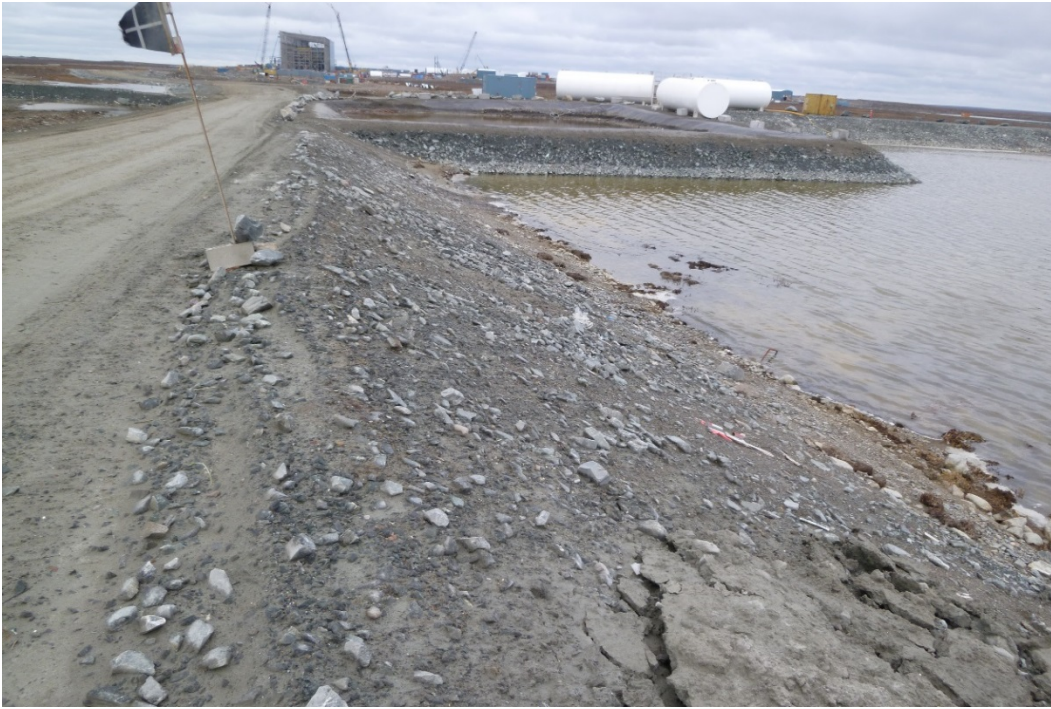
*Photograph 23: DP1-B, Upstream Slope of Access Road along West Side of P1, Looking North towards Snow Melt Pond (20 September 2017)*

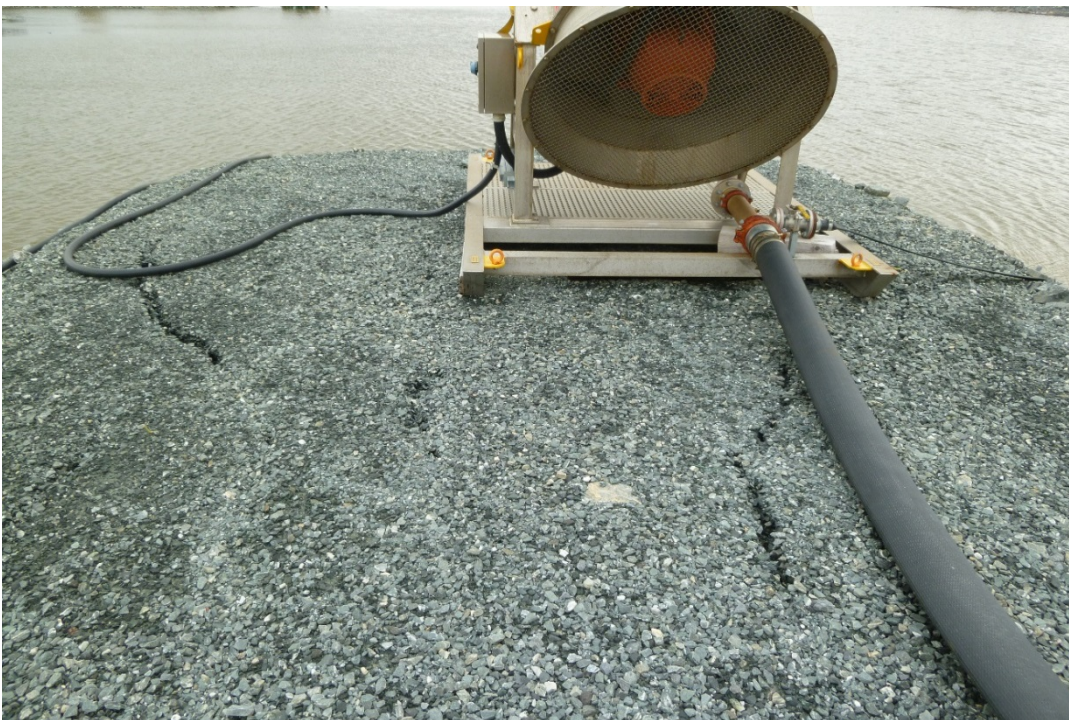
*Photograph 24: DP1-B Cracking Observed in Crest of Jetty for Evaporator #2*

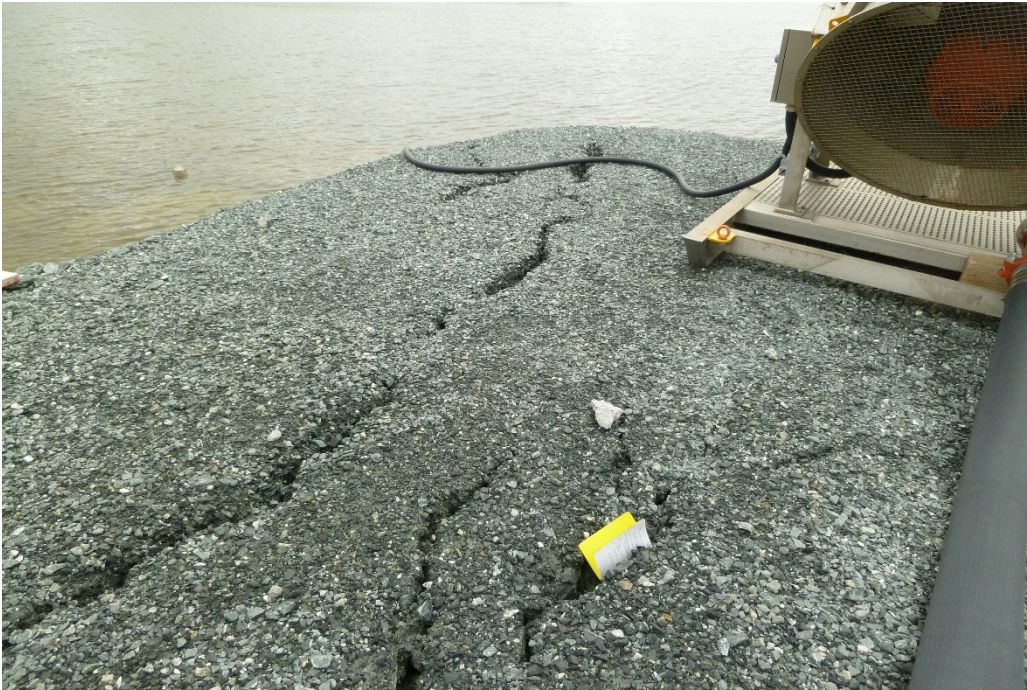
*Photograph 25: DP1-B, Cracking Observed (3 to 10 cm wide) in Jetty for Evaporator #1*

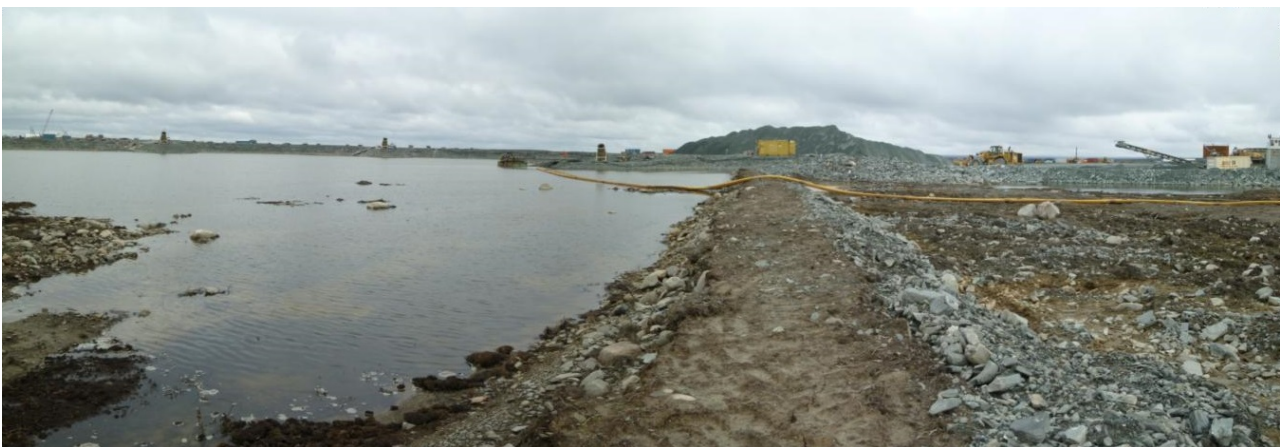
*Photograph 26: P1 Till Dividing Berm, Looking East (20 September 2017)*

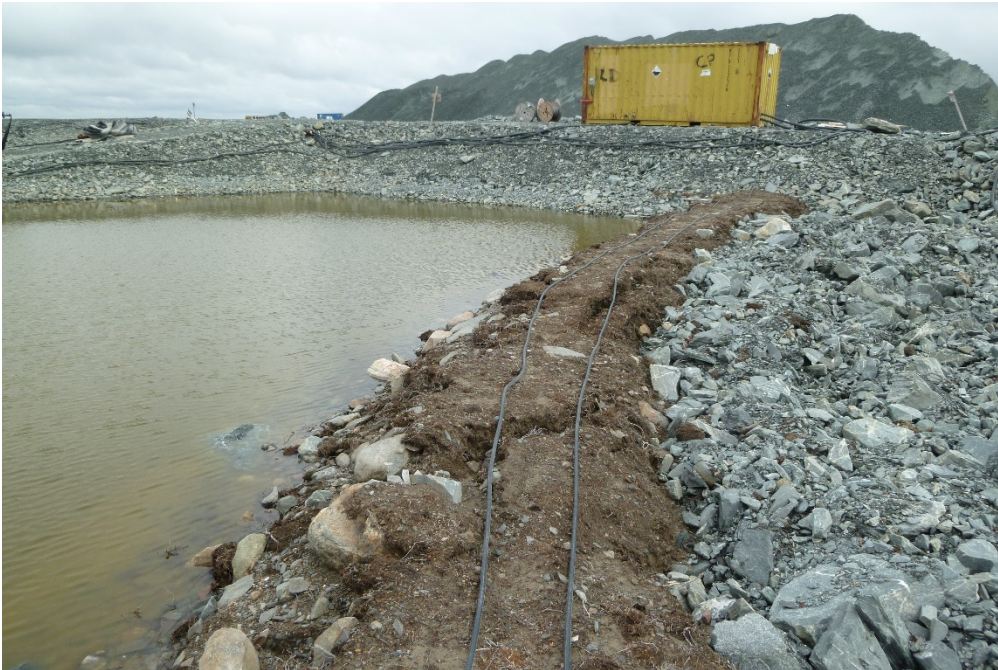
*Photograph 27: P1 Till Dividing Berm, Erosion and Cracking Observed, Looking East near Intersection with DP1-B (Station 0+420)*

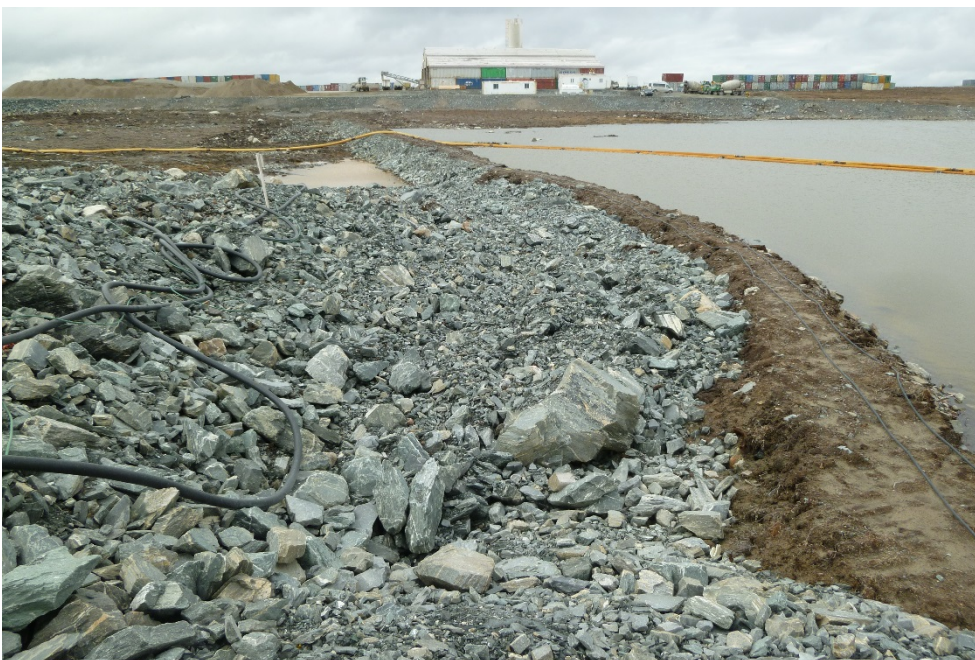
*Photograph 28: P1 Till Dividing Berm, Looking West (20 September 2017)*

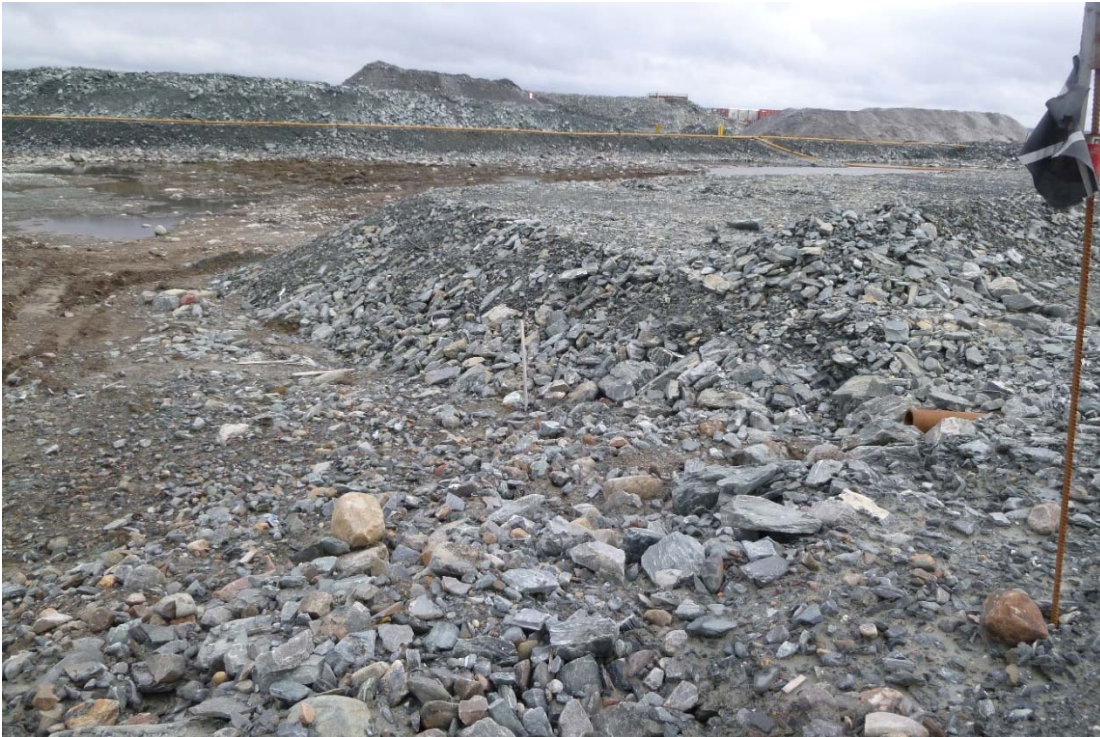
*Photograph 29: DP2-A, Upstream Slope of West End of Dike, Looking East (20 September 2017)*

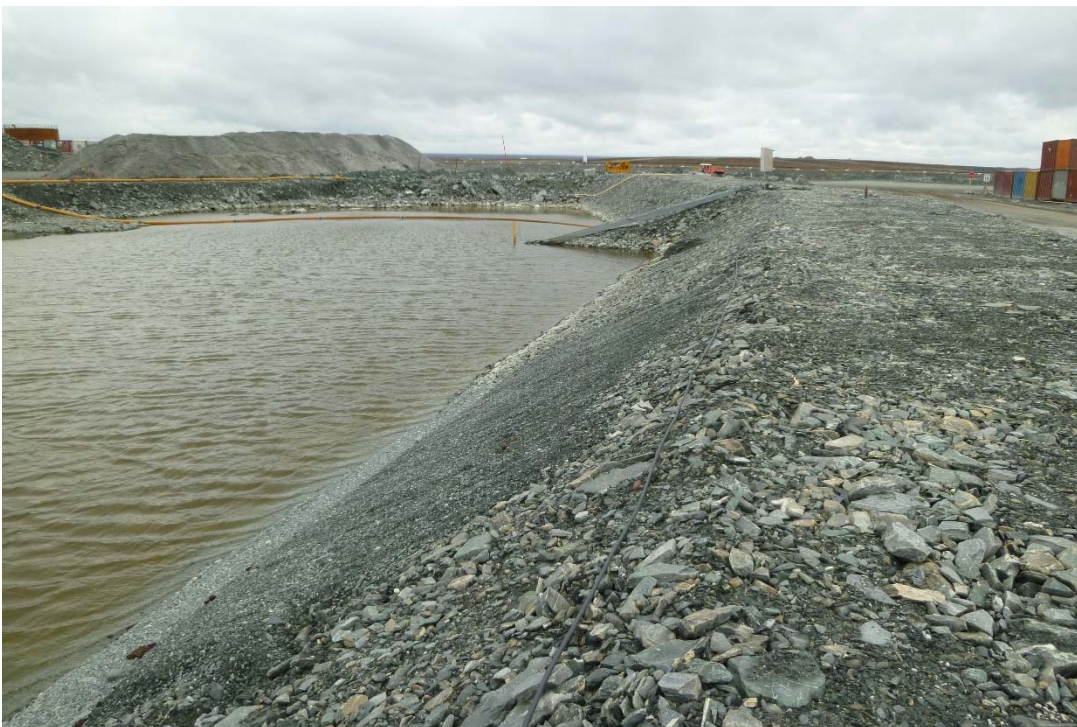
*Photograph 30: DP2-A, Upstream Slope near Station 0+025, Looking East. Finer Grained Material on Slope Where Historic Slump was Remediated (20 September 2017)*

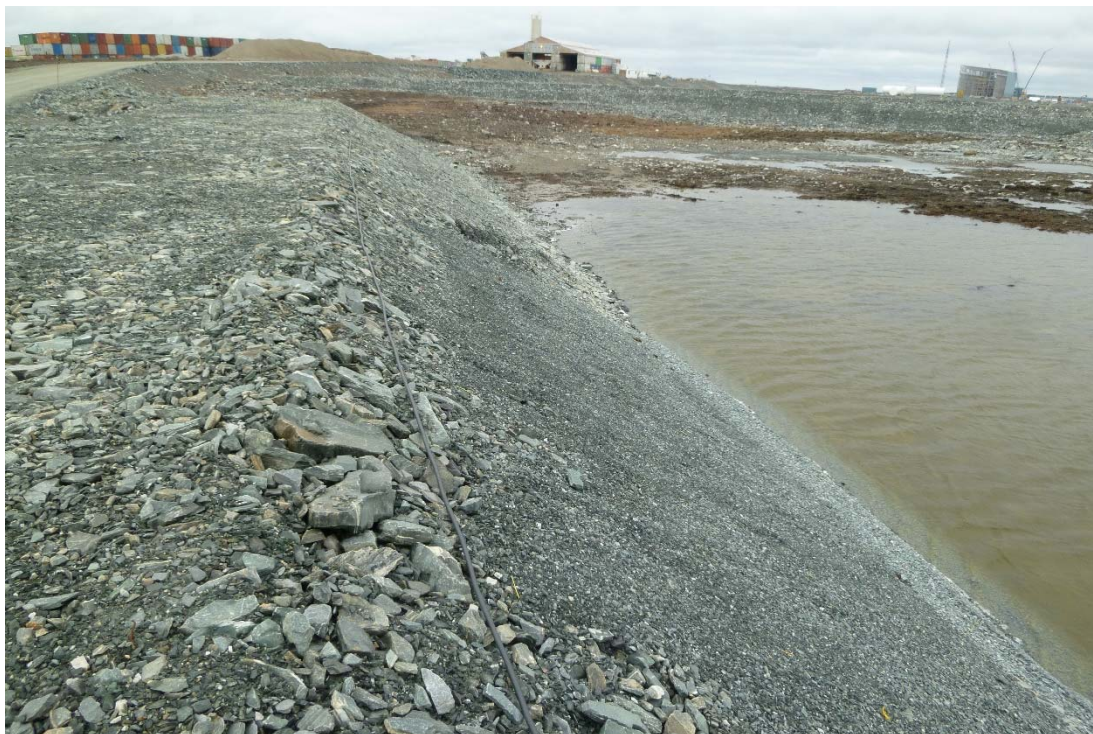
*Photograph 31: DP2-A, Upstream Slope near Station 0+065, Looking West. Finer Grained Material on Slope Where Historic Slump was Remediated (20 September 2017)*

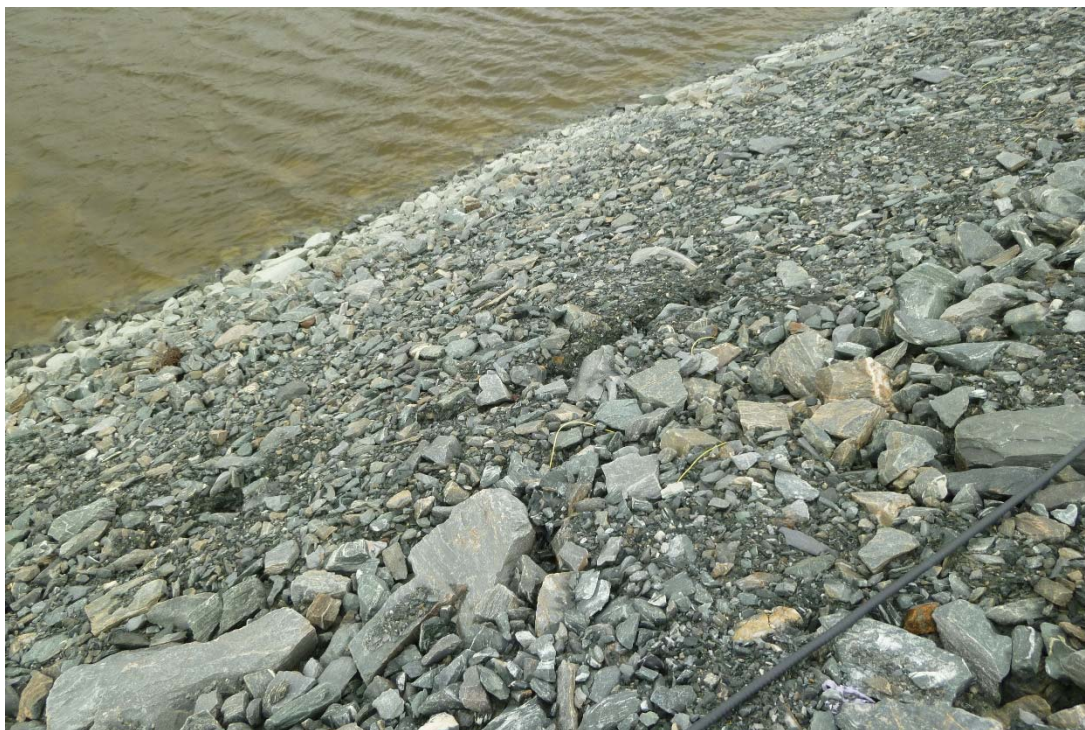
*Photograph 32: DP2-A, Cracking on Upstream Slope near Station 0+075 (20 September 2017)*

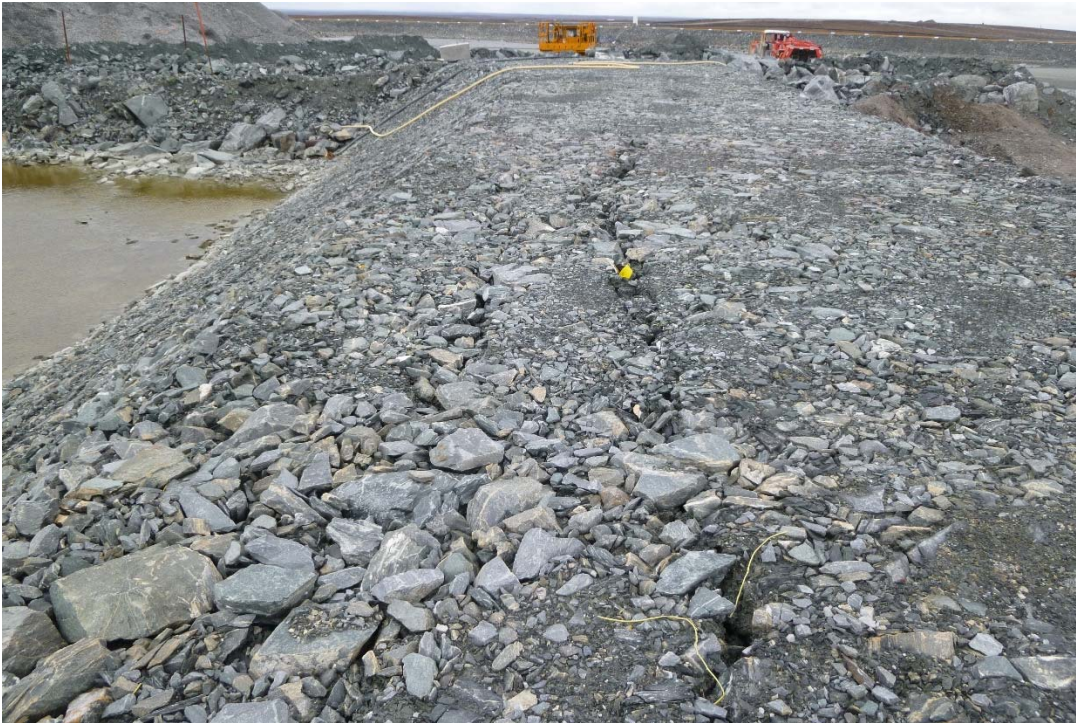
*Photograph 33: DP2-A, Cracking on Crest of Dike near Station 0+090, Looking East (20 September 2017)*

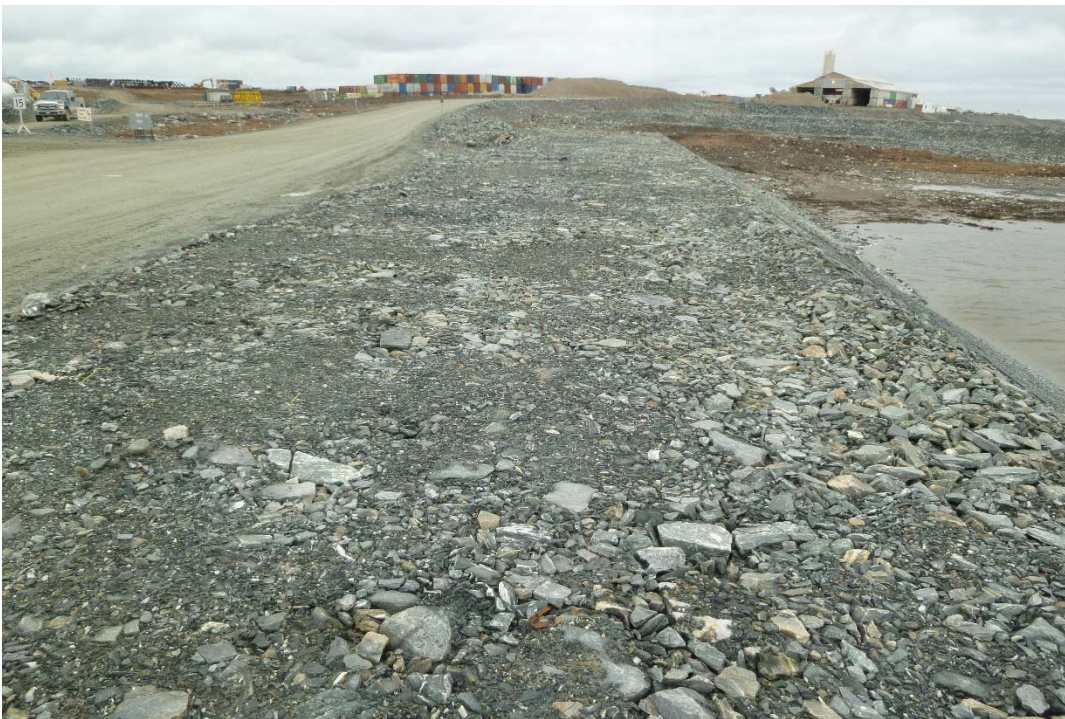
*Photograph 34: DP2-A, Crest of Dike near Station 0+070, Looking West (20 September 2017)*

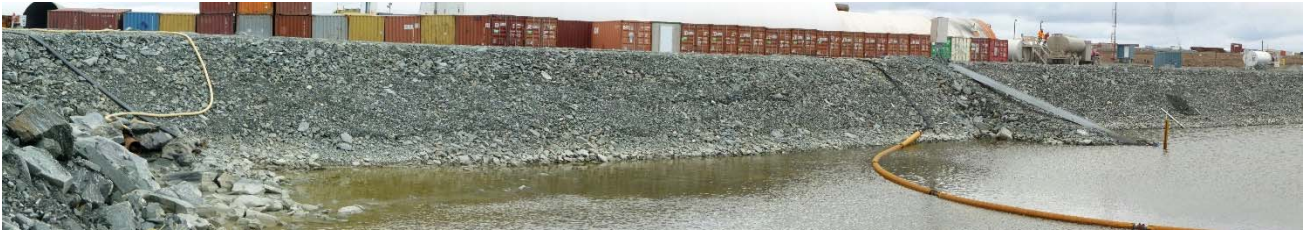
*Photograph 35: DP2-A, Upstream Face of East End of Dike, Looking South, some Cracking Visible (20 September 2017)*

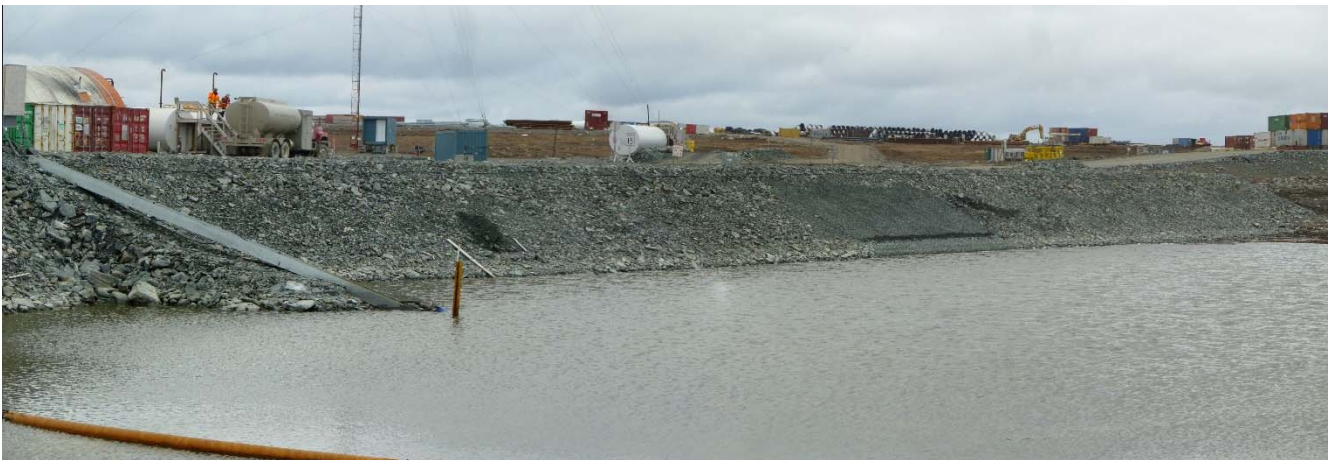
*Photograph 36: DP2-A, Upstream Face of West End of Dike, Looking South. Repair of Previous Sloughing of the Slope Visible, near Station 0+065 (20 September 2017)*

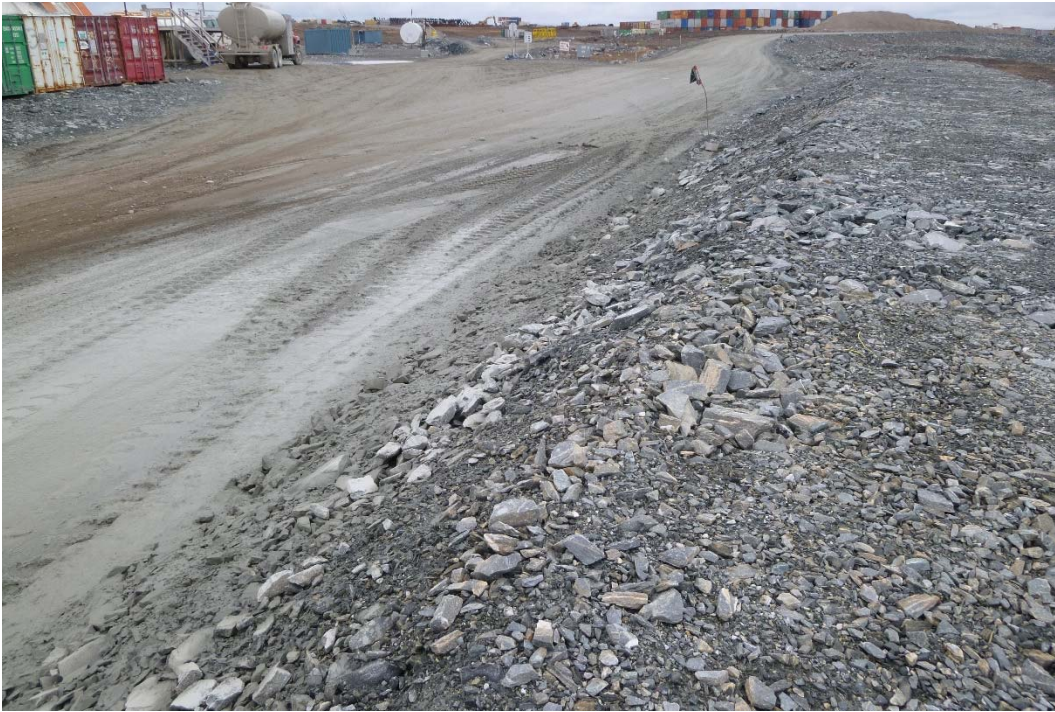
*Photograph 37: DP2-A, Downstream Slope Adjacent to Access Road, Looking West (20 September 2017)*

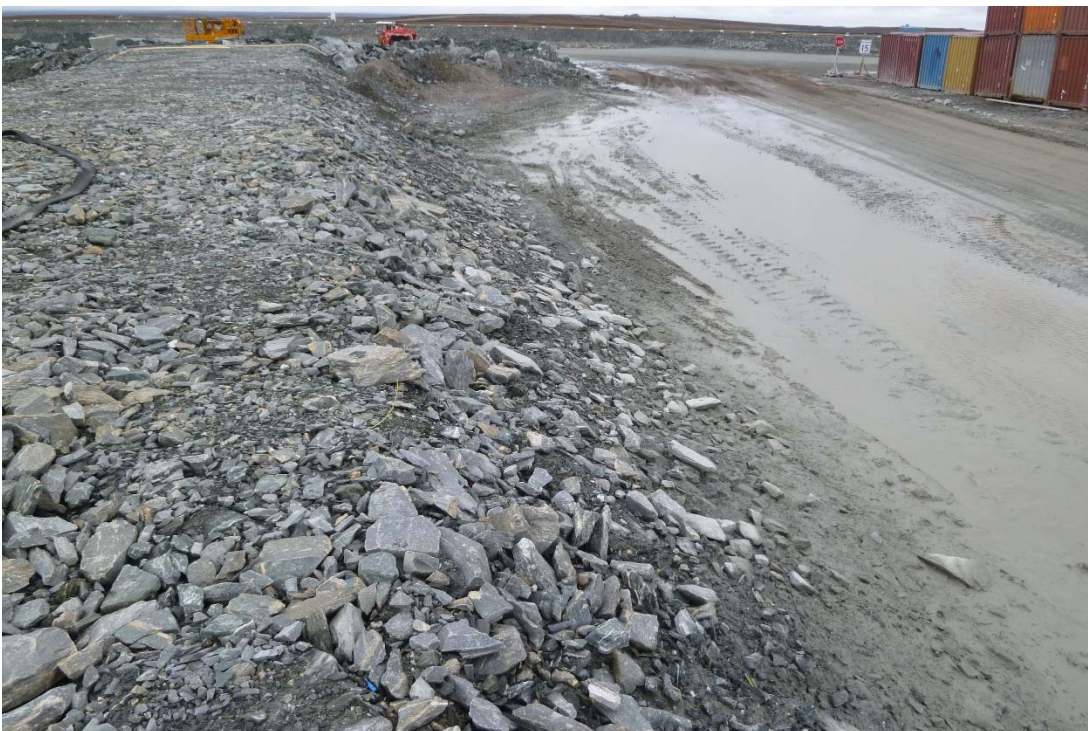
*Photograph 38: DP2-A, Downstream Slope Adjacent to Access Road, Looking East (20 September 2017)*

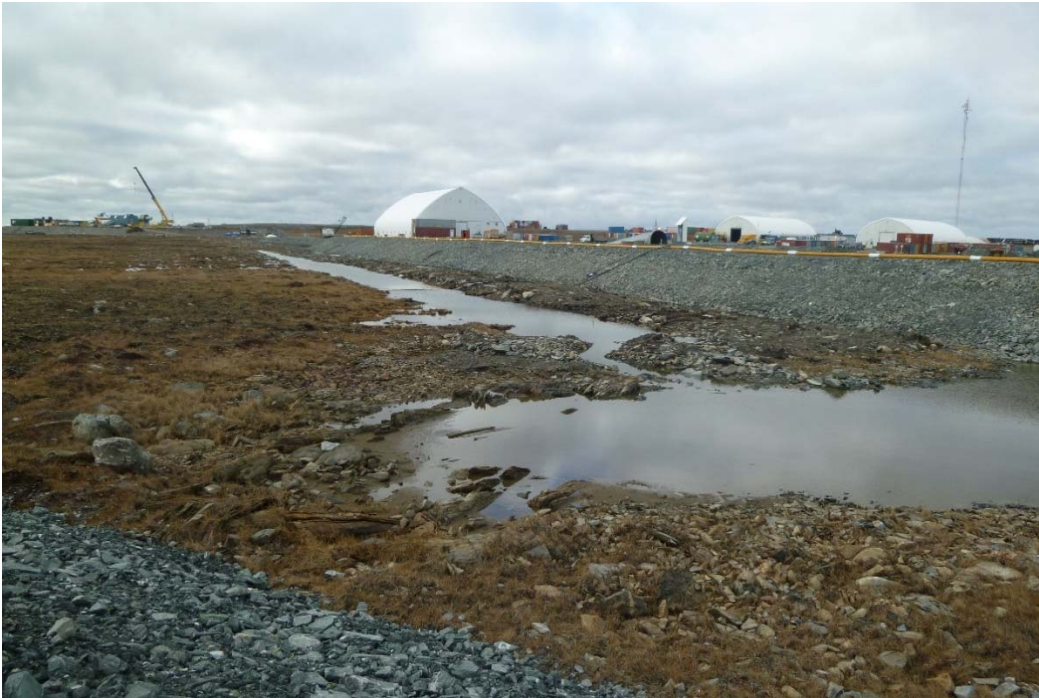
*Photograph 39: DP3-A, Downstream Slope and Run-off and Seepage Collection Channel, Looking West from Saline Pond (19 September 2017)*

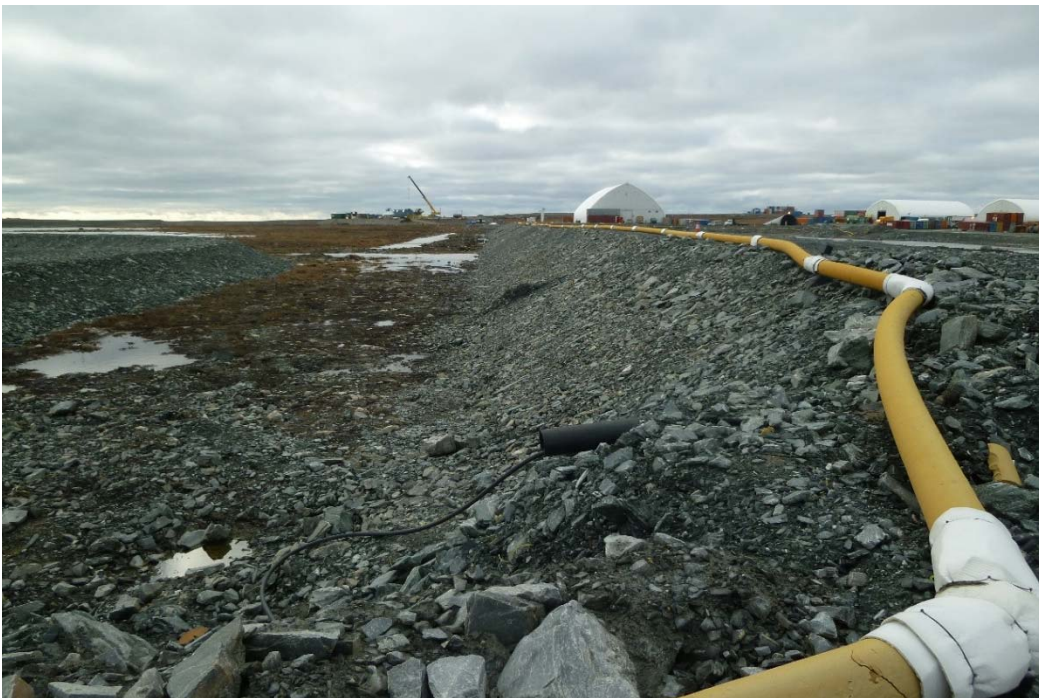
*Photograph 40: DP3-A, Downstream Slope near Station 0+300, Looking Southwest. Saline Pond Berm to Left (19 September 2017)*

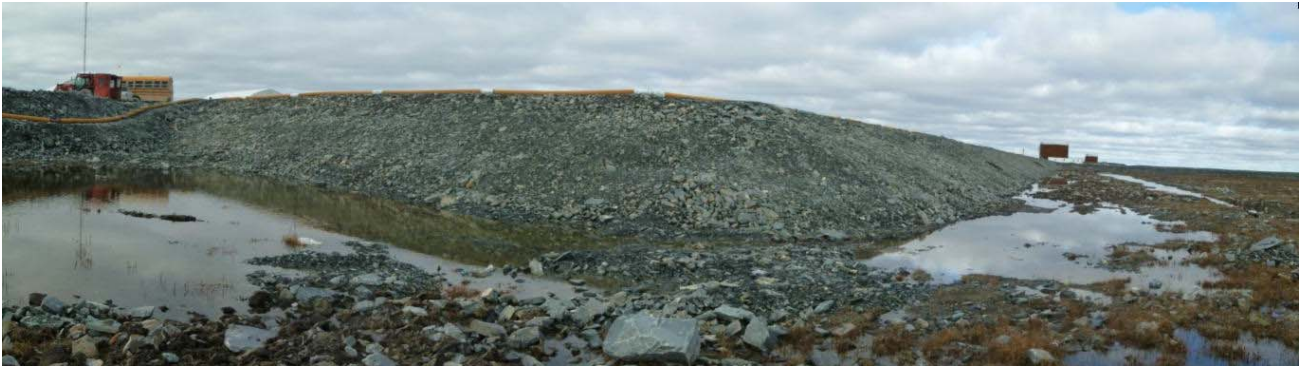
*Photograph 41: DP3-A, Downstream Face of Dike near Station 0+050, Looking North (19 September 2017)*

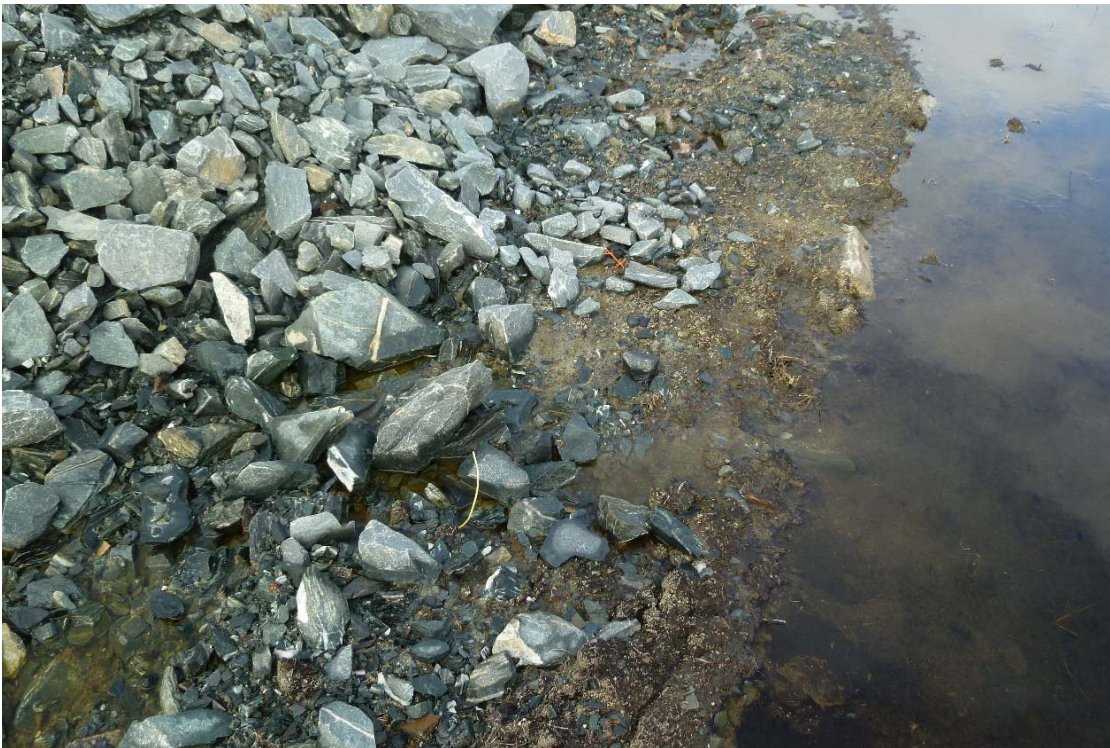
*Photograph 42: DP3-A, Visible Seepage from Toe of Dike near Station 0+050 (19 September 2017)*

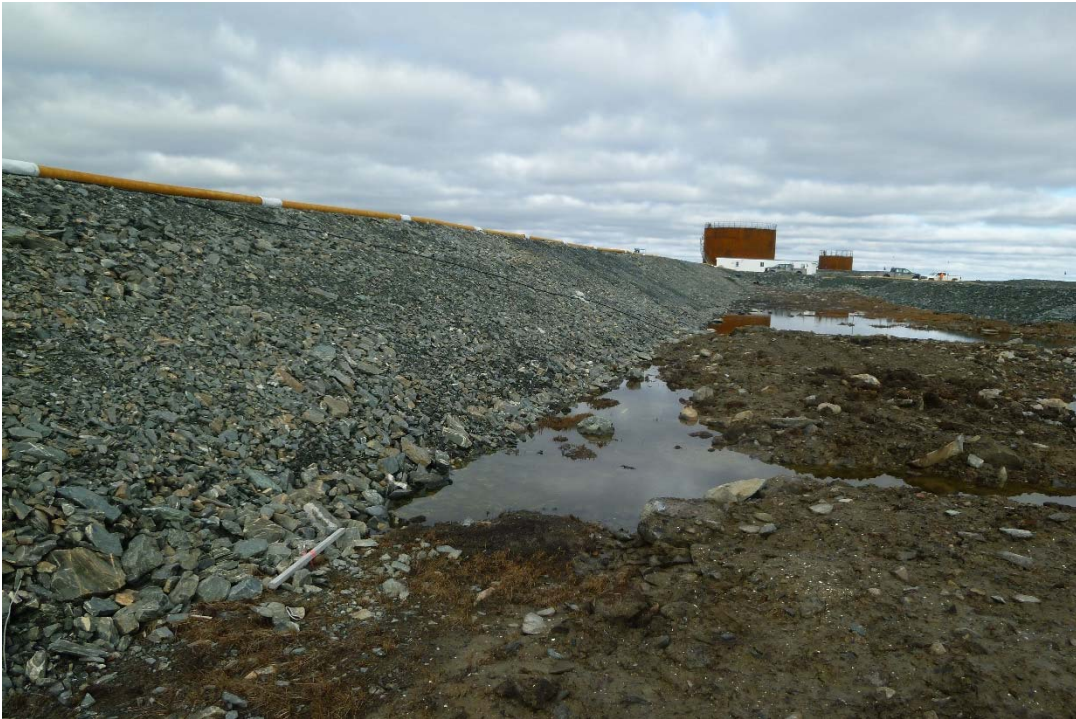
*Photograph 43: DP3-A, Downstream Face near Station 0+220, Looking Northeast (19 September 2017)*

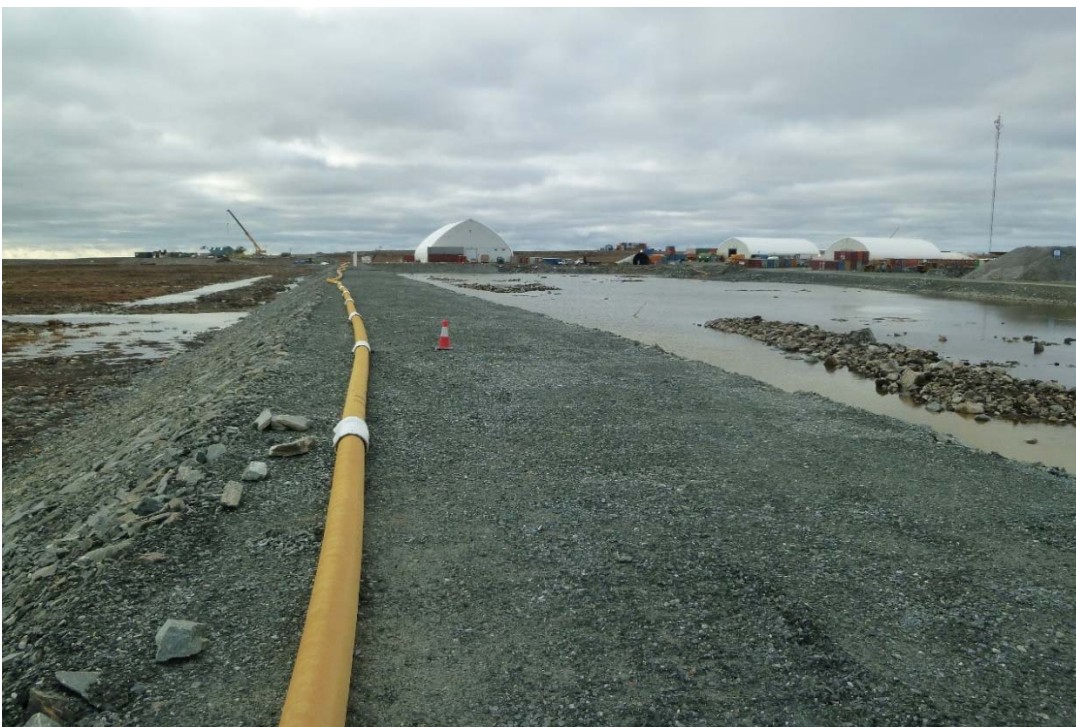
*Photograph 44: DP3-A Crest near Station 0+260, Looking West (19 September 2017)*

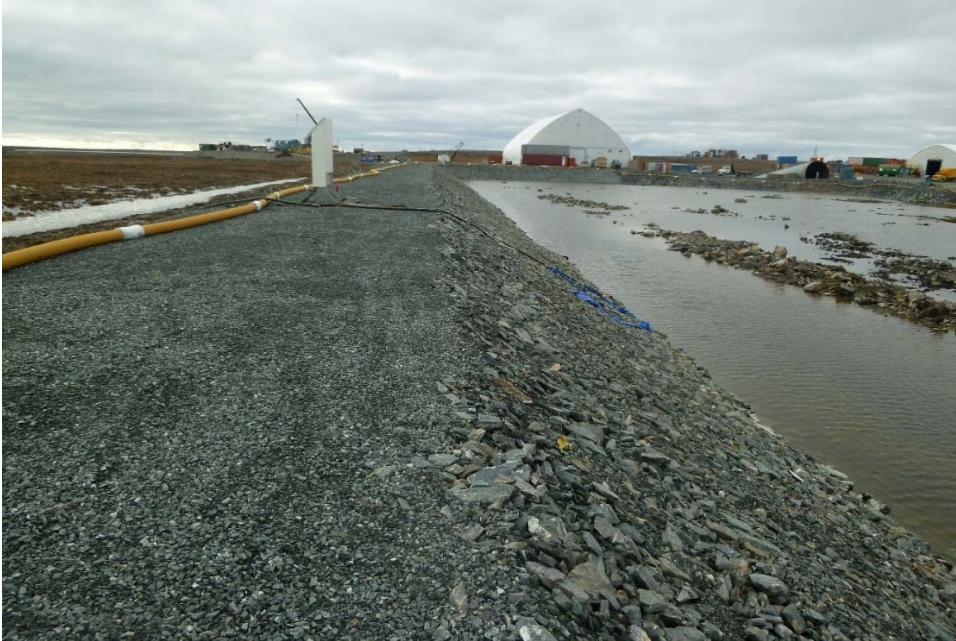
*Photograph 45: DP3-A, Upstream Slope near 0+170, Looking West (19 September 2017)*

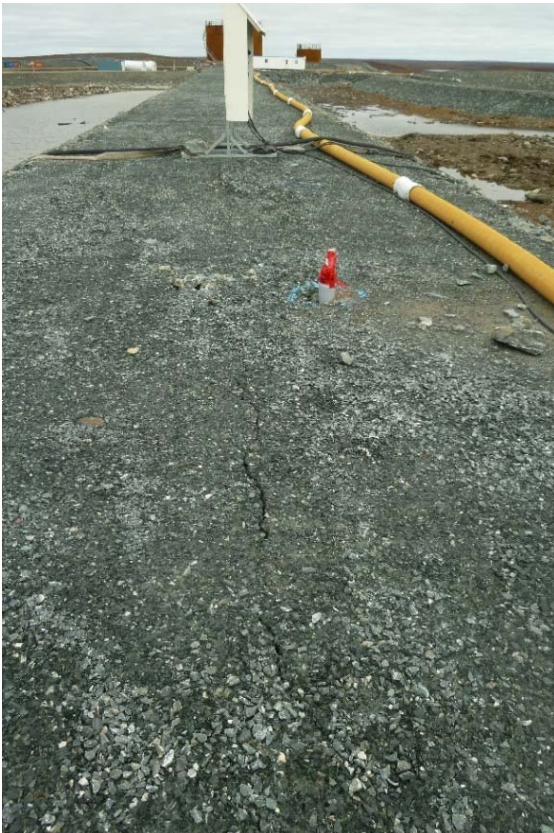
*Photograph 46: DP3-A, Cracking Observed on Crest near Station 0+150, Looking Southwest (19 September 2017)*

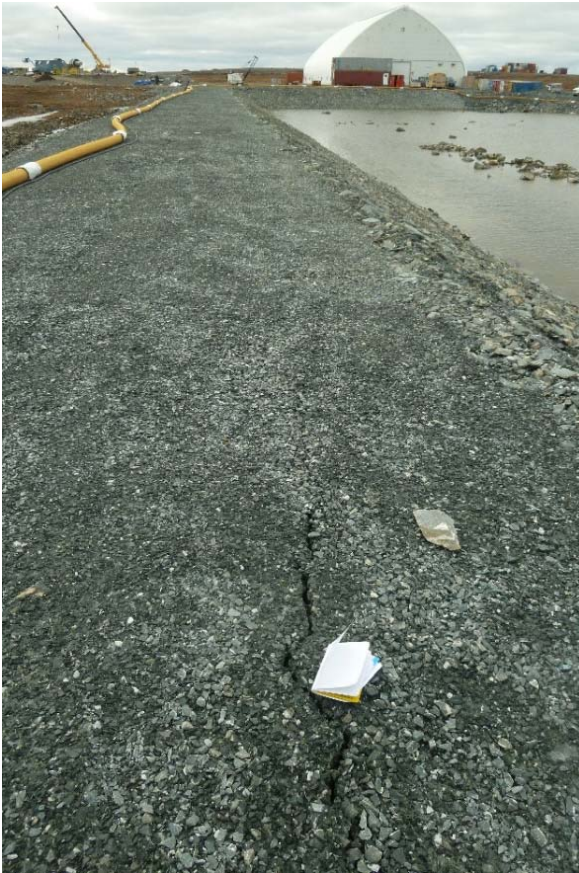
*Photograph 47: DP3-A, Cracking Observed on Crest near Station 0+140 (19 September 2017)*

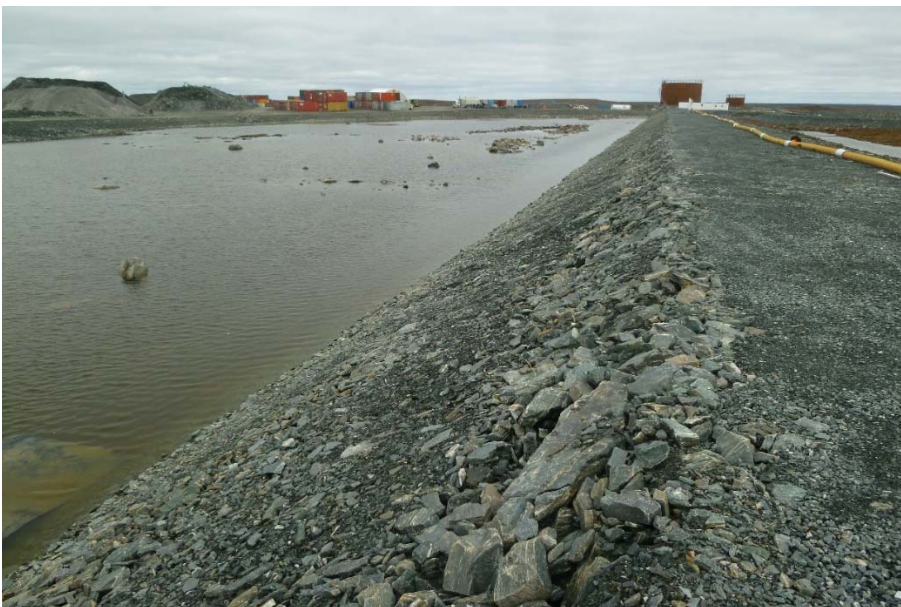
*Photograph 48: DP3-A, Upstream Slope, Looking Northeast near Station 0+050 (19 September 2017)*

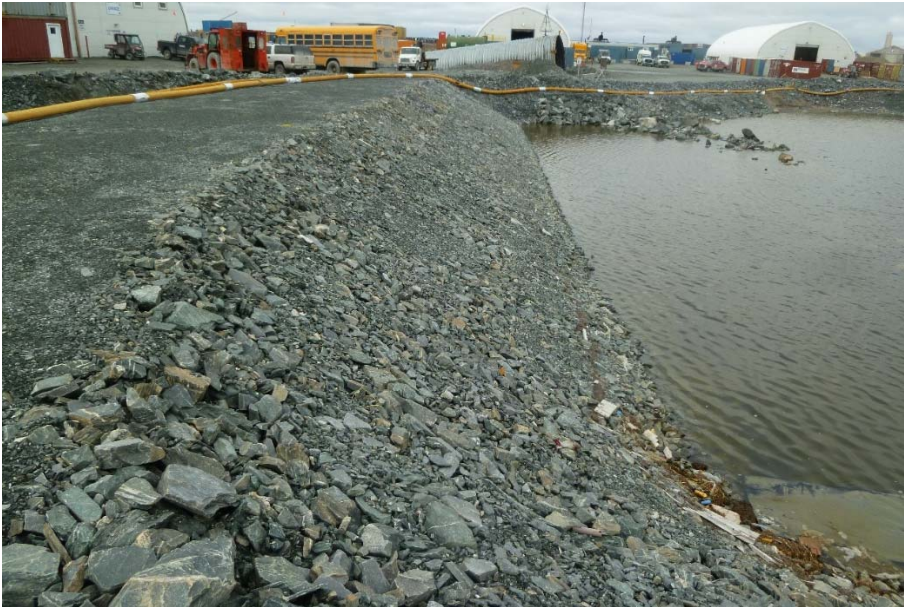
*Photograph 49: DP3-A, Upstream Slope near Station 0+040, Looking West. (19 September 2017)*

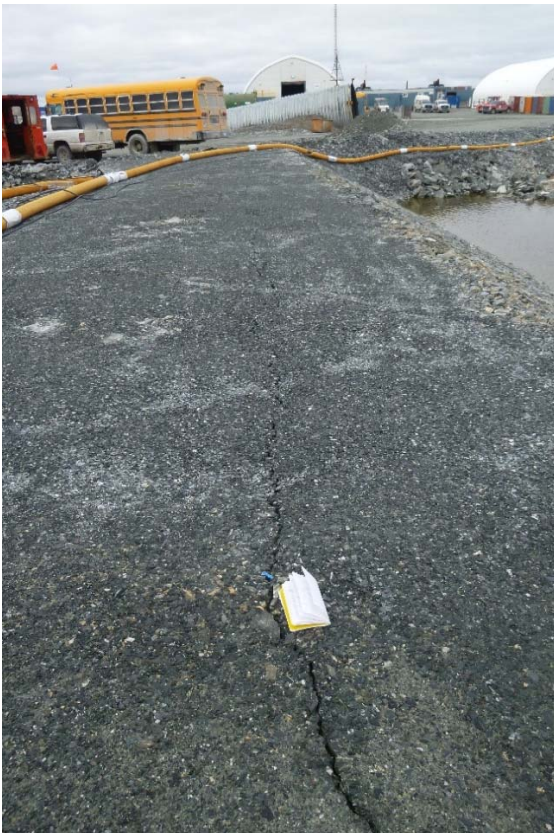
*Photograph 50: DP3-A, Cracking Observed on Crest from Station 0+000 to 0+050, Looking West (19 September 2017)*

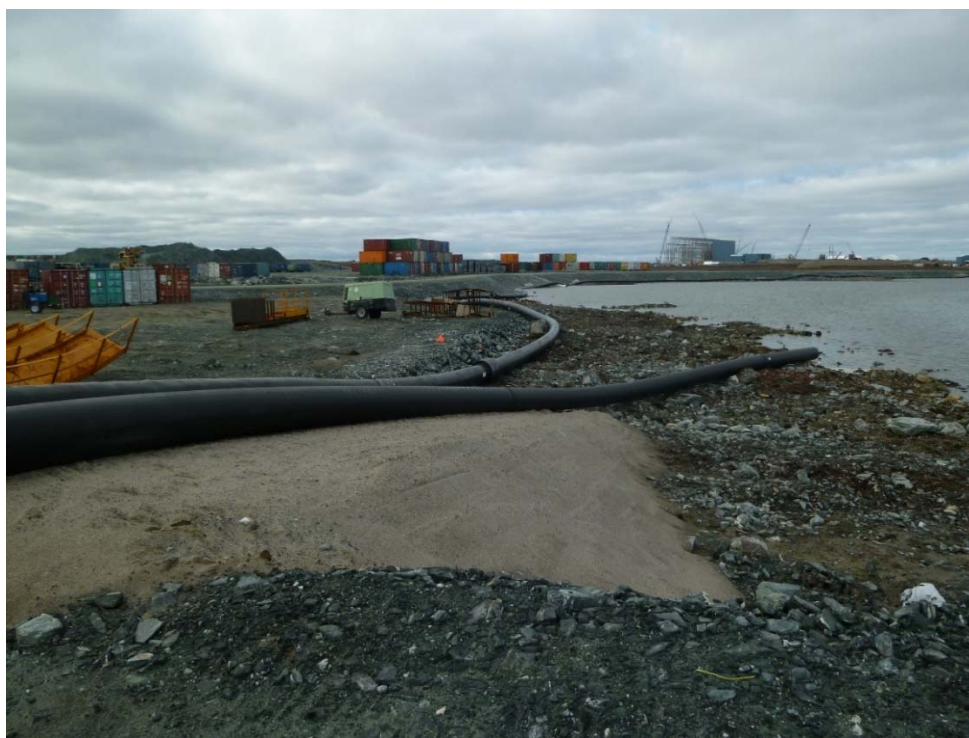
*Photograph 2: D-CP1, Water Pipeline Ramp Upstream of the Dike near Station 1+140, Looking West. Sand is Susceptible to Erosion (19 September 2017)*

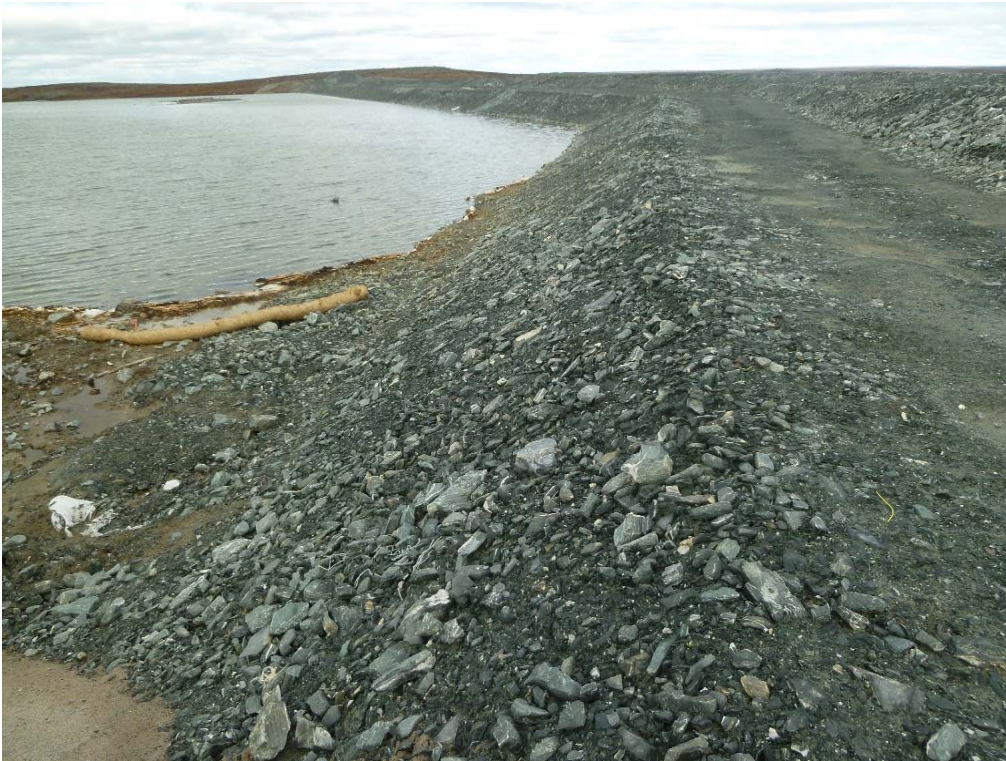
*Photograph 3: D-CP1 - Upstream Slope near Station 1+140, Looking Northeast (19 September 2017)*

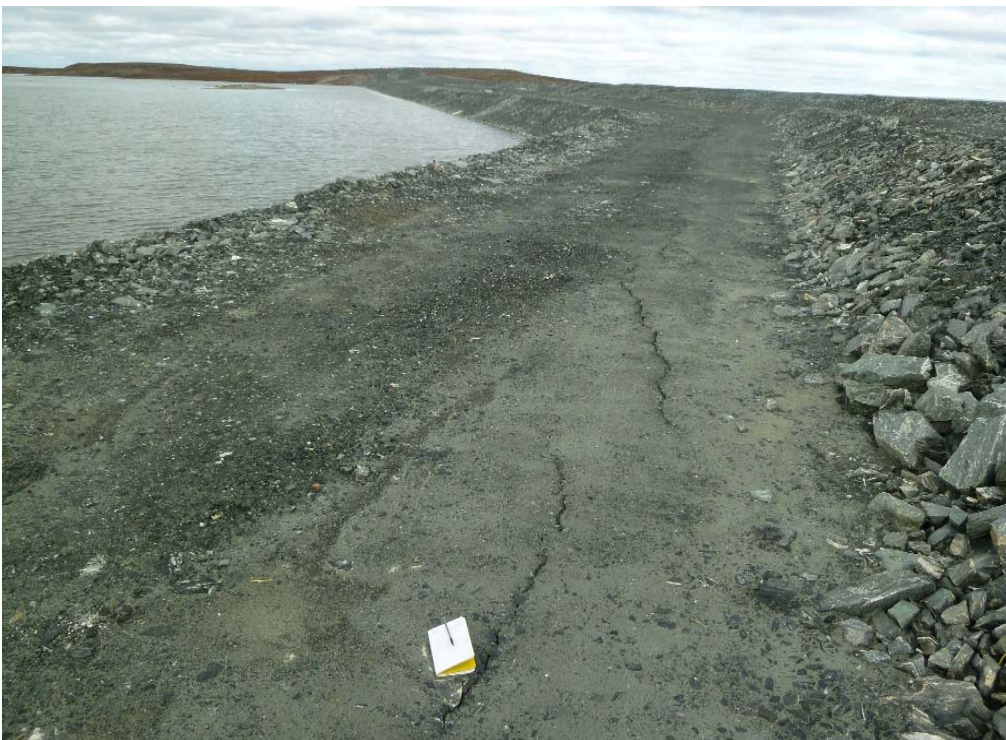
*Photograph 4: D-CP1, Cracking on Upstream Bench Crest near Station 1+150, Looking Northeast (19 September 2017)*

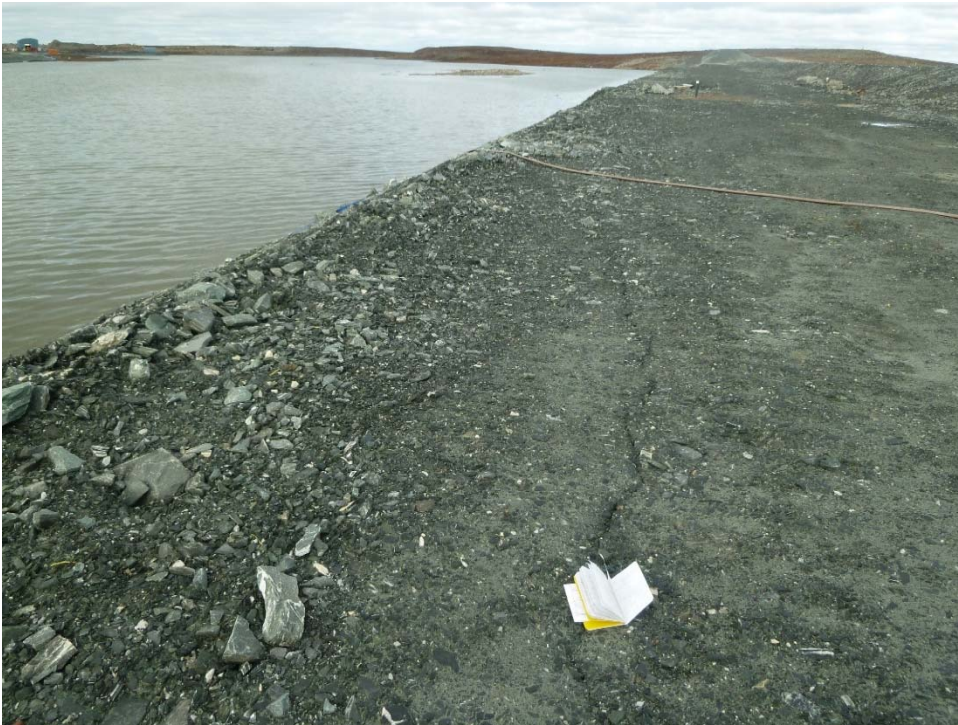
*Photograph 5: D-CP1, Cracking along Upstream Bench Crest near Station 1+225, Looking North (19 September 2017)*
