## APPENDIX A1

P-Area DP1-A, DP1-B, DP2-A and DP3-A

# **APPENDIX A 2**

**Permanent Water Management Facilities: D-CP1, D-CP5, Channel 5, Berm 3, Saline Pond, and Channel 2**

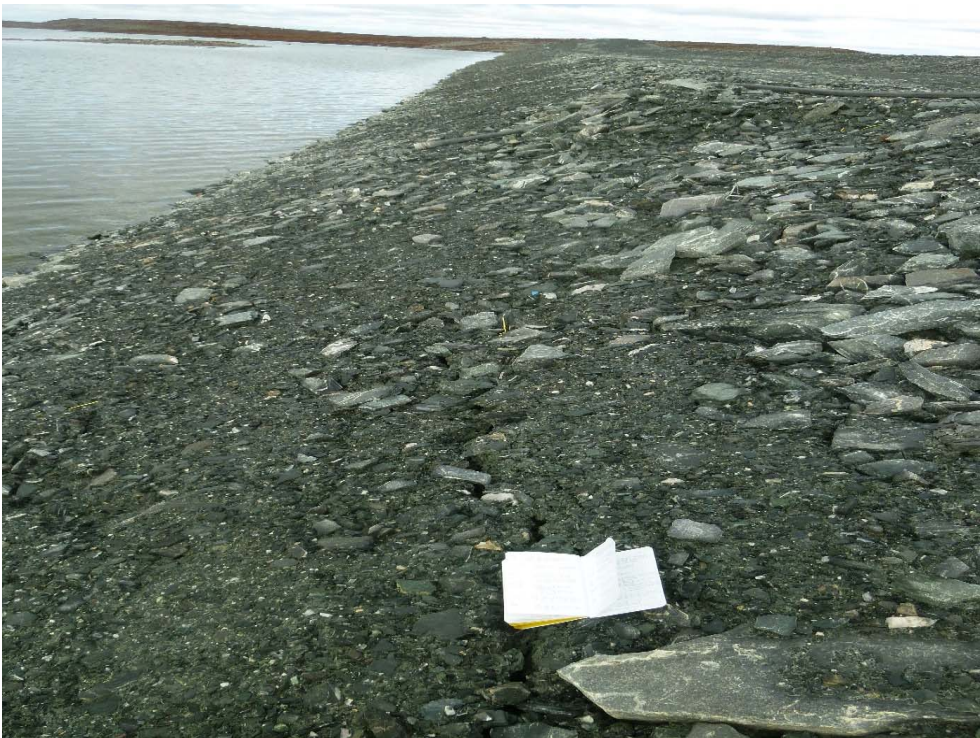
*Photograph 6: D-CP1, Cracking on Upstream Slope near Station 1+270, Looking North (19 September 2017)*

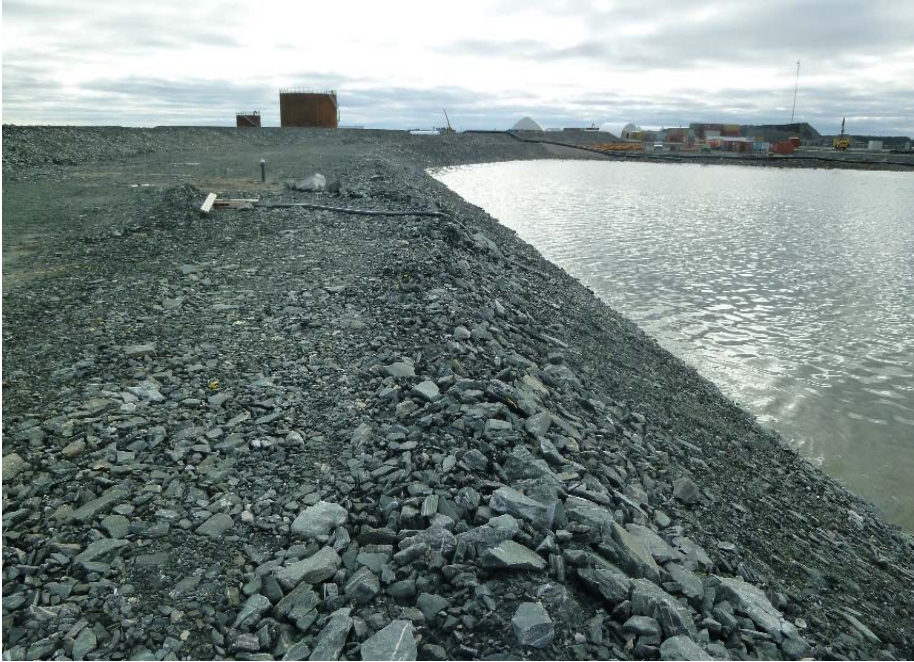
*Photograph 7: D-CP1, Upstream Bench Crest and Upstream Slope near Station 1+285, Looking South (19 September 2017)*

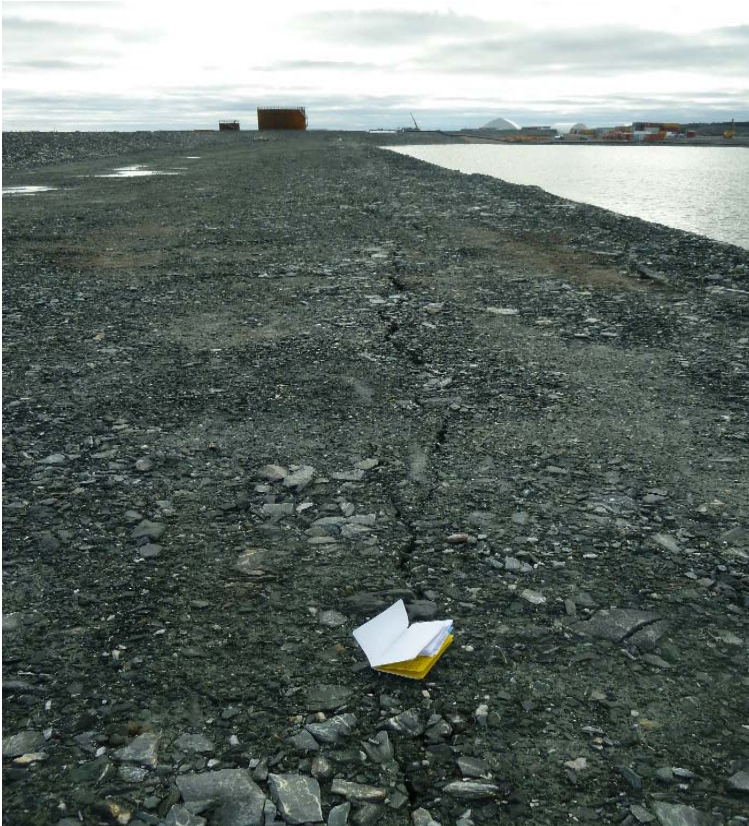
*Photograph 8: D-CP1, Cracking along Upstream Bench Crest near Station 1+450, Looking South (19 September 2017)*

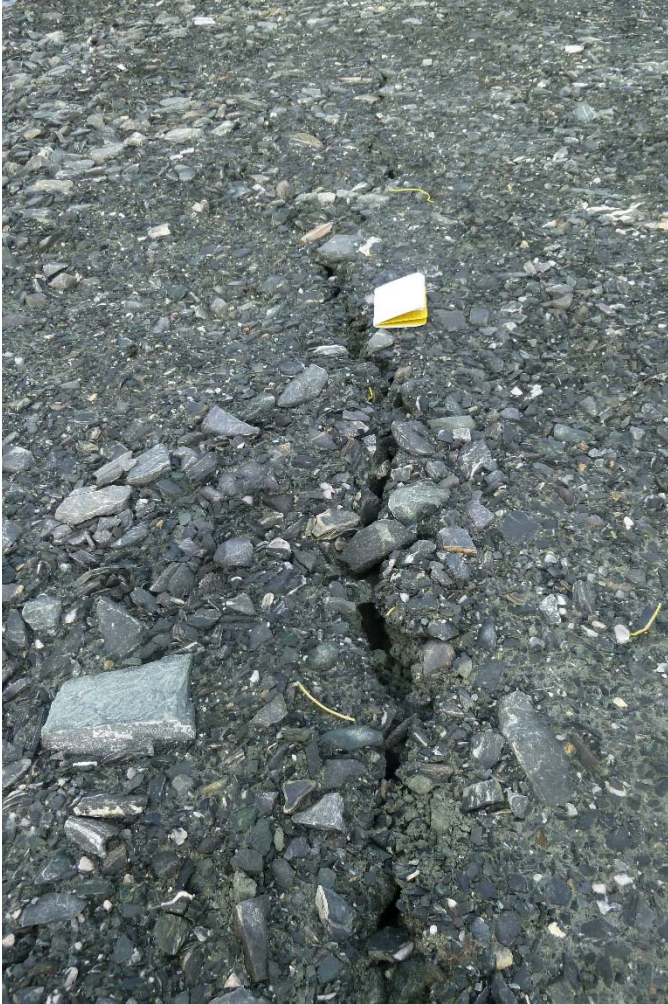
*Photograph 9: D-CP1, Crack (approximately 2 to 3 cm wide) on Upstream Bench near Station 1+435 (19 September 2017)*

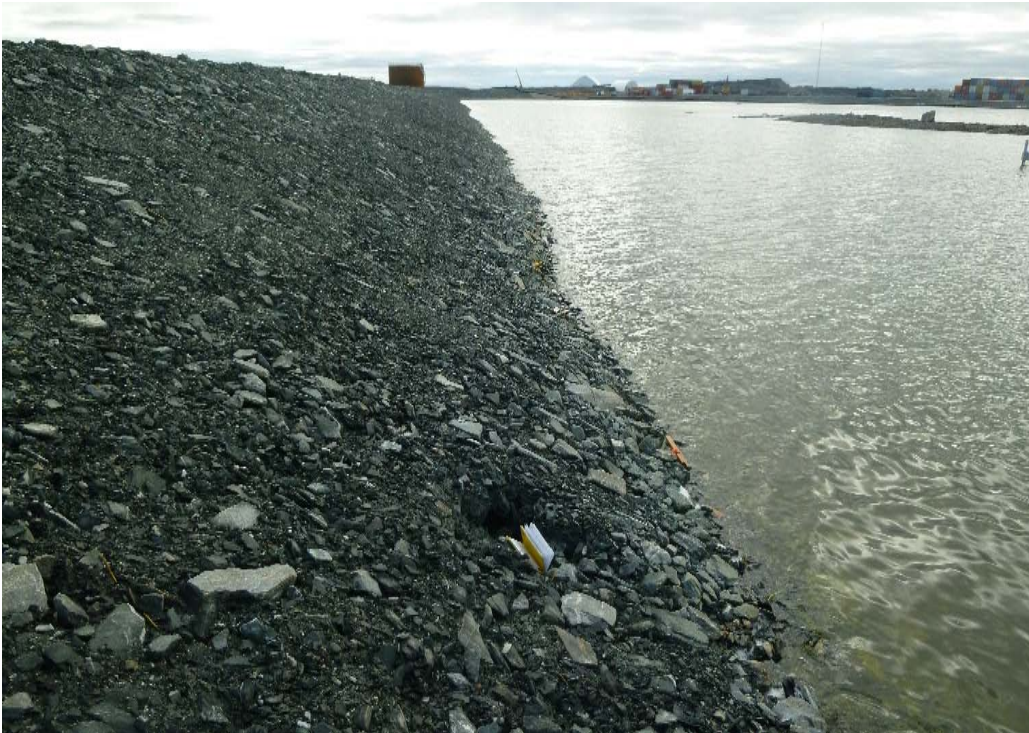
*Photograph 10: D-CP1, Small Settlement/depression near Upstream Toe near Station 1+500, Looking South (19 September 2017)*

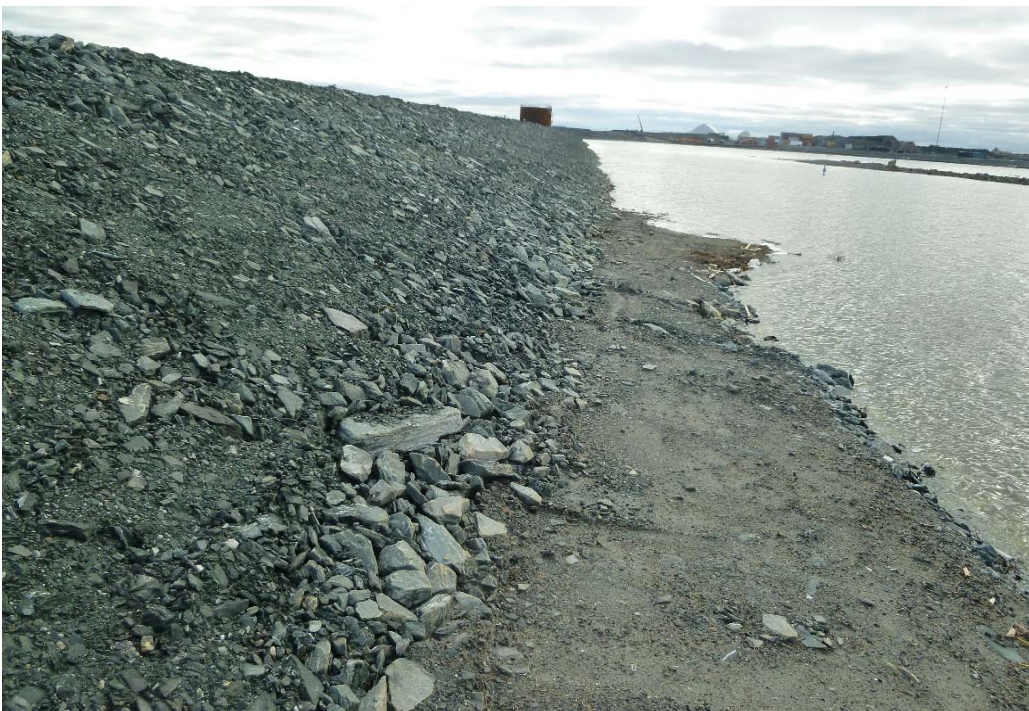
*Photograph 11: D-CP1, Upstream Slope Near Station 1+525, Looking South (19 September 2017)*

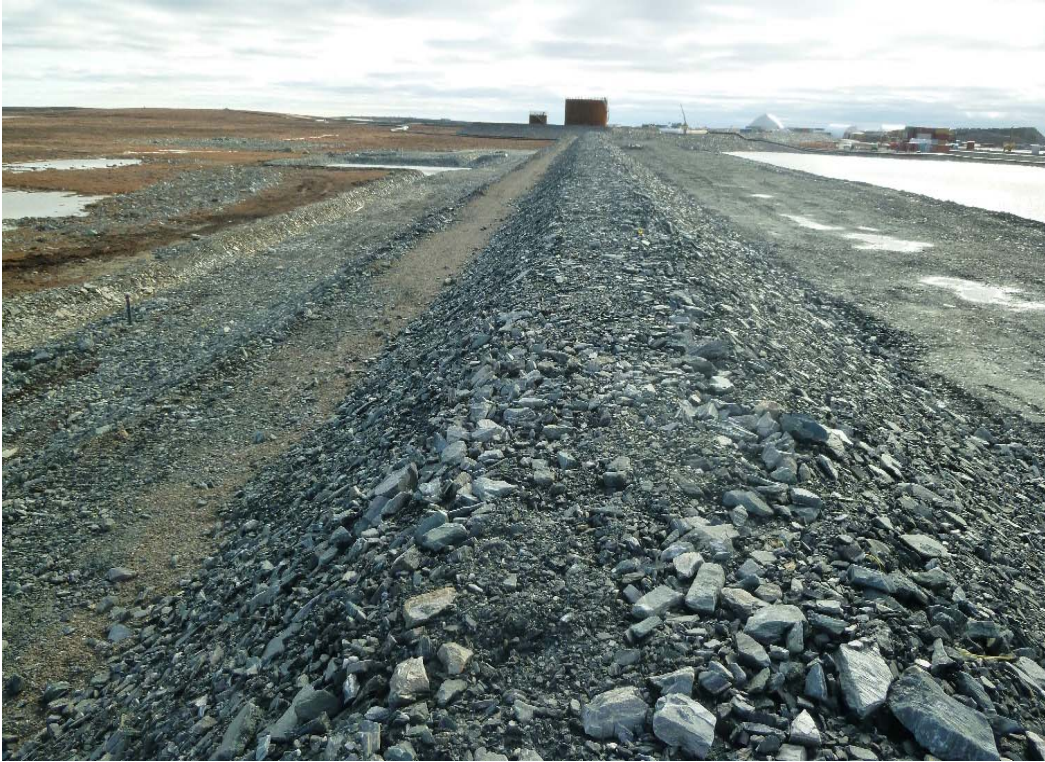
*Photograph 12: D-CP1, Crest Looking South near Station 1+450 (19 September 2017)*

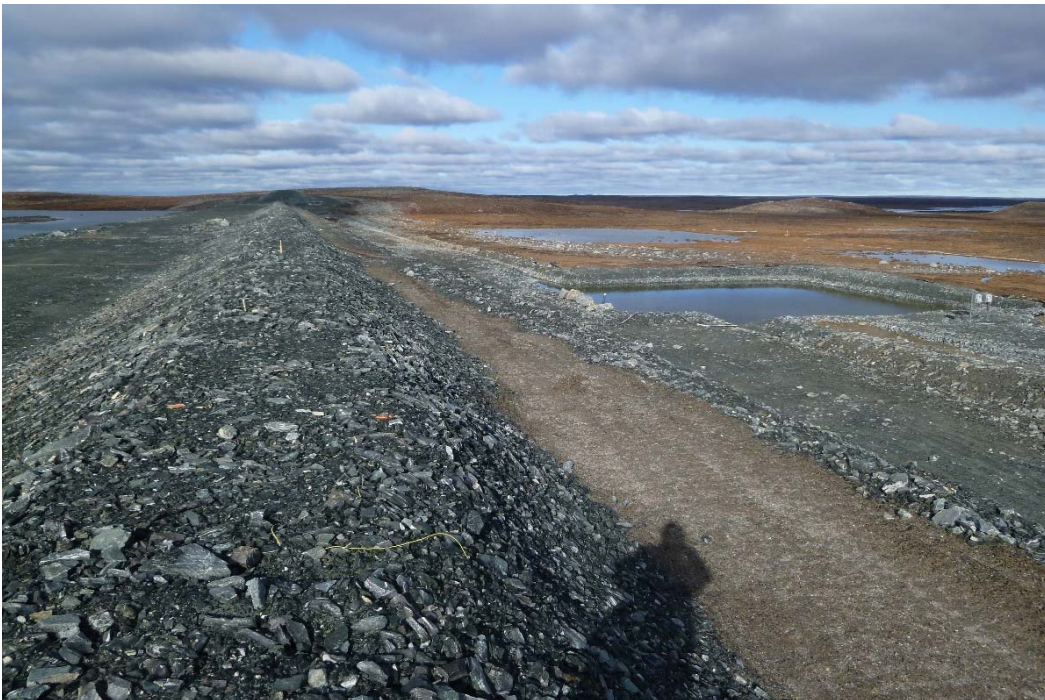
*Photograph 13: D-CP1, Crest and View of Downstream Sump Looking Northeast near Station 1+230 (19 September 2017)*

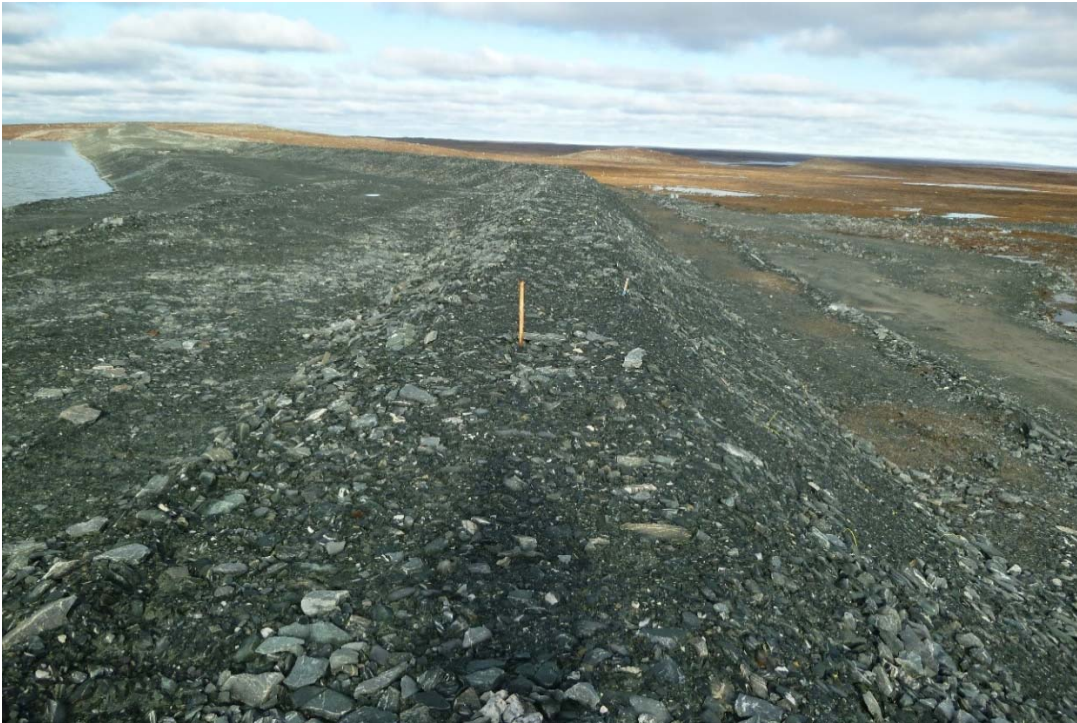
*Photograph 14: D-CP1, Overview of Crest near Station 1+150, and Looking Northeast (19 September 2017)*

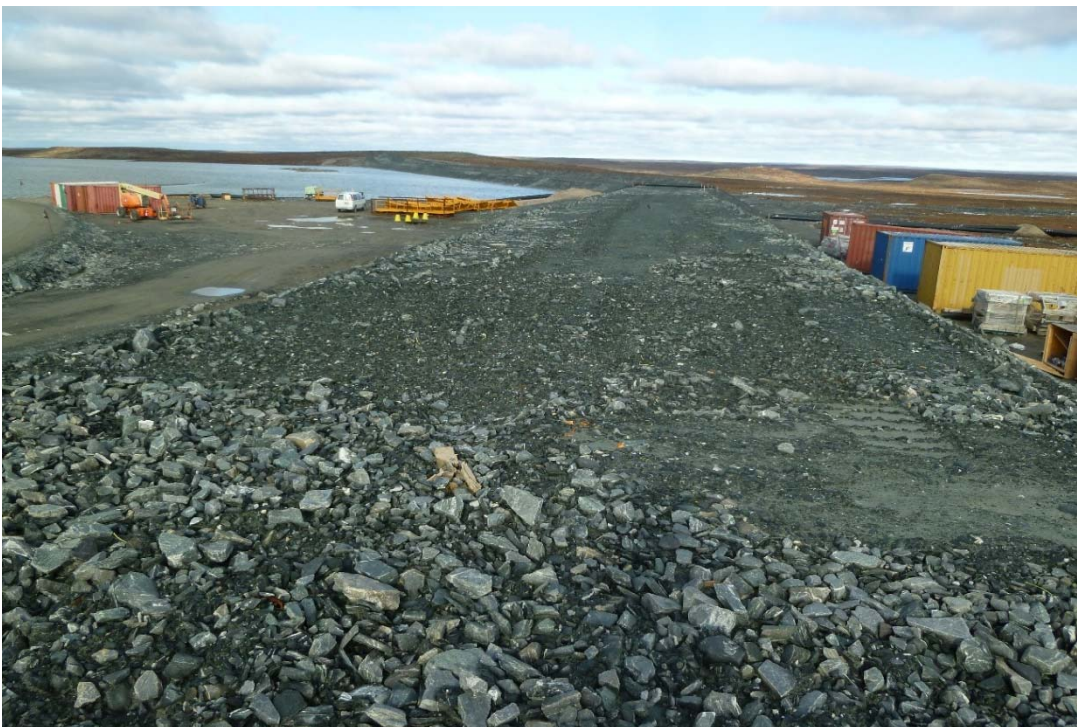
*Photograph 15: D-CP1, Overview of Crest near Station 1+000, and Looking Northeast (19 September 2017)*

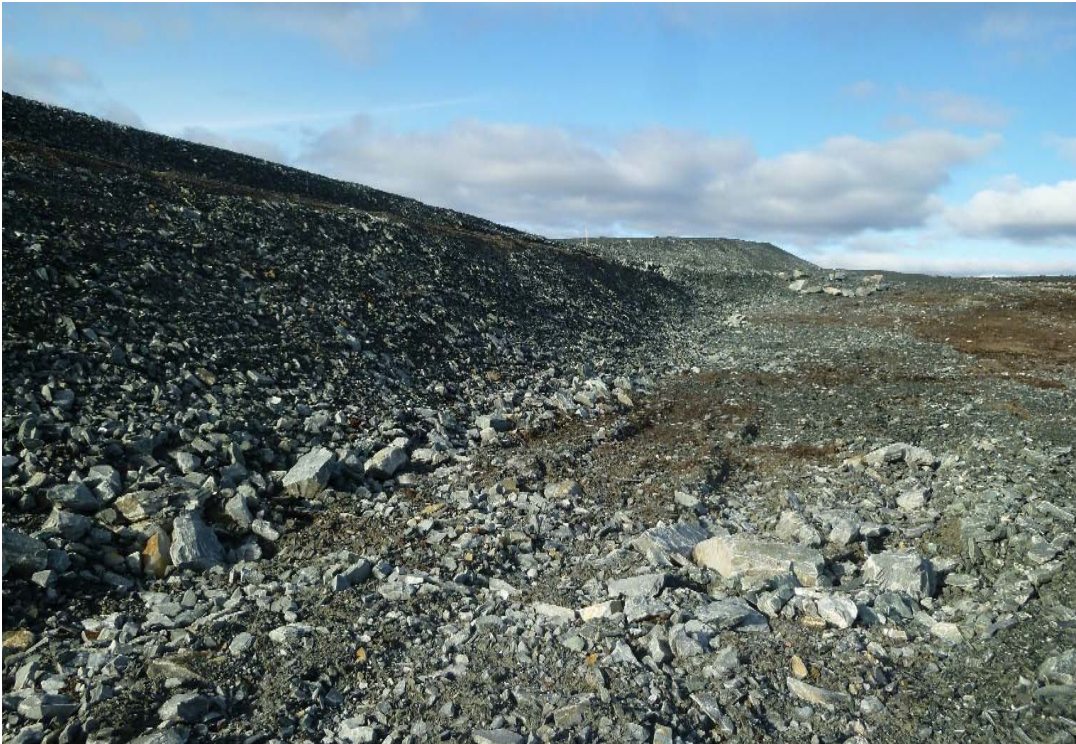
*Photograph 16: D-CP1, Downstream Slope and North Abutment near Station 1+525, Looking North (19 September 2017)*

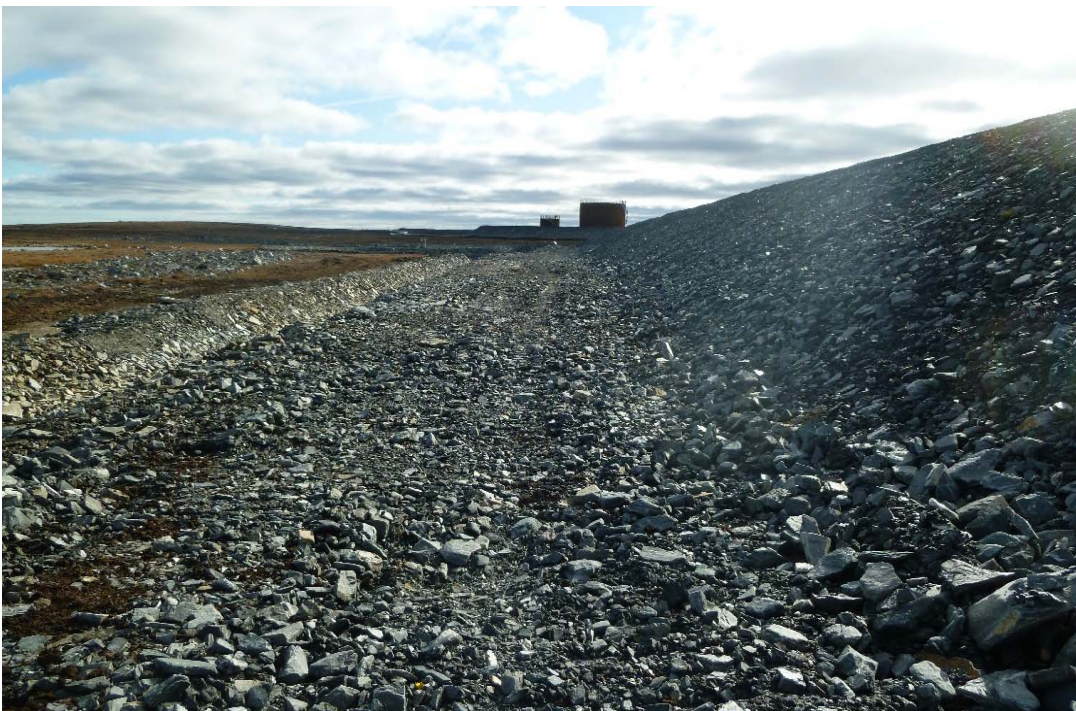
*Photograph 17: D-CP1, Downstream Slope near Station 1+450, and Looking South (19 September 2017)*
